# Merricourt Wind Power Project Topsoil Inspection Report PU-08-932/PU-19-144

*Prepared for:*  
**North Dakota  
Public Service Commission**

The North Dakota Public Service Commission (PSC) retained Wenck Associates, Inc. (Wenck) to complete topsoil inspections during construction of the EDF Renewable Development, Inc. (EDF)/Otter Tail Power Company (OTP) Merricourt Wind Power Project (Project). The purpose of the inspections was to ensure the Project is constructed in compliance with the siting laws and rules and the applicable PSC Orders for the Project, which includes a requirement that topsoil must be segregated from subsoil during Project installation. This Project was initially identified as case PU-08-932 and is understood to ultimately be transferred from EDF Renewable Development, Inc. to Otter Tail Power via PU-19-144.

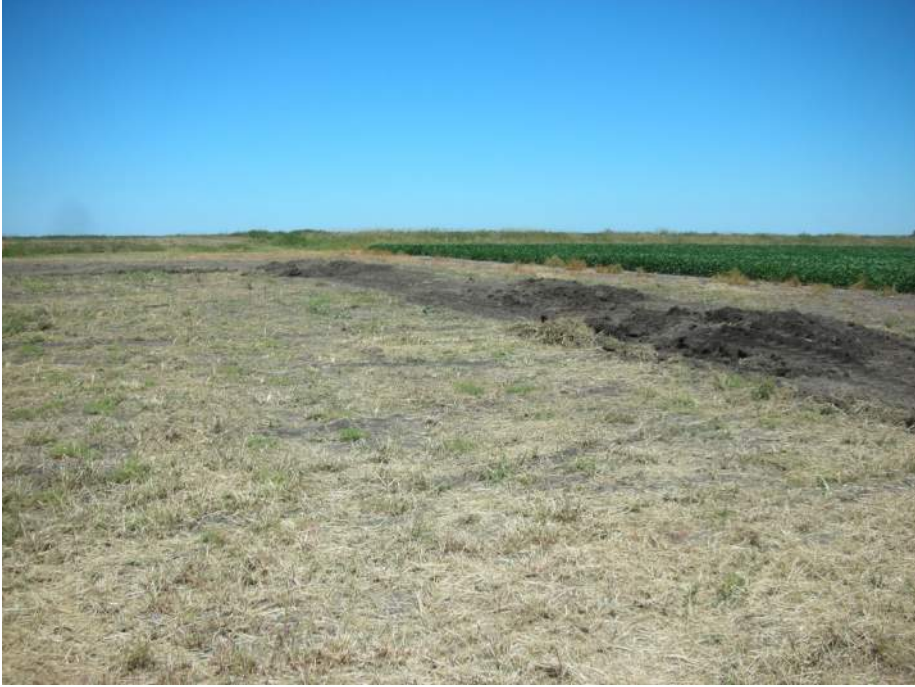
<p><b>Photo Point: 2677n</b></p>	
<p><b>Location of Photo:</b> Lat: 46.14199085 Long: -99.01936055</p>

<p><b>Direction Taken:</b> North <b>Description:</b>  Beginning of topsoil stockpile around the perimeter of the headquarter (O&amp;M) site.</p>	
<p><b>Photo Point: 2678w</b></p>	
<p><b>Location of Photo:</b> Lat: 46.14223434 Long: -99.01936299</p>

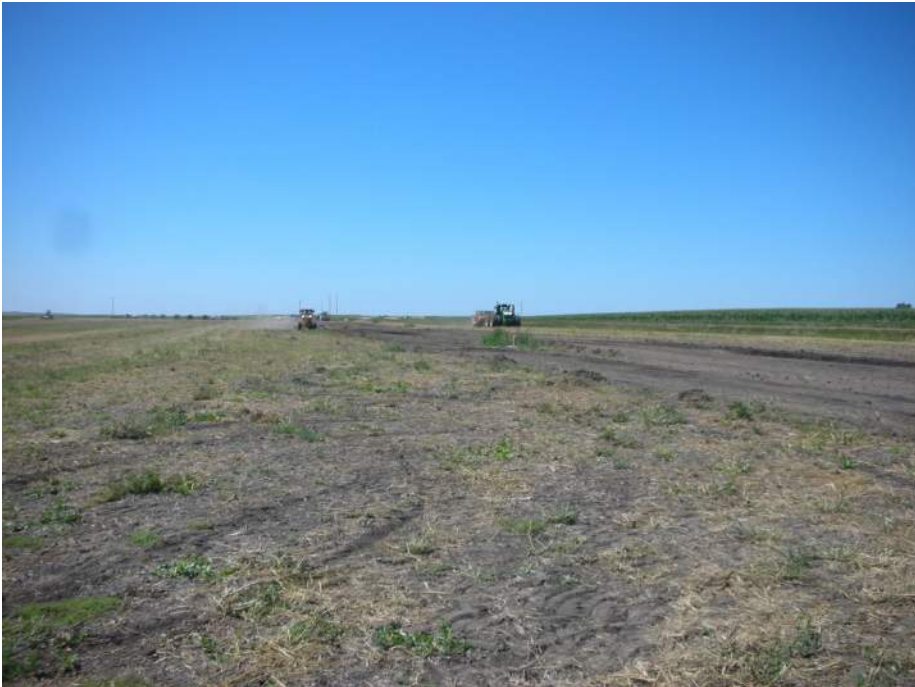
<p><b>Direction Taken:</b> West <b>Description:</b>  Blade and scrapper at work.</p>

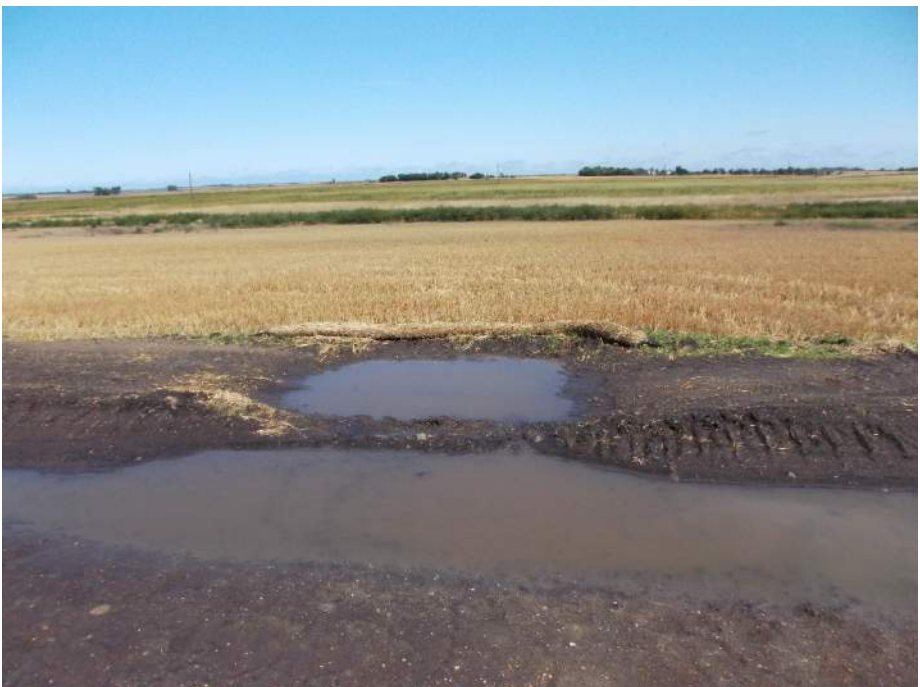
<b>Direction Taken:</b> Northeast  <b>Description:</b> Straw wattle installed in swale along T-29 access road.

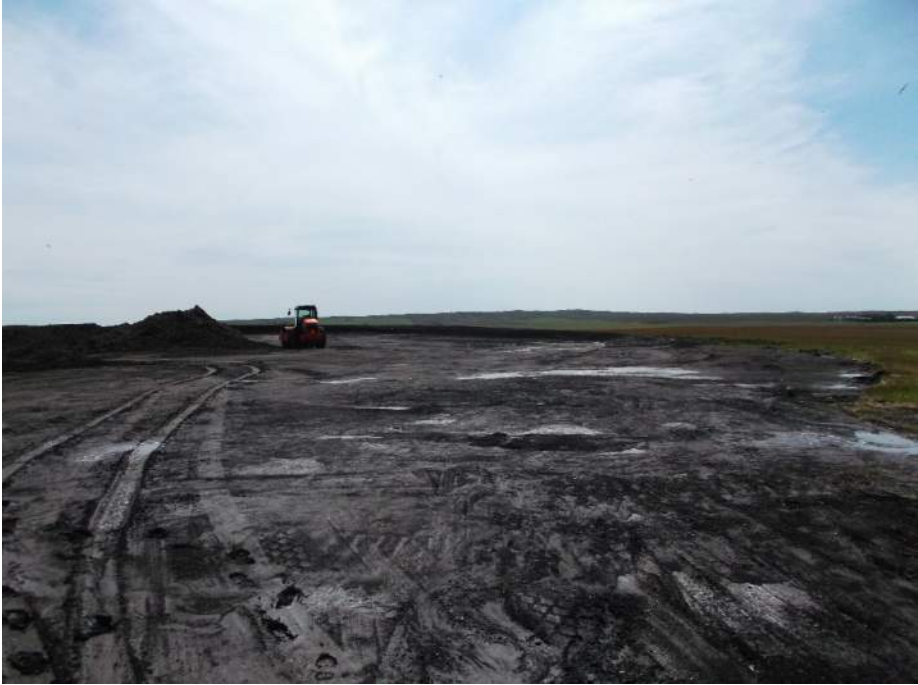
<p><b>Photo Point: 186a</b></p>	
<p><b>Location of Photo:</b>          Lat: 46.140734          Long: -99.049731</p>

<p><b>Direction Taken:</b>          South</p> <p><b>Description:</b>          Overlooking T-29 pad site. Topsoil stripped to color change. Topsoil stockpile within perimeter of site. Subsoil stockpile in center of site from pit dug for foundation.</p>	
<p><b>Photo Point: 186b</b></p>	
<p><b>Location of Photo:</b>          Lat: 46.140734          Long: -99.049731</p>

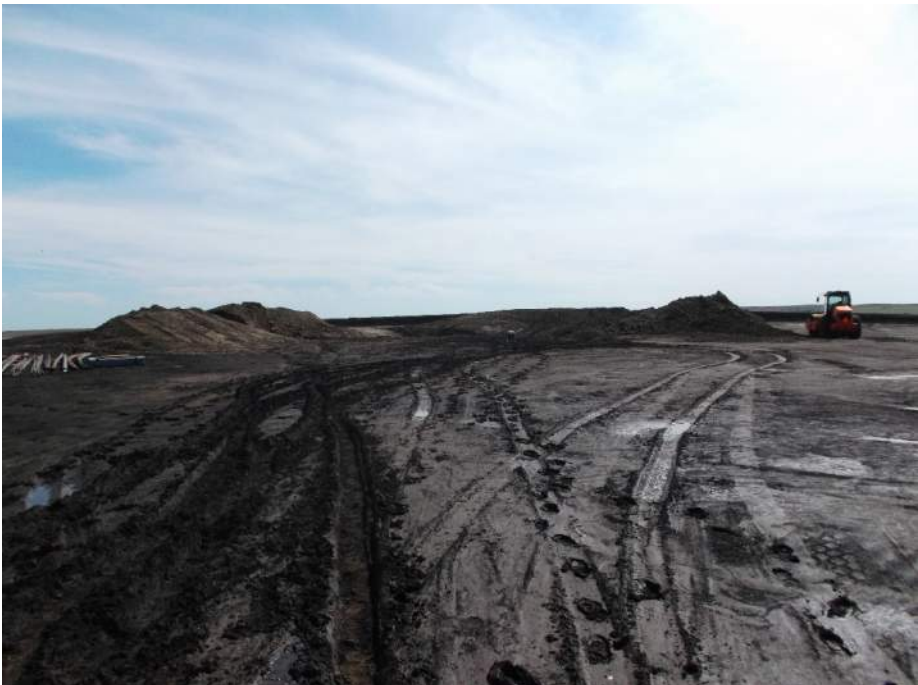
<p><b>Direction Taken:</b>          South-southeast</p> <p><b>Description:</b>          Overlooking T-29 pad site. Topsoil stockpile within perimeter of site. Subsoil stockpile in center of site from pit dug for foundation.</p>

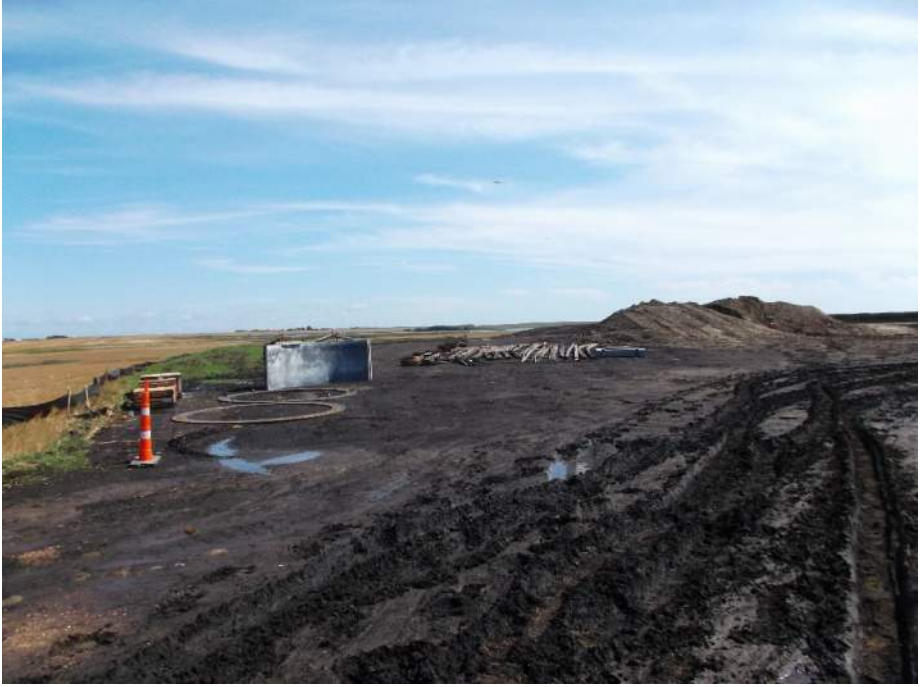
<p><b>Photo Point: 186c</b></p>	
<p><b>Location of Photo:</b>  Lat: 46.140734  Long: -99.049731</p>

<p><b>Direction Taken:</b>  Southeast</p> <p><b>Description:</b>  Overlooking T-29 pad site. Subsoil stockpile in center of site from pit dug for foundation. Silt fence installed.</p>	
<p><b>Photo Point: 187</b></p>	
<p><b>Location of Photo:</b>  Lat: 46.147353  Long: -99.072726</p>

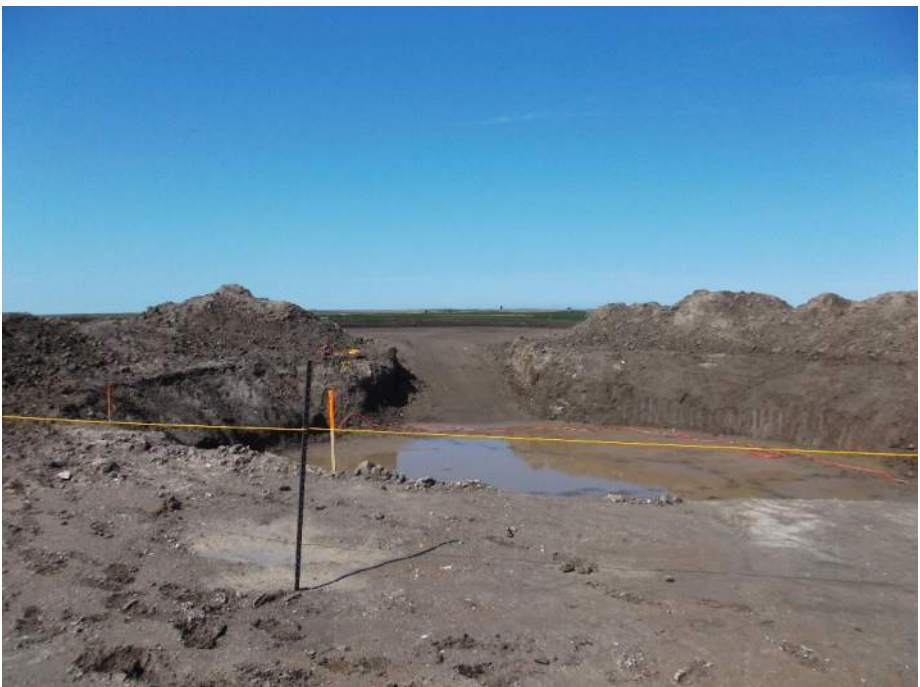
<p><b>Direction Taken:</b>  North</p> <p><b>Description:</b>  Overlooking T-26 pad site. Pit dug for turbine foundation. Topsoil stripped to color change. Topsoil stockpile on north and northwest side of perimeter. Subsoil stockpile placed around foundation pit.</p>

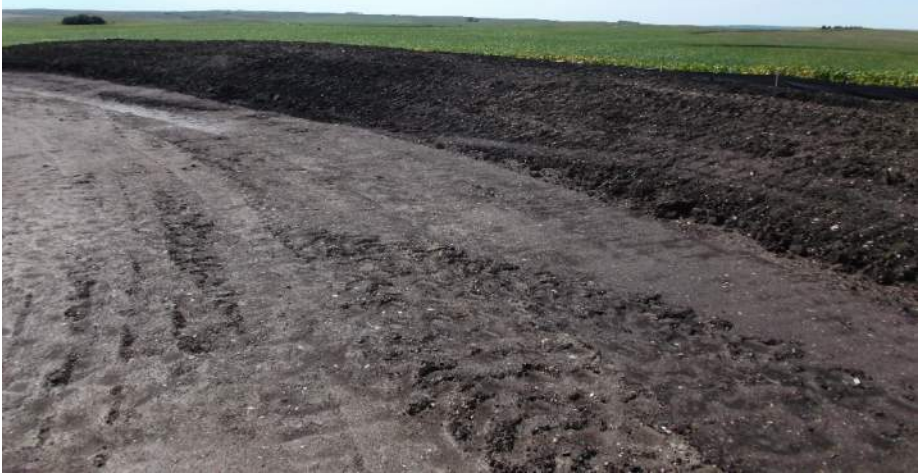
<b>Photo Point: 188a</b>	
<b>Location of Photo:</b> Lat: 46.147756 Long: -99.073191

During site inspections, there was a location where the topsoil stockpile was observed to have some minor mixing with subsoil, which can be expected when working with large heavy machinery. Mr. Hackley and Mr. Peck discussed this issue and it was recommended that a backhoe could collect approximately 3-inches from the top of the stockpile and spread the mixed soil first before applying the remainder of unmixed topsoil. This would ensure that the mixed soil would be kept below the topsoil and any subsoil mixing would be very minimal. Mr. Peck concurred and the issue can be resolved during replacement.

<b>Direction Taken:</b> West-northwest  <b>Description:</b> Topsoil stockpile at T-26 pad site. Some subsoil mixing on right side of photo. Silt fence installed.

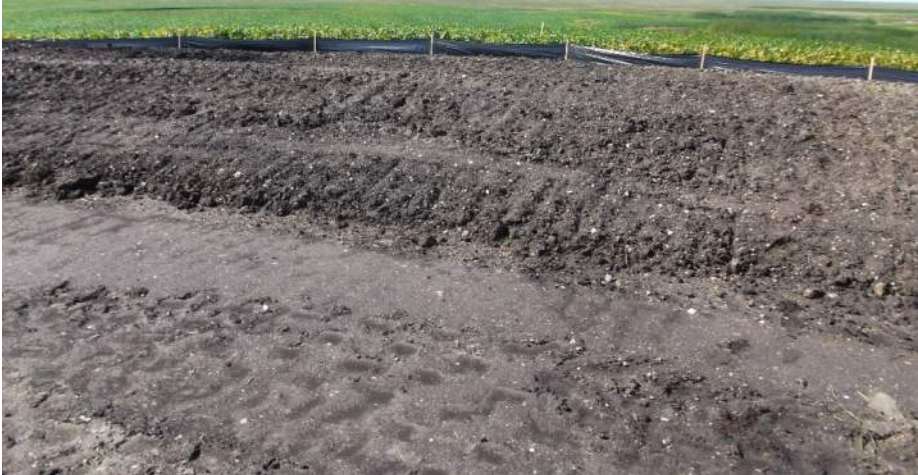
<b>Photo Point: 188b</b>	
<b>Location of Photo:</b> Lat: 46.147756 Long: -99.073191

<b>Direction Taken:</b> Northwest  <b>Description:</b> Continuation of topsoil stockpile at T-26 pad. Subsoil and topsoil mixing continues.

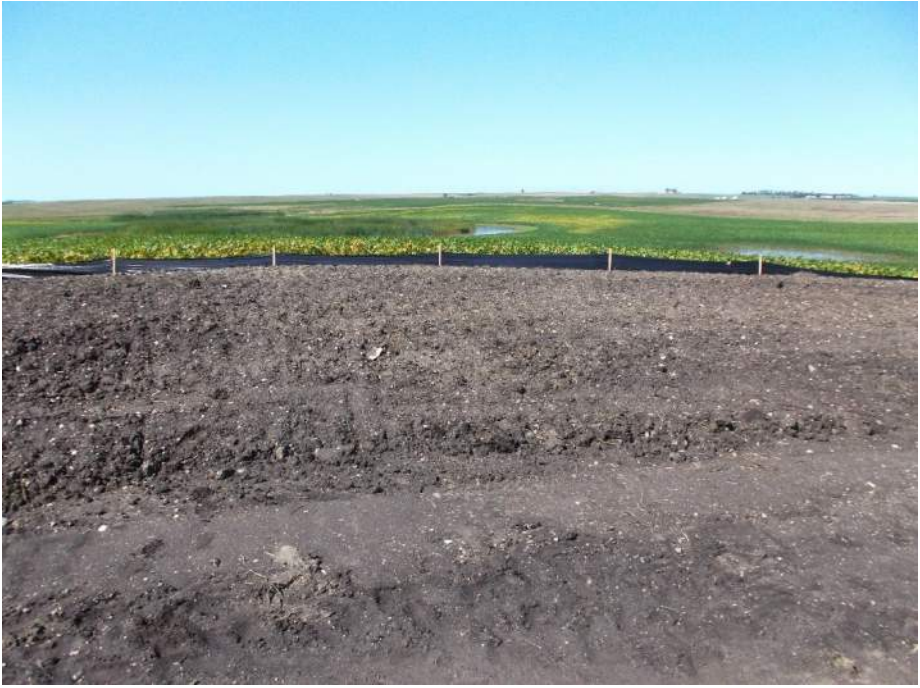
<p><b>Photo Point: 188c</b></p>	<div data-bbox="191 262 488 430"> <p><b>Location of Photo:</b>                      Lat: 46.147756                      Long: -99.073191</p> </div> <div data-bbox="191 430 488 535"> <p><b>Direction Taken:</b>                      North</p> </div> <div data-bbox="191 535 488 1026"> <p><b>Description:</b>                      Continuation of topsoil stockpile at T-26 pad. Subsoil and topsoil mixing continues.</p> </div>

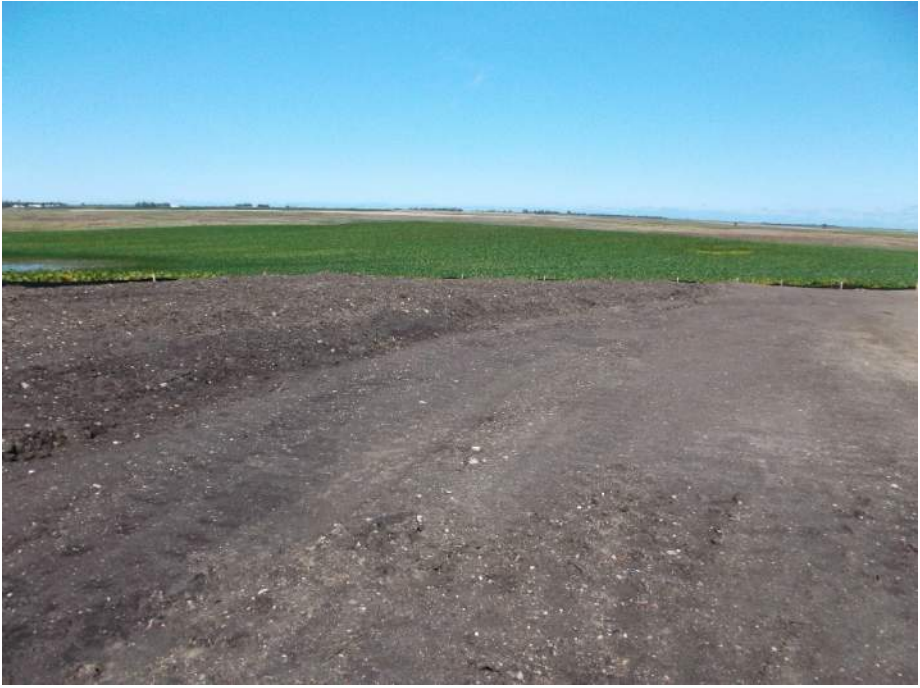
<p><b>Photo Point: 188d</b></p>	<div data-bbox="191 1094 488 1262"> <p><b>Location of Photo:</b>                      Lat: 46.147756                      Long: -99.073191</p> </div> <div data-bbox="191 1262 488 1367"> <p><b>Direction Taken:</b>                      Northeast</p> </div> <div data-bbox="191 1367 488 1856"> <p><b>Description:</b>                      Continuation of topsoil stockpile at T-26 pad. Subsoil and topsoil mixing continues.</p> </div>

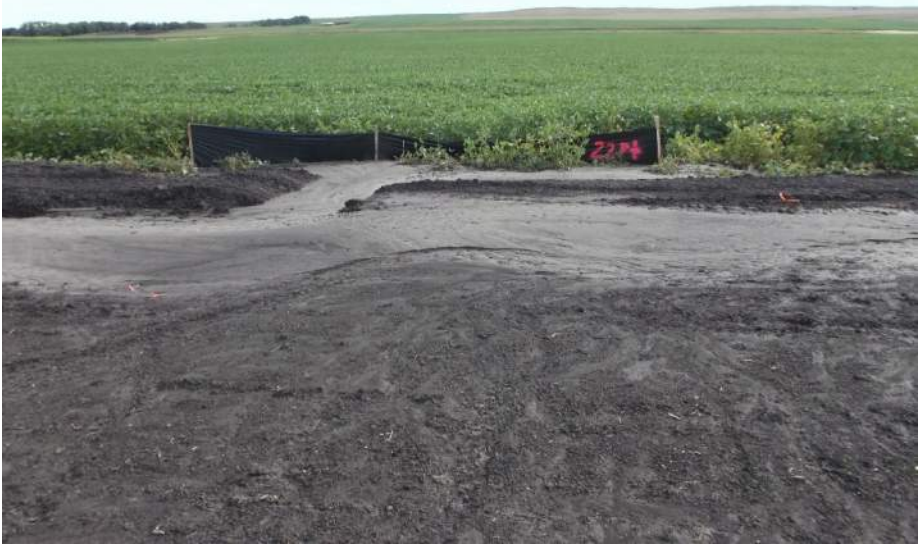
<p><b>Photo Point: 191</b></p>

<p><b>Location of Photo:</b>                  Lat: 46.140615                  Long: -99.006076</p>	
<p><b>Direction Taken:</b>                  South</p> <p><b>Description:</b>                  Silt fence within swale along access road to T-54 pad. Sand sediment contained. Contractor correctly avoided topsoil stockpile in drainage area. Contractor will need to carefully segregate sediments during topsoil replacement.</p>	
<p><b>Photo Point: 192a</b></p>

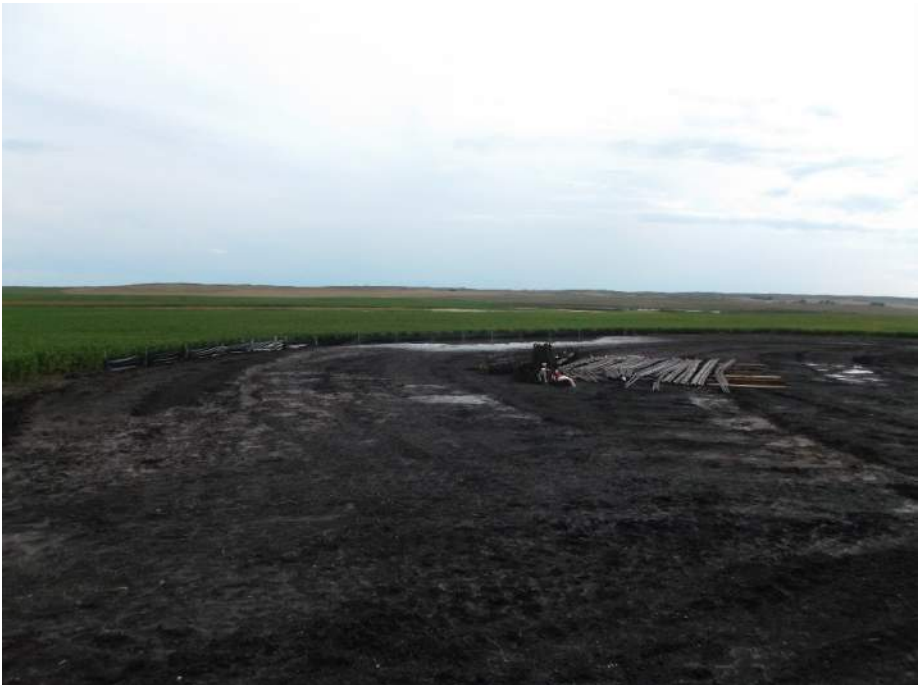
<p><b>Location of Photo:</b>                  Lat: 46.140633                  Long: -99.006286</p>	
<p><b>Direction Taken:</b>                  South</p> <p><b>Description:</b>                  Area stripped to color change at T-54 pad site. Silt fence contained sediment.</p>

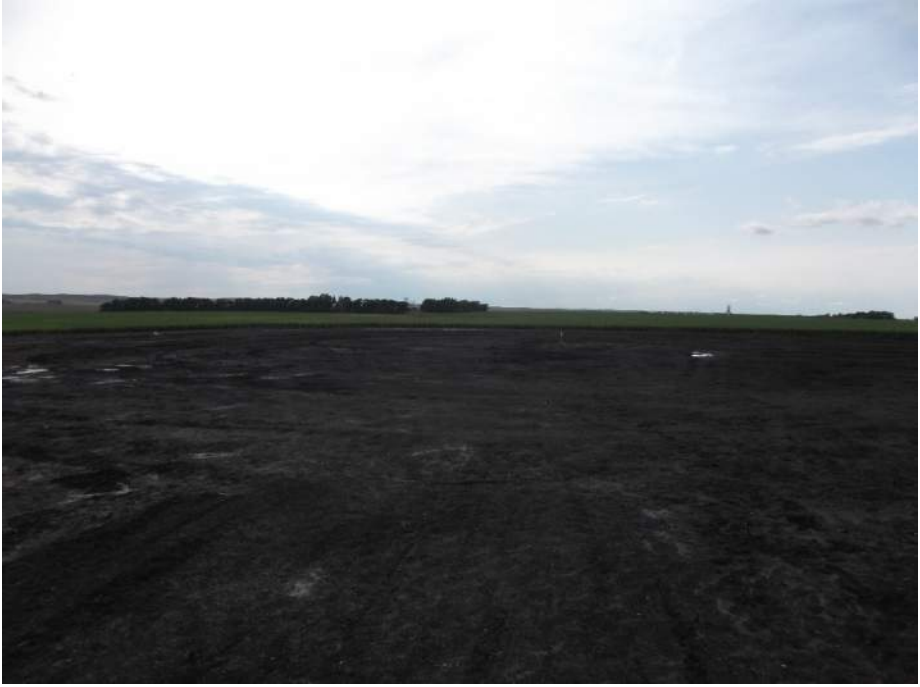
<p><b>Photo Point: 192b</b></p>

<p><b>Location of Photo:</b> Lat: 46.140633 Long: -99.006286</p>	
<p><b>Direction Taken:</b> East</p> <p><b>Description:</b> Overlooking adequately stripped T-54 pad site.</p>	
<p><b>Photo Point: 192c</b></p>

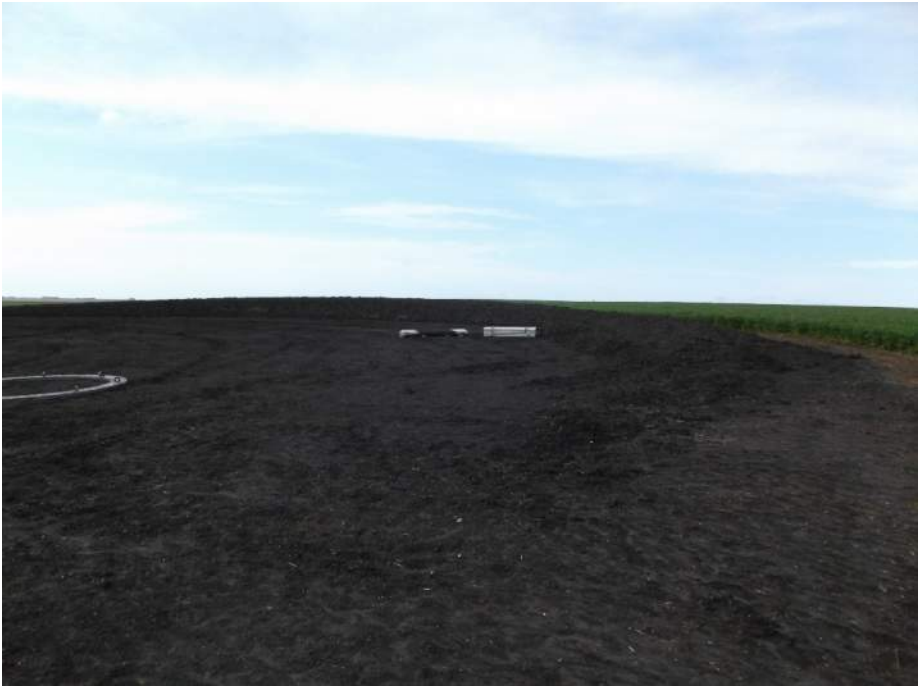
<p><b>Location of Photo:</b> Lat: 46.140633 Long: -99.006286</p>	
<p><b>Direction Taken:</b> Northeast</p> <p><b>Description:</b> Topsoil stockpile within T-54 pad site perimeter.</p>

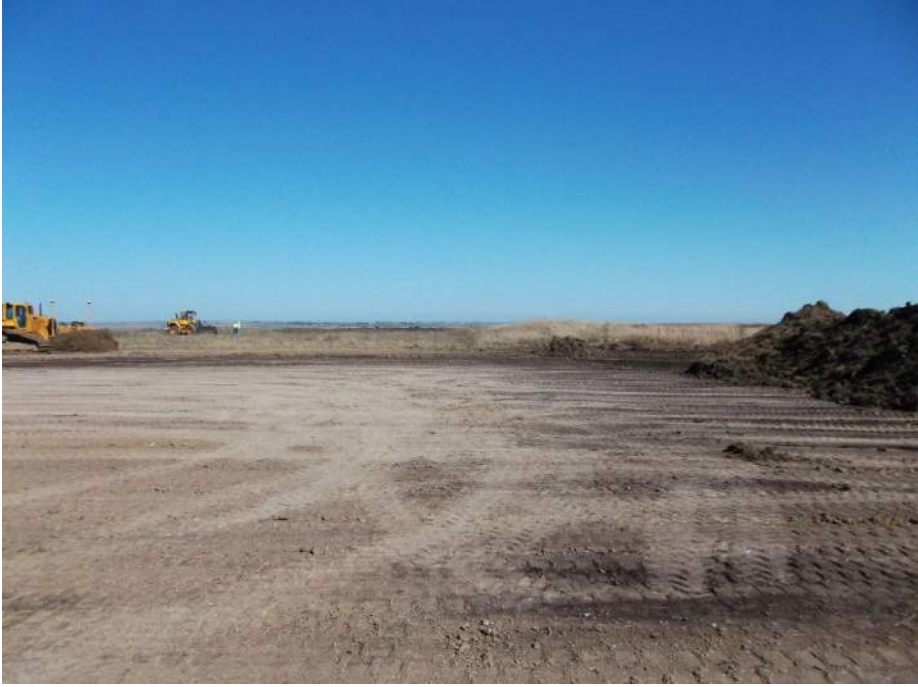
<b>Photo Point: 194b</b>	
<b>Location of Photo:</b> Lat: 46.112238 Long: -99.06498

<b>Direction Taken:</b> North  <b>Description:</b> Overlooking east side of new proposed substation site. Majority of surface soils at site showed violent effervescence with HCl test.	
<b>Photo Point: 195</b>	
<b>Location of Photo:</b> Lat: 46.112994 Long: -99.065592

It is also recommended that the limited topsoil resources located at the proposed new substation site should not be mixed with adjacent, higher quality, natural soil during construction of the Project. Due to the substation site being previously disturbed, the soils are of significantly lower quality and would degrade any other topsoil should it be mixed. This recommendation was further relayed during a 3 October 2019 phone conversation with John Papasergia (EDF).

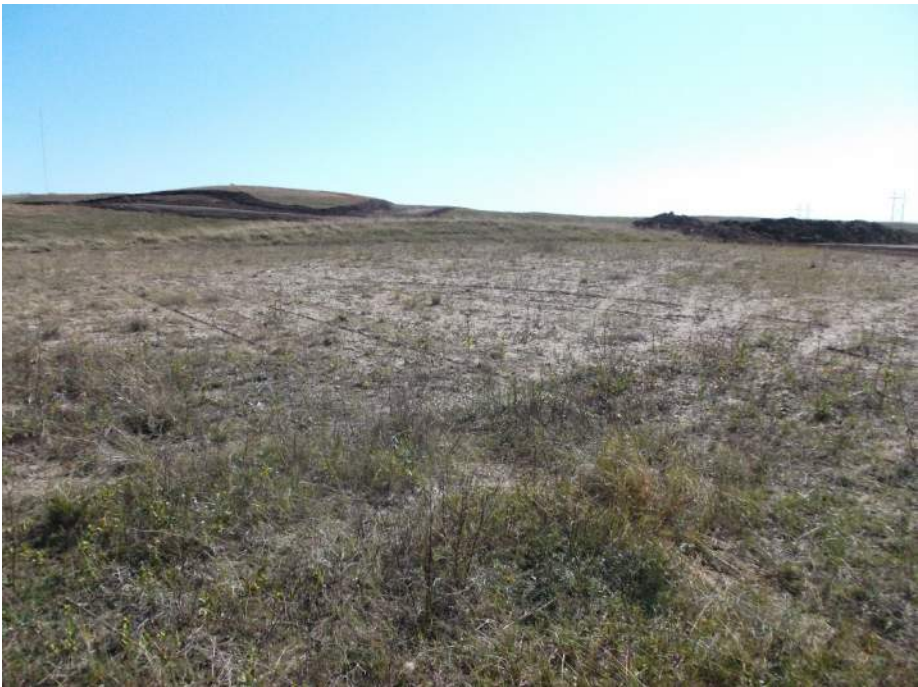
<b>Direction Taken:</b> East  <b>Description:</b> Surface soils within new proposed substation site boundary prior to site stripping. Sparse vegetation suggests in-situ topsoil is limited to non-existent.

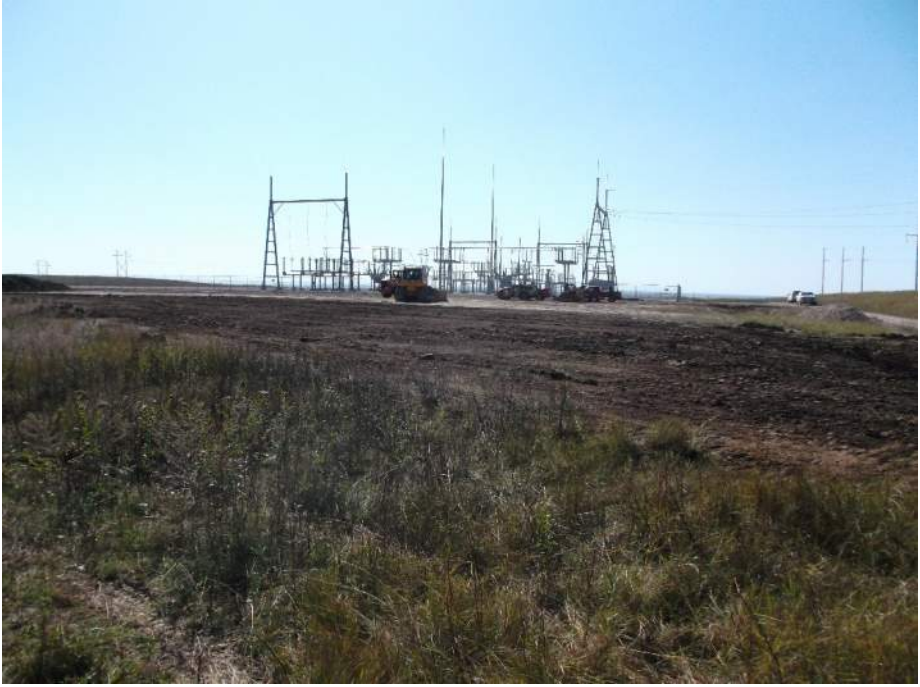
<p><b>Photo Point: 196</b></p>	
<p><b>Location of Photo:</b> Lat: 46.113116 Long: -99.066016</p>

<p><b>Direction Taken:</b> South</p> <p><b>Description:</b> Existing substation adjacent to new proposed substation site.</p>	
<p><b>Photo Point: 197</b></p>	
<p><b>Location of Photo:</b> Lat: 46.112782 Long: -99.066196</p>

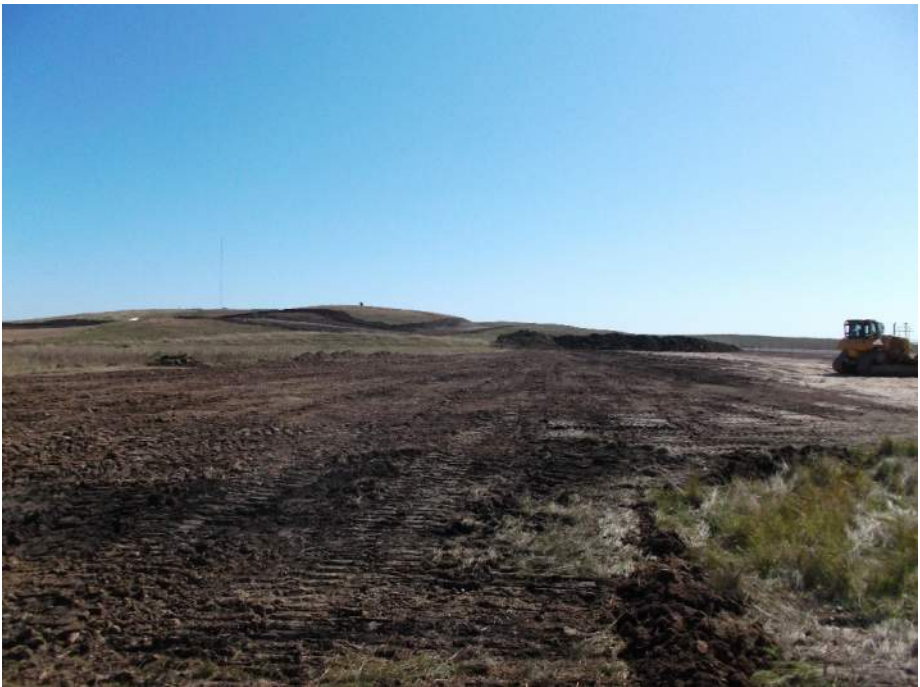
<p><b>Direction Taken:</b> South</p> <p><b>Description:</b> Overlooking new proposed substation site. New stockpile connecting with suspected previous topsoil stockpile</p>
