PU-19-144 Merricourt Wind Power Project Construction Inspection Report

Prepared for:
**North Dakota
Public Service Commission**

Observation Point Photolog

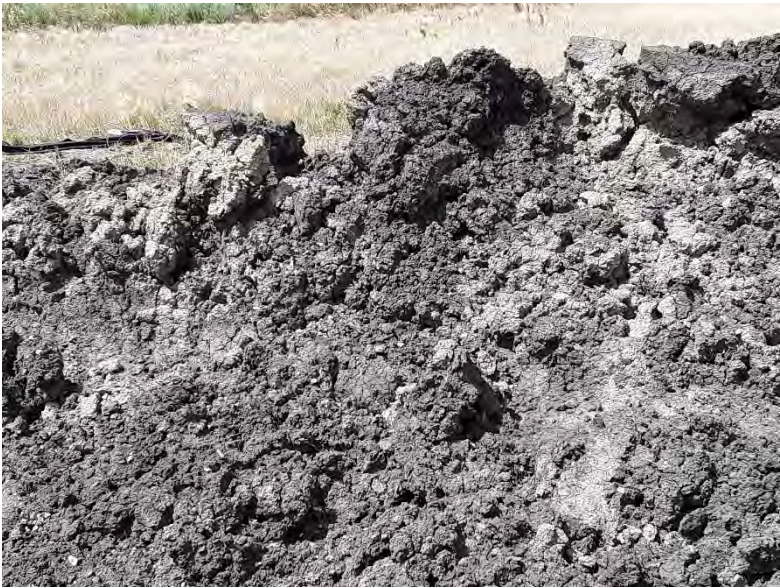
Photo Point: 2829	
Location of Photo: Lat: 46.14072135 Long: -99.03902935

Direction Taken: West Description: Stockpile on the area around Turbine 30, and the face shows minor topsoil/subsoil mixing. Other piles near this tower look appropriate.	
Photo Point: 2830	
Location of Photo: Lat: 46.14095589 Long: -99.03798776	
Direction Taken: N/A Description: Stripped area for Turbine 30. The stripping at this location should have included approximately 3 more inches of topsoil.

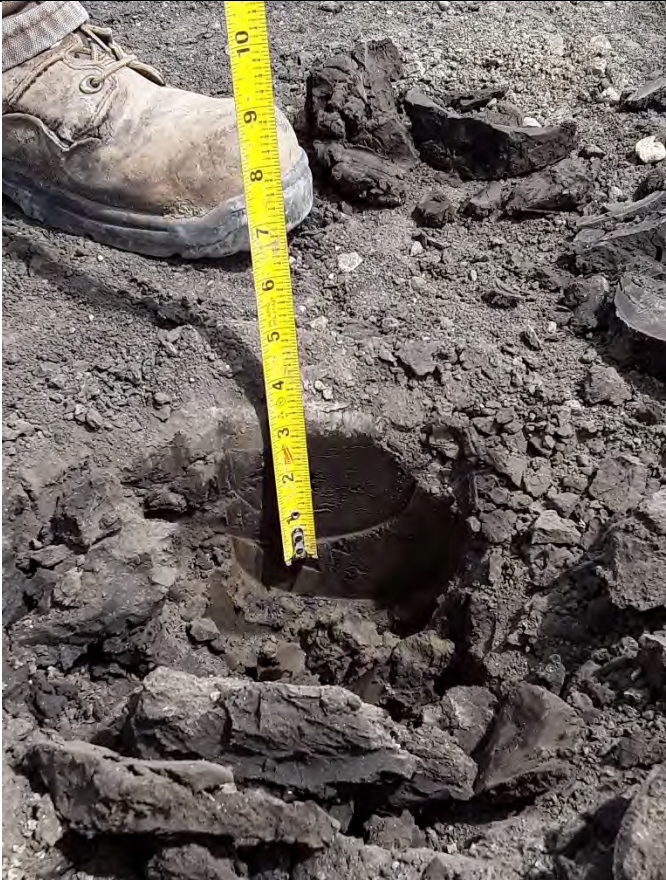
<p>Photo Point: 2831</p>	
<p>Location of Photo: Lat: 46.14110049 Long: -99.03867054</p>	 
<p>Direction Taken: North</p> <p>Description: Overlooking the construction of Turbine Tower 30.</p>	
<p>Photo Point: 2832</p>	
<p>Location of Photo: Lat: 46.147849 Long: -99.072791</p>	 
<p>Direction Taken: North</p> <p>Description: Silt fence near Turbine 26 needs repairs/maintenance before complete failure occurs.</p>

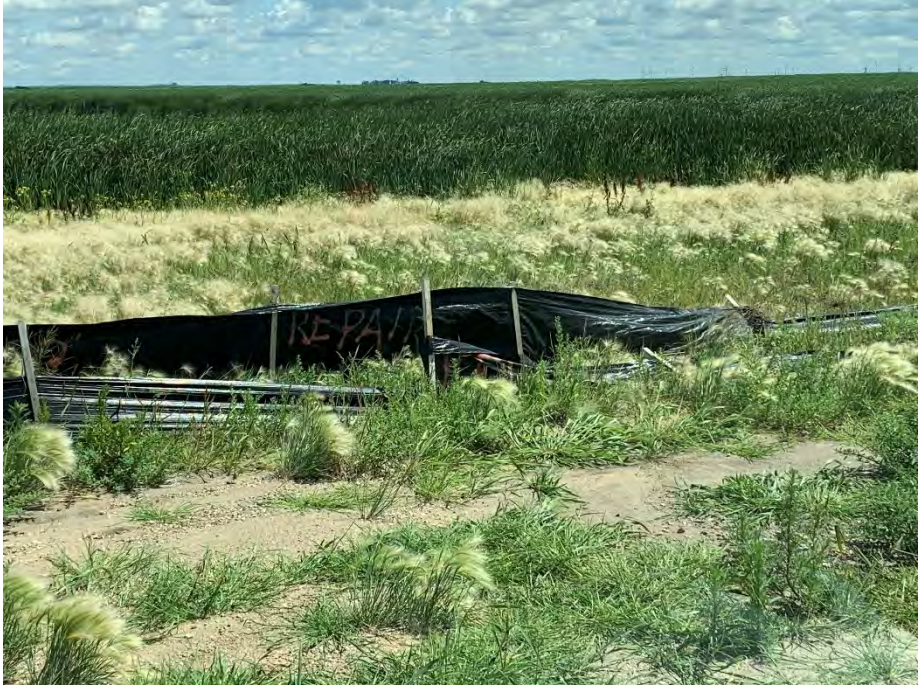
<p>Direction Taken: East</p> <p>Description: Soil erosion along Turbine 26 access road. Silt Fence noted as needing repair.</p>	
<p>Photo Point: Z-3</p>	
<p>Location of Photo: Lat: 46.14569851 Long: -99.0711368</p>

- ▲ Incorporate frequent inspection of erosion control measures, especially along shoulder and backslopes and near waterbodies, as well as frequently monitor, replace, and repair non-functioning BMPs (i.e., silt fences).

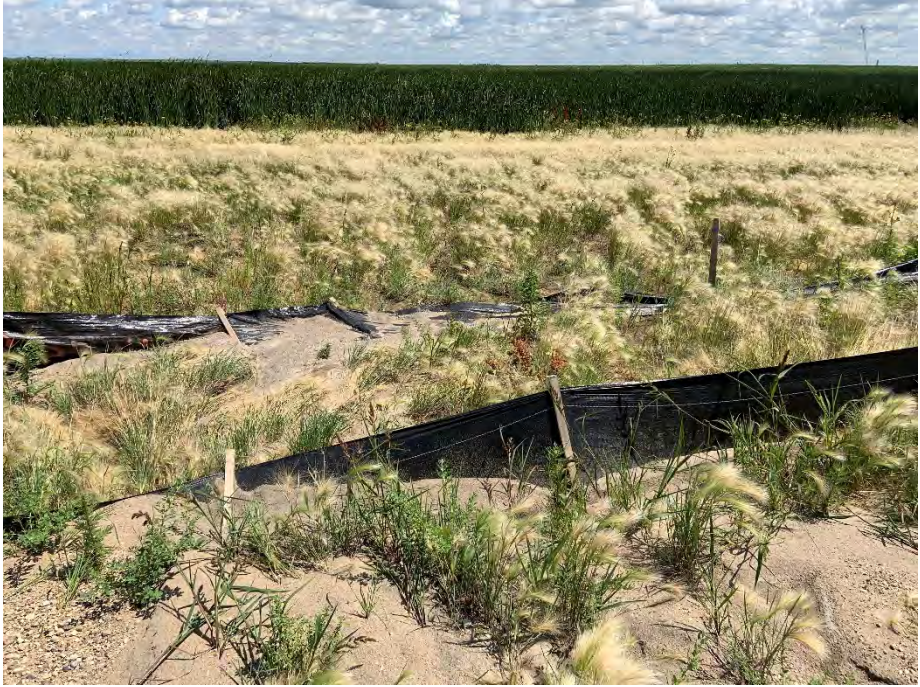
<p>Direction Taken: East</p> <p>Description: Soil erosion along Turbine 26 access road. Silt Fence needs repair.</p>

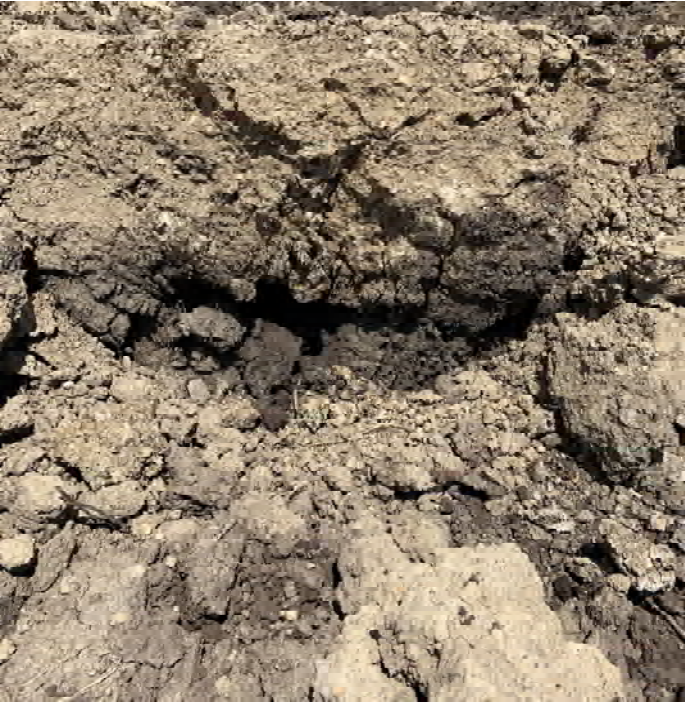
<p>Location of Photo: Lat: 46.11645956 Long: -99.02665577</p>	
<p>Direction Taken: NA</p> <p>Description: Soil mixing present, with subsoil being placed atop in-situ topsoil near Turbine 36.</p>

- ▲ Inquire about previous topsoil stripping and segregation near Observation Points Z-5, Z-6, 2837, 2838, 2840, 2842, 2846, 2847, 2860, 2861 (Turbine Locations 36, 48, 49, MET2 and MET2 access road) and proposed reclamation techniques.

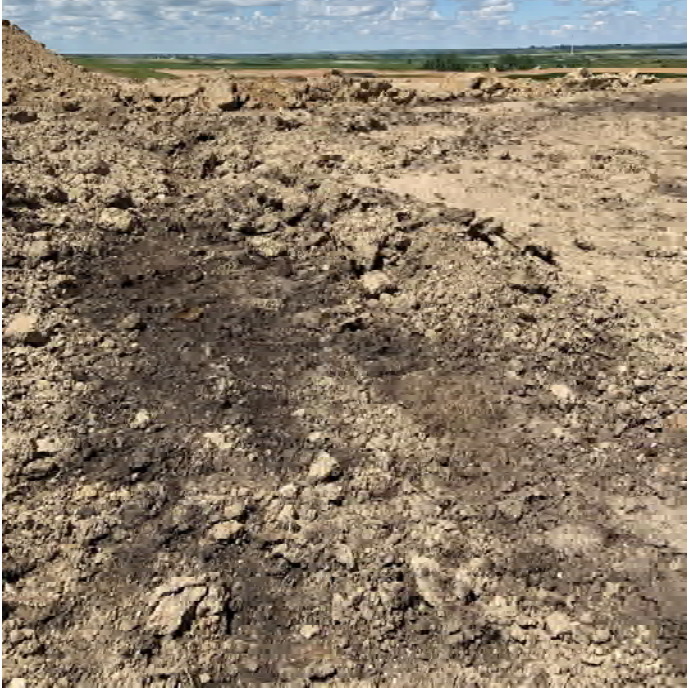
<p>Photo Point: Z-6</p>

<p>Location of Photo: Lat: 46.11645956 Long: -99.02665577</p>	
<p>Direction Taken: South</p> <p>Description: Soil mixing present, with subsoil being placed atop in-situ topsoil. Turbine 36.</p>	
<p>Photo Point: Z-7</p>

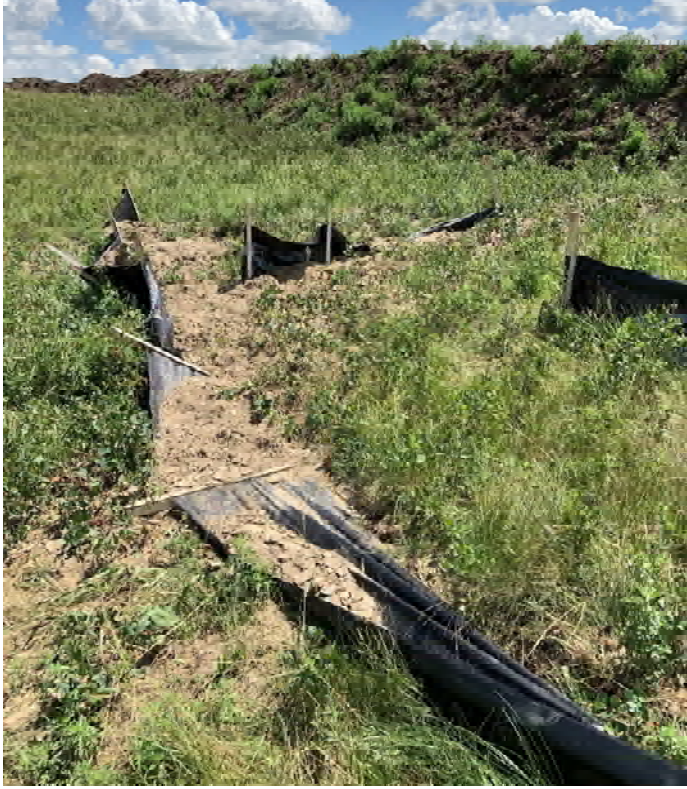
<p>Photo Point: Z-8</p>

<p>Location of Photo: Lat: 46.11689514 Long: -99.027656</p>	
<p>Direction Taken: East</p> <p>Description: Soil Erosion visible from a failing sediment fence needing repair. Turbine 36.</p>	
<p>Photo Point: Z-9</p>

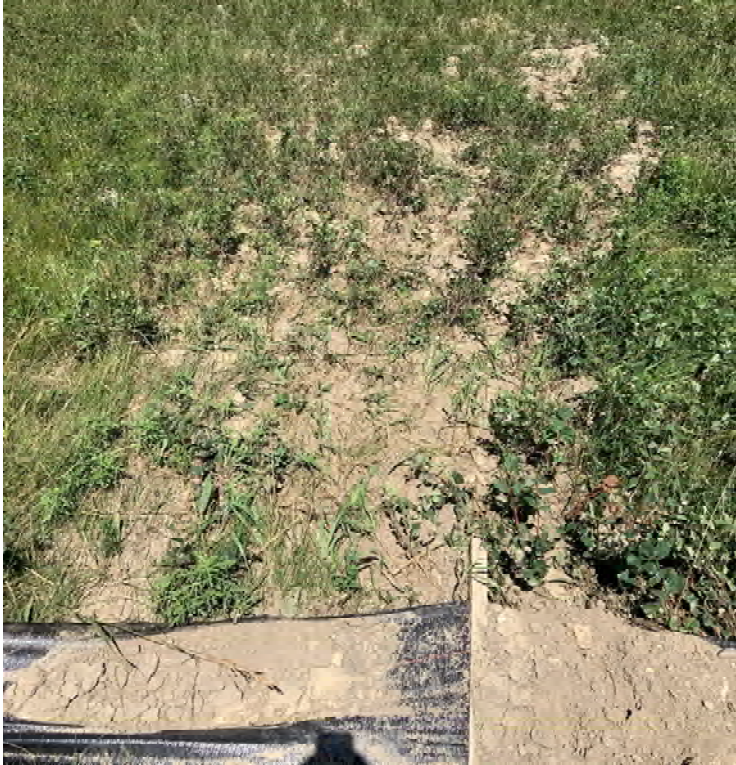
<p>Location of Photo: Lat: 46.11689514 Long: -99.027656</p>	
<p>Direction Taken: North</p> <p>Description: Soil Erosion and washout area visible from a failing sediment fence needing repair. Turbine 36.</p>

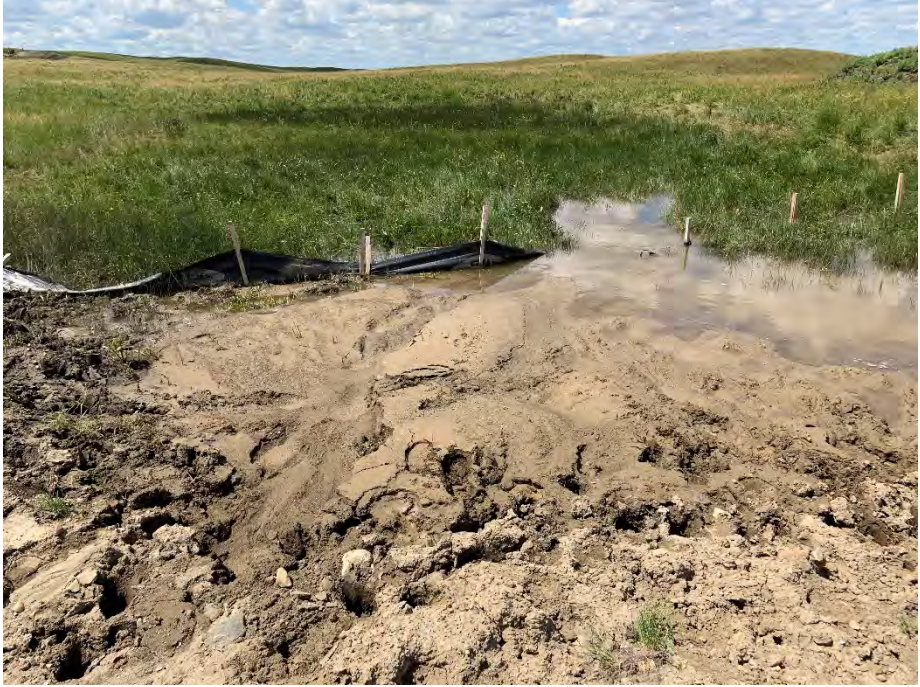
<p>Photo Point: Z-10</p>	
<p>Location of Photo: Lat: 46.11598029 Long: -99.02785801</p>

<p>Direction Taken: Northwest</p> <p>Description: Runoff and sediment erosion entering pothole wetland. Turbine 36.</p>	
<p>Photo Point: Z-11</p>	
<p>Location of Photo: Lat: 46.141357 Long: -99.038387</p>

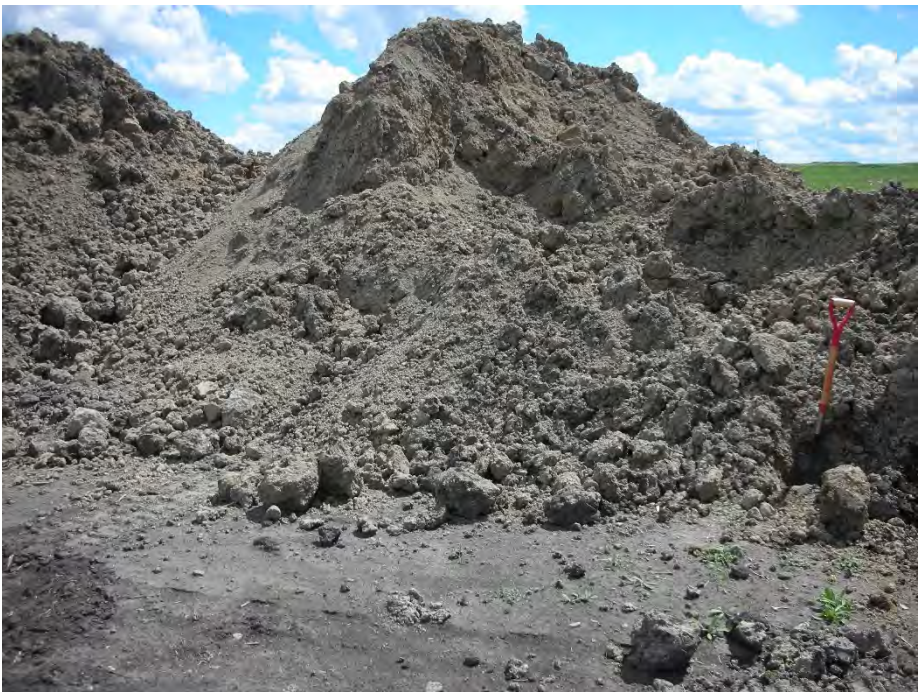
Direction Taken: Northeast Description: Subsoil in stockpile appears to be segregated from topsoil, but is piled on unstripped in-situ topsoil.

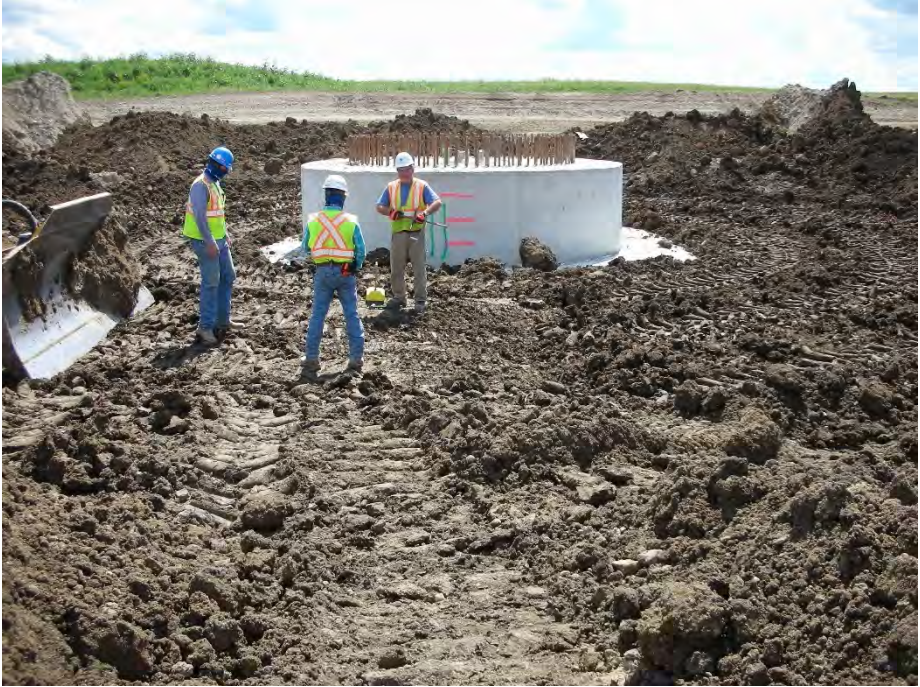
<p>Photo Point: 2841</p>

5. Use of mixed topsoil as subsoil backfill (**Observation Points 2841, 2848**).
 - a. Both points had no discernable soil segregation. Crews backfilling foundations were not able to identify which stockpiles were topsoil or subsoil at point 2848. Discussion with Wanzek crews onsite revealed issues obtaining desired Soil Proctor results during compaction testing (i.e., reporting 92% vs. specified 95%) and admitted subsoil was stockpiled atop in-situ topsoil.

<p>Location of Photo: Lat: 46.07959267 Long: -99.0482143</p>	
<p>Direction Taken: South</p> <p>Description: Wanzek crew backfilling a poured pad for Turbine 49. Some mixed topsoil was observed being returned as subsoil for compaction and proctor testing.</p>	
<p>Photo Point: 2842</p>

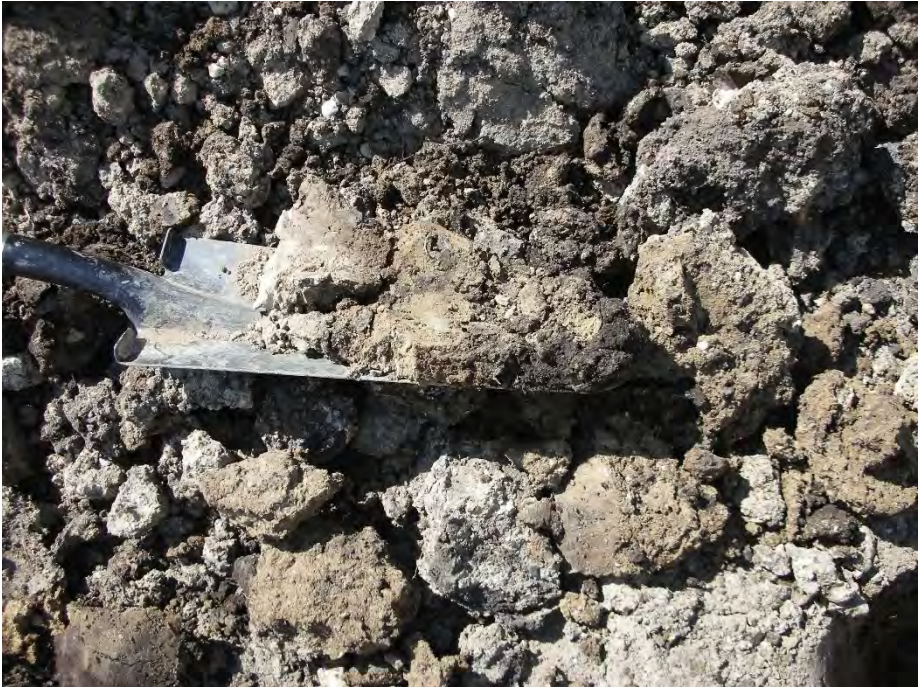
<p>Location of Photo: Lat: 46.07955069 Long: -99.04801241</p>	
<p>Direction Taken: West</p> <p>Description: Mixed soil stockpile placed on top of unstripped in-situ topsoil at Turbine 49 site.</p>

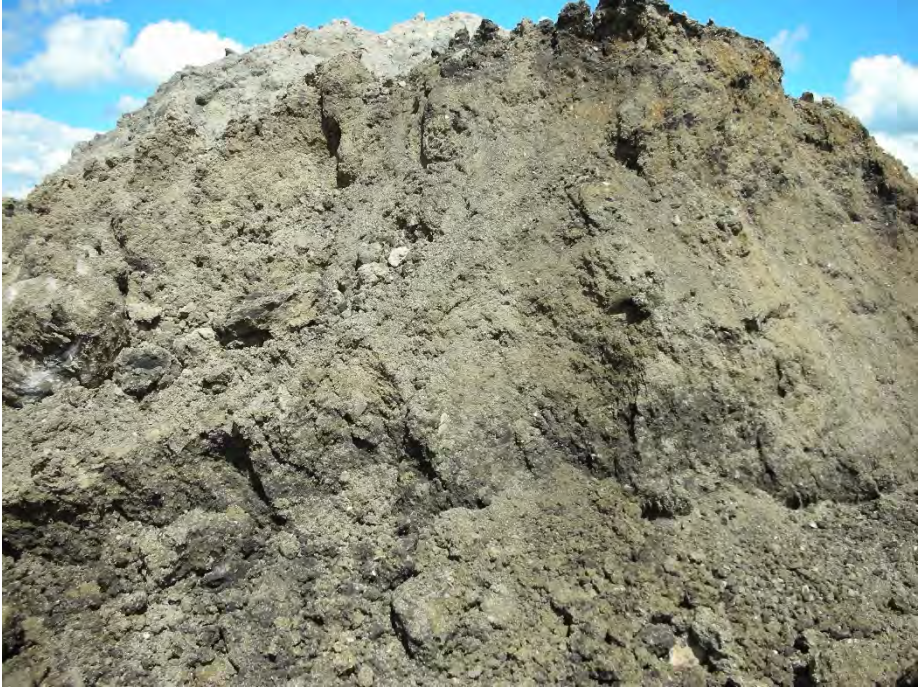
A close-up view of the open stockpile face. The soil is dark and appears to be mixed with some larger rocks or clumps. The texture is rough and uneven. The background shows a clear blue sky with some light clouds.
<p>Location of Photo: Lat: 46.07955069 Long: -99.04801241</p>	
<p>Direction Taken: East</p> <p>Description: Open stockpile face displays mixed soil being used as backfill at Turbine 49.</p>

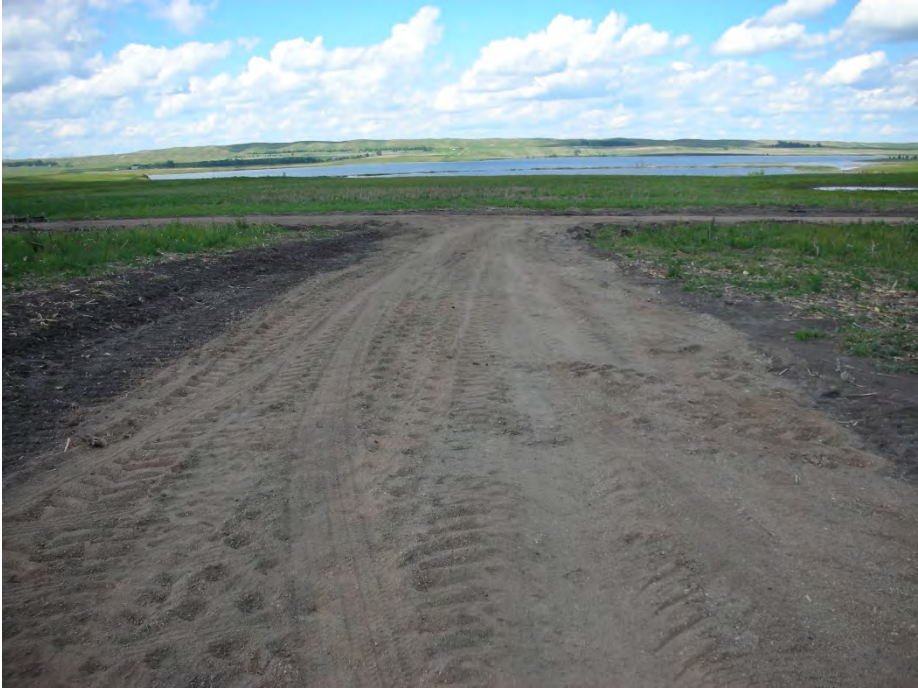
1. Access Roads not stripped of topsoil (**Observation Points 2846, 2847, 2860, 2861**).
 - a. Project map indicates MET2 contains a permitted primary access road. Approximately 8-inches of unstripped topsoil remained underneath the placed gravel at observation point 2846/2847.

<p>Location of Photo: Lat: 46.07899856 Long: -99.04484566</p>	
<p>Direction Taken: North</p> <p>Description: Road to MET2 Tower not stripped of topsoil. Class 5 and/or grade (gravel) laid on top. Wanzek crew mentioned this will likely be a permanent road.</p>

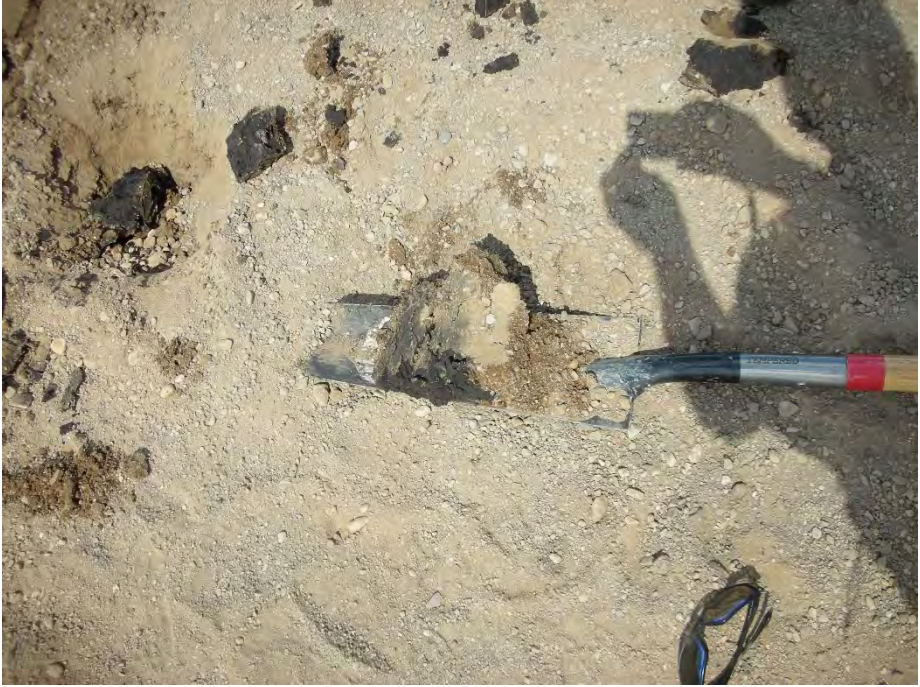
Photo Point: 2847	
Location of Photo: Lat: 46.07899856 Long: -99.04484566

Direction Taken: North Description: Profile slice of soil on access road to MET2 Tower. Road to MET2 Tower not stripped of topsoil. Class 5 and/or grade (gravel) laid on top of in-situ topsoil. Topsoil appeared to be compacted.	
Photo Point: 2848	
Location of Photo: Lat: 46.07867418 Long: -99.04486776

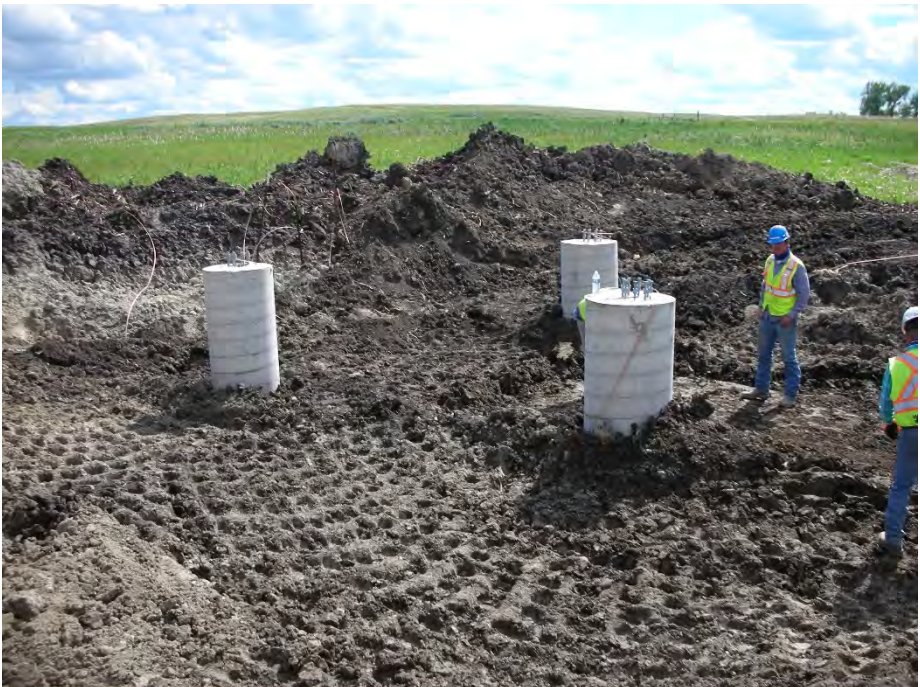
Direction Taken: South Description: No discernable soil segregation at stockpiles around MET2 Tower. Stockpiles contained a mix a topsoil and subsoil.

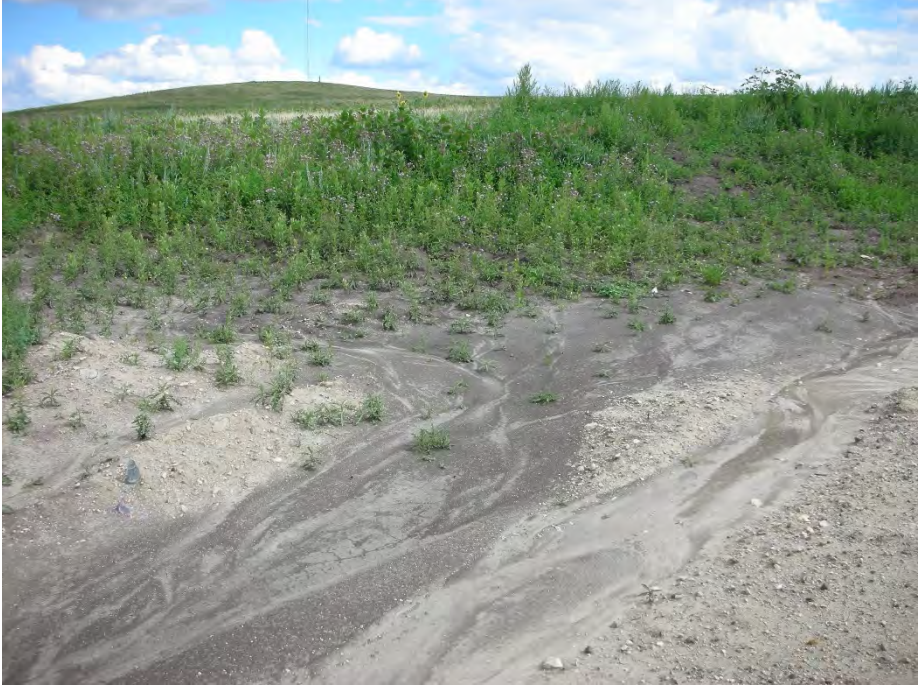
<p>Photo Point: 2853</p>

<p>Location of Photo: Lat: 46.11545849 Long: -99.06188194</p>	
<p>Direction Taken: Southeast</p> <p>Description: Minor topsoil erosion off topsoil stockpile.</p>	
<p>Photo Point: 2854</p>

- ▲ Implement erosional control methods for covering topsoil stockpiles, such as hydromulches, to prevent erosion of stockpiled topsoil, especially if stockpiled soil is to be left over winter.

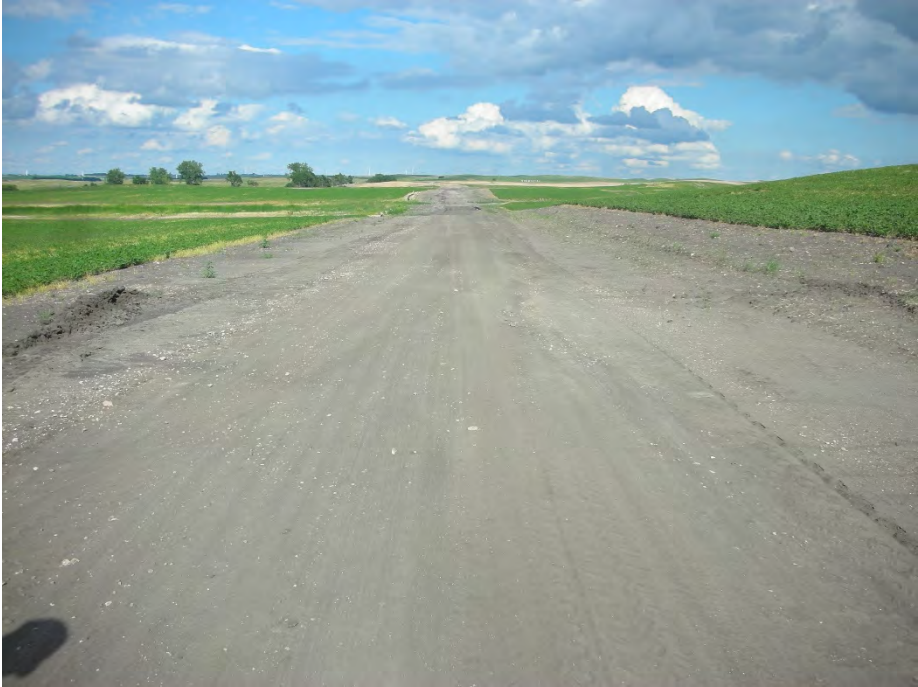
- b. Follow-up discussion after the construction inspection with John Papasergia informed Wenck that points 2860/2861 were at the temporary "A" road, which is proposed to be removed and reclaimed by Wanzek in the near future.

<p>Location of Photo: Lat: 46.12119102 Long: -99.04374281</p>	
<p>Direction Taken: East</p> <p>Description: Access road not stripped of topsoil. Adjacent undisturbed areas had 12" of topsoil, and there was 6" of topsoil remaining on the road. EDF contact mentioned in follow-up call that this temporary road will be decommissioned.</p>

- ▲ Implement methods to alleviate compaction during abandonment and reclamation at temporary road "A" as documented at observation point 2860/2861.
- ▲ Inquire as to how stripping information is disseminated across the construction crews and organization for soil handling work. If construction crews cannot identify stockpile types, inquire as to what communication methods and available information is used to distinguish the appropriate use for stockpiled soil replacement.
