**Merricourt Wind Power Project
As-Built Inspection Report**

File No. 227701305

November 2021

**North Dakota Public Service
Commission**

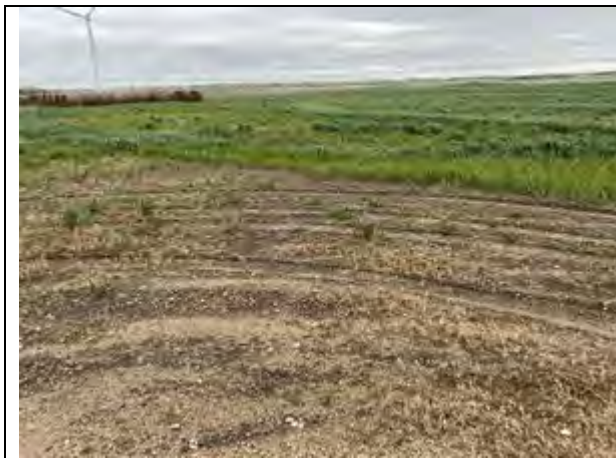
Observation Point: 3

Multiple turbines, collection lines, drain crossings, and access roads were inspected by Stantec, and the observation points were consistent with the as-built shapefiles (**Observation Points 3, 5, 10, 25, 49, 71, and 75**). Stantec also observed a total of 75 constructed turbines and 6 unconstructed alternate turbines according to the As-Built drawings submitted to the PSC (PU-08-932 Docket 272). Additionally, unconstructed alternate turbine locations were inspected, and observed to be in compliance with the As-Built plans (**Observation Point 54**).

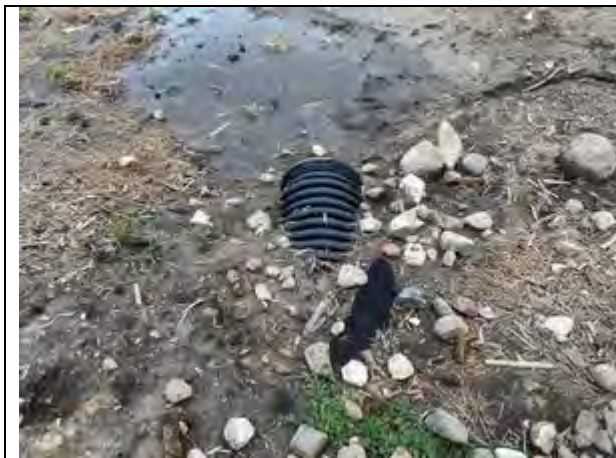
Observation Point: 45

Stantec observed several areas of construction within the USFWS easement tracts (**Observation Points 45, 46, and 47**). These points were observed to be an area of erosion from Drain Crossing #81, as identified in the As-Built drawings, into a farm field and could potentially be filling into a wetland within the easement area.

According to Section 7.14 of Docket 225 2nd Amendment to Application for a Certificate of Site Compatibility and Docket 272 Letter enclosing As-Built maps and Drawings, Stantec is of the opinion it appears EDF avoided wetlands under USFWS easements to the extent possible by rerouting collection lines and utilizing alternate turbine locations. However, to avoid impacts to these easement, Stantec recommends PSC inquire about repairing drain crossings and installing BMP's (See **Section 5.2.6.1**).
