N O R T H  
**Dakota** | Environmental Quality  
 Be Legendary.™

October 3, 2019

**April 13<sup>th</sup>, 16<sup>th</sup>, and 28<sup>th</sup>, 2015 portions of inspection reports attached.**

## INSPECTION REPORT

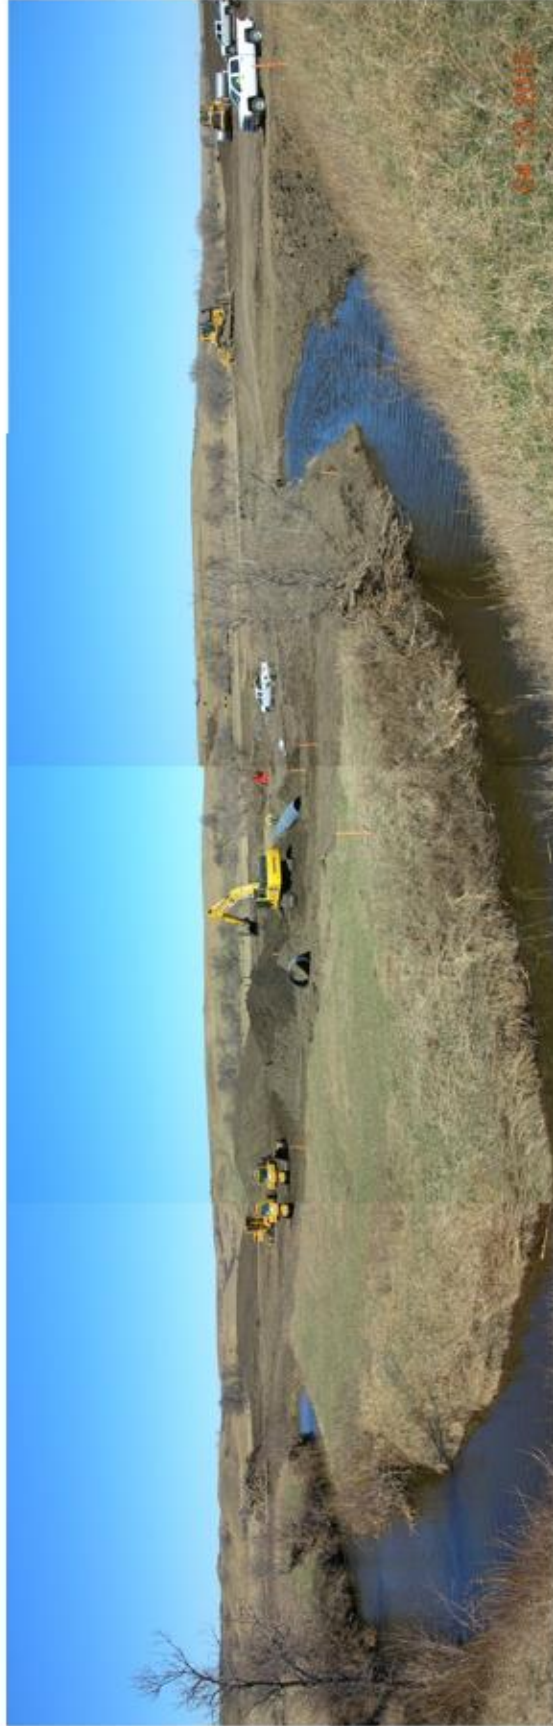
**Figure 3. SPGM removal for a four-acre segment of the Shop Access Road on both sides of Coyote Creek with a temporary topsoil stockpile in left background and a temporary subsoil stockpile in middle background – facing west with fence line in center-west marking the section line common to Section 30 on right (north) and Section 31 on left (south) – photograph taken south of large white hoop building pictured in right background in Figure 1**

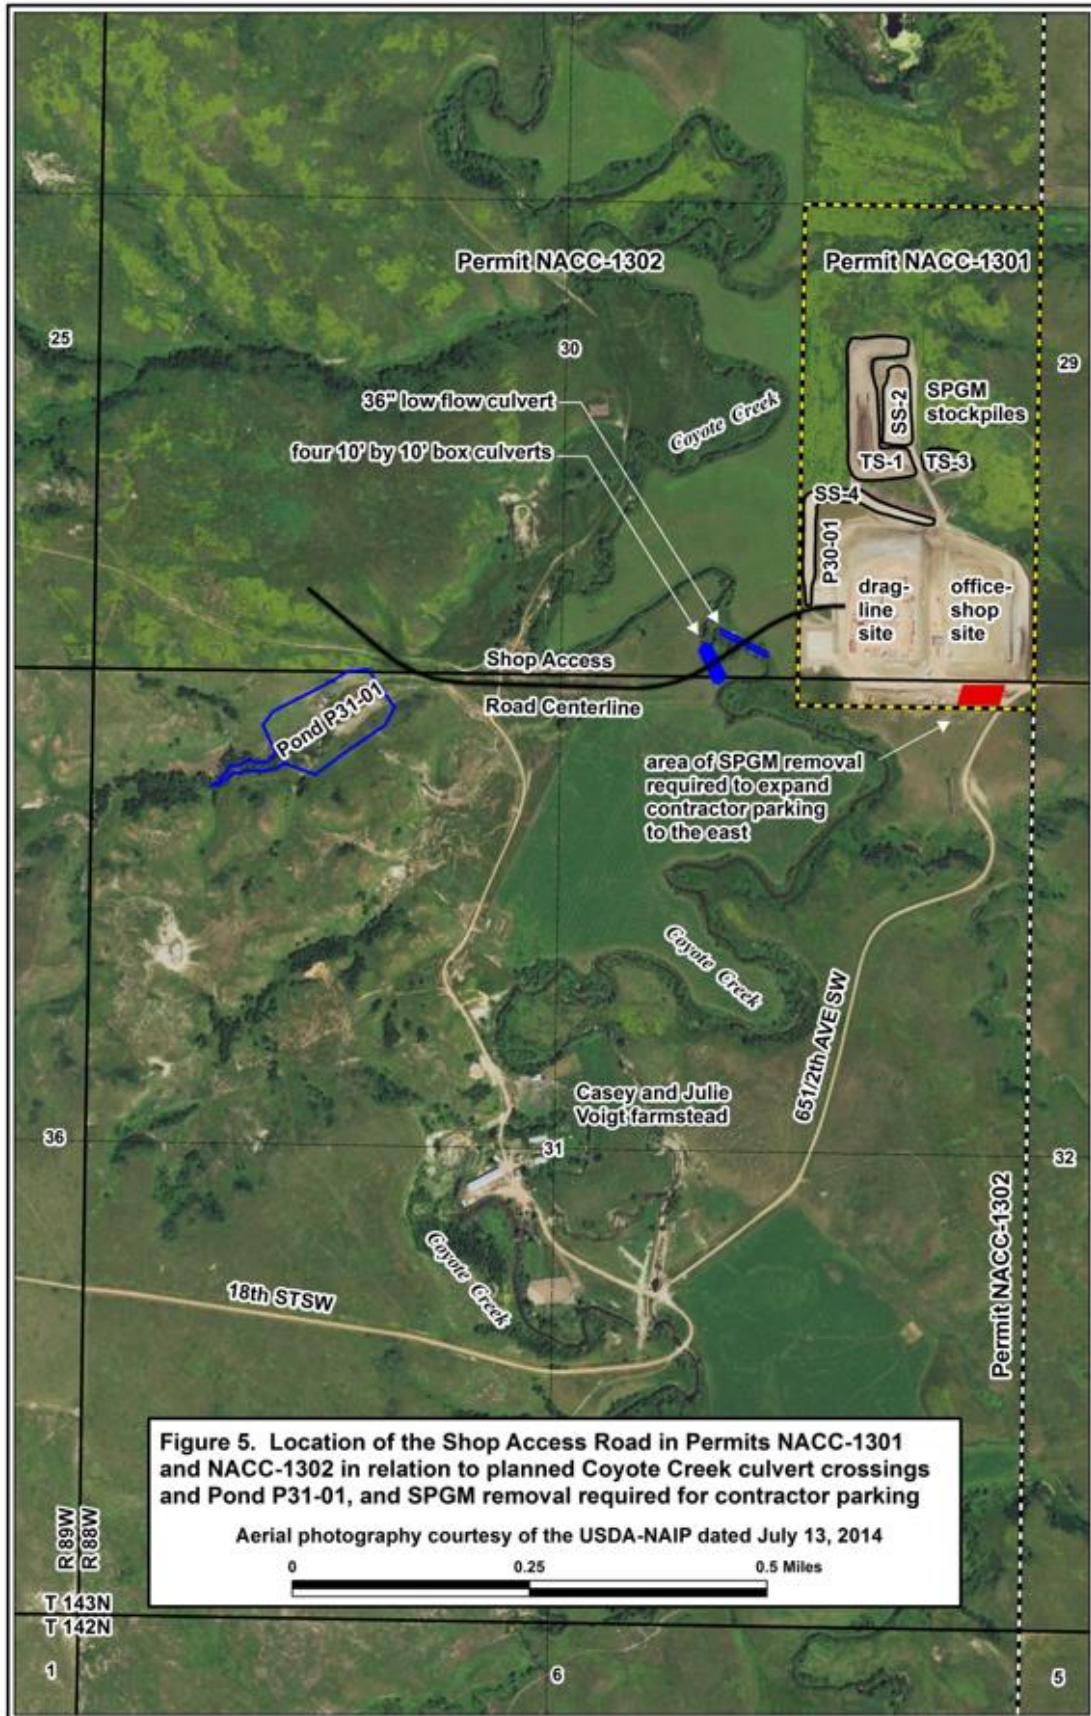
Based on the foregoing permit excerpts and observations from the April 13, 2015 inspection, it appears that CCMC is conducting operations for the Shop Access Road Coyote Creek culvert installations in reverse order of that approved in Permit NACC-1302. CCMC should have requested commission approval to revise culvert installation plans and provided adequate justification for doing so. Furthermore, it appears that potentially serious environmental risks are posed by installing the low flow culvert prior to diverting Coyote Creek flow through the box culverts. The Coyote Creek stream flow is now restricted through the low flow culvert until the box culverts are installed to divert the stream presumably after June 1<sup>st</sup>. High stream flow resulting from a heavy precipitation event may overtop the low flow culvert and cut through culvert backfill and the Shop Access Road corridor causing downstream sediment deposition. CCMC is advised to expedite box culvert installation so Coyote Creek flow can be diverted through the box culverts immediately after the U.S. Army Corps of Engineers spring restriction of regulated activity expires. CCMC is also advised to refrain from building any segment of the Shop Access Road near Coyote Creek that could function as an embankment and cause upstream flooding if stream flow is restricted by the low flow culvert.

**Figure 4. Panorama of 36 inch low flow steel culvert installation in Coyote Creek for the Shop Access Road Coyote Creek crossing - facing west on left and rotating to face north on right with temporary culvert in place on center-right for equipment crossing - refer to Figure 5 for culvert location - note temporary topsoil stockpile in left background and a temporary subsoil stockpile in middle background - also note that dozer was in motion when photographs were taken**

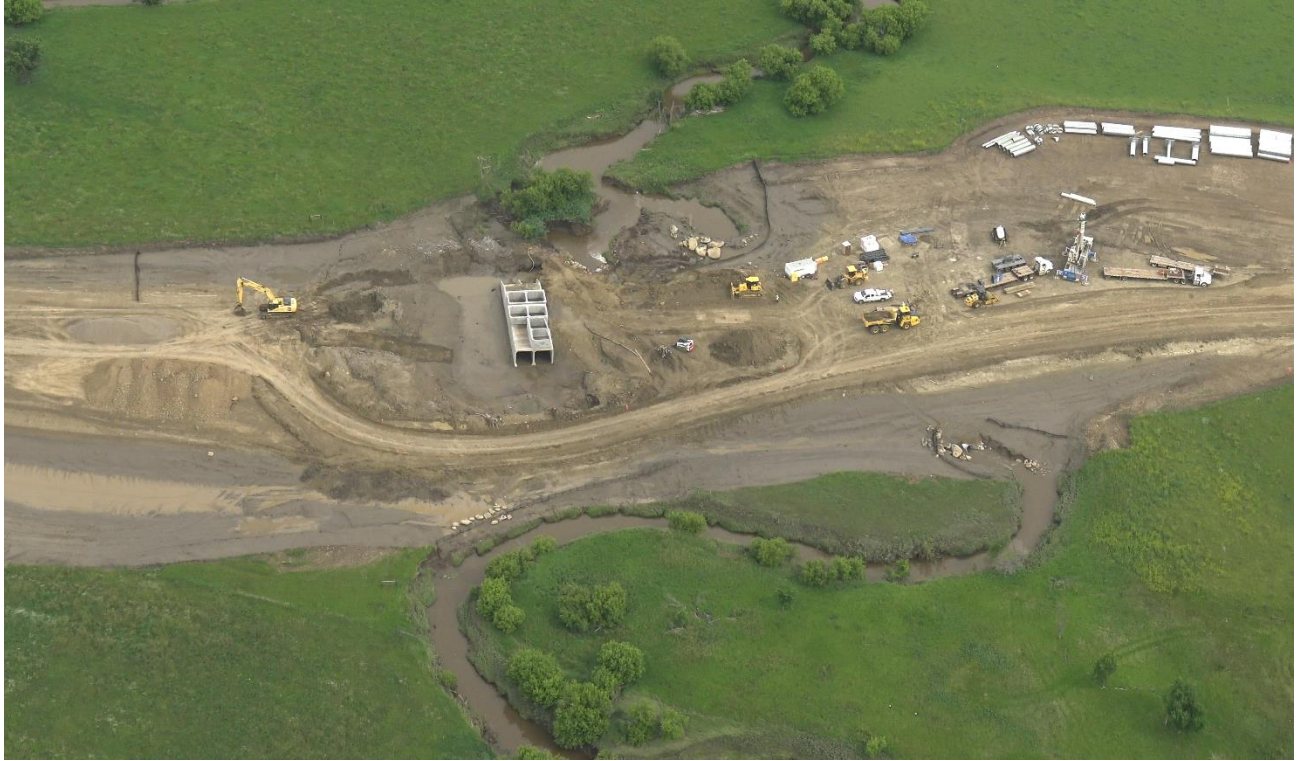
Figure 1- Coyote Creek at access road crossing site taken during June 25, 2015 flyover inspection

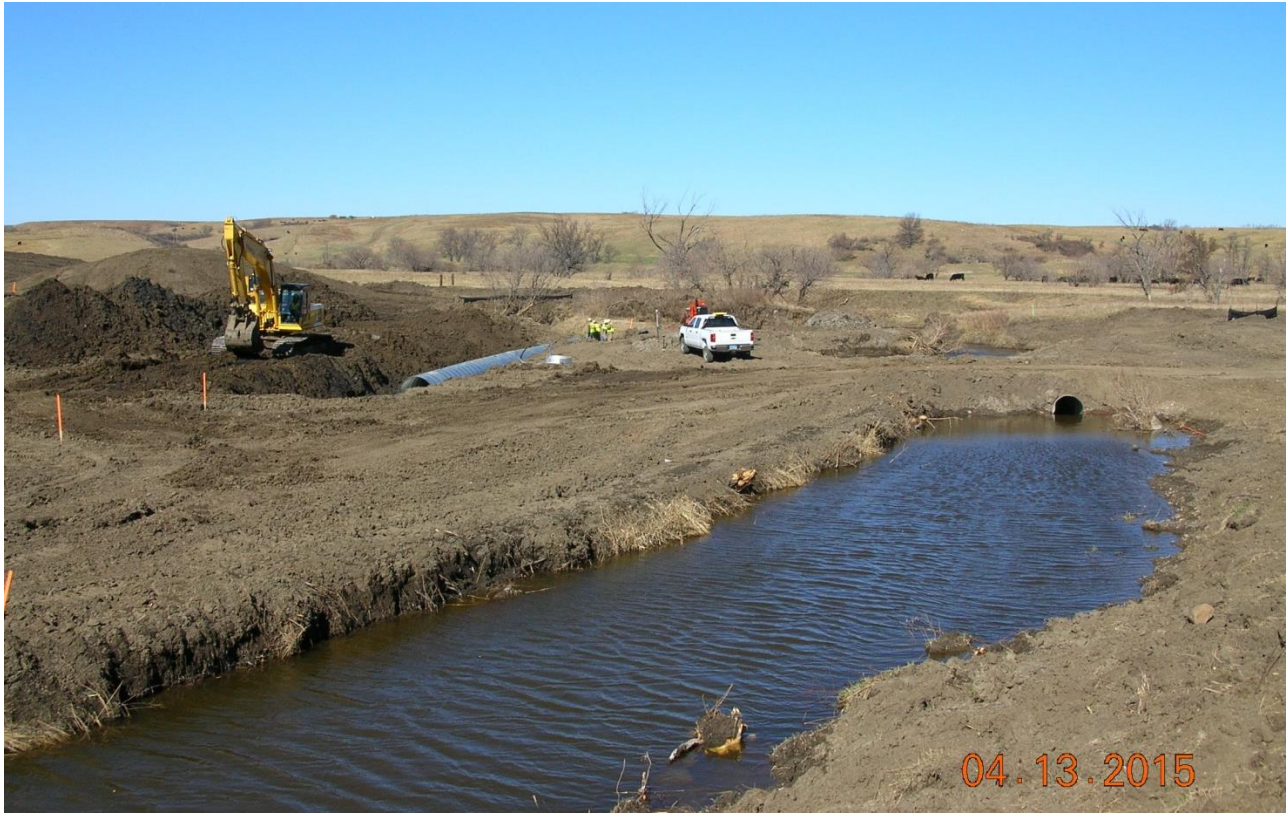
Figure 2 – Low flow culvert installation in progress on Coyote Creek on April 13, 2015

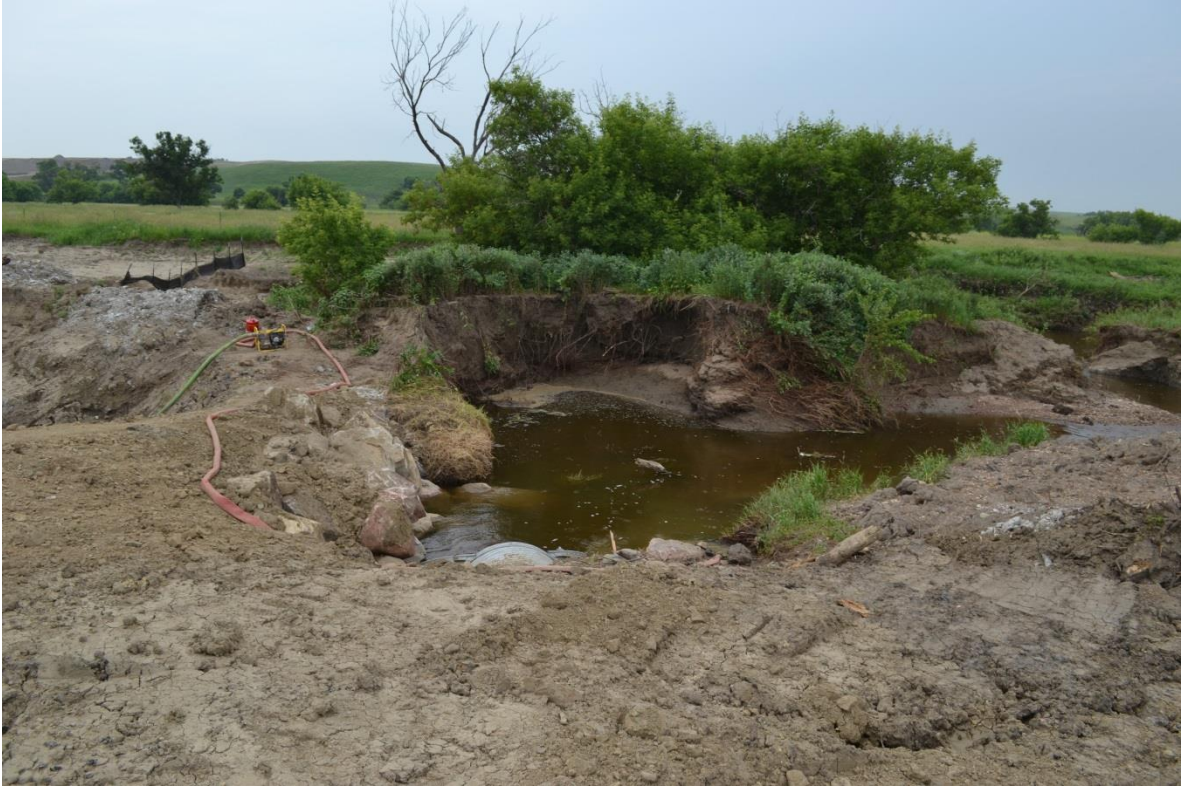
As a result of this inspection, Notice of Violation (NOV) 1502 will be issued to Coyote Creek Mining Company, L.L.C. for failure to control erosion at the low flow culvert outlet.

Figure 3- Erosion to stream bank, center. Channel plug and box culvert site to the left.

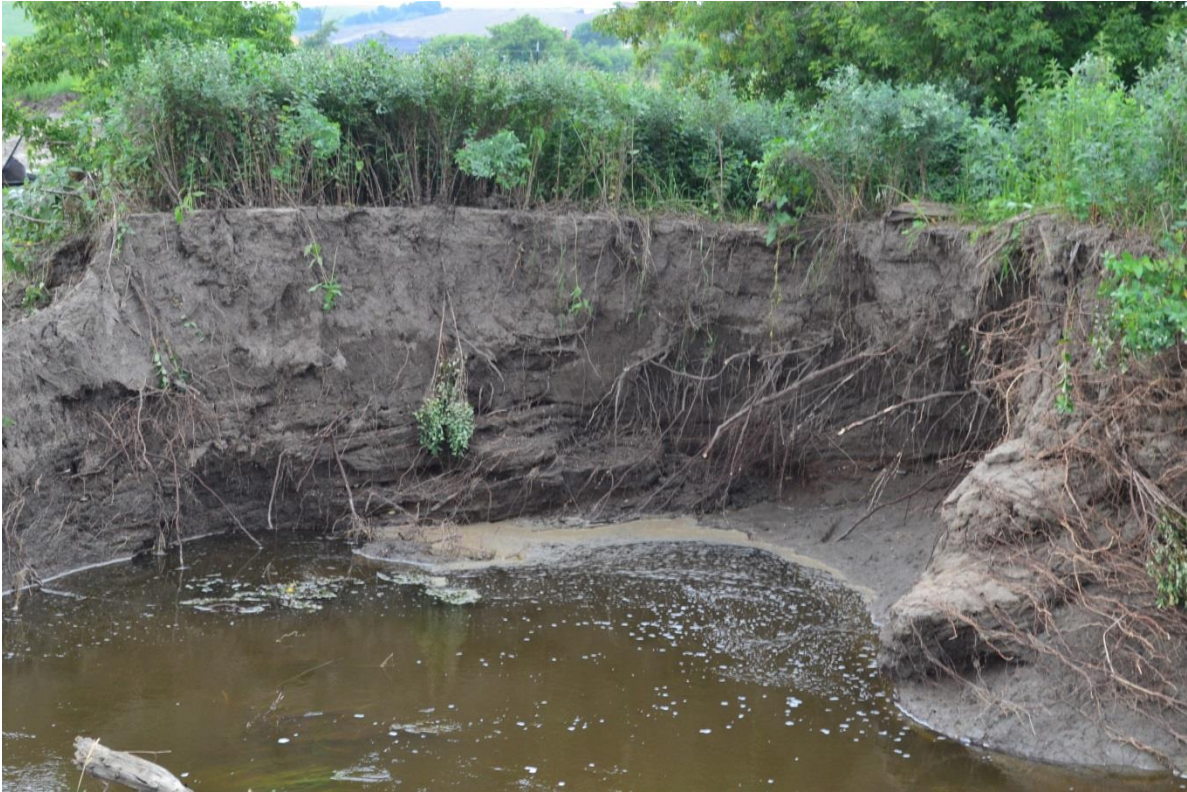
Figure 4- Closer view of bank erosion feature located across from the 60-inch culvert

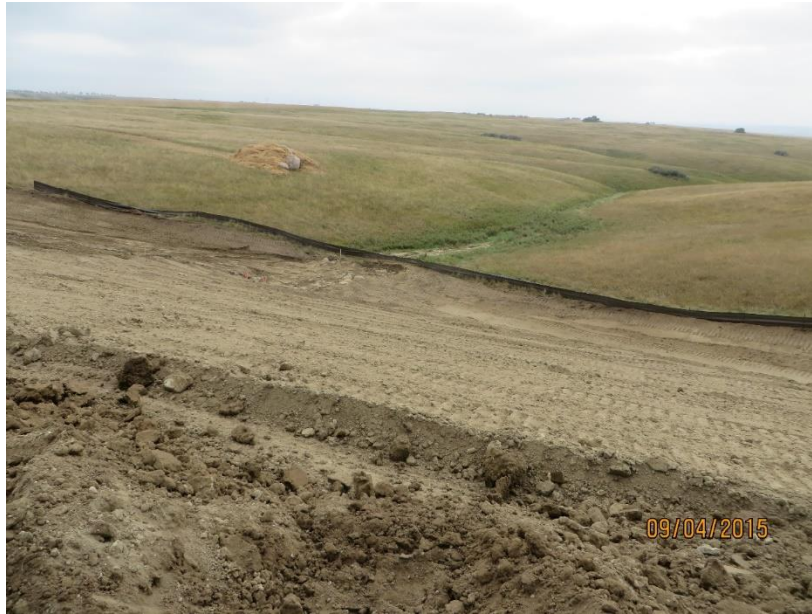
A minor amount of sediment-laden water had passed about 30 feet beyond/through a silt fence (but still within the permit area) on the west side of the haulroad in the SW1/4 of Section 18 forming a silt-laden crust on the surface. It did not appear the sediment-laden water went around or undercut the silt fence, but rather went through the silt fence. Most of the plunge pool downstream of the culvert outlet had filled with the silty/sandy sediment. CCM was instructed to clean up the sediment beyond the silt fence as soon as possible and Baranko's construction supervisor was notified of the required clean-up work. A skid steer was to be mobilized immediately and clean-up was expected to be done within the hour. Several areas of deep fill along the haulroad corridor will likely experience similar issues prior to final soil stabilization with seeding, mulching, erosion control fabric installation and other BMP's. Prior to final haulroad corridor reclamation processes for those areas in loose soil conditions, it is recommended that CCM install double silt fences down-gradient of deep fill drains if operationally feasible to minimize the potential for a similar situation in the future.

### **Minor sediment-laden deposition through haulroad corridor silt fence**

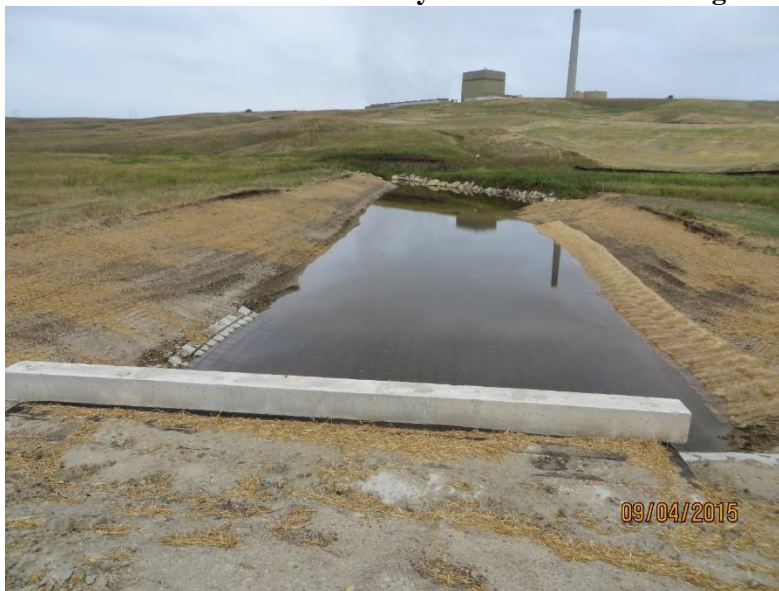
The Brush Creek crossing project is completed and only some minor clean-up and BMP installation items remain. At the time of inspection, CCM was installing silt fence along the south side of the box culvert and additional plans were to adjust silt fence locations in other areas around the crossing.

**Completed Brush Creek crossing in the SE1/4 of Section 10  
View is toward the northeast – Coyote Station in the background**

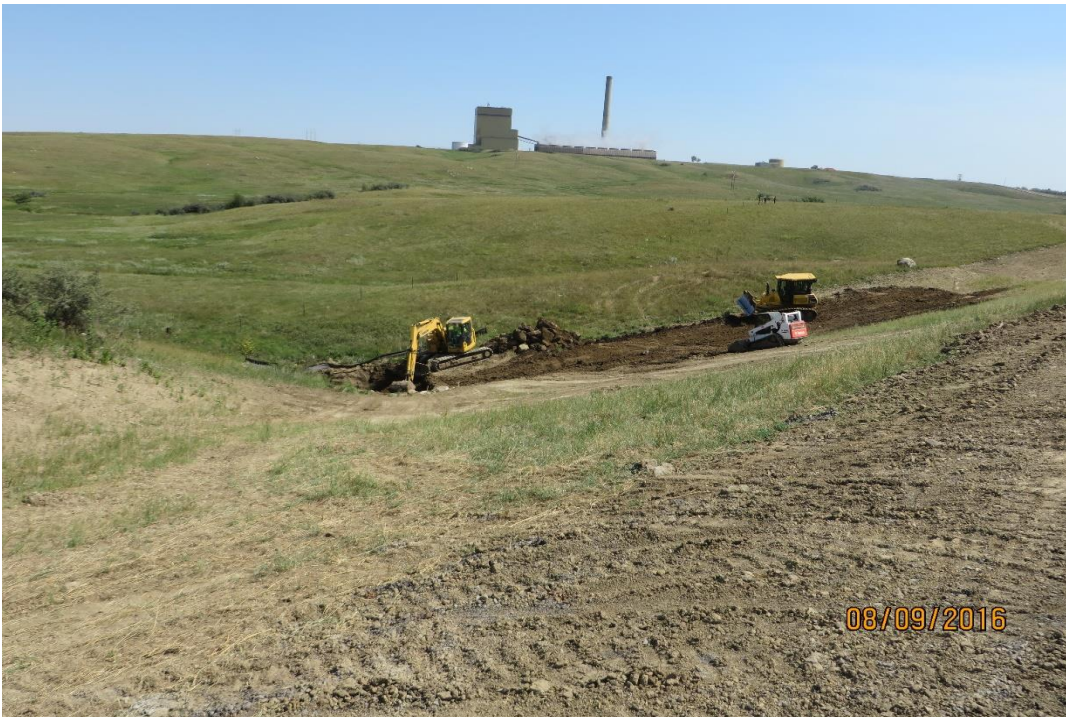
**Figure 1. Sump clean-out at Discharge Point No. 6**

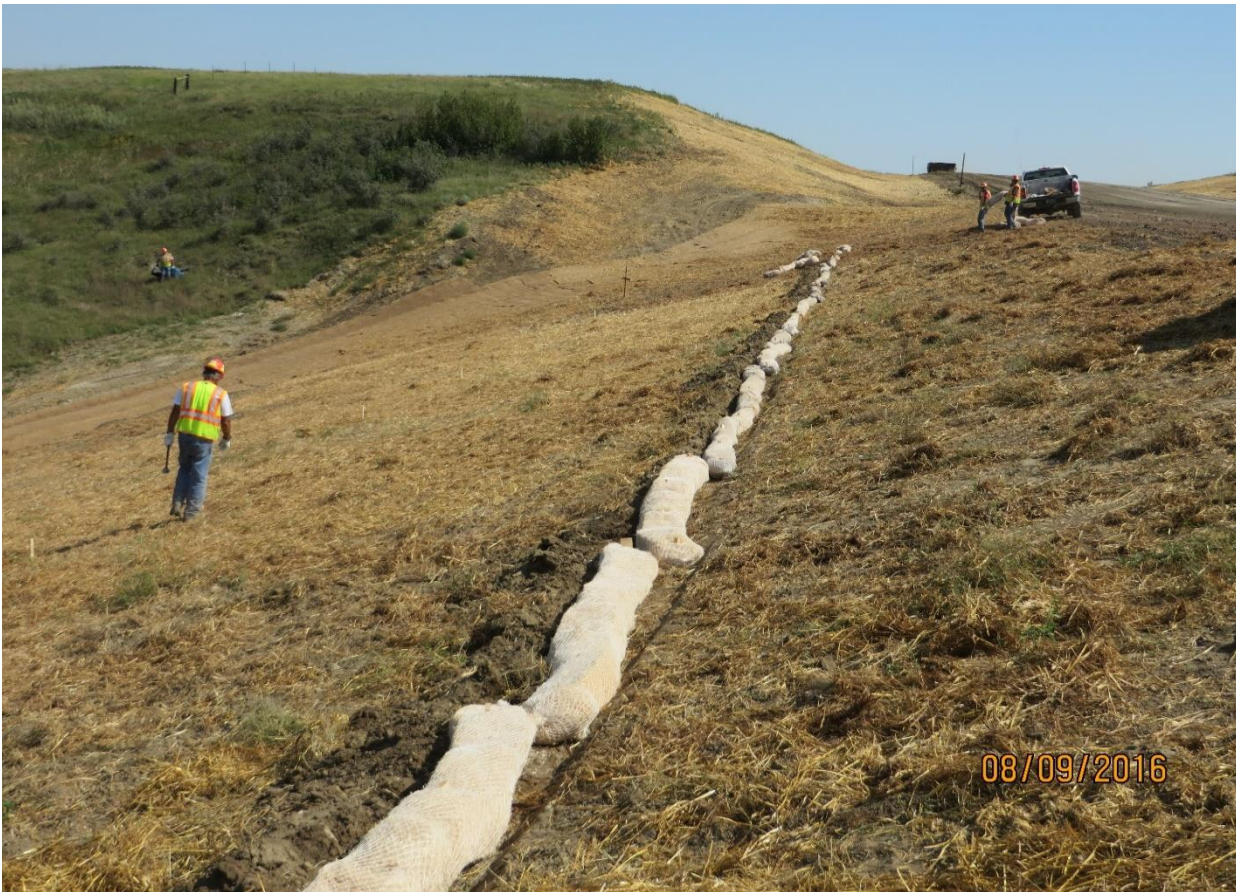
All areas along the haulroad requiring erosion repair have been graded, seeded and mulched as necessary. In a couple of instances, steep slope areas were seeded and mulched prior to July 25th, and then after approval was given to spread a veneer of topsoil to promote vegetative growth, were respread with topsoil and re-seeded and re-mulched. In addition to the reclamation efforts described, crews were repairing and replacing silt fence, installing erosion control blanket in critical areas, and installing straw wattles in series adjacent to, and perpendicular with the haulroad on steep in-slopes areas (**Figure 2**) as well as cleaning and augmenting rock checks along steep haulroad drains.

**Figure 2. Installation of straw wattles at Discharge Point No. 9 in the SE1/4 of Section 8  
View is toward the west**

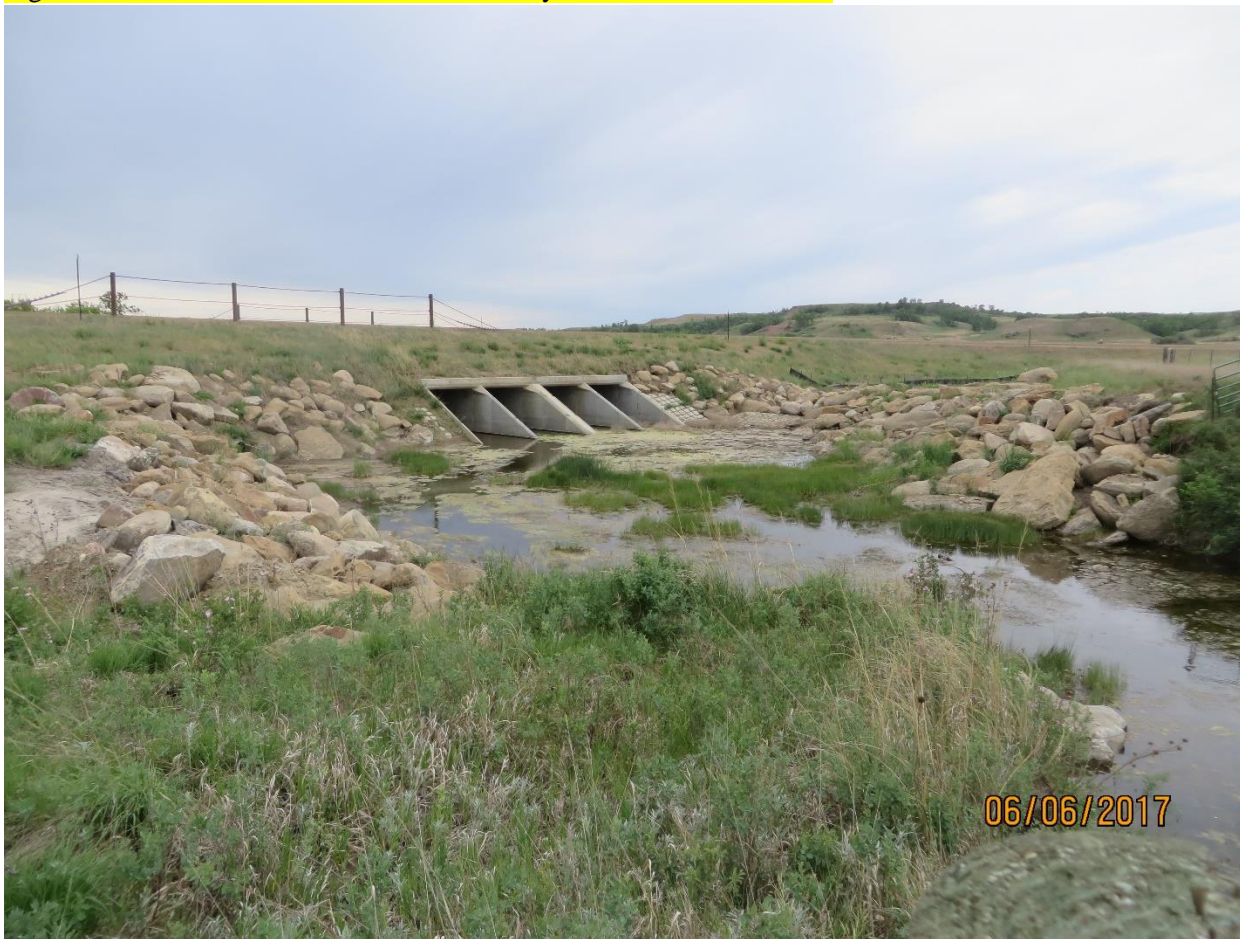
Figure 1: North end of the box culverts in Coyote Creek in Section 30

Smaller rock may need to be added to the riprap associated with the box culvert in Section 30 since there are gaps between the large rocks and the underlayment material is visible in spots.

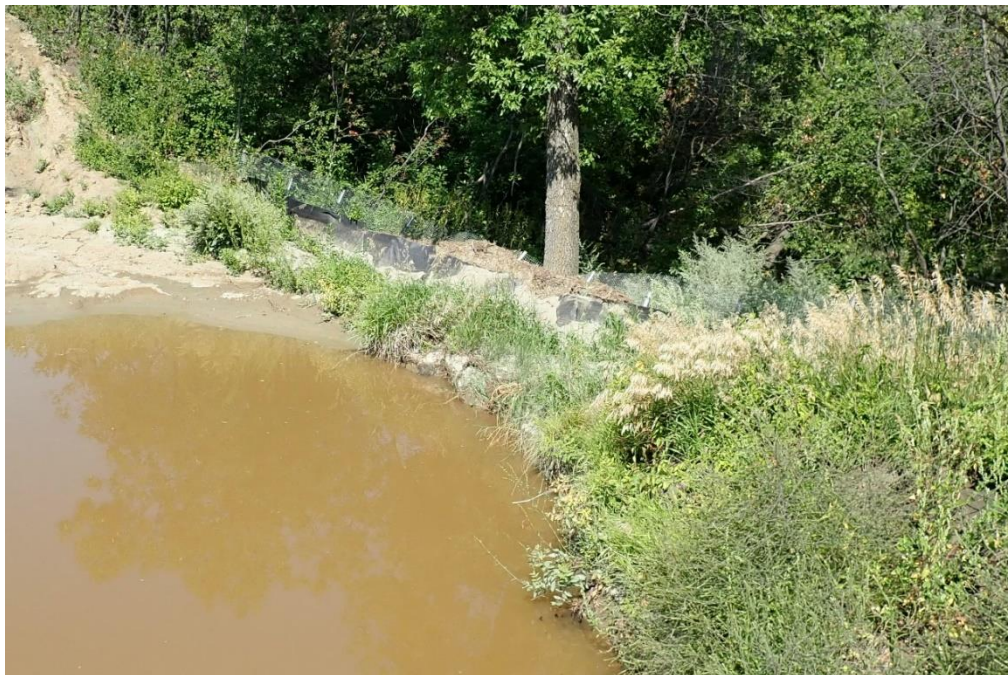
**Figure 1. East sump north of the 2017 pit in the SE $\frac{1}{4}$  of Section 24**

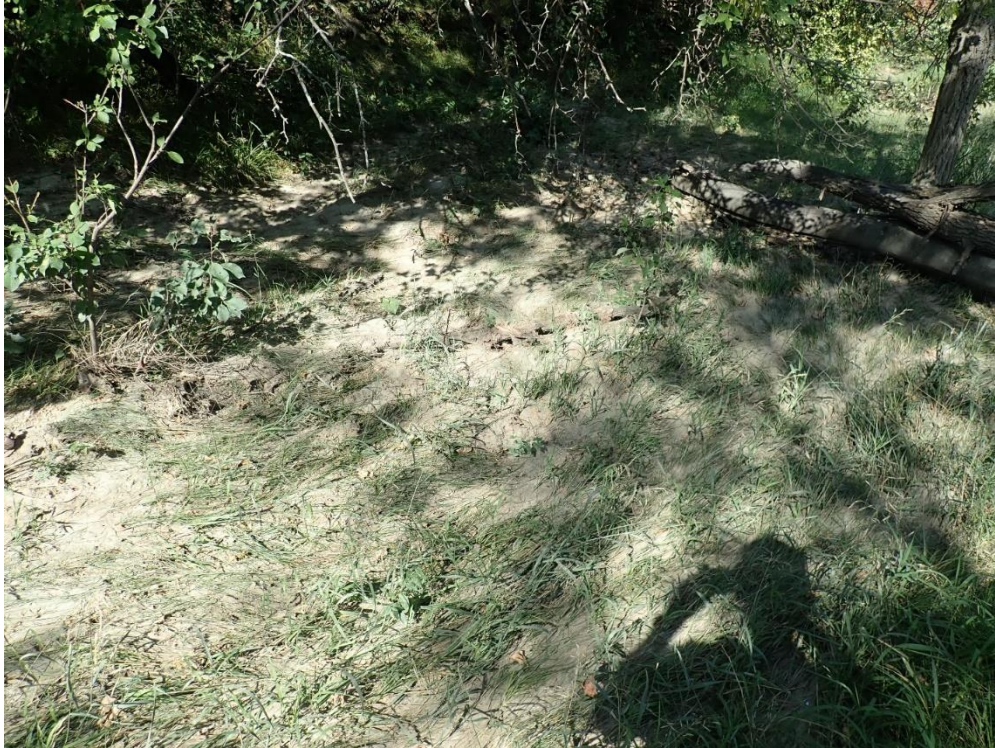
**Figure 1. Sediment on undisturbed area downstream from sump north of the 2017 pit in the SE/14 of Section 24**

these events that the sumps overflowed. These rains had filled the sumps to capacity. The water management plan for this area should be re-evaluated.

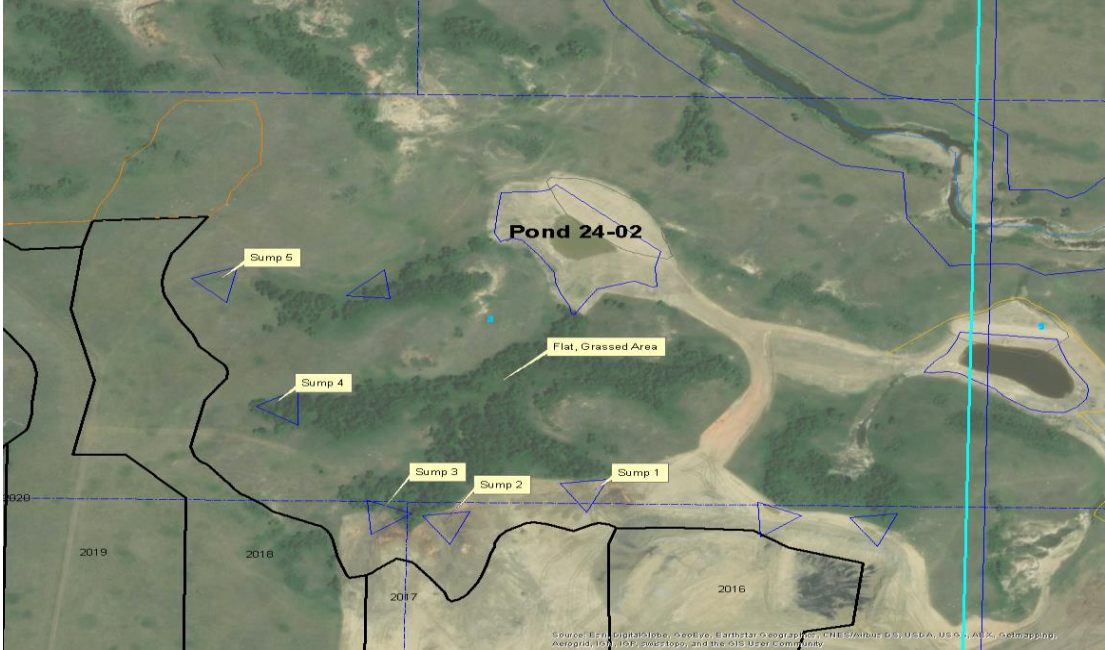
Figure 2: Sumps in SE 1/4 Sec. 24

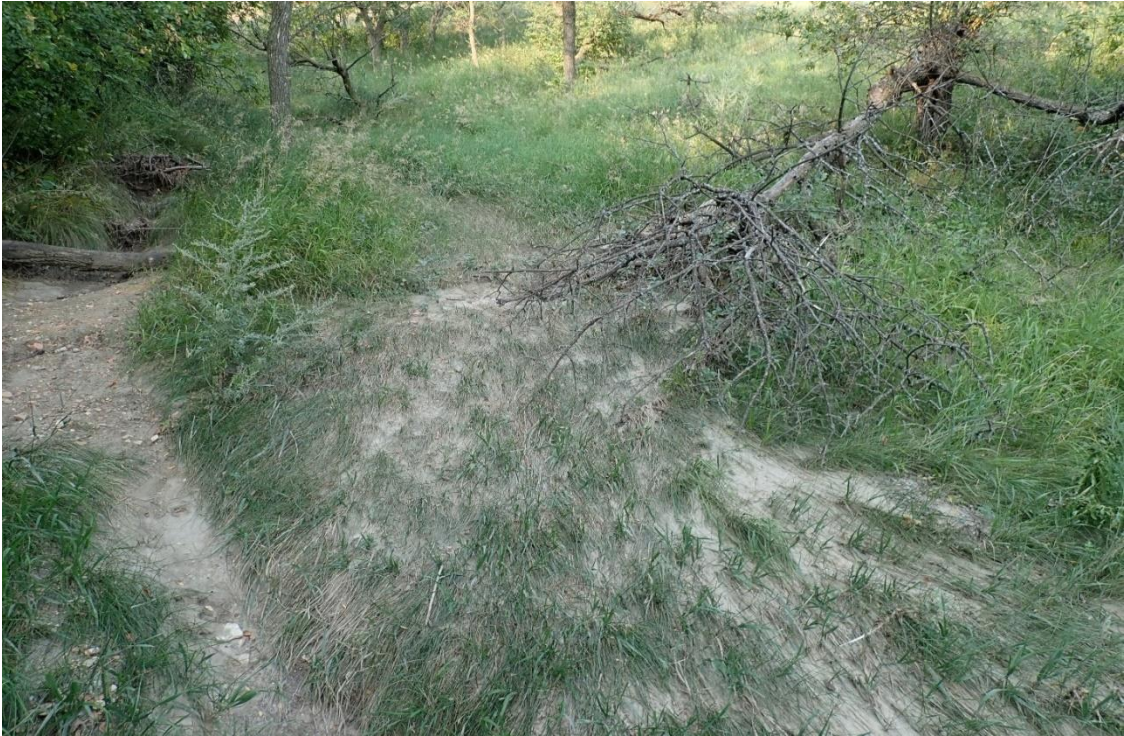
Figure 3: Sediment downstream of Sump 2

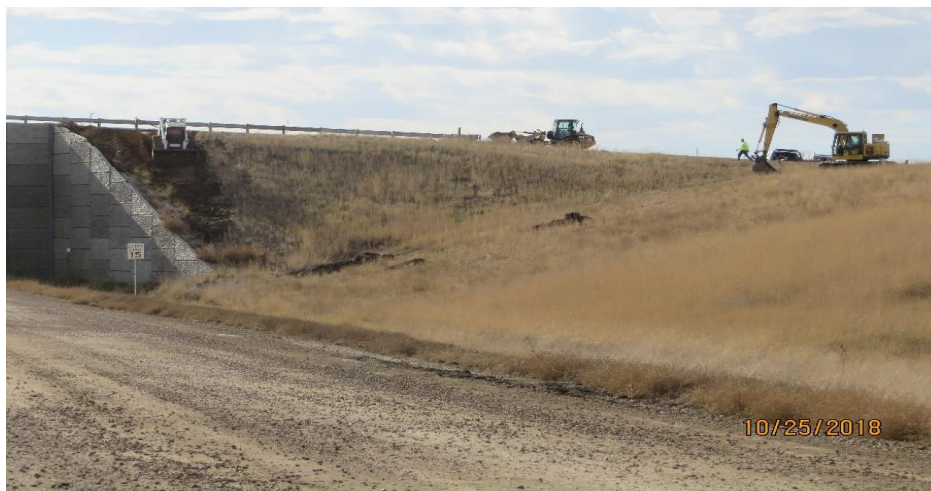
**Figure 1. Erosion repair work along County Road 12 crossing**

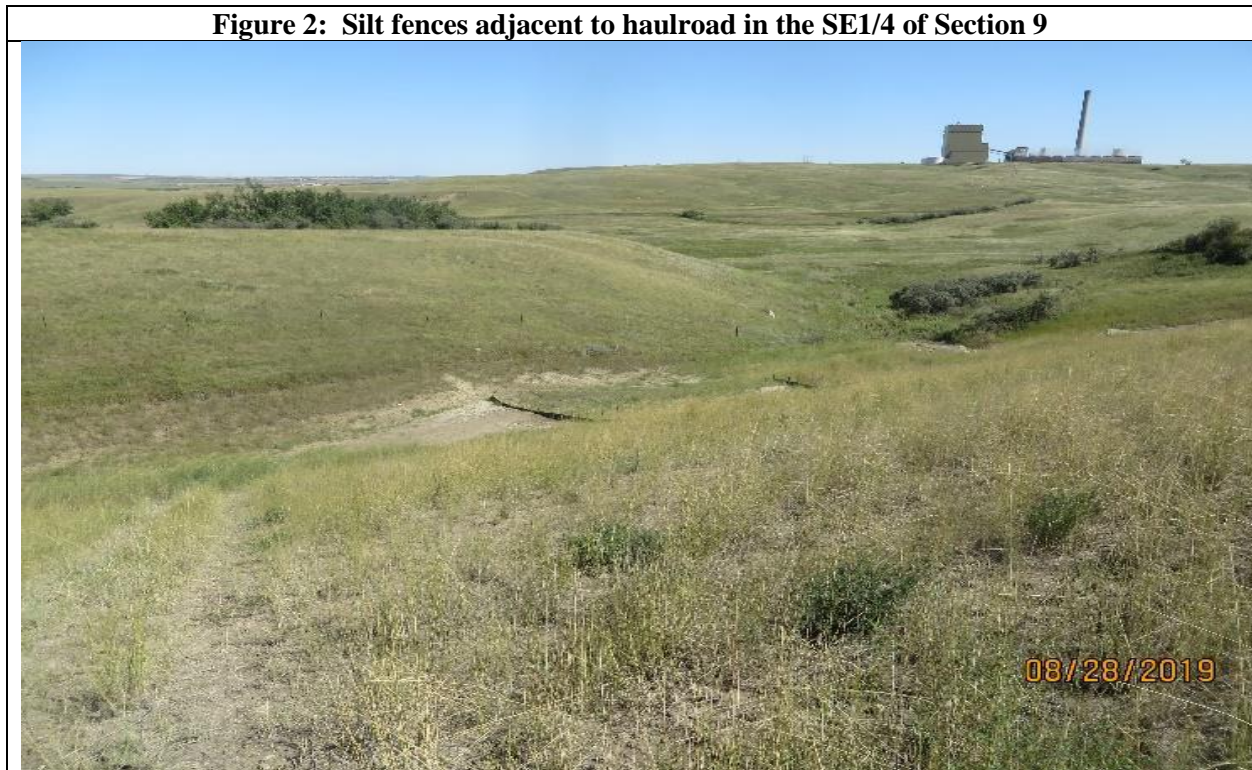
Several silt fences associated with the haul road ditch north of County Road No. 12 are holding silt that should be removed to allow the silt fences to function as intended. This includes silt fences in the south ditch of the haul road near Brush Creek and silt fences on the north side of the haul road in the SE1/4 of Section 9, discharge point No. 6, as depicted in **Figure 2**.

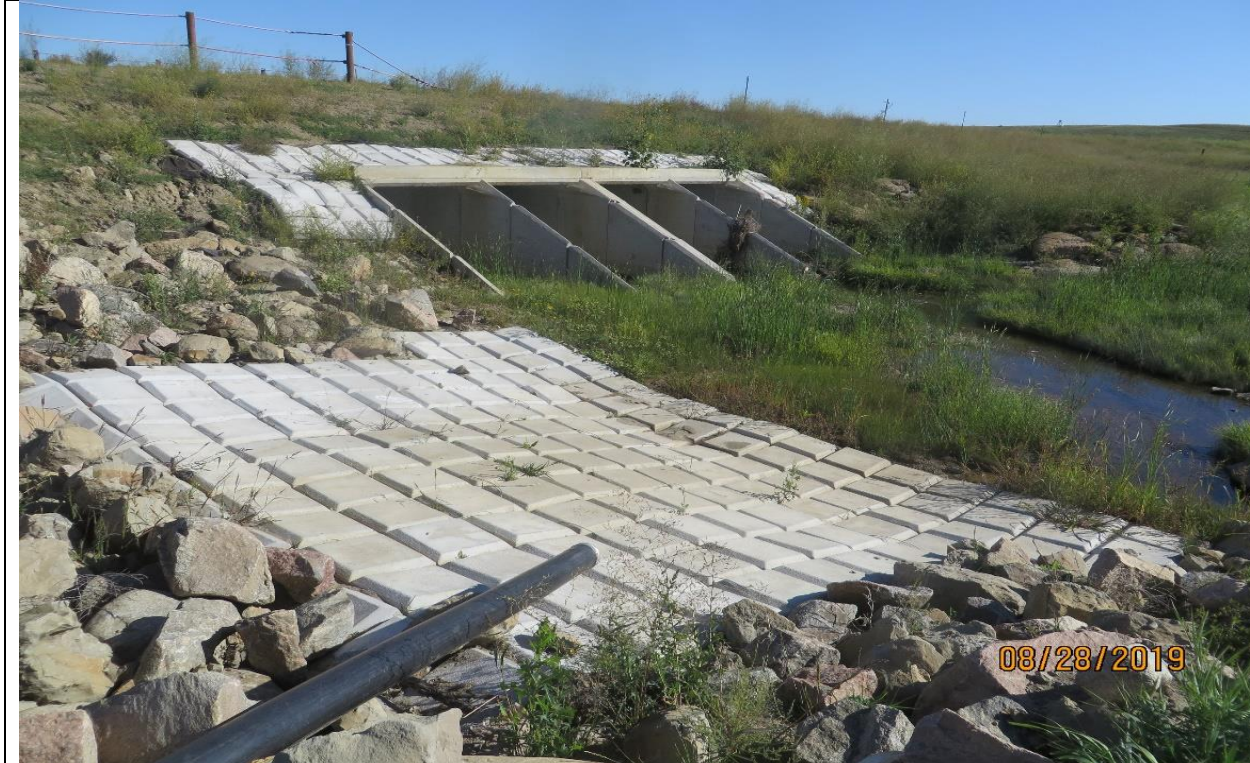
The interface of access road ditches adjacent to the south side of Coyote Creek in Sections 30 and 31 appear stable, as does the east ditch on the north side of the access road. A delta has formed in front of the west box culvert on the south side of Coyote Creek in Sections 30 and 31 and is becoming stabilized with vegetation as depicted in **Figure 4**. The delta is diverting stream flow to the eastern box culverts. CCMC placed fabric or blanket material under the riprap where runoff from the access road enters Coyote Creek at this location last spring and there was no evidence of any active erosion occurring. Concrete armor is in place above the rock riprap and a silt fence is in place in the road ditch immediately west of the concrete and rock armor. A pond dewatering polypipe at this site was placed so that discharges hit the concrete matting above the rock riprap adjacent to the stream channel.

**Figure 4: Delta adjacent to west box culvert, south side of the haul road in Sections 30 and 31**

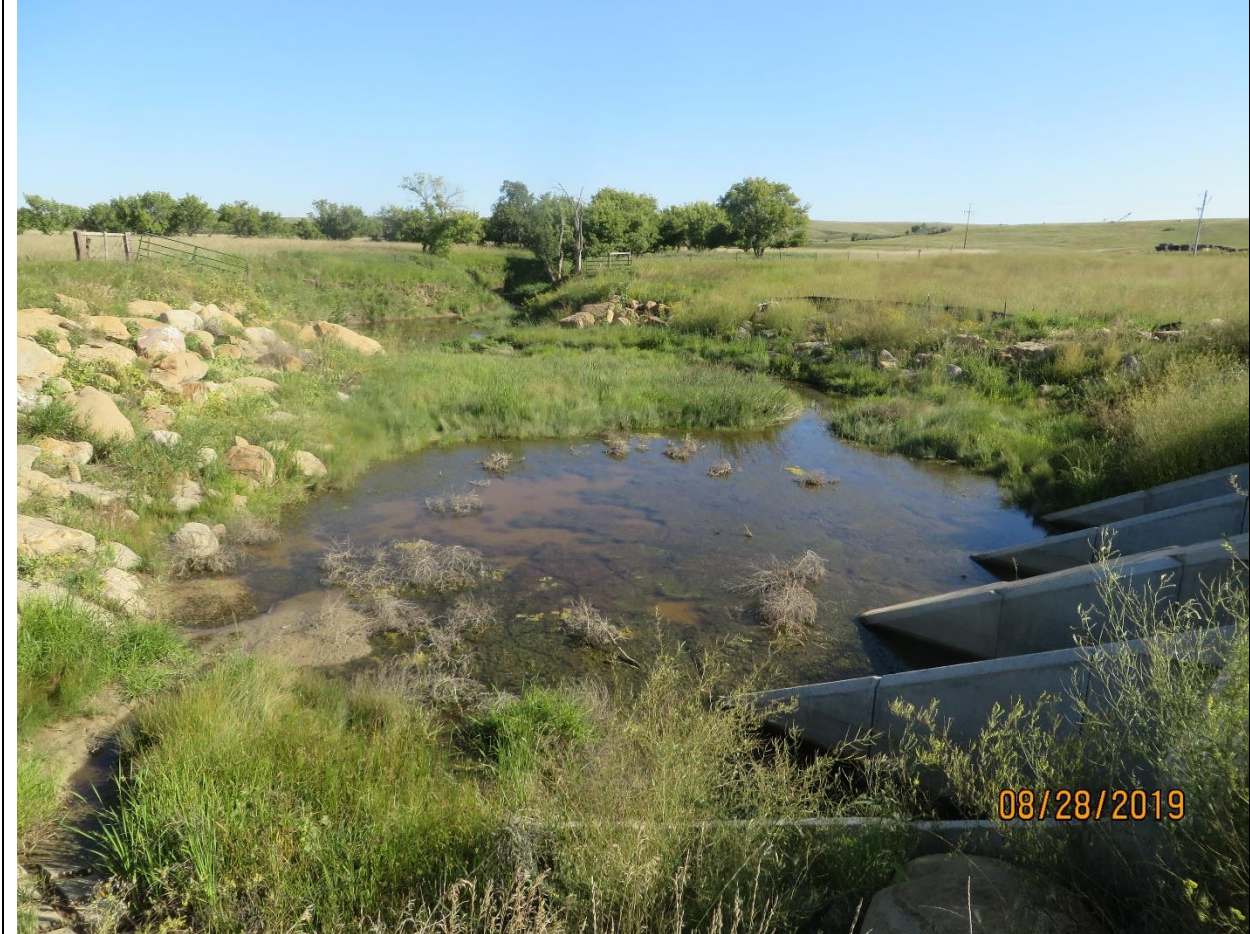
A small delta of sediment is present in the stream channel north of the west box culvert on the north side of the Section 30 and 31 access road crossing, as depicted in **Figure 5**. This delta is beyond the riprap that is being used to stabilize the stream bank. The riprap being used to stabilize the creek bank consists of very large rock and it is possible erosion could occur under this rock. CCMC should further inspect and monitor this site to ensure erosion does not occur under the riprap. A silt fence is in place in the road ditch immediately west of this site and the ditch is becoming well vegetated.

**Figure 5: Small delta in stream channel north of the west of box culvert,  
north side of Sections 30 and 31 access road**
