# Public Service Commission State of North Dakota

July 23, 2018

The Reclamation Division has reviewed your concerns regarding your land located in the NW $\frac{1}{4}$  of Section 34, T146N, R88W, as outlined in your May 4, 2018 email. Your property is located off-permit and adjacent to Surface Coal Mining Permit NACT-9501 at the Coteau Properties Freedom Mine.

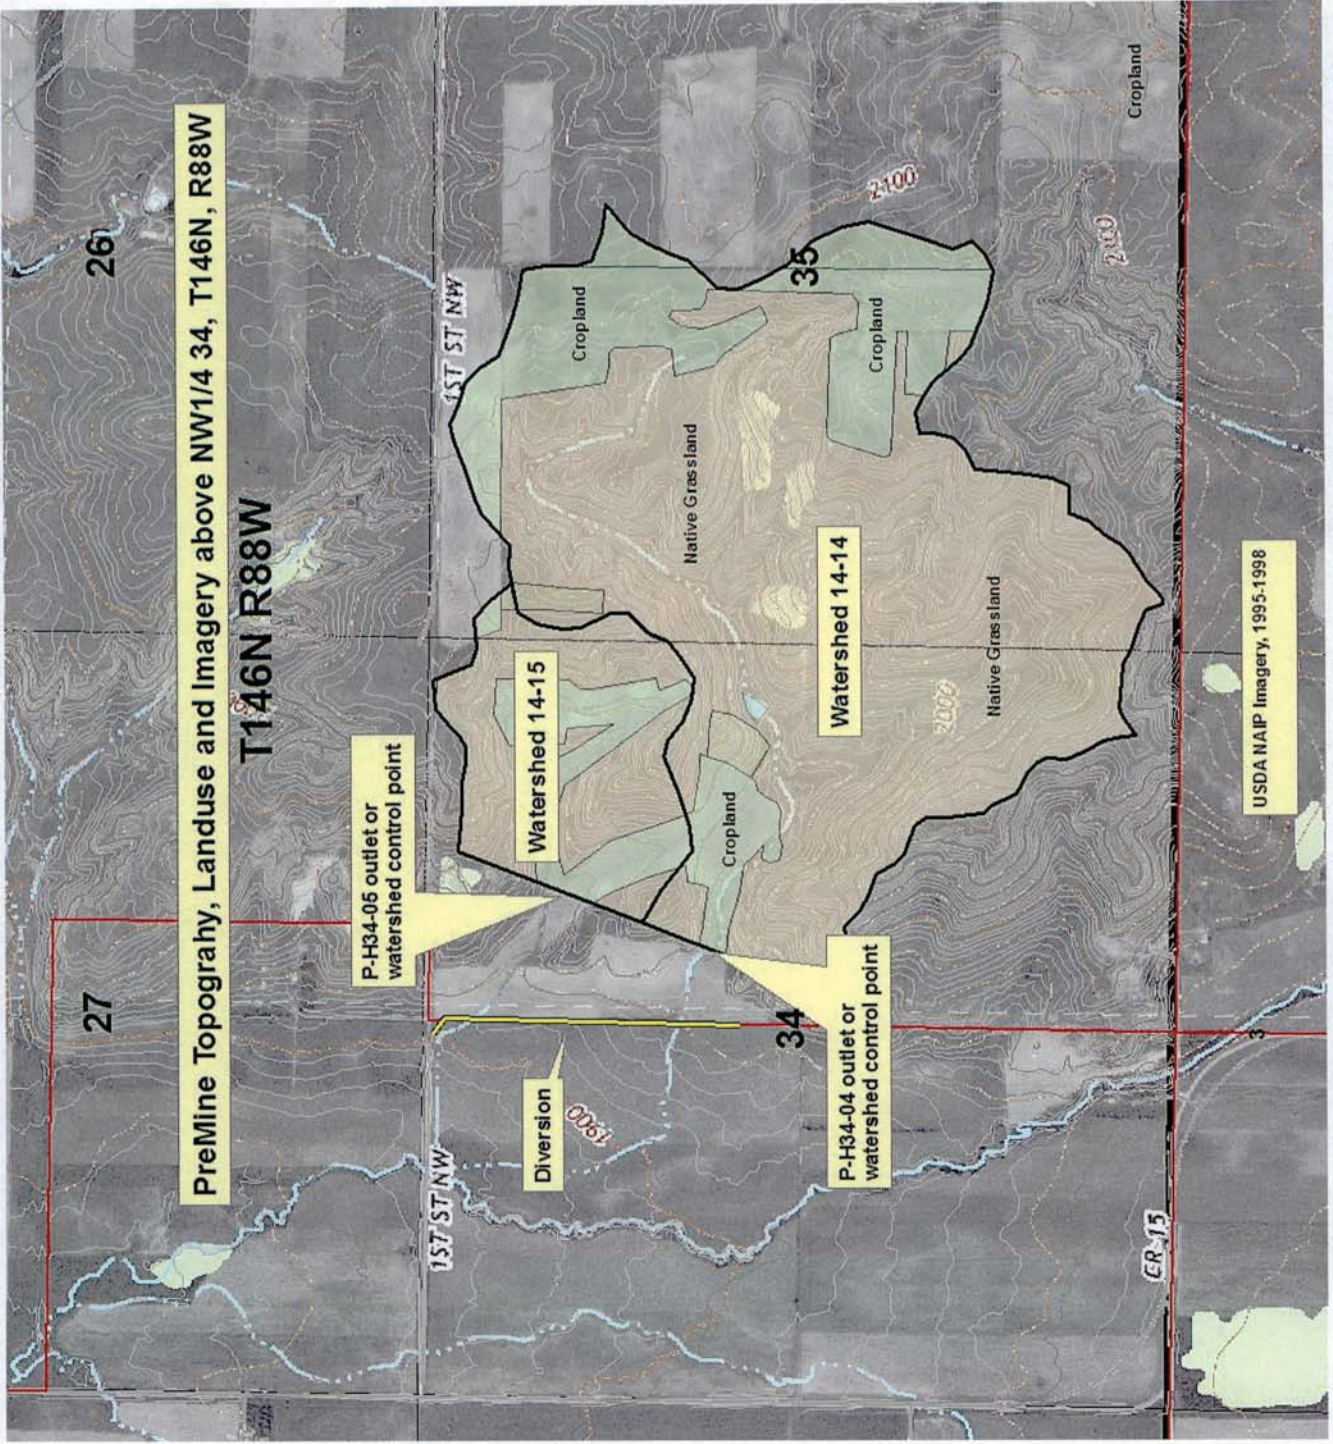
PreMine Topography, Landuse and Imagery above NW1/4 34, T146N, R88W

aerial photography indicates well-defined erosion patterns in the NW¼ of Section 34, well before the area was permitted, mined, and reclaimed.

On August 28, 2007, Coteau submitted the application for Revision No. 30 to Surface Coal Mining Permit NACT-9501. This revision proposed changes to the postmine topography and watershed boundaries in the NE¼ of Section 34. The size of watershed 14-14 (most of the area controlled by sediment pond P-H34-04) decreased slightly (5 acres smaller than premine) but the size of watershed 14-15 (most of the area controlled by sediment pond P-H34-05) was increased by 132 acres. The combined area of watersheds (14-4 and 14-15) increased by a total of 127 acres. Revision No. 30 also proposed some land use changes for the NE¼ of Section 34 including changing the postmine land use of a portion of the watersheds from cropland to native grassland. Attached are maps depicting pre- and post-mine watersheds 14-14 and 14-15.

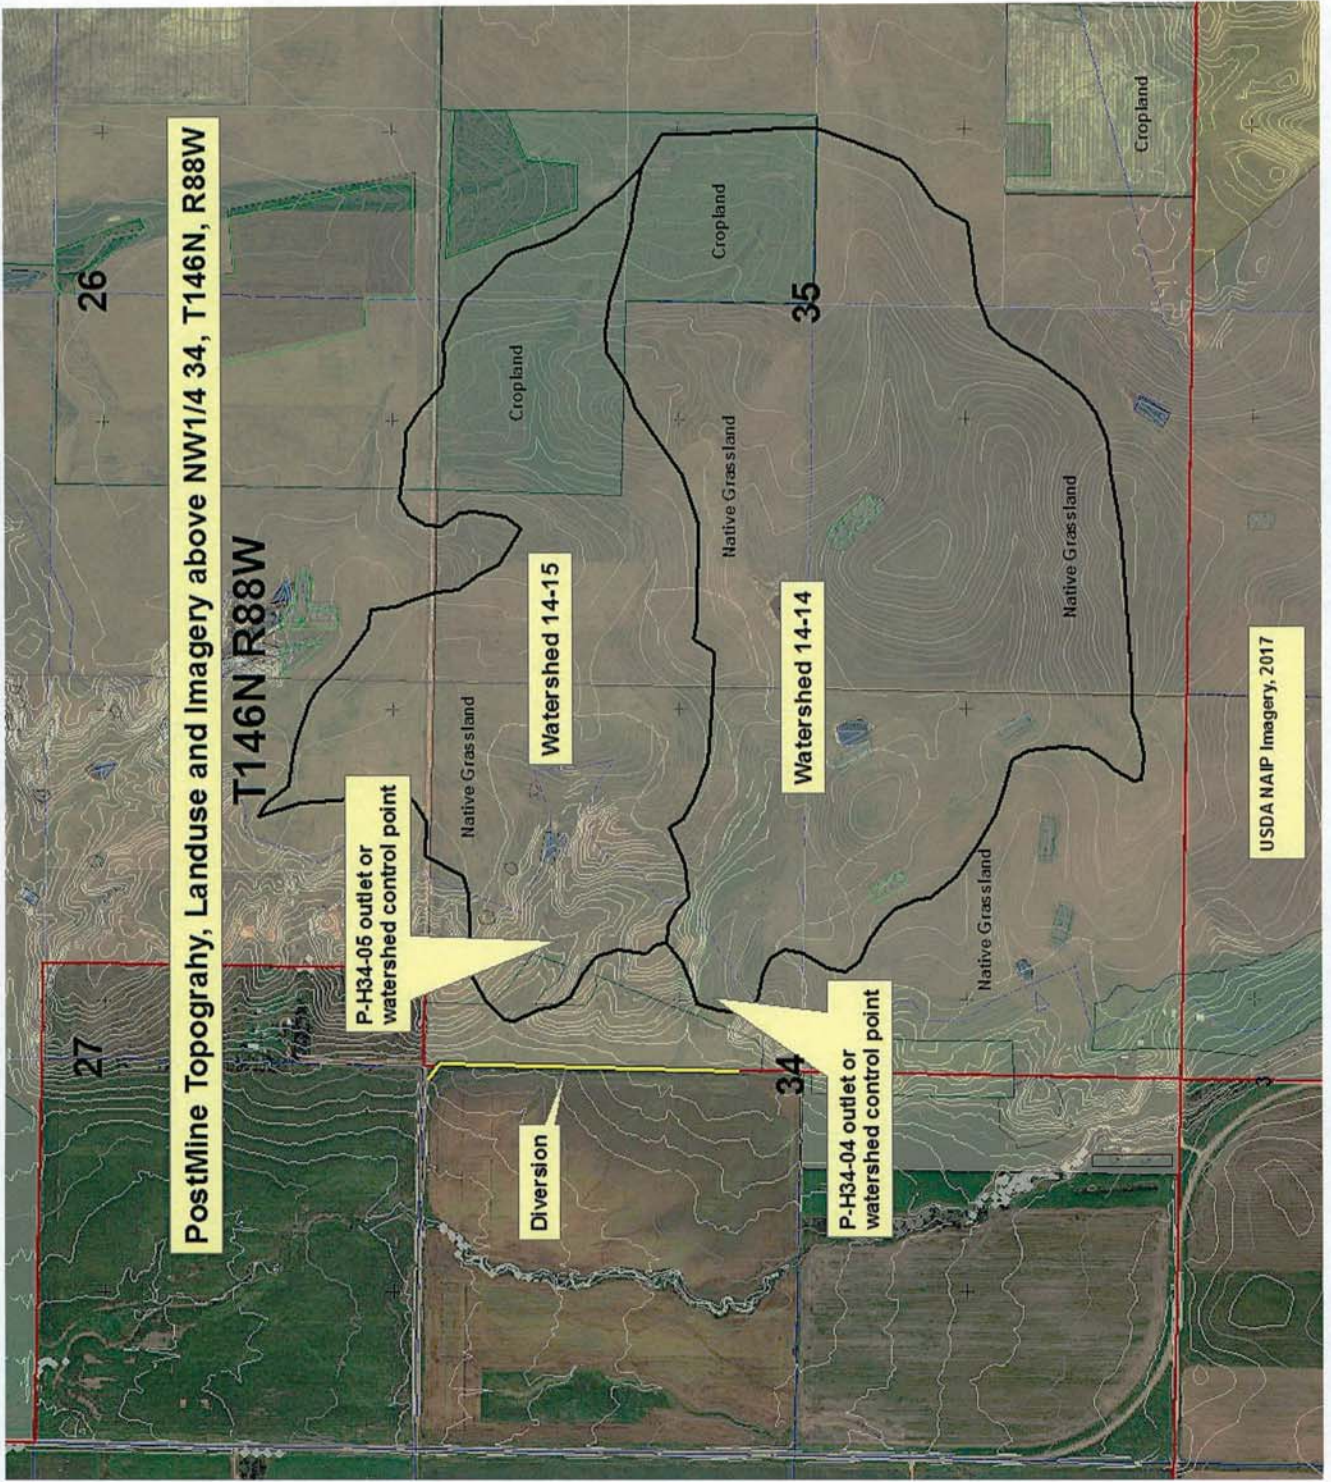
PostMine Topography, Landuse and Imagery above NW1/4 34, T146N, R88W

Our analysis shows that even though the total combined watershed size increased after reclamation, the expected total flow rates and volumes are less than the premine condition. This is due to a number of reasons but is primarily due to the reclaimed or postmine watersheds being less steep than the premine watersheds. The premine average slope of watershed 14-15 was 12.7% and the postmine average slope is 4.4%. In addition, the shallow and claypan soils that were common in the premine watershed were replaced with deeper, loamy soils with higher infiltration rates. In addition, there is less cropland and more native grassland in the reclaimed watershed than in the premine watershed. The perennial native grassland vegetation generally has a lower runoff potential than cropland.

**Required Action:** During our reanalysis of the Probable Hydrologic Consequences (PHC), we noted the reclaimed grassland drainage channel for watershed 14-15 (within the permit area) enters the reconstructed diversion at a right angle and drops several feet in elevation over a very short distance. This configuration has resulted in erosion and maintenance problems in the past. The original drainage channel flowed in a more northwesterly direction and entered the existing diversion near the northeast corner of the NW¼ of Section 34. We will require Coteau to re-route this drainage channel in a more northwesterly manner, similar to how it existed prior to mining. This will result in a more stable configuration and much of the drainage from watershed 14-15 will flow almost directly into the east-west reconstructed road ditch rather than flowing into the north-south reconstructed diversion. As a result of this reconfiguration, most of the drainage from watershed 14-15 will "bypass" your property with the exception of the south road ditch. Most of this "reconfiguration work" will take place within the permit area; however, the point at which the reconfigured drainage channel will enter the reconstructed diversion is located on your property and we encourage you to work with Coteau to accommodate the reconfiguration of this drainage channel.

However, in our review of the matter, we concluded that Coteau should reconfigure the upstream drainage channel from watershed 14-15 into the reconstructed diversion channel. This is discussed further under **Required Action** near the end of this letter.

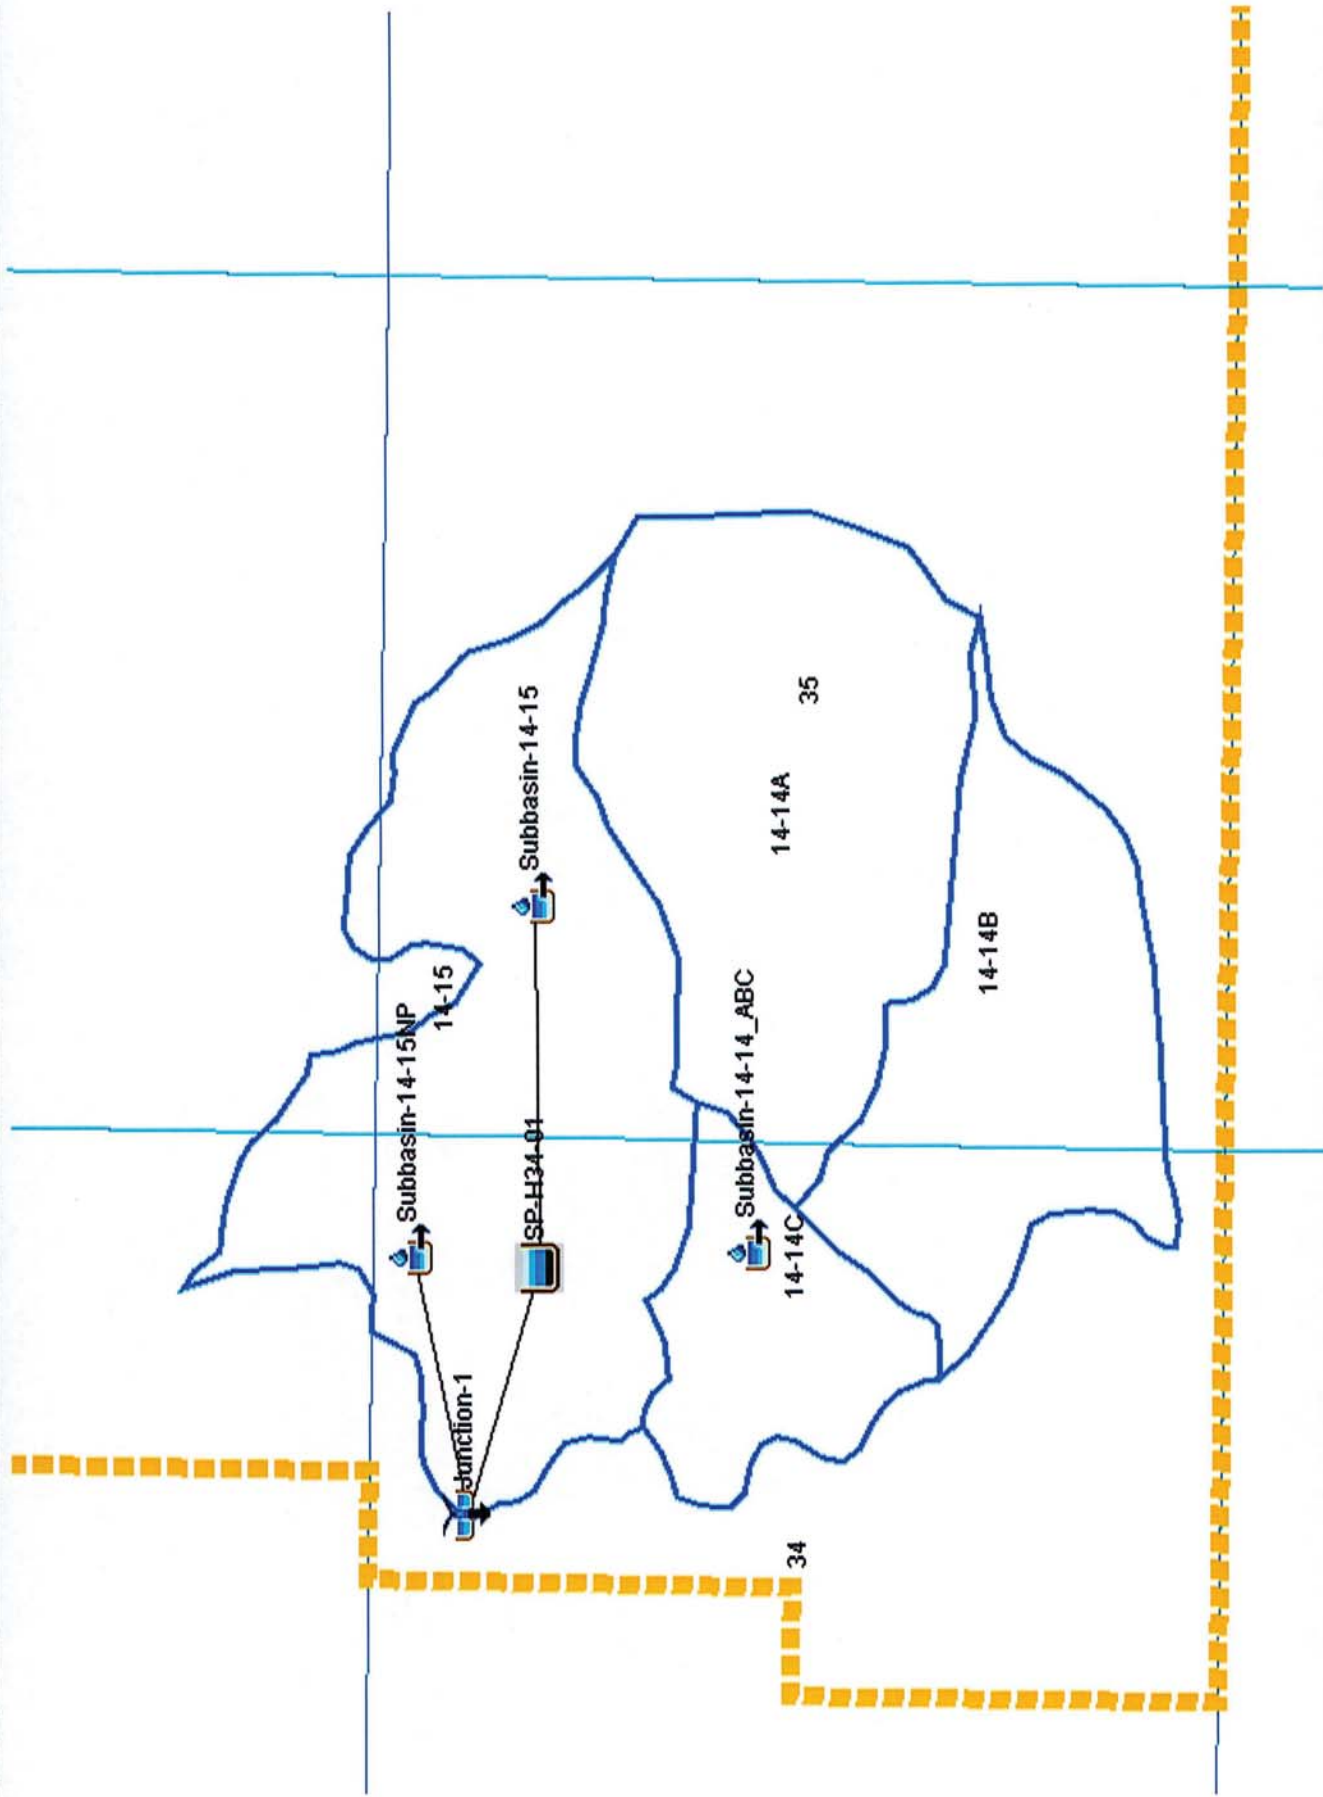
The Reclamation Division staff have reviewed the flow modeling provided by Coteau and have determined the parameters and assumptions used were appropriate and reflected the actual conditions. In response to your concerns, staff again modeled both watersheds and the results of our independent modeling are similar to those provided by Coteau in Revision 30. A copy of our analysis is attached.

Hydrologic Element	Drainage Area (MT2)	Peak Discharge (CFS)	Time of Peak	Volume (AC-FT)
Subbasin-14-14_ABC	0.44	103.8	26Jun2018, 20:45	17.1
Subbasin-14-15	0.28	40.8	26Jun2018, 21:45	10.7
SP-H34-01	0.28	43.2	26Jun2018, 21:45	9.0
Subbasin-14-15NP	0.05	18.6	26Jun2018, 20:15	2.0
Junction-1	0.33	45.7	26Jun2018, 21:45	10.9
