INSPECTION REPORT

DATE OF INSPECTION: April 26, 2018

PERMITTEE - MINE: Coteau Properties Company - Freedom Mine

PERMITS INSPECTED: NACT-9501

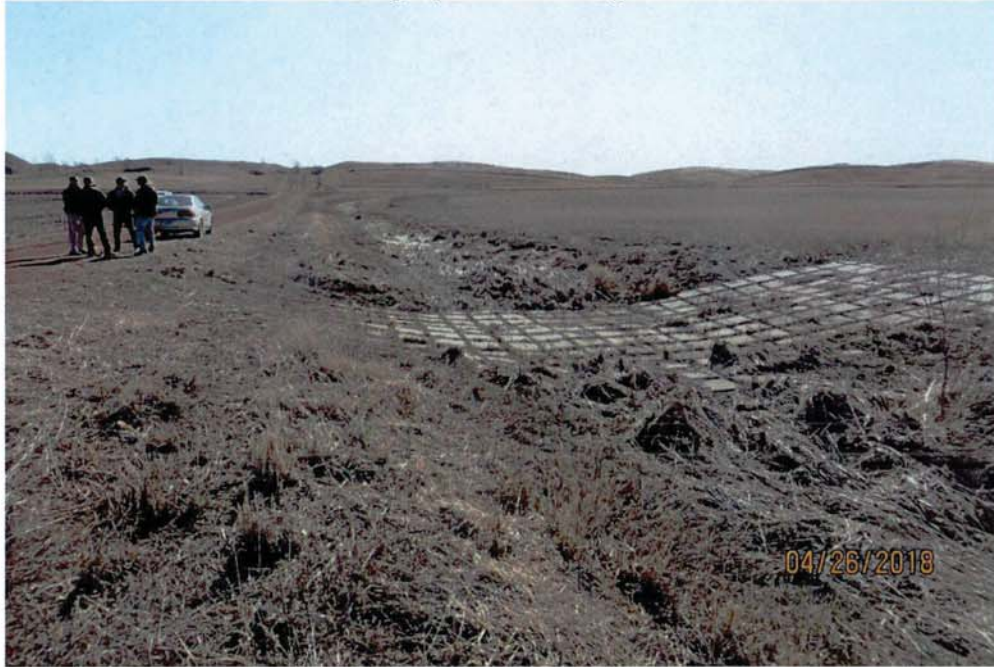
1. Figure 1 also depicts the locations where the photographs in Figures 2 through 11 were taken. Figures 2 and 3 are photographs of the Flexcrete crossing. Mr. Eisenbeis claims Coteau did not have the proper authorization to reconstruct the diversion on his property and the deeper road ditch now limits equipment access to his land. Mr. Eisenbeis said one potential renter was not interested in leasing his cropland because of poor access to his field.

**Figure 2. Flexcrete crossing in the road ditch on the north side of the NW¼ of Section 34.
Photograph taken facing east.**

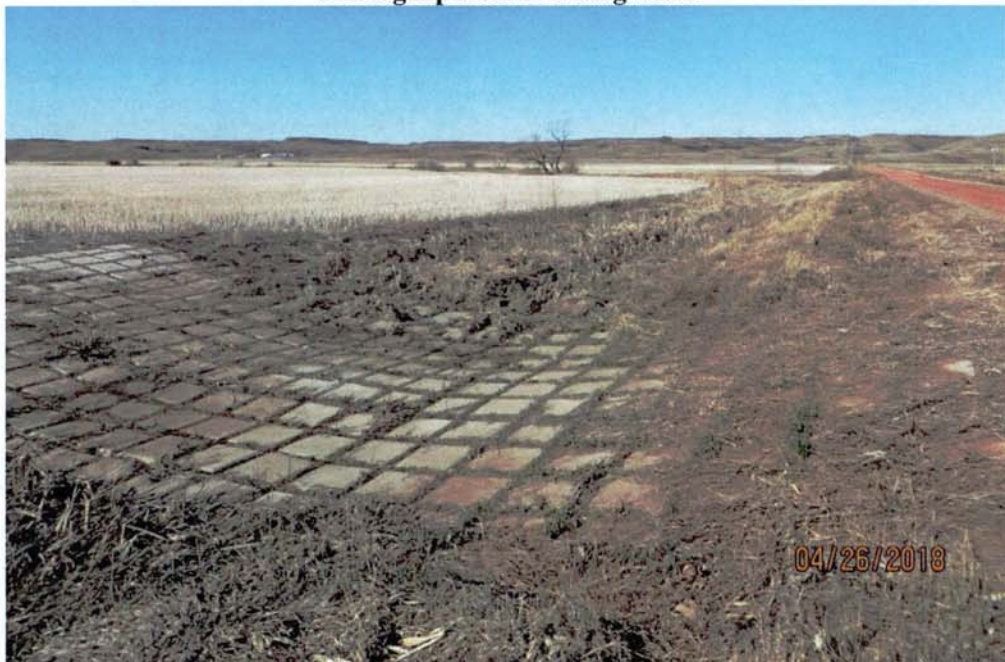
**Figure 3. Flexcrete crossing in the road ditch on the north side of the NW¼ of Section 34.
Photograph taken facing west.**

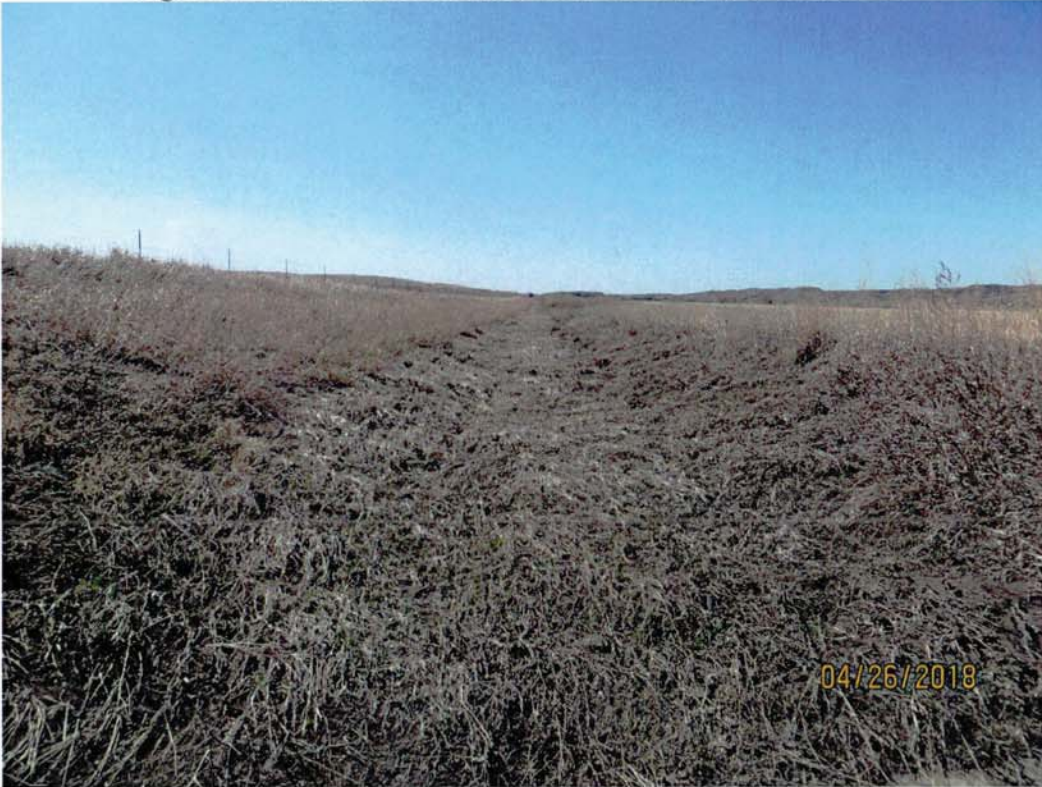
The diversion and its associated berm are generally well established with perennial vegetation, primarily smooth brome grass. Figure 4. Vegetation is not well established on approximately 100 feet of the west side of the diversion berm and some soil sloughing has occurred in this area. Figure 5. This area is down slope from the drainage of reclaimed sediment pond P-H34-04.

Figure 4. Diversion on the east side of the NW¼ of Section 34.

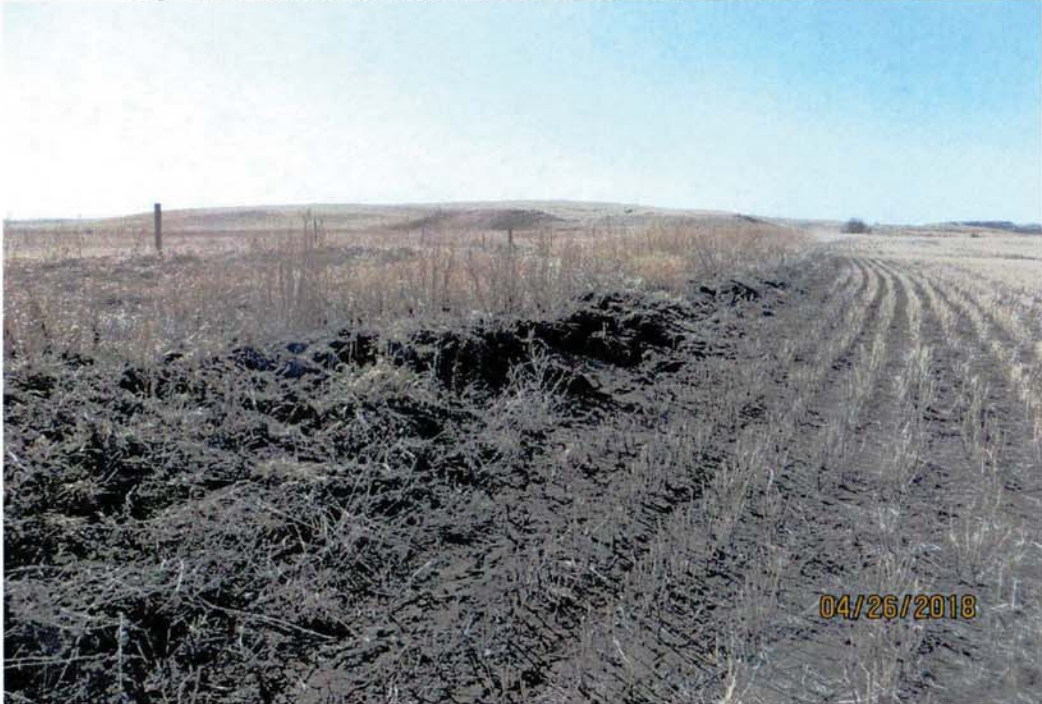
Figure 5: Soil sloughing on the west side of the diversion berm.

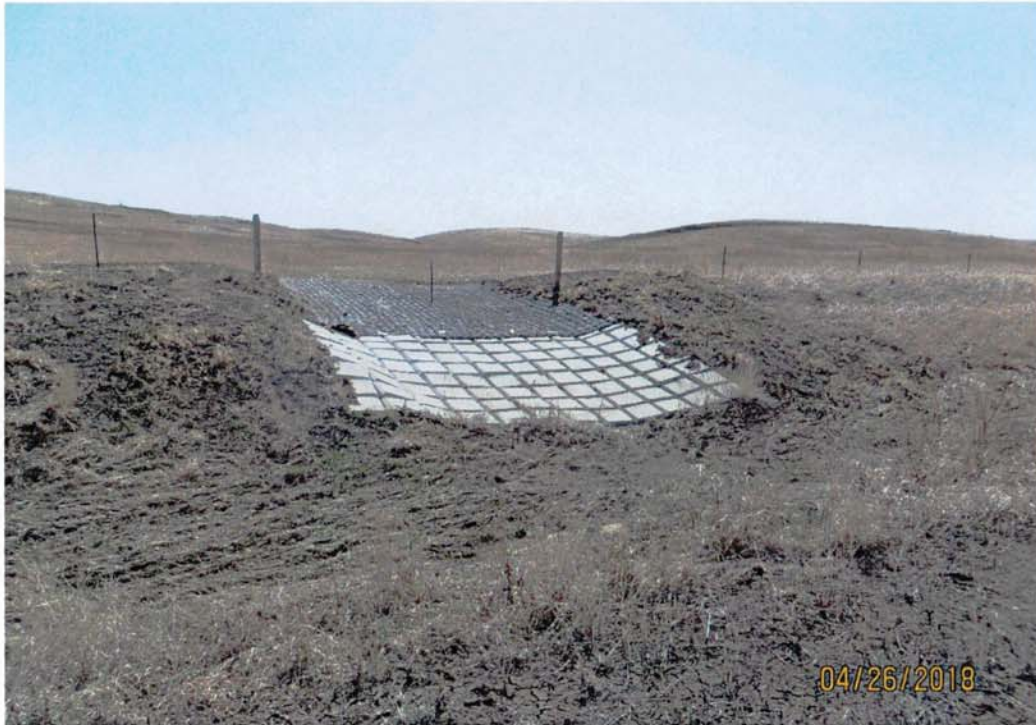
Runoff from the north drainage in the NE $\frac{1}{4}$ of Section 34 enters the reconstructed diversion in the NW $\frac{1}{4}$ of Section 34 at a right angle and drops approximately 10 feet to the bottom of the diversion. This entry point is lined with concrete flex matting and the site appears stable after this year's spring snow runoff event(s). This drop structure was originally constructed of Creflex blocks; however, much of the Creflex was replaced with Flex-A-Mat in June 2017 when erosional features were repaired. Figure 6.

Figure 6. Concrete flex matting at the inlet where water enters the diversion from the NE¼ of Section 34.

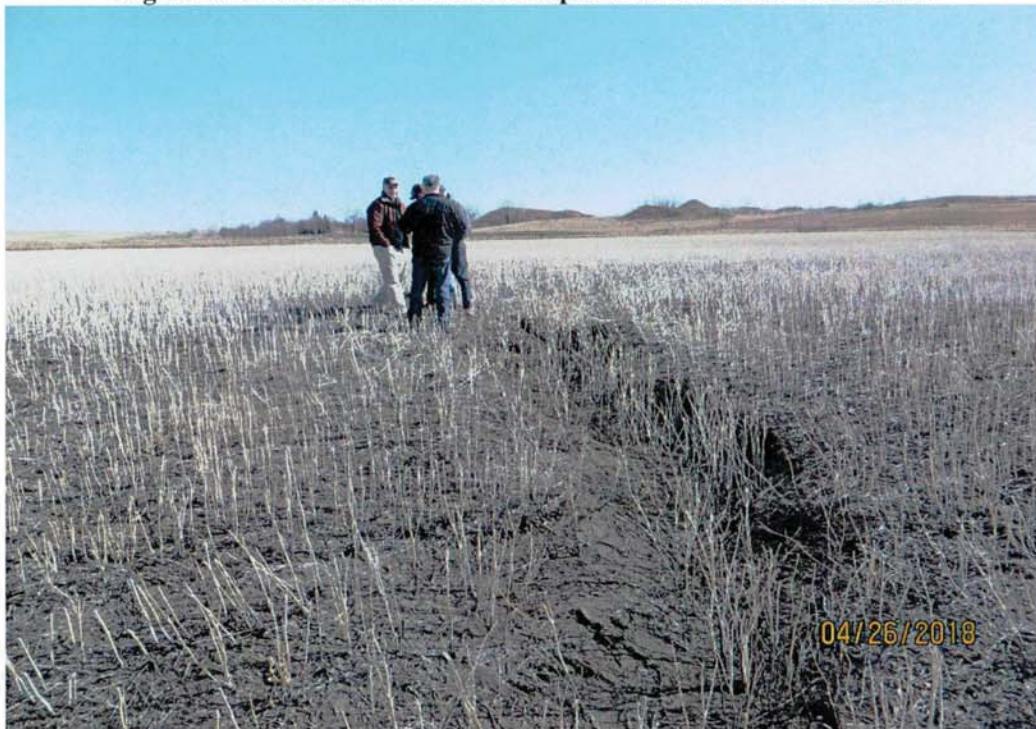
Other erosional features were observed on the Eisenbeis property and most were located in the E $\frac{1}{2}$ NE $\frac{1}{4}$ NW $\frac{1}{4}$ of Section 34. It appeared these erosional features were created from runoff that occurred last spring because canola stubble from last year's crop was present in these features. Only minor sediment deposition from runoff that occurred this spring was observed (up to an inch or two of deposition in portions of the older erosional features). The erosional features varied in size and the largest one observed was approximately 16 inches deep, 2 feet wide and 25 feet long. Figures 7, 8, and 9.

Figure 7: Erosional features on cropland in NW1/4 of Section 34.

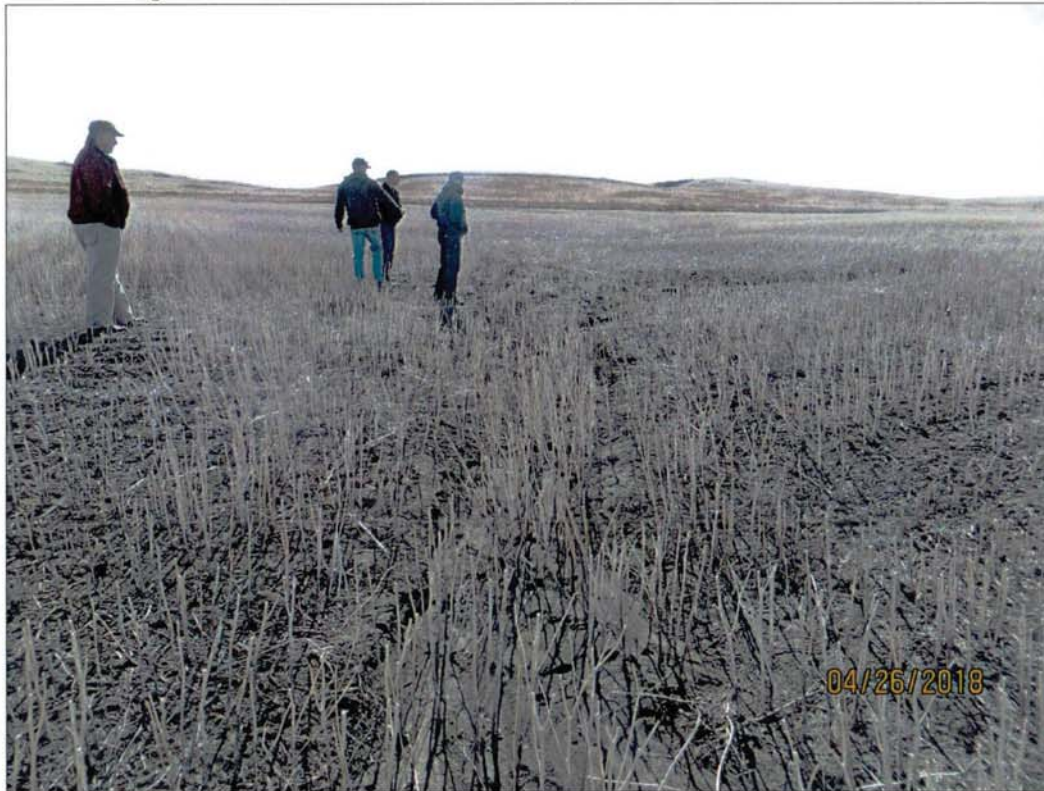
Figure 8: Erosional features on cropland in NW1/4 of Section 34

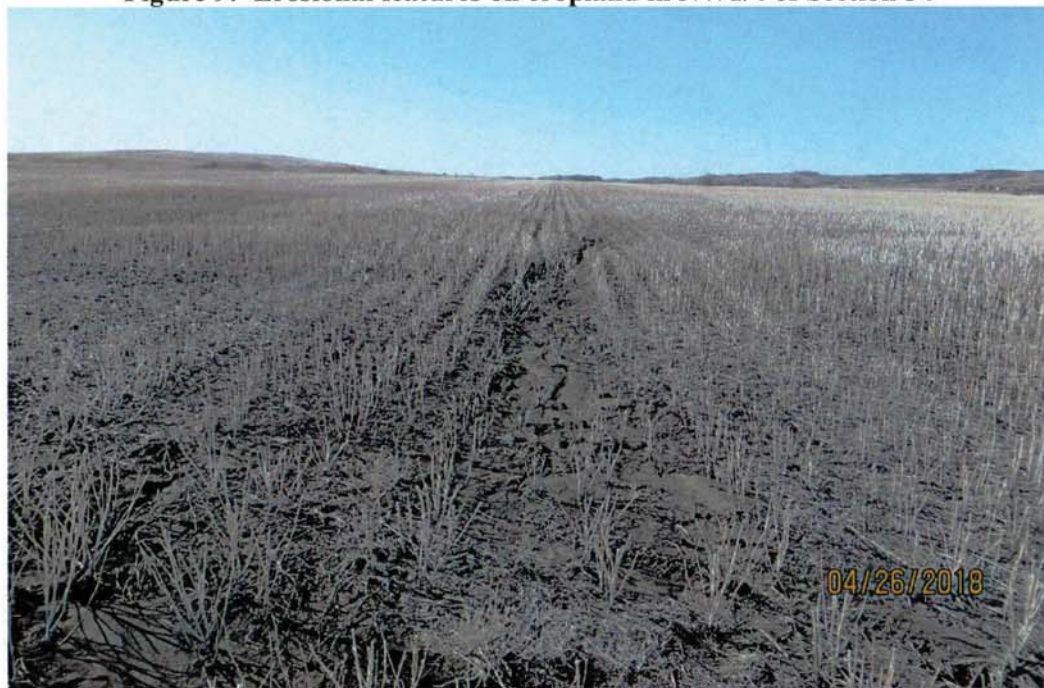
Figure 9: Erosional features on cropland in NW1/4 of Section 34

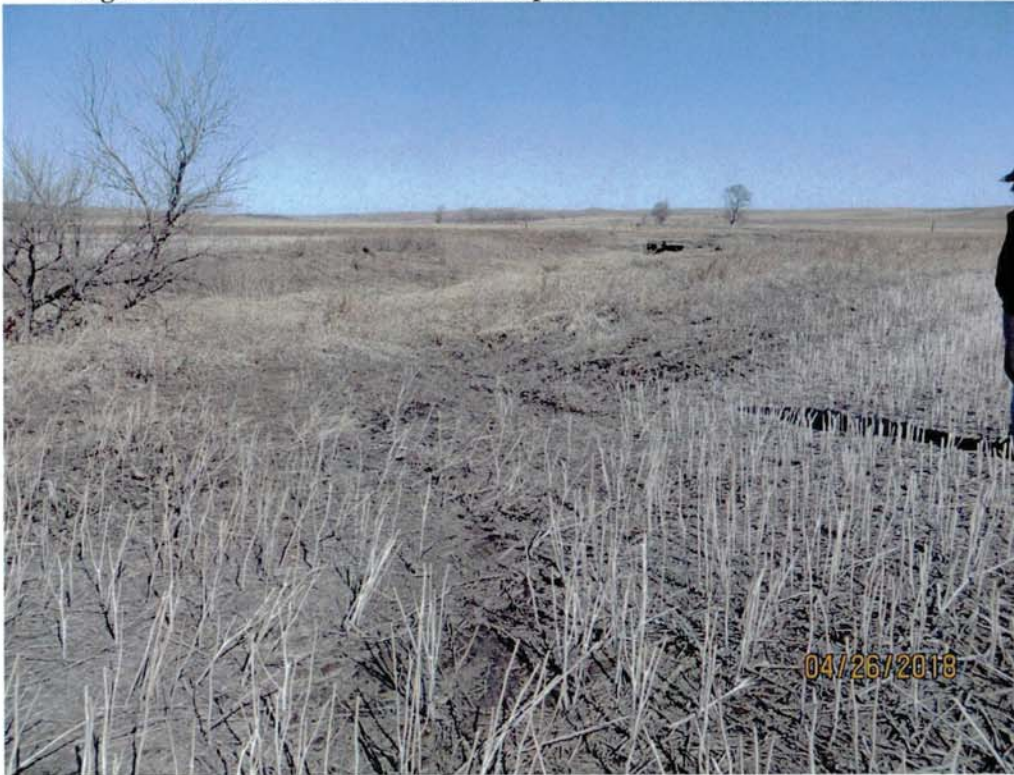
Additional erosional features were observed in the NW $\frac{1}{4}$ NE $\frac{1}{4}$ NW $\frac{1}{4}$ of Section 34 where runoff from the field enters a natural drainageway. These erosional features appeared to have formed last year. Figure 10. Several handfuls of erosion control fabric and an anchoring staple were collected in the field during the inspection.

Figure 10: Erosional features on cropland in the NW1/4 of Section 34.

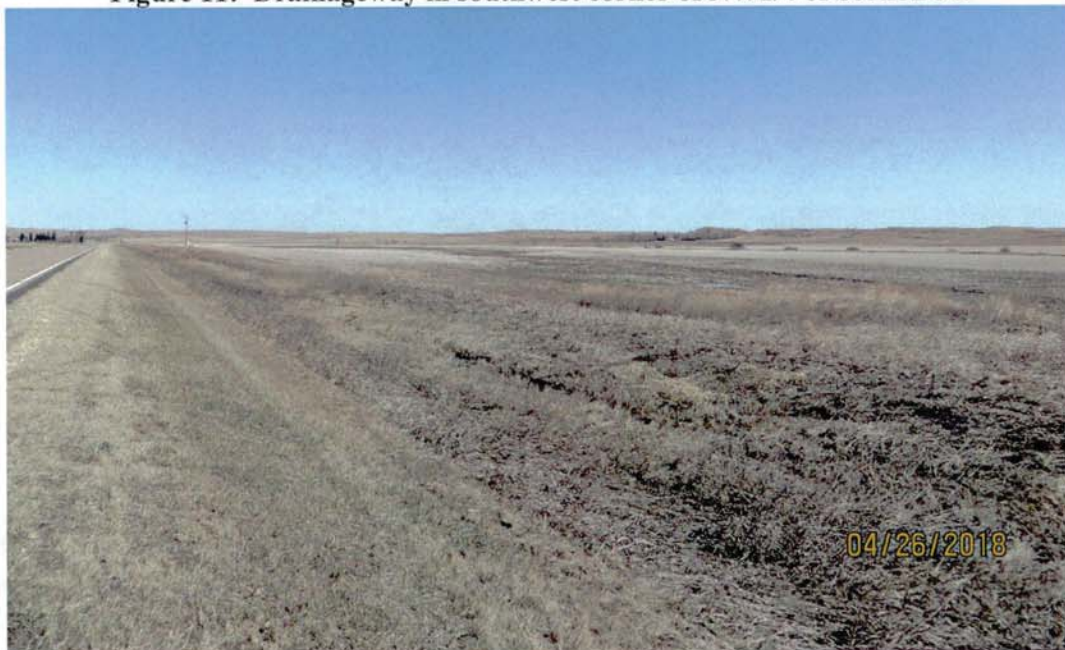
drainageway in cropland in the NW $\frac{1}{4}$ SW $\frac{1}{4}$ of Section 34. The natural drainageway extends northward into the Eisenbeis property at the southwest corner of the NW $\frac{1}{4}$ of Section 34 and continues meandering northward through the Eisenbeis cropland. With the exception of a small portion of the southwest corner, the drainageway is cropped when it is dry enough to support planting equipment; during wet years the drainageway and adjacent area are left idle. The drainageway was too wet to be cropped in 2017 but the field was cultivated when it dried out last summer or fall. Figure 11.

Figure 11: Drainageway in southwest corner of NW1/4 of Section 34.
