# Public Service Commission

## State of North Dakota

July 23, 2018

The Reclamation Division has reviewed your concerns regarding your land located in the NW $\frac{1}{4}$  of Section 34, T146N, R88W, as outlined in your May 4, 2018 email. Your property is located off-permit and adjacent to Surface Coal Mining Permit NACT-9501 at the Coteau Properties Freedom Mine.

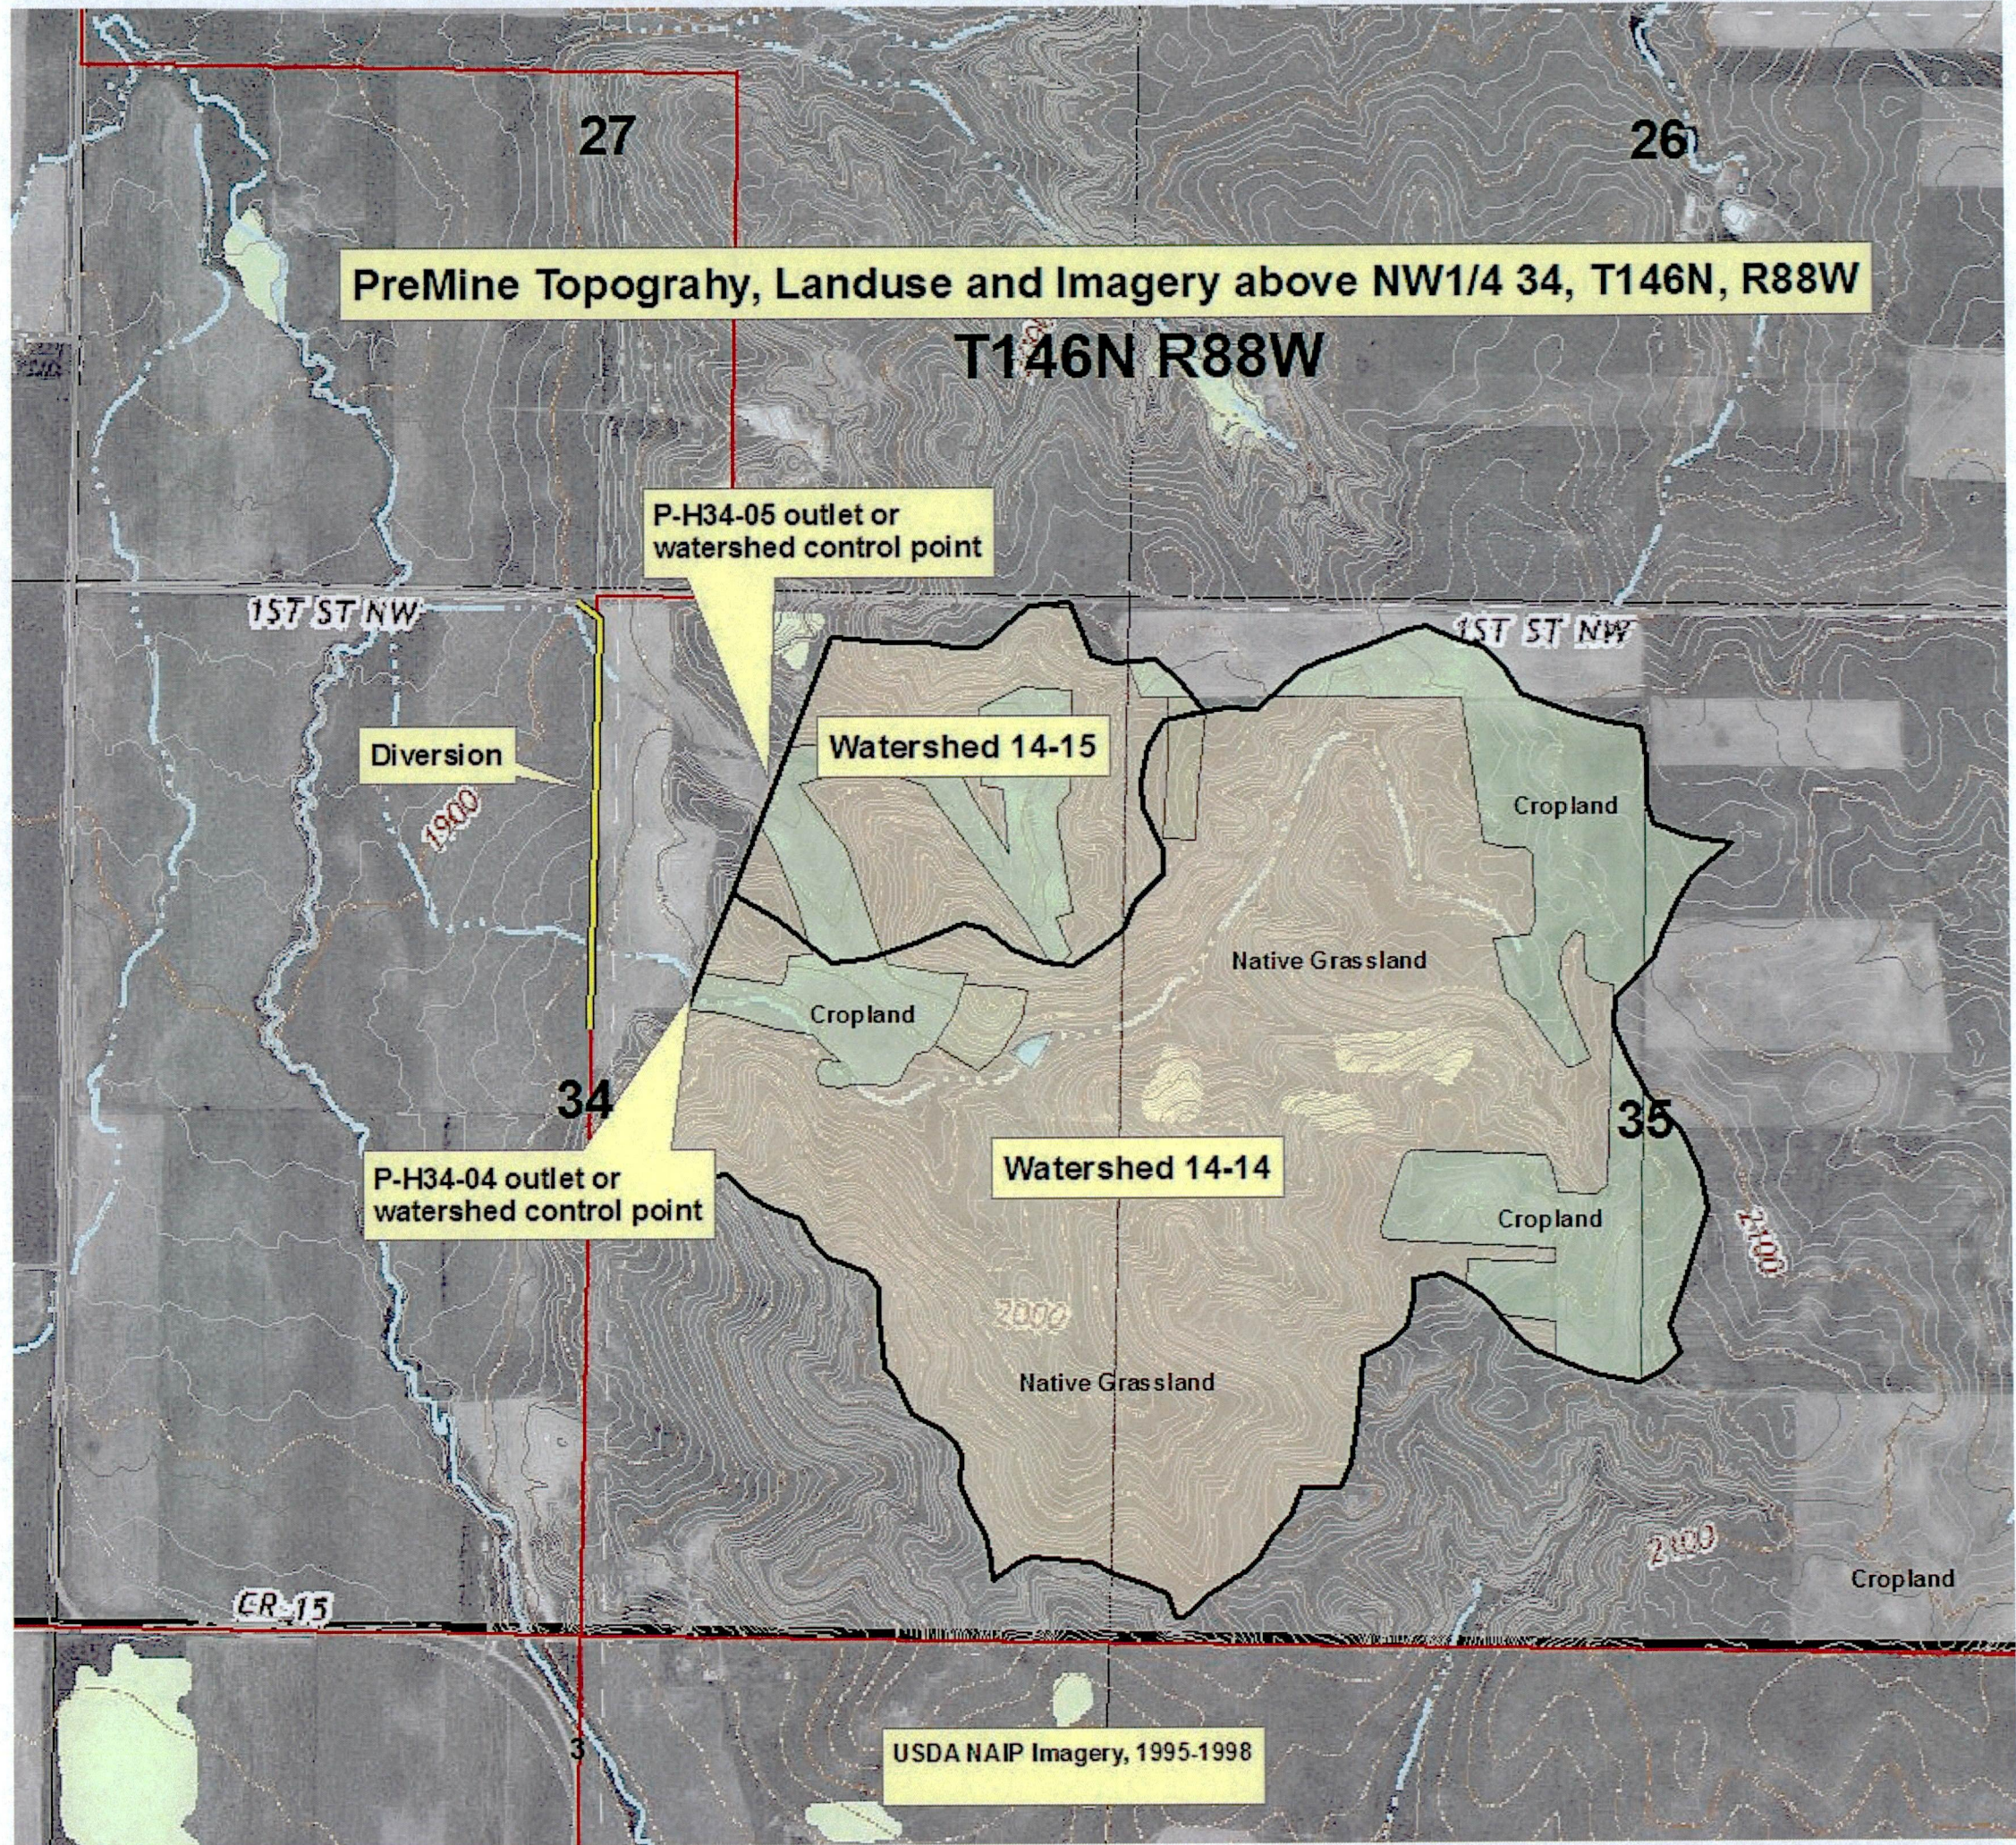
PreMine Topograhly, Landuse and Imagery above NW1/4 34, T146N, R88W

Reclamation Division staff noted on several occasions an existing diversion located on the east side of your property in the NW $\frac{1}{4}$  of Section 34 (off-permit). This diversion flowed to the north until it intercepted the south road ditch of the road between the NW $\frac{1}{4}$  of Section 34 and the SW $\frac{1}{4}$  of Section 27. We are uncertain who constructed this diversion and when it was constructed but it appears to have been in place for a long time. We assume that it was constructed to alleviate erosion on the downstream areas in the NW $\frac{1}{4}$  of Section 34. Historic

aerial photography indicates well-defined erosion patterns in the NW $\frac{1}{4}$  of Section 34, well before the area was permitted, mined, and reclaimed.

On August 28, 2007, Coteau submitted the application for Revision No. 30 to Surface Coal Mining Permit NACT-9501. This revision proposed changes to the postmine topography and watershed boundaries in the NE $\frac{1}{4}$  of Section 34. The size of watershed 14-14 (most of the area controlled by sediment pond P-H34-04) decreased slightly (5 acres smaller than premine) but the size of watershed 14-15 (most of the area controlled by sediment pond P-H34-05) was increased by 132 acres. The combined area of watersheds (14-4 and 14-15) increased by a total of 127 acres. Revision No. 30 also proposed some land use changes for the NE $\frac{1}{4}$  of Section 34 including changing the postmine land use of a portion of the watersheds from cropland to native grassland. Attached are maps depicting pre- and post-mine watersheds 14-14 and 14-15.

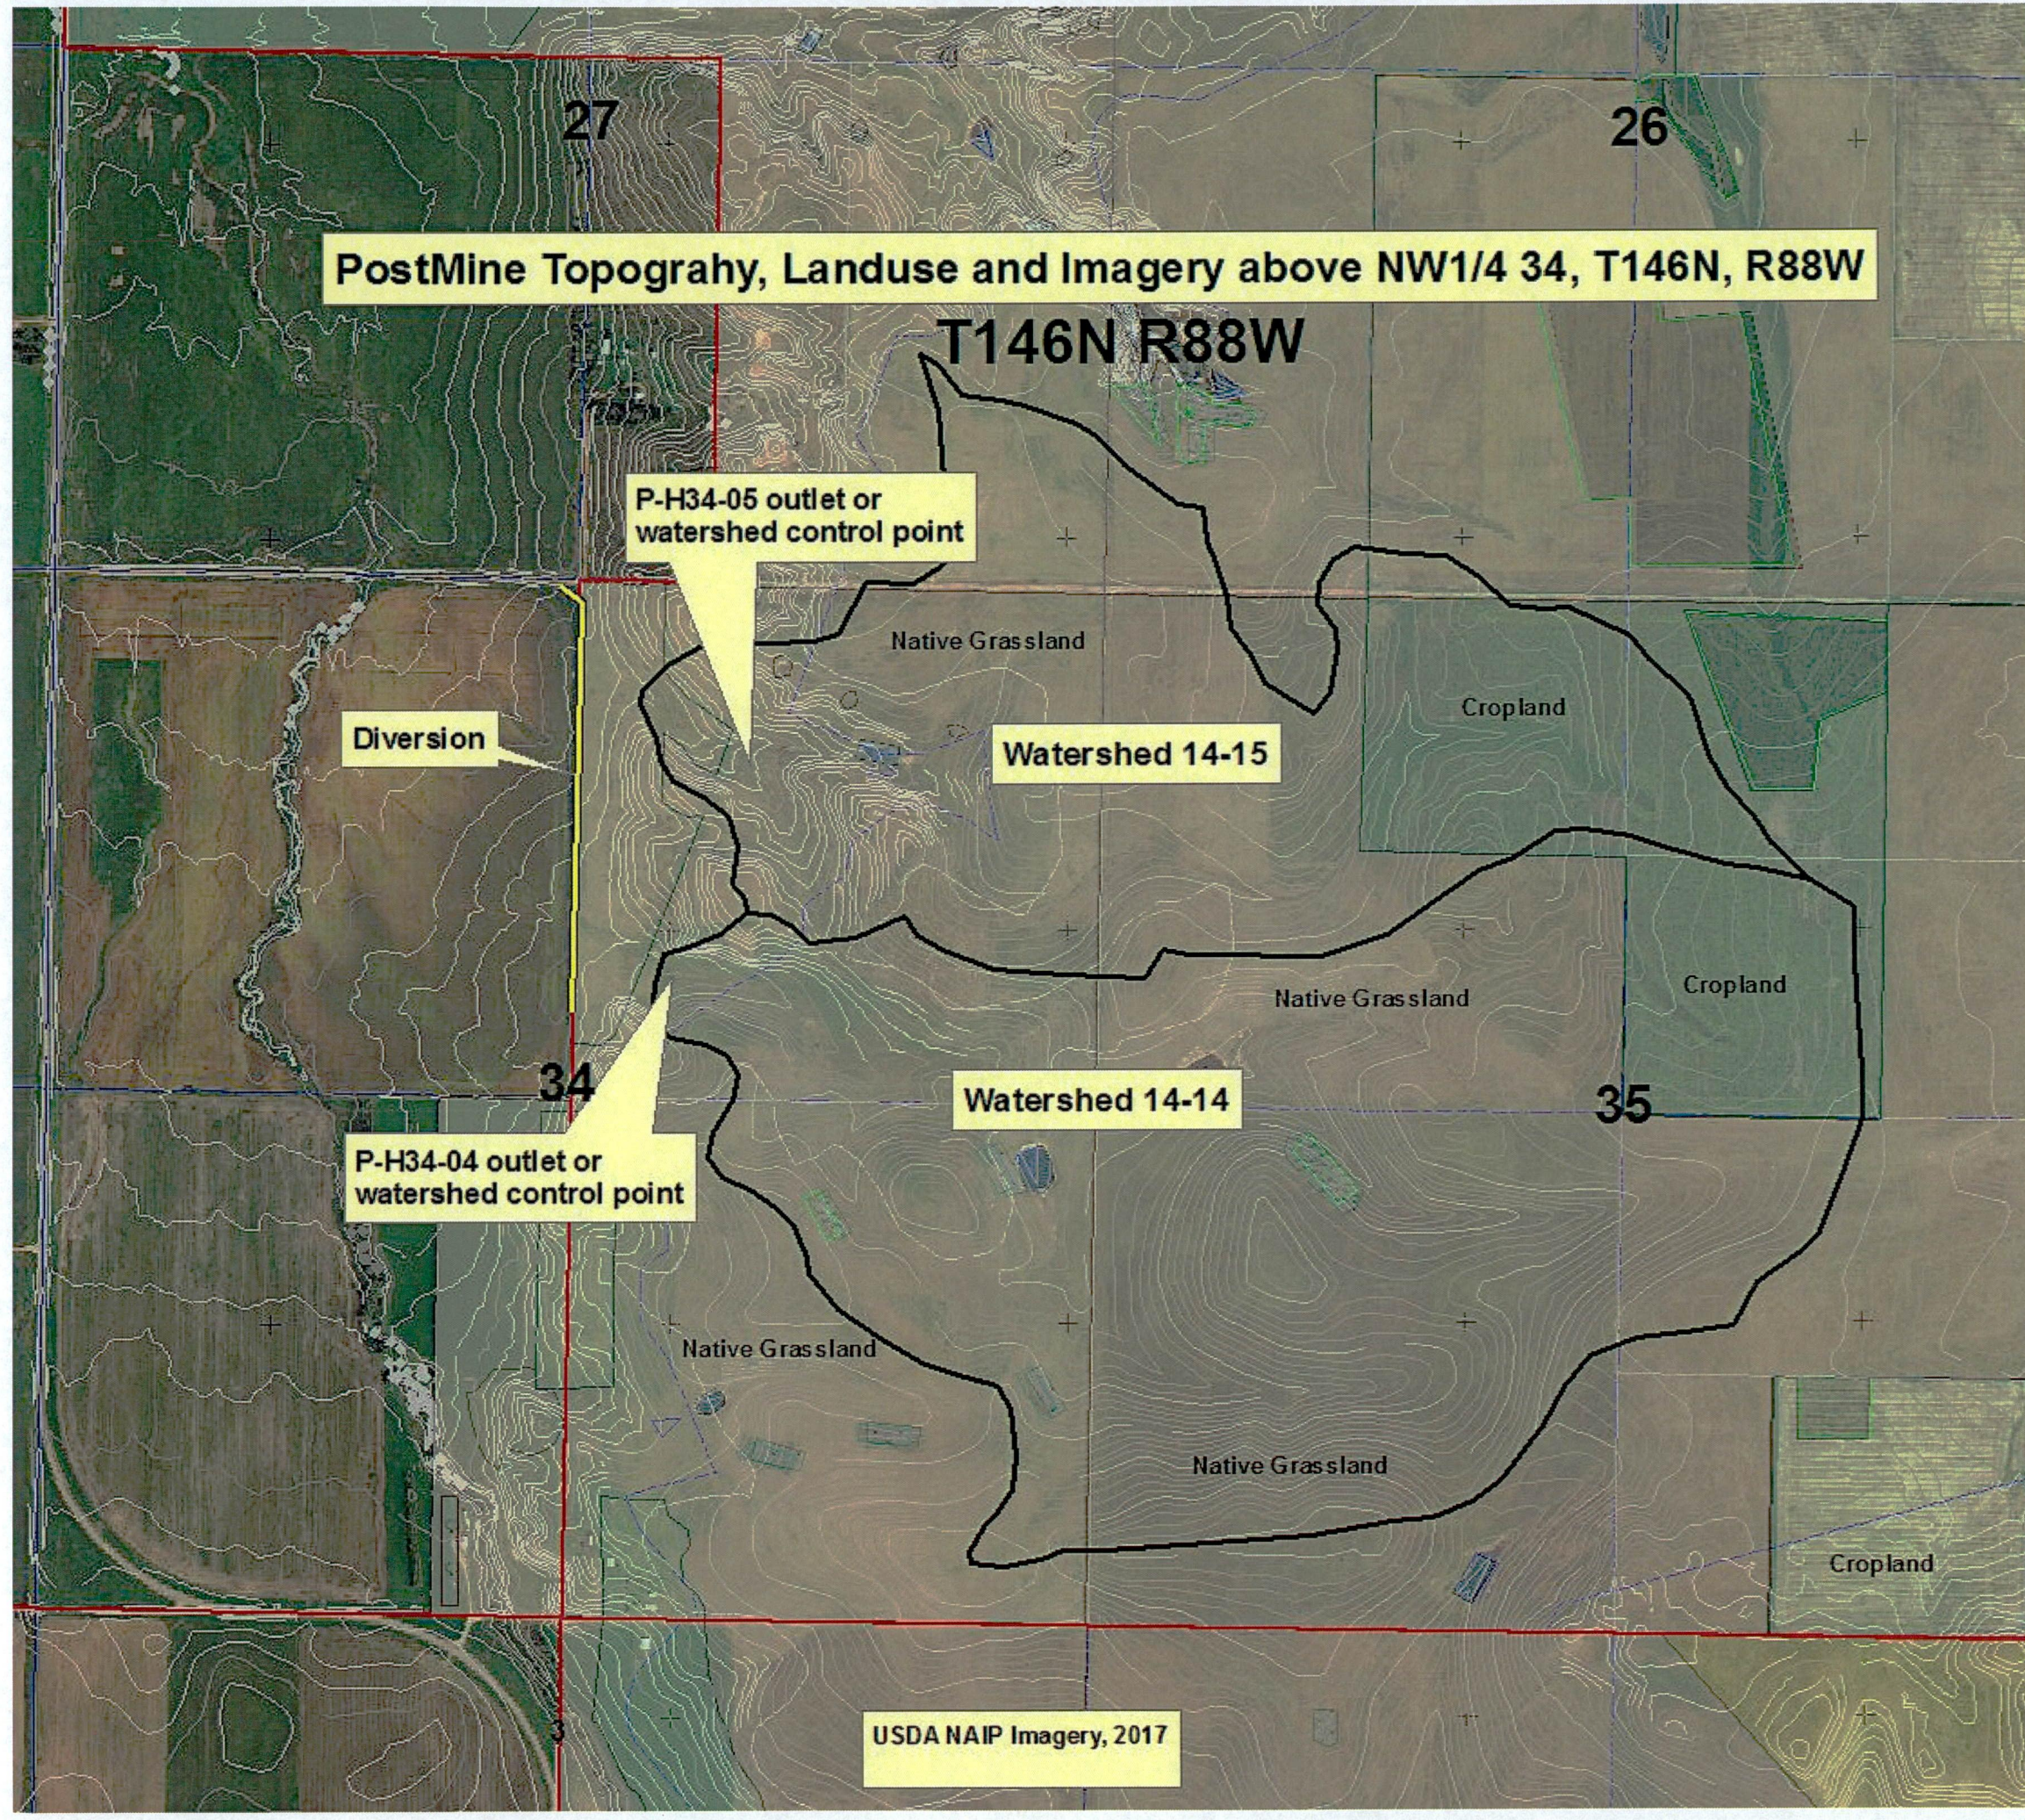
PostMine Topograhpy, Landuse and Imagery above NW1/4 34, T146N, R88W

Our analysis shows that even though the total combined watershed size increased after reclamation, the expected total flow rates and volumes are less than the premine condition. This is due to a number of reasons but is primarily due to the reclaimed or postmine watersheds being less steep than the premine watersheds. The premine average slope of watershed 14-15 was 12.7% and the postmine average slope is 4.4%. In addition, the shallow and claypan soils that were common in the premine watershed were replaced with deeper, loamy soils with higher infiltration rates. In addition, there is less cropland and more native grassland in the reclaimed watershed than in the premine watershed. The perennial native grassland vegetation generally has a lower runoff potential than cropland.

**Required Action:** During our reanalysis of the Probable Hydrologic Consequences (PHC), we noted the reclaimed grassland drainage channel for watershed 14-15 (within the permit area) enters the reconstructed diversion at a right angle and drops several feet in elevation over a very short distance. This configuration has resulted in erosion and maintenance problems in the past. The original drainage channel flowed in a more northwesterly direction and entered the existing diversion near the northeast corner of the NW¼ of Section 34. We will require Coteau to re-route this drainage channel in a more northwesterly manner, similar to how it existed prior to mining. This will result in a more stable configuration and much of the drainage from watershed 14-15 will flow almost directly into the east-west reconstructed road ditch rather than flowing into the north-south reconstructed diversion. As a result of this reconfiguration, most of the drainage from watershed 14-15 will "bypass" your property with the exception of the south road ditch. Most of this "reconfiguration work" will take place within the permit area; however, the point at which the reconfigured drainage channel will enter the reconstructed diversion is located on your property and we encourage you to work with Coteau to accommodate the reconfiguration of this drainage channel.

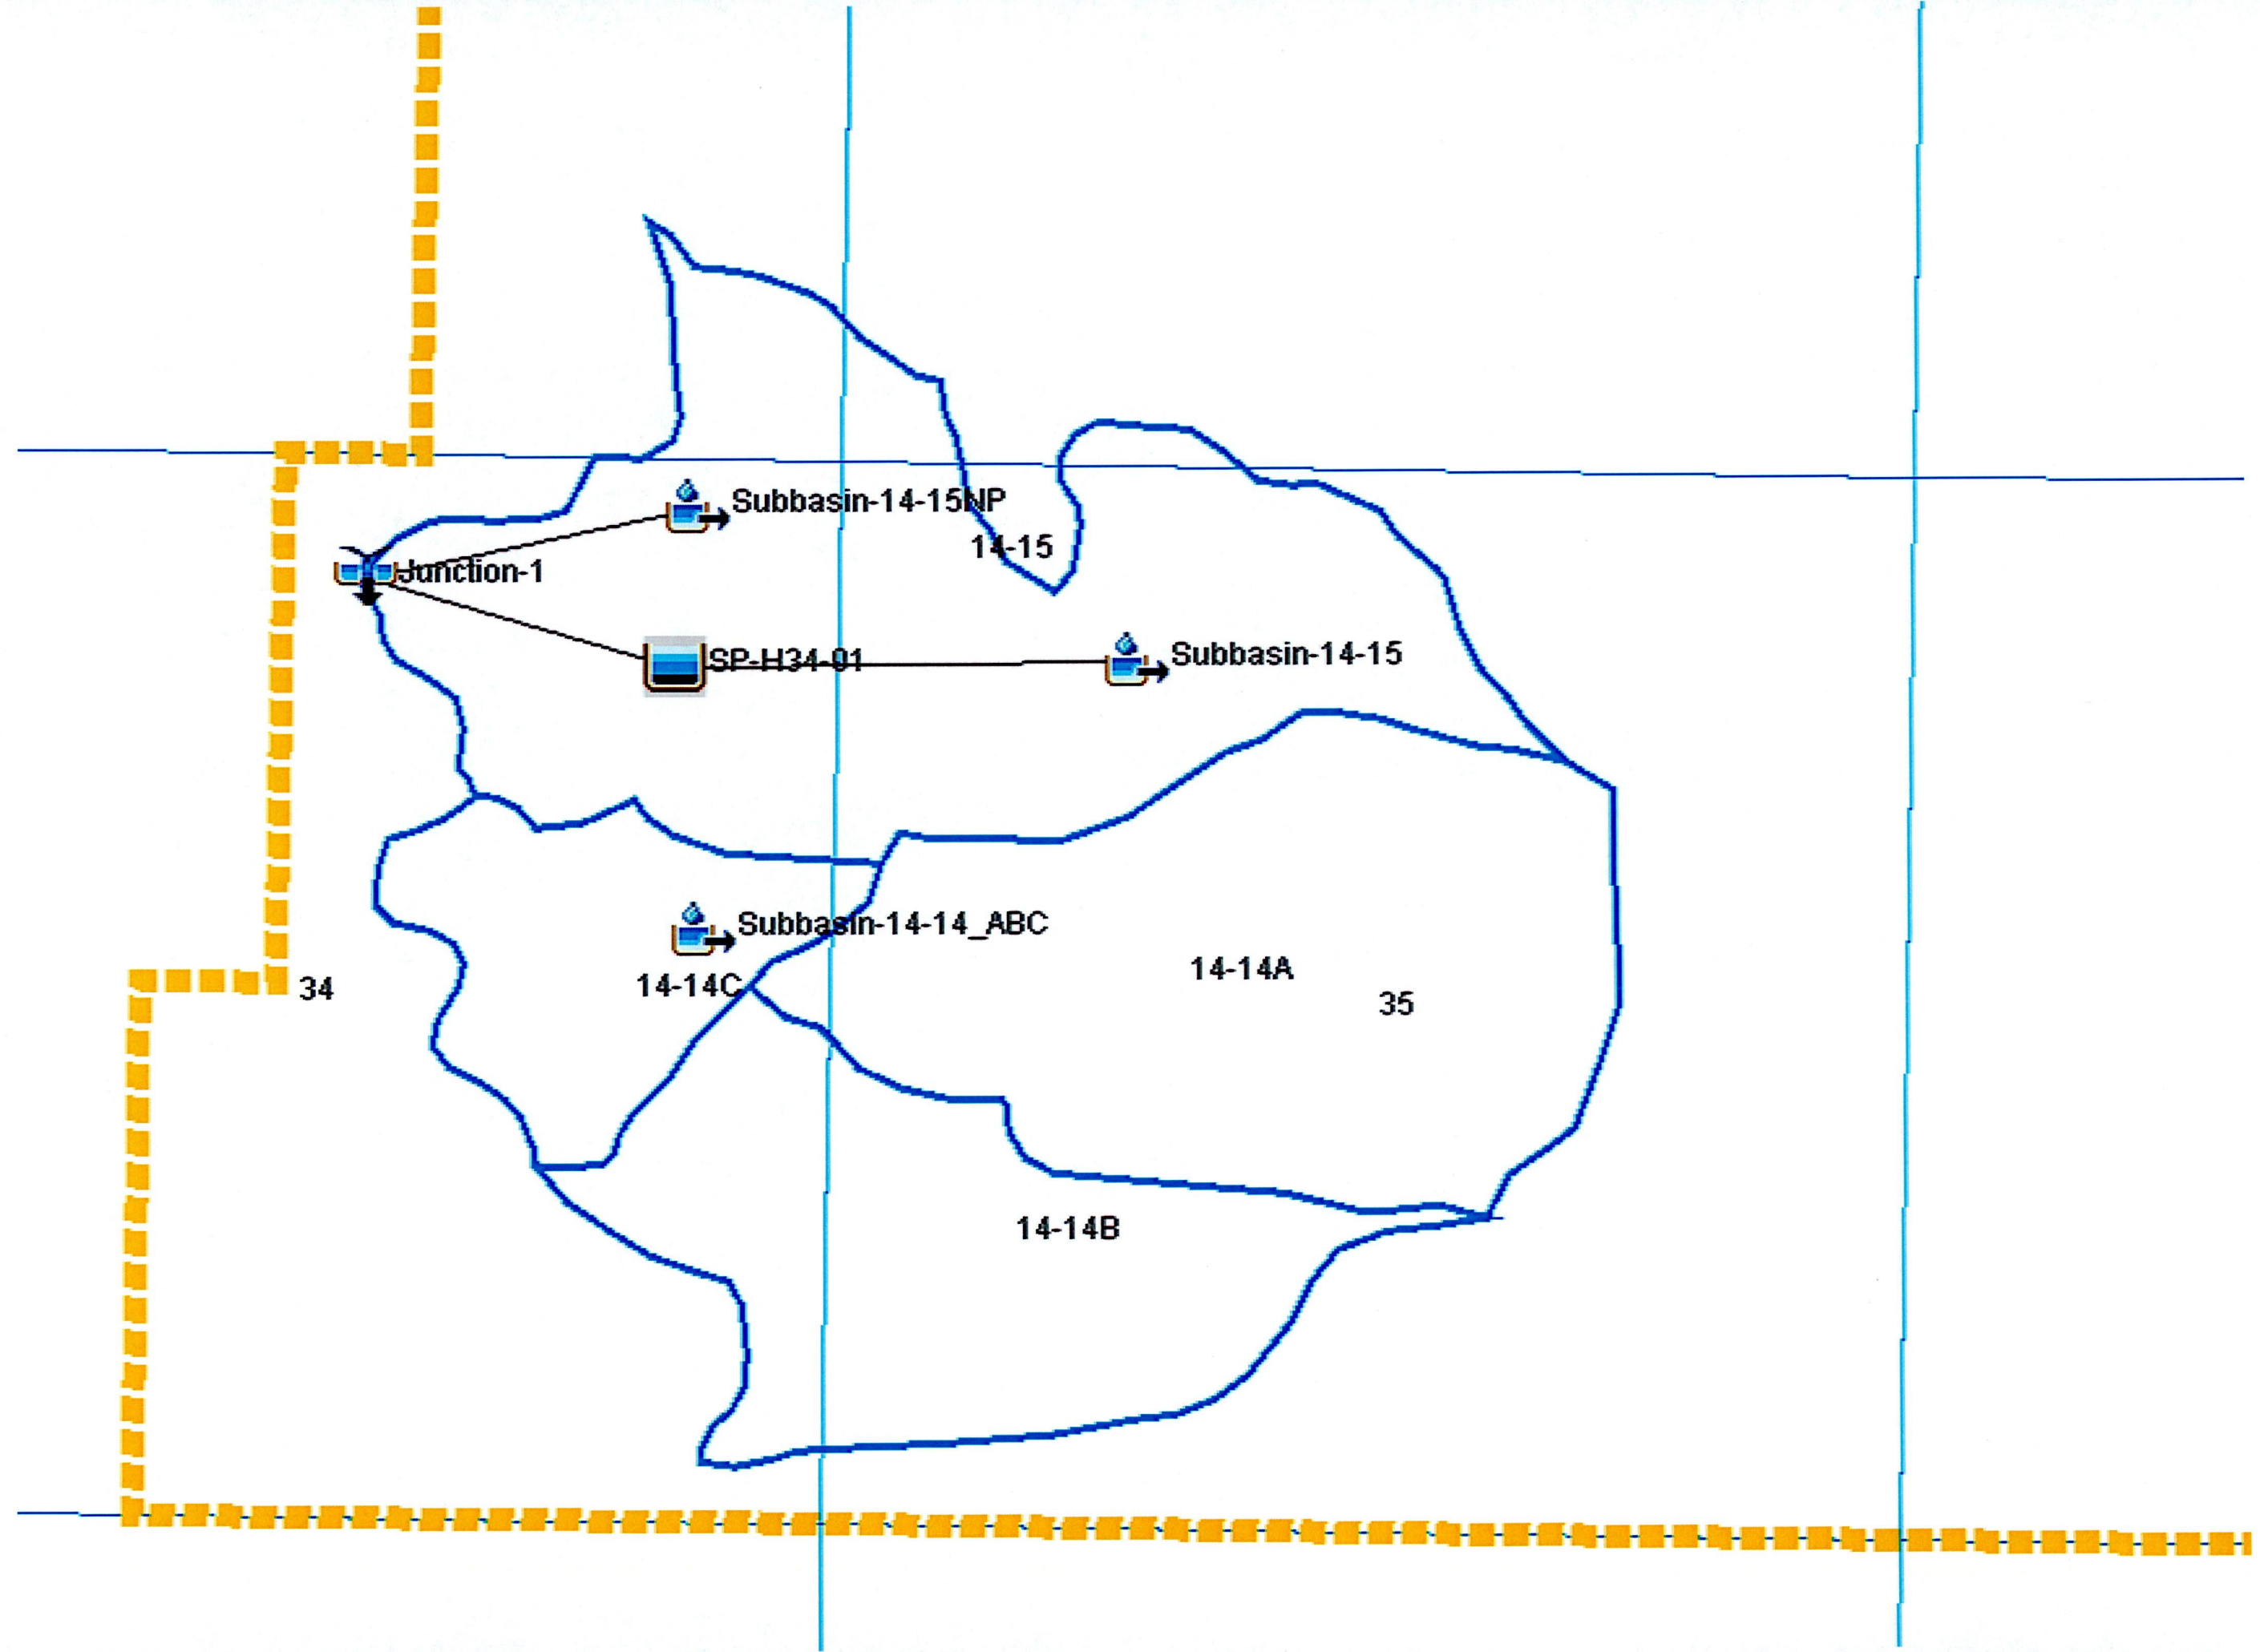
Global Summary Results for Run "Run 10-24"

The Reclamation Division staff have reviewed the flow modeling provided by Coteau and have determined the parameters and assumptions used were appropriate and reflected the actual conditions. In response to your concerns, staff again modeled both watersheds and the results of our independent modeling are similar to those provided by Coteau in Revision 30. A copy of our analysis is attached.
