THE COTEAU PROPERTIES COMPANY

June 19, 2018

This letter is in response to your letter dated May 14, 2018. Provided are responses to each of the following questions or requests.

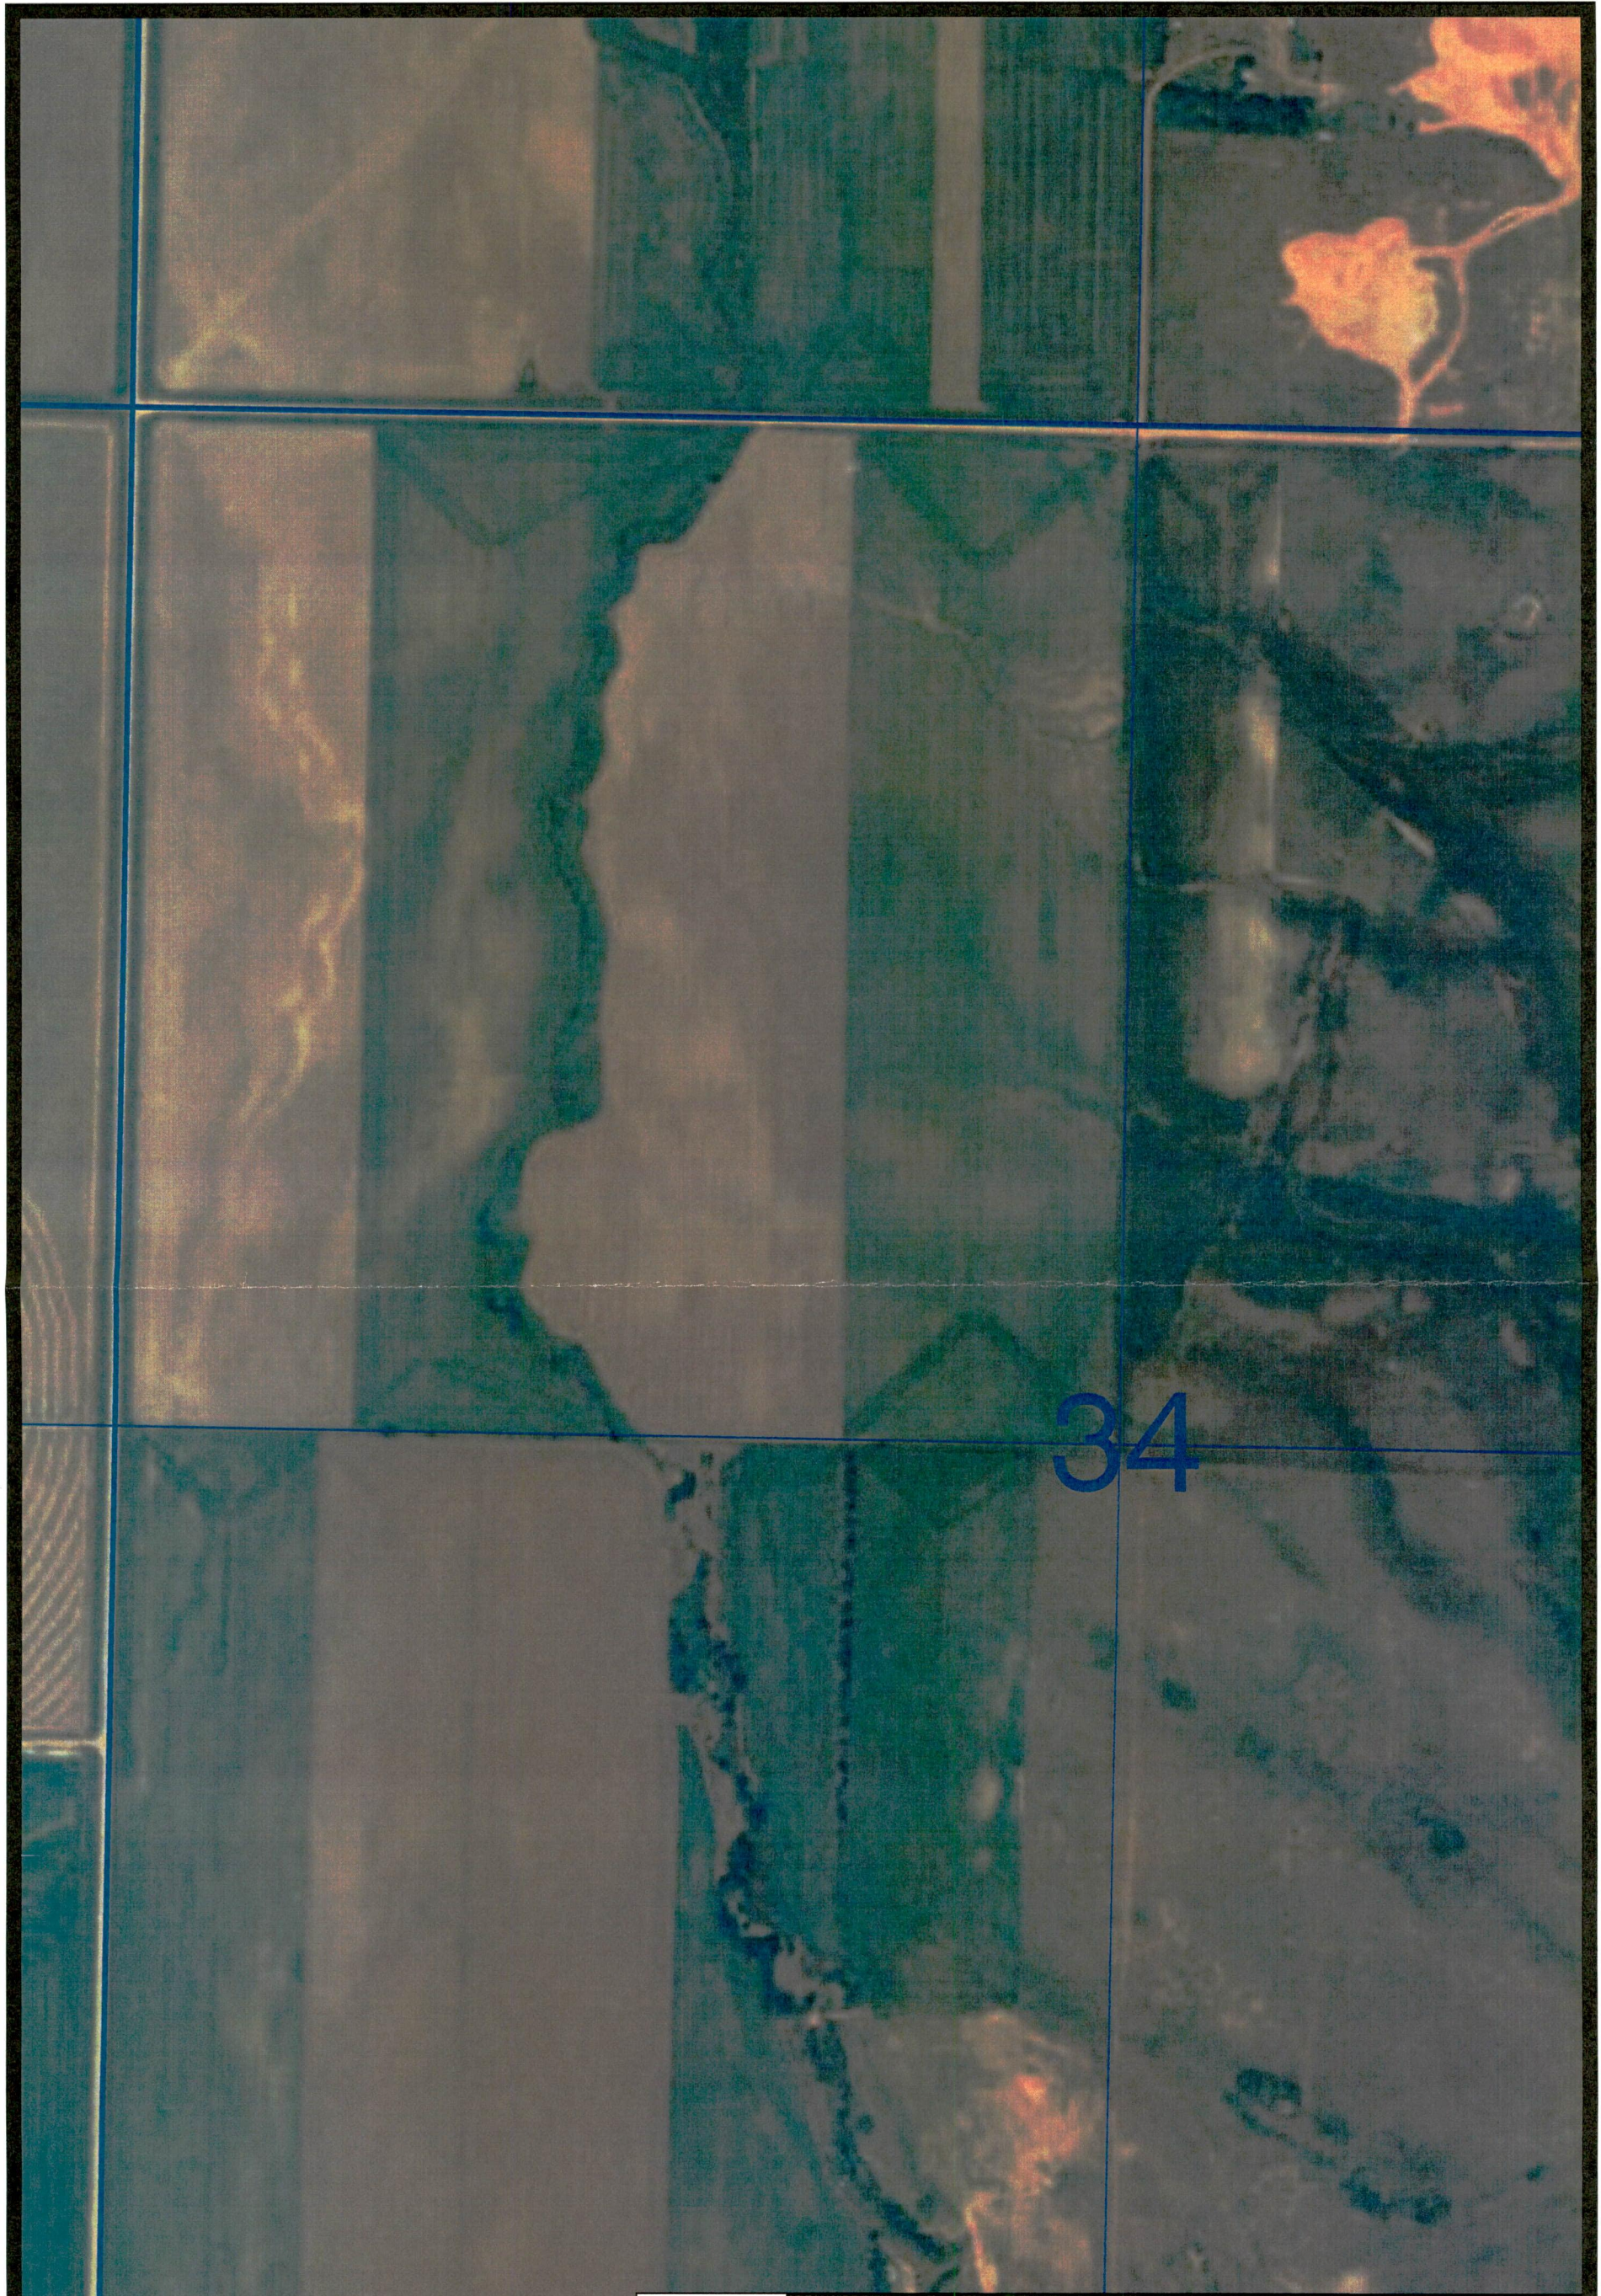
FREEDOM MINE BEULAH, ND 58523
		8			
		7			
		6			
		5			
		4			
		3			
		2			
		1			
		0			
					FIGURE 2 AERIAL PHOTO JULY 2, 1996
					SCALE: 1"=400' PAPER SIZE 11"x17" PROJECT: REVISION:

The diversion was in poor condition. It was silted in areas and blown out in others. There were also small trees or shrubs growing in the diversion channel. There was little to no elevation difference between the field and diversion bottom and between the field, ditch bottom, and the road top. The ditch had filled in with sediment over the years and when water did flow in this area, it mostly flattened out over a broad area and flooded into the adjoining field.

The diversion was not capable of handling pre-mining flows. This is evident by the erosion shown in Figures 1 and 2, attached. Figures 1 and 2 are aerial photographs of the field from 1977 and 1996 respectively.

It should be noted that flows during mining and following mining are less than the flows which occurred pre-mining. It should also be noted that erosion and flooding occurred in the subject field long before mining, as can be shown by viewing aerial photos, including Figures 1 and 2, dating back several decades prior to Coteau entering the area.

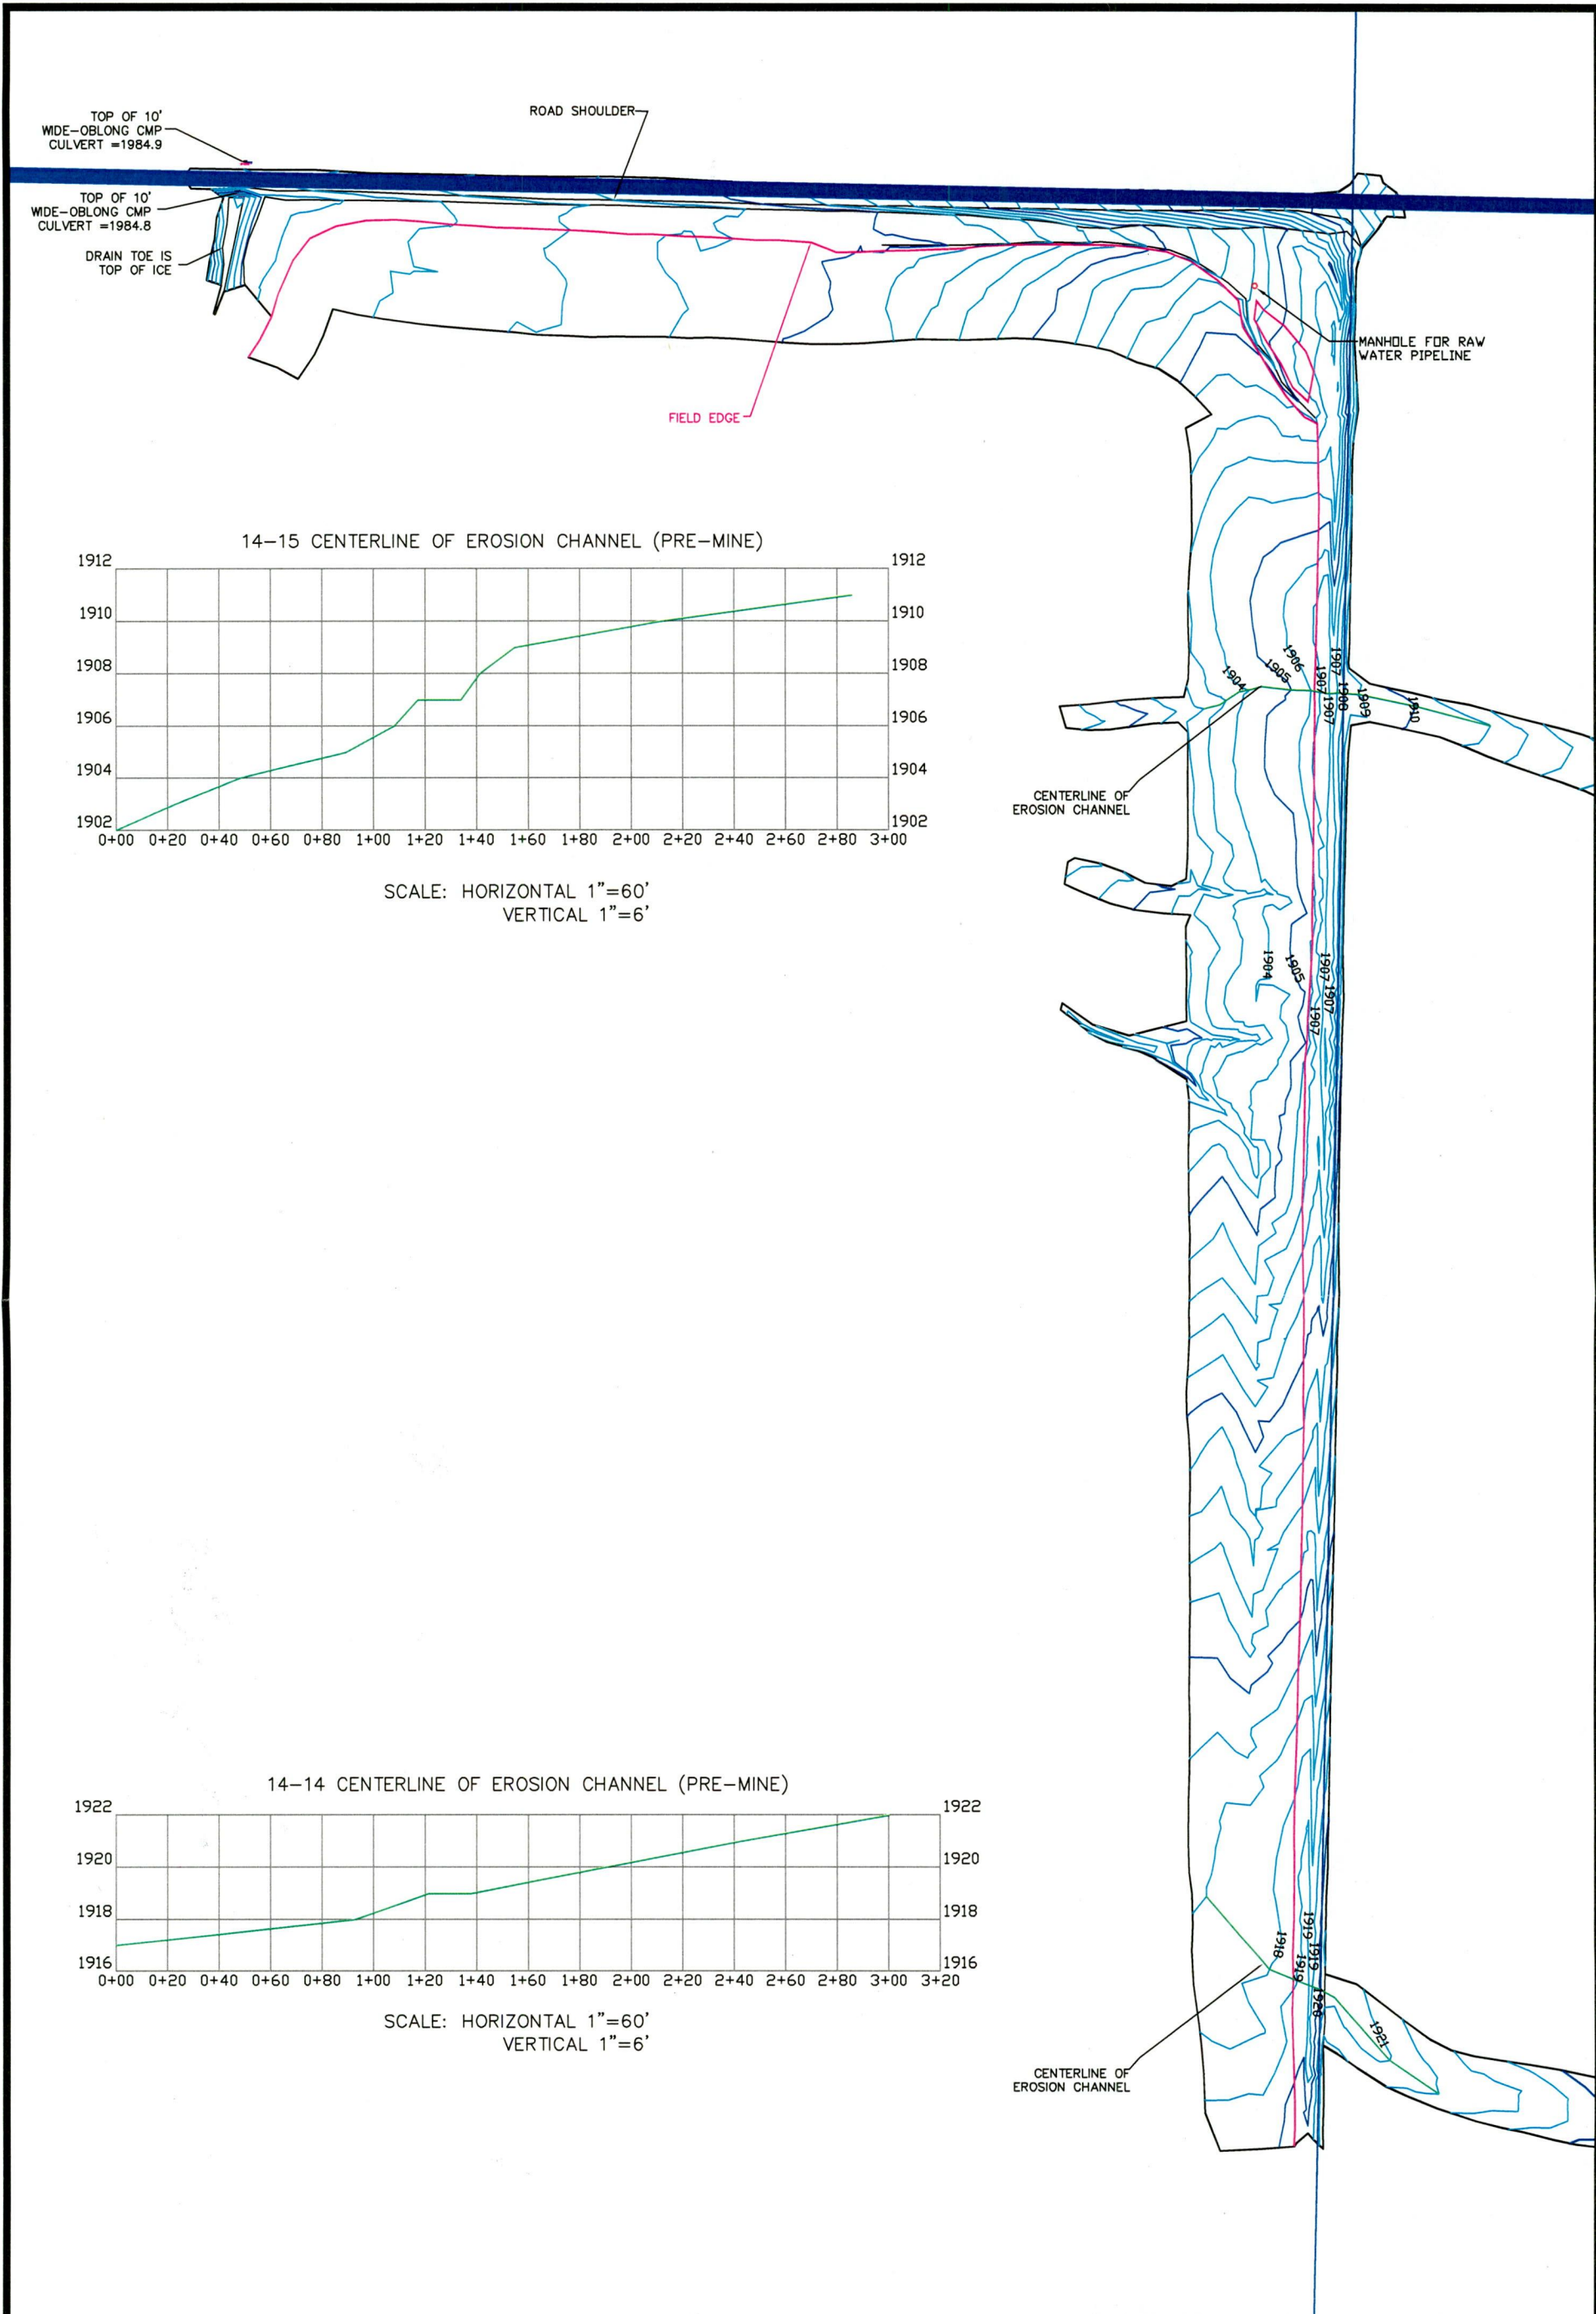
FIGURE 3

The producer approached Coteau in both 2010 and 2011 about aiding in repairing erosion in the field while the sediment ponds were in place and functioning. Additionally, Figure 3 is the original ground topography survey prior to reconstruction of the diversion. As can be seen in the drawing, there are several areas that show erosion west or below the diversion. Figure 3 includes two cross-sections of the existing diversion, one at the entrance of watershed 14-14 and one at the entrance of watershed 14-15. Both cross-sections indicate that runoff would flow across the diversion to the west uninterrupted. This survey was collected on November 29, 2011, after installation of the sedimentation ponds, but prior to the reconstruction of the diversion or removal of any sedimentation ponds.

Mining operations did not cause increased flows and erosion was already occurring prior to any mining operations in the area. As noted above, flows were less during and following mining than the flows pre-mining.
