Site/Project Location: Denbury 12-inch Cedar Hills Pipeline

Date of Inspection: 6 July 2021

78 PU-19-294 Filed 07/19/2021 Pages: 3
Construction Inspection Report
Keitu Engineers & Consultants, Inc.

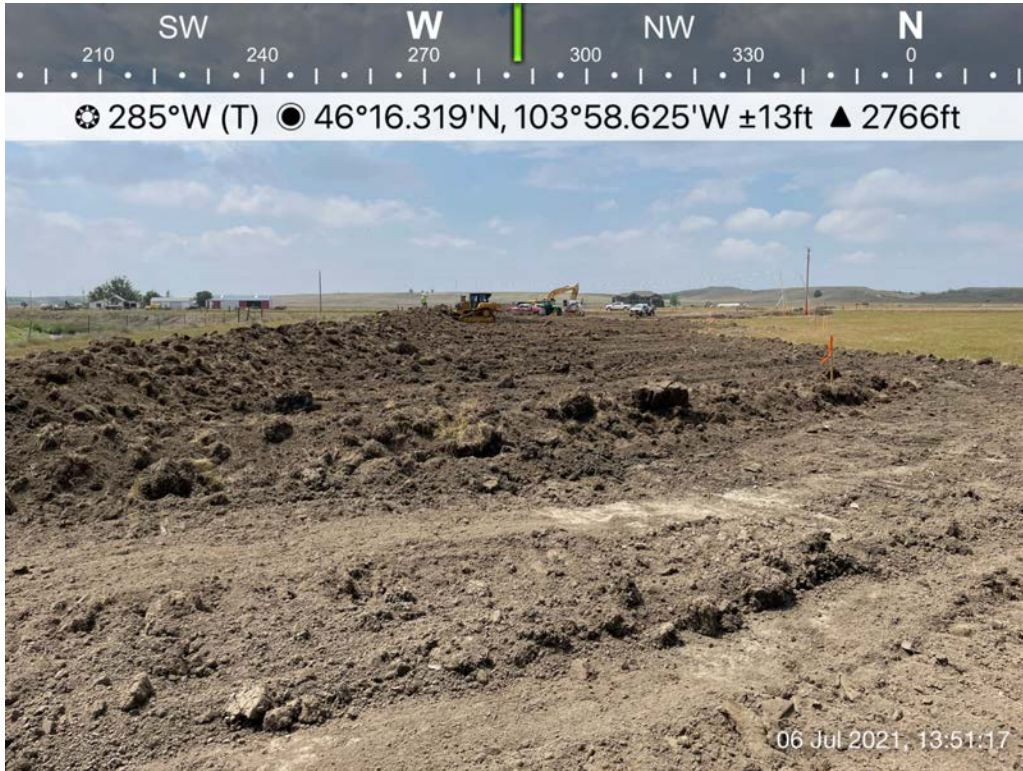
A bulldozer started stripping topsoil in the area where machinery will be staged to bore pipe underneath Little Beaver Creek. Topsoil depth varied from 6-12 inches deep at the boring location. The bulldozer operated carefully removed the topsoil until the subsoil layer became visible and moved the topsoil into a berm on the west side of the cleared area. The subsoil was not removed, so the topsoil pile was kept segregated on the west side of the cleared area.

The bulldozer operator demonstrated proper understanding of the rules and regulations for topsoil removal and removed the topsoil to a depth where the subsoil started to appear. Multiple passes were made over the same ground to remove the topsoil in increments to smoothly strip the topsoil layer at proper depths across the varying contours of the field.

Report Photo #1 "Bulldozer Stripping Topsoil for HDD Bore at Little Beaver Creek"

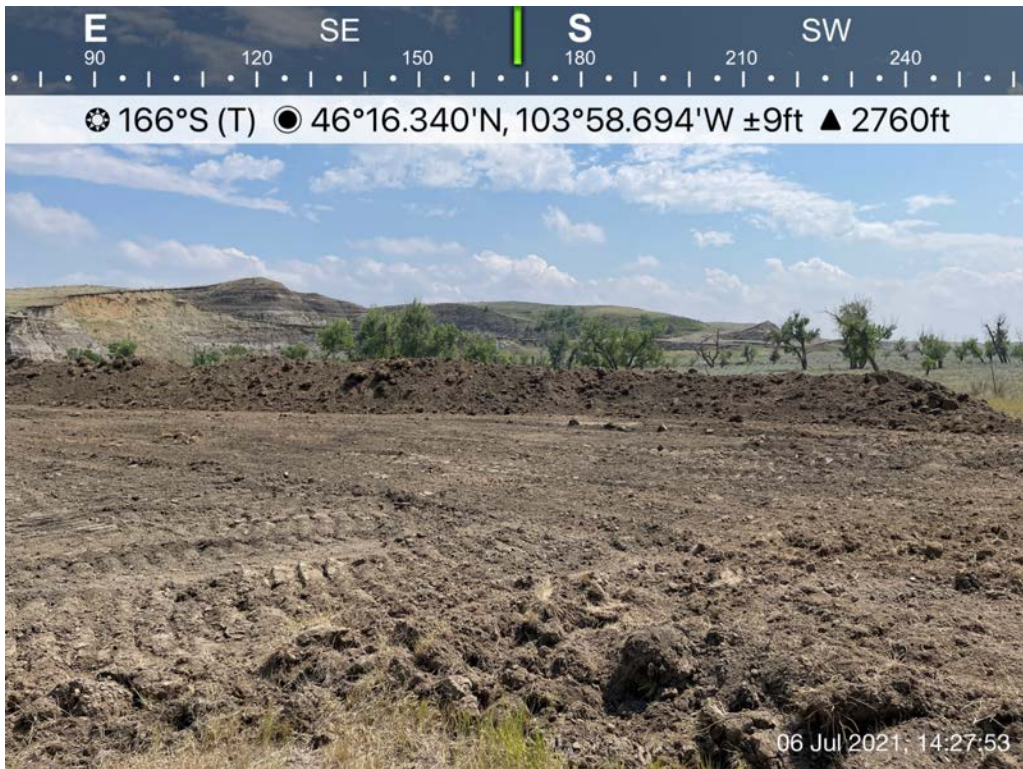
Report Photo #2 "Topsoil Pile on the West Side of the Cleared Area"

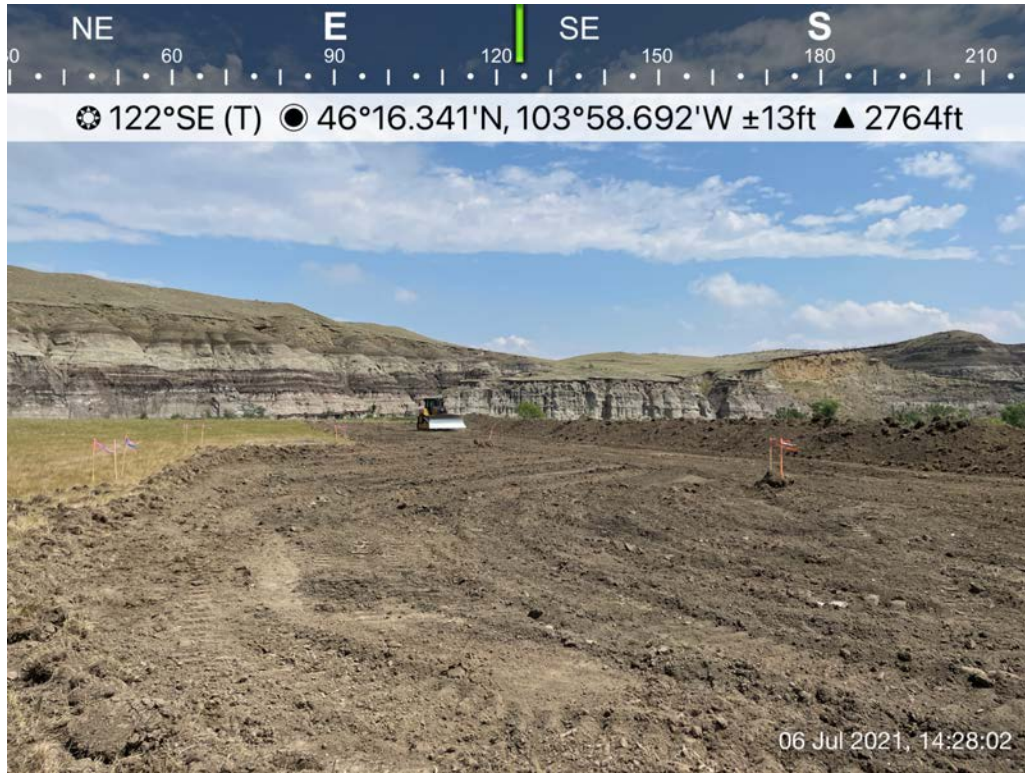
Topsoil segregation was noted to be acceptable at this time in the areas observed. Equipment operator was reminded to strip soil, where it existed, down to a maximum of 12 inches or to the depth where subsoil appeared. Equipment operators have demonstrated proficiency in topsoil removal and segregation in compliance with the Commission's Order.

Report Photo #3 "Topsoil Stripped for HDD Boring Activities"
