Site/Project Location: Denbury 12" Cedar Hills CO2 Pipeline

Date of Inspection: 4 August 2021

82 PU-19-294 Filed 08/18/2021 Pages: 5
Construction inspection report
Keitu Engineers & Consultants, Inc.

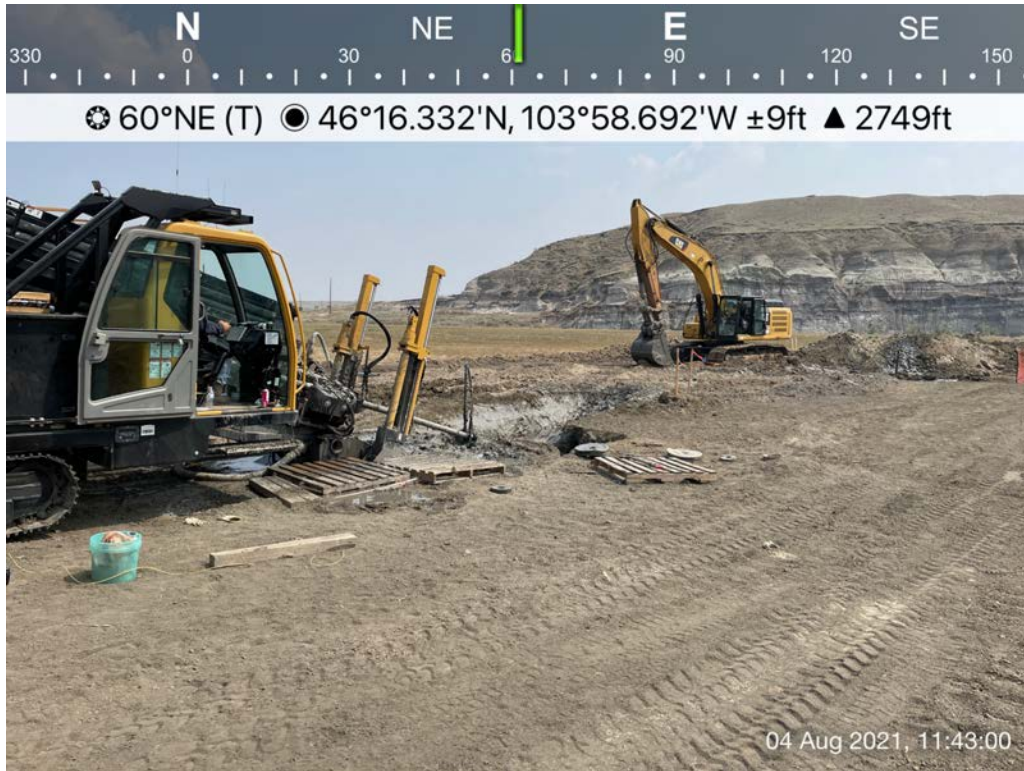
Report Photo #1 "Boring Machine Boring HDD Pipe under Little Beaver Creek"

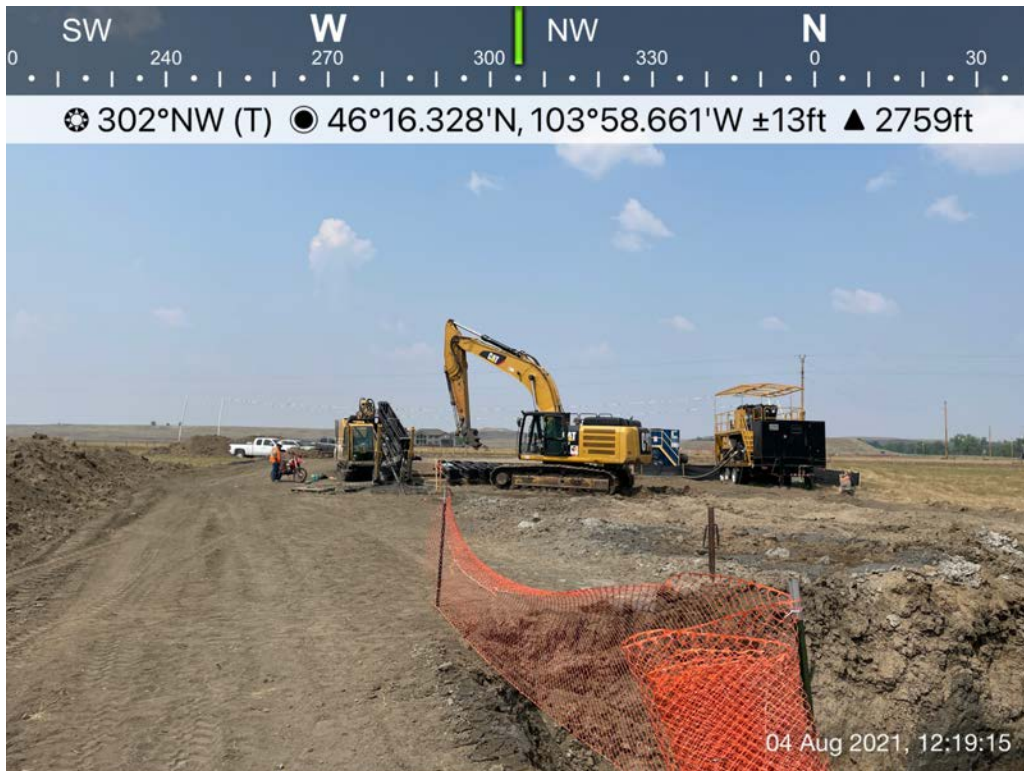
Report Photo #2 "Machinery Set Up for HDD Bore under Little Beaver Creek"

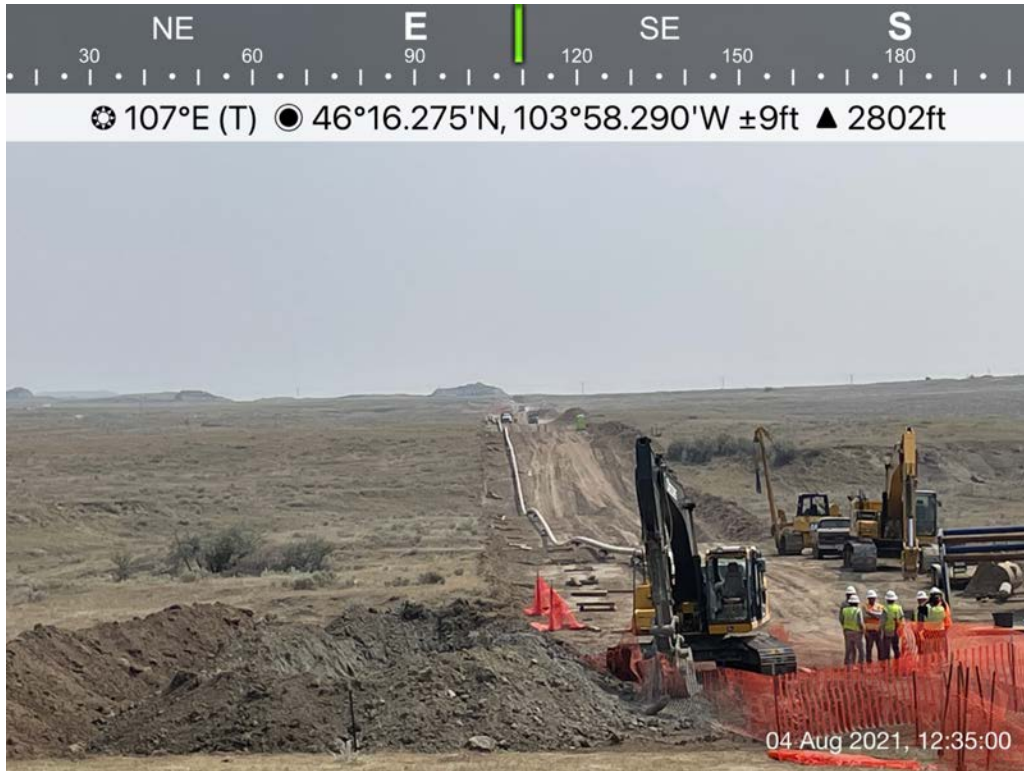
Report Photo #3 "Pipe Prepped on Rollers to be pulled through Bore"

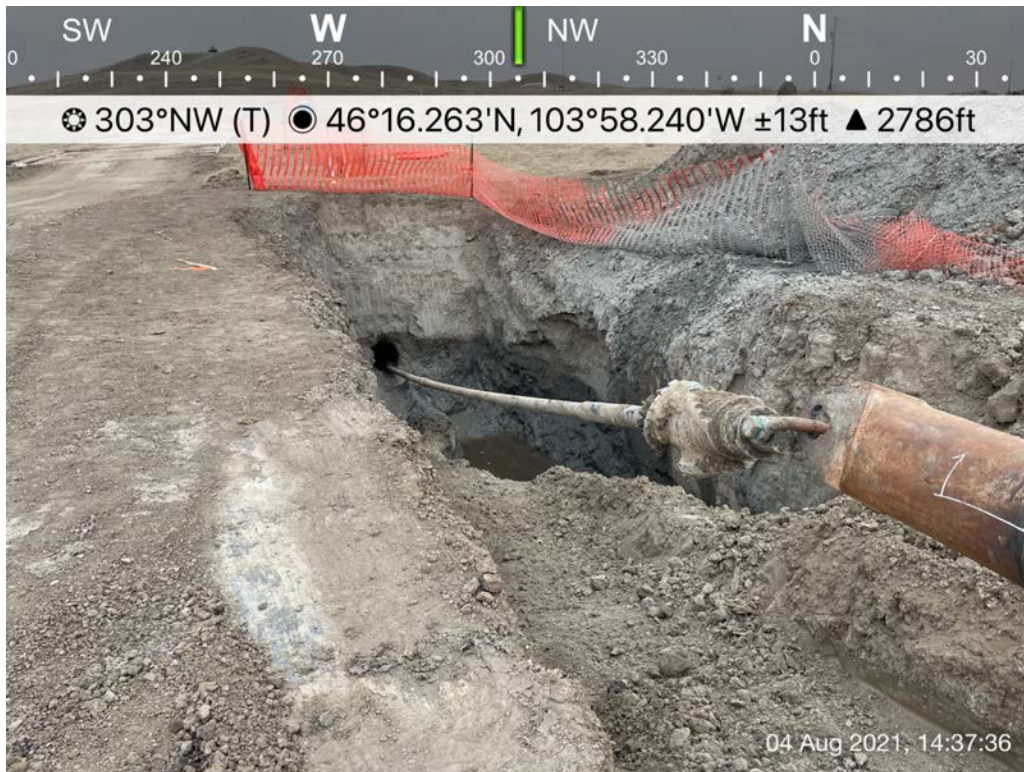
Report Photo #4 "Pipe Connected and Being Pulled Through Little Beaver Creek Bore"

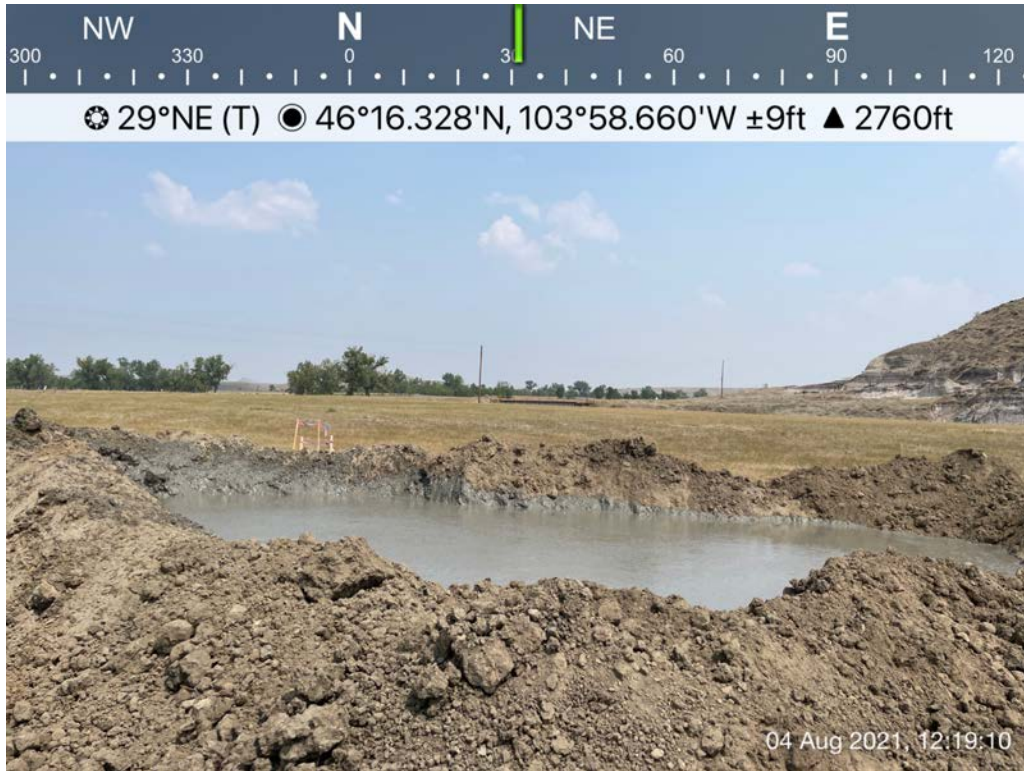
Boring activities were completed without issue. Basins of water used by the boring machine were segregated on both ends of the bore were segregated with earthen dams of subsoil. These basins were to be pumped out and removed from the construction site upon completion of the boring activities. Photo GPS points were taken during the inspection as a location reference for the east and west ends of the HDD bore.

Report Photo #5 "West Side Used Water Basin"

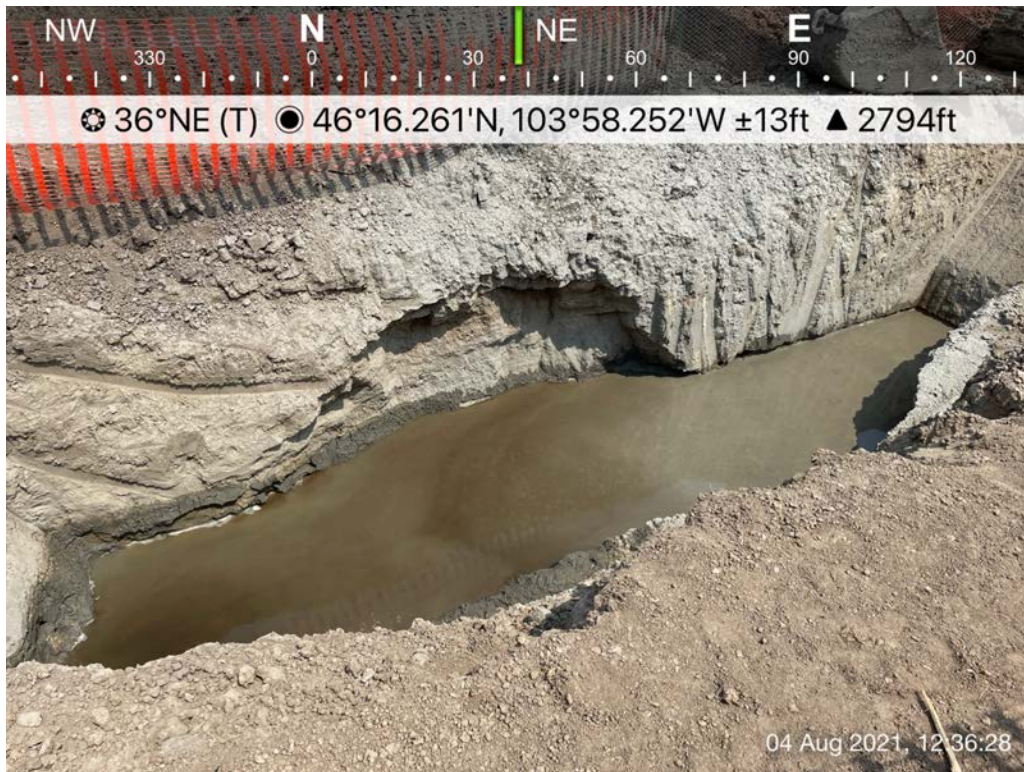
Report Photo #4 "East Side Used Water Basin"
