**Site/Project Location:** Denbury 12" Cedar Hills CO2 Pipeline

**Date of Inspection:** 30 August 2021

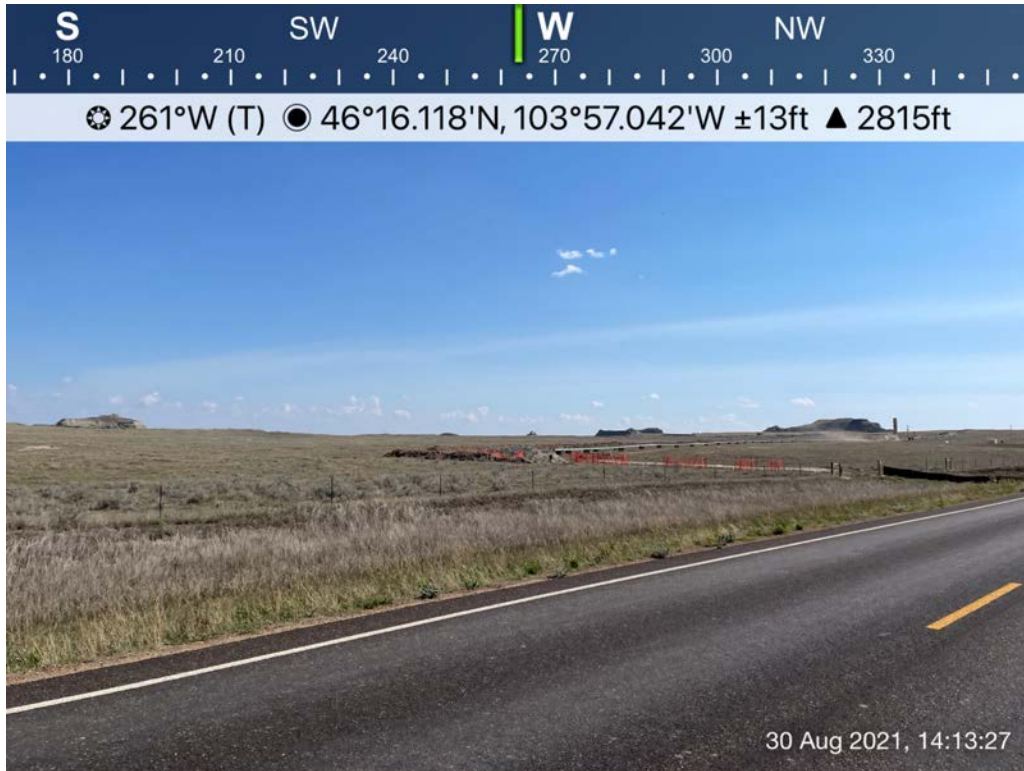
The information requested by the Commission has not been filed as of September 13, 2021. At the time of the inspection on August 30, 2021, construction activities were noted at both of the proposed route adjustments. The information requested by the Commission needed to be filed and approved prior to construction in the two route adjustments outside of the designated corridor.

**Photo #1 "Pipeline Running South along Camp Crook Road with Reroute 2 Area at Far End of Photo"**

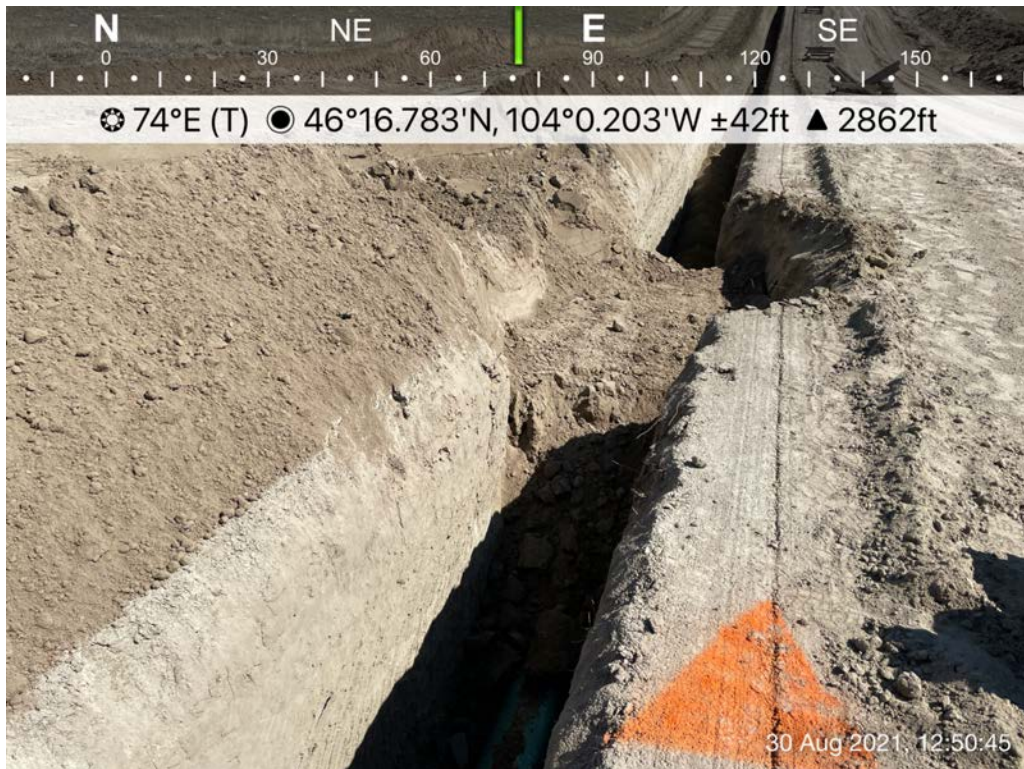
The depth of the lowered pipe was measured in several locations prior to being backfilled with subsoil and the depth of the pipe from the surface ranged from 56" to 68" and noted to be in compliance with Commission's Order. Sandbags were stacked for trench breaks in several locations along the open trenched areas observed during the inspection.

**Photo #2 "Pipe Lowered and being Backfilled with Subsoil"**

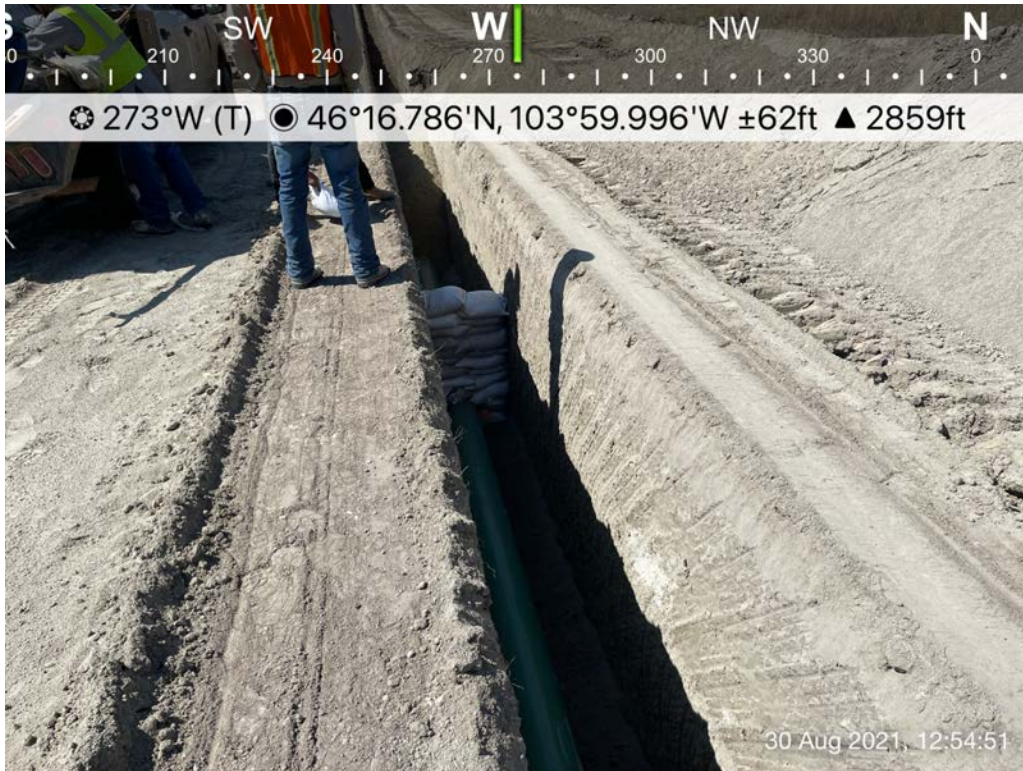
**Report Photo #3 "Trench Break"**

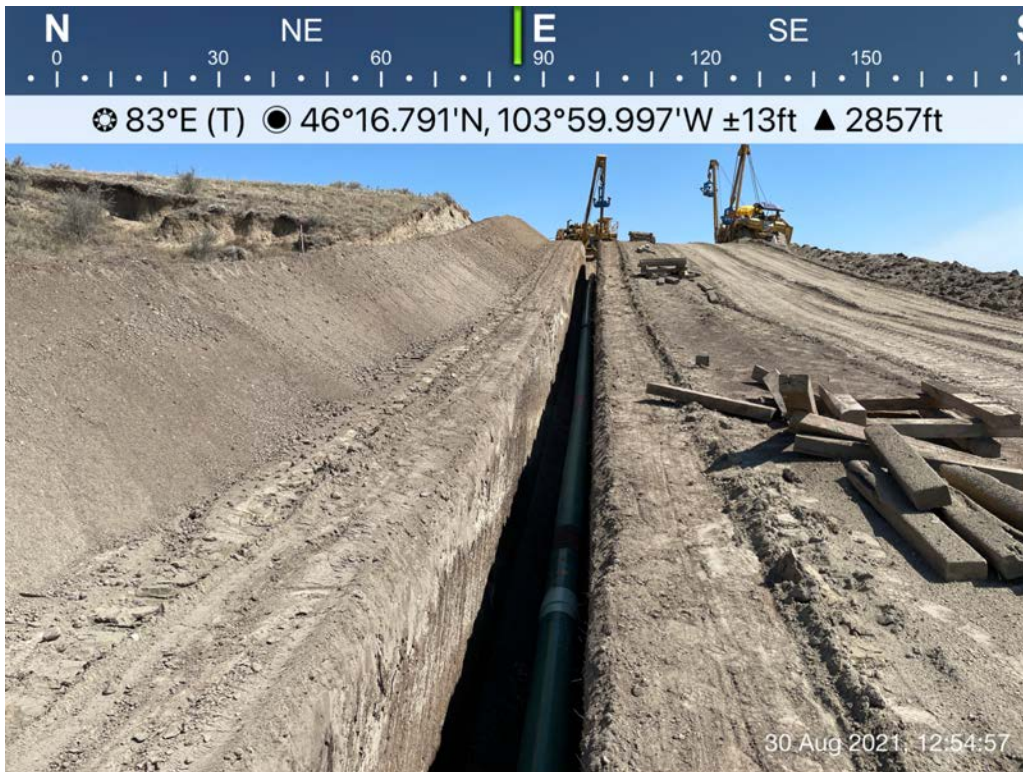
**Report Photo #4 "Pipe Lowered and Ready for Backfill"**

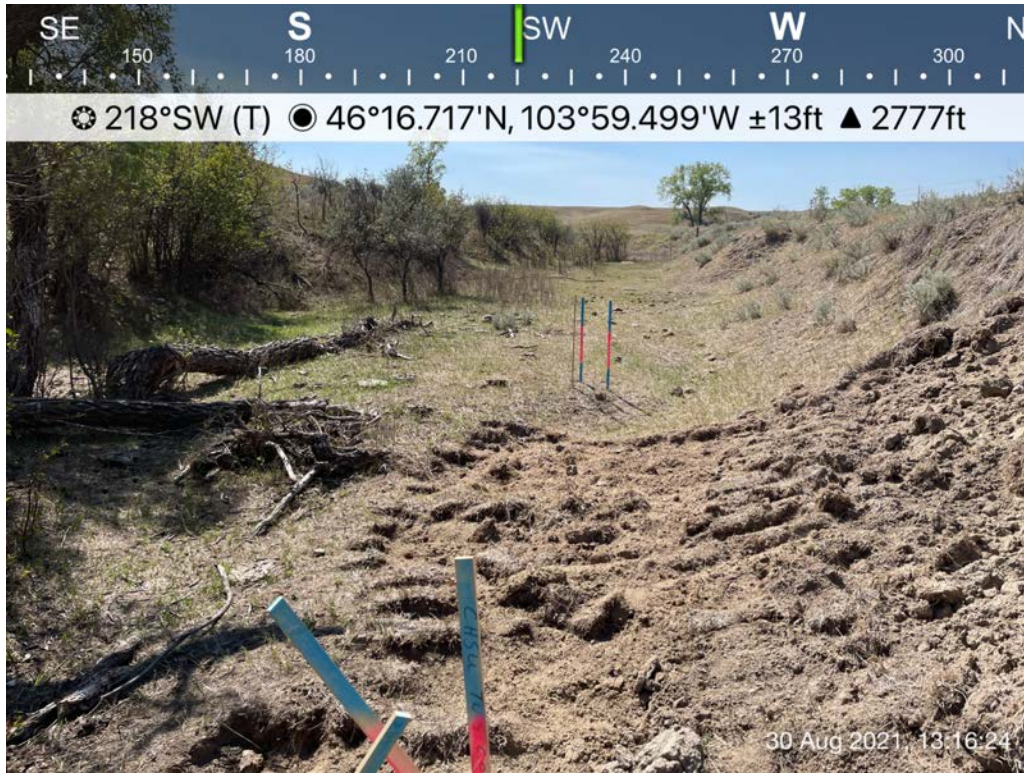
**Report Photo #5 "Backfilling with Subsoil"**

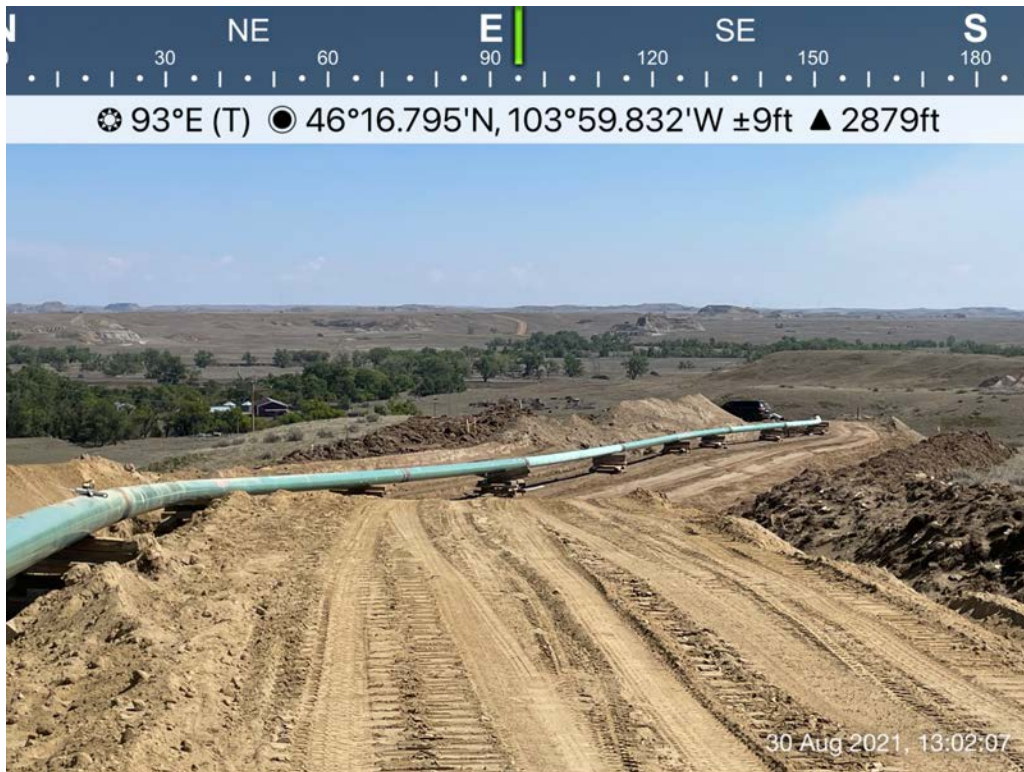
**Report Photo #6 "ROW Re-Routed away from Existing Pipeline at Reroute Area 1"**

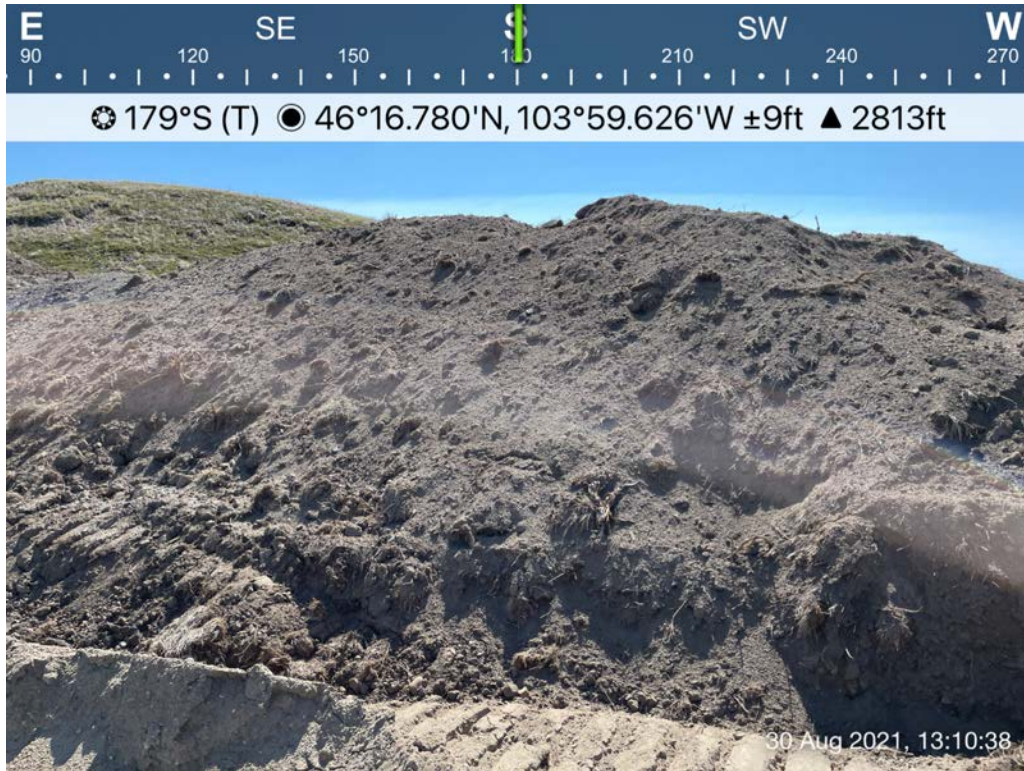
During the inspection, it was noted that the topsoil removed along the Project corridor was properly segregated from subsoil. All topsoil was placed on one side of the line and subsoil on the opposite side. Erosion control and stormwater management BMPs were being placed in areas of concern by a crew following behind the heavy equipment that was backfilling trenched areas with subsoil. Stormwater crews will be monitoring the effectiveness of the BMPs during rain events and will adjust BMPs as needed. The Project area had not received any recent precipitation at the time of the inspection.

**Report Photo #7 "Topsoil Pile"**

Burying of the remaining pipe was ongoing at the time of the inspection and was expected to be completed in September 2021. Reclamation and revegetation seeding is expected to be completed by November 2021. Topsoil piles along ROW will be replaced on top of disturbed areas prior to fertilizing and reseeding.

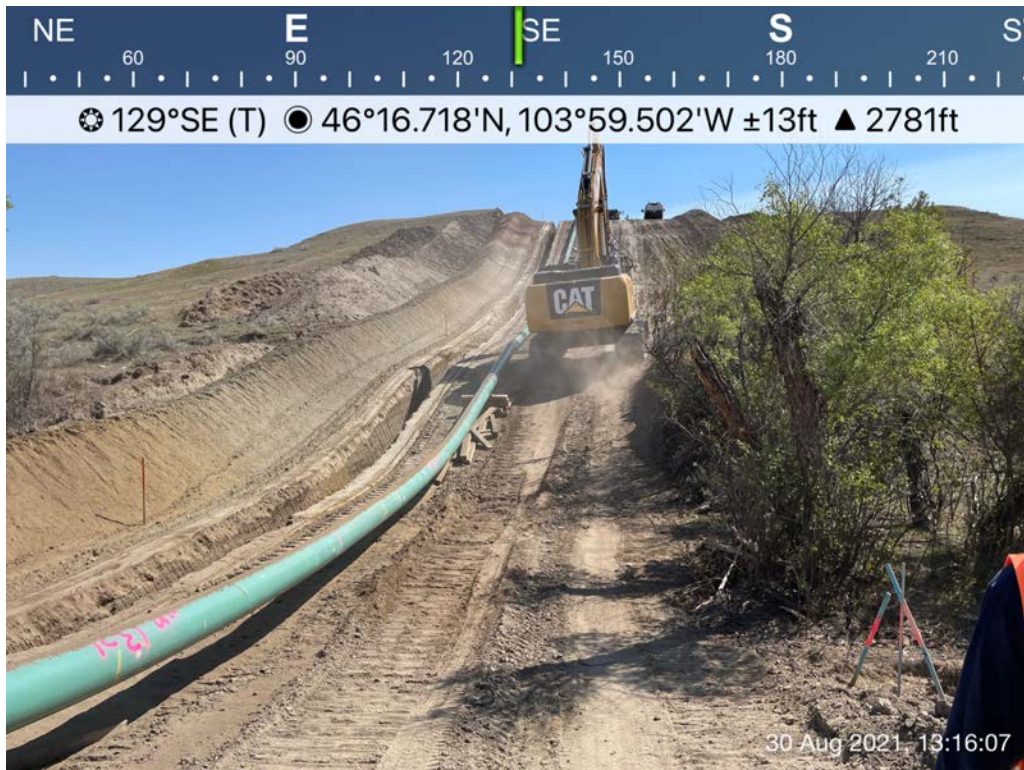
Removal of trees and shrubs were noted in one location where construction activities crossed through a narrow ravine. Denbury's Environmental consultant confirmed that tree and shrub counts were taken and the tree/shrub species removed were predominately green ash and American elm.

**Report Photo #8 "Ravine where Trees and Shrubs Removed along ROW"**
