Reclamation and Revegetation Inspection Report

Denbury 12" Cedar Hills CO2 Pipeline
Denbury Green Pipeline- North Dakota, LLC

ND PSC Case No. PU-19-294

November 2023

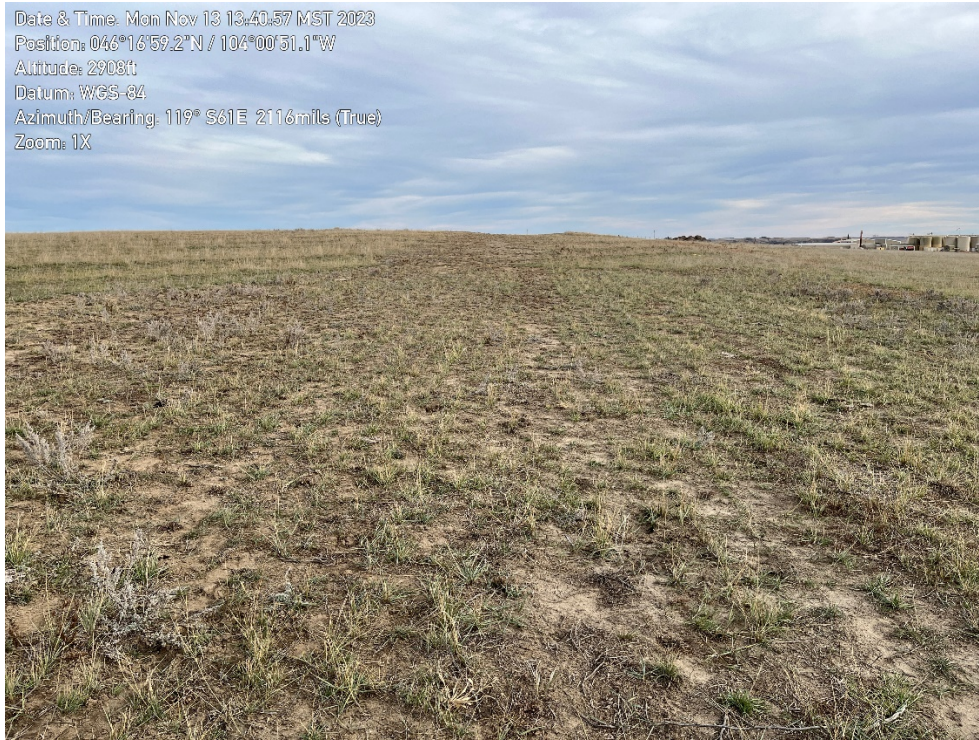
At the time of the visit, the Project area was well-maintained, secured, and in good condition and is as near as practical to pre-construction surface topography conditions. Some areas were reseeded with suitable plants but lack sufficient surface cover. The low density of vegetation is likely due to historically low precipitation rates in the area over the past 2 years. These areas will likely recover adequately given additional time. Photographs depicting conditions in two areas are provided for reference.

Report Photo #1: West Portion of Pipeline ROW with Revegetation Apparent

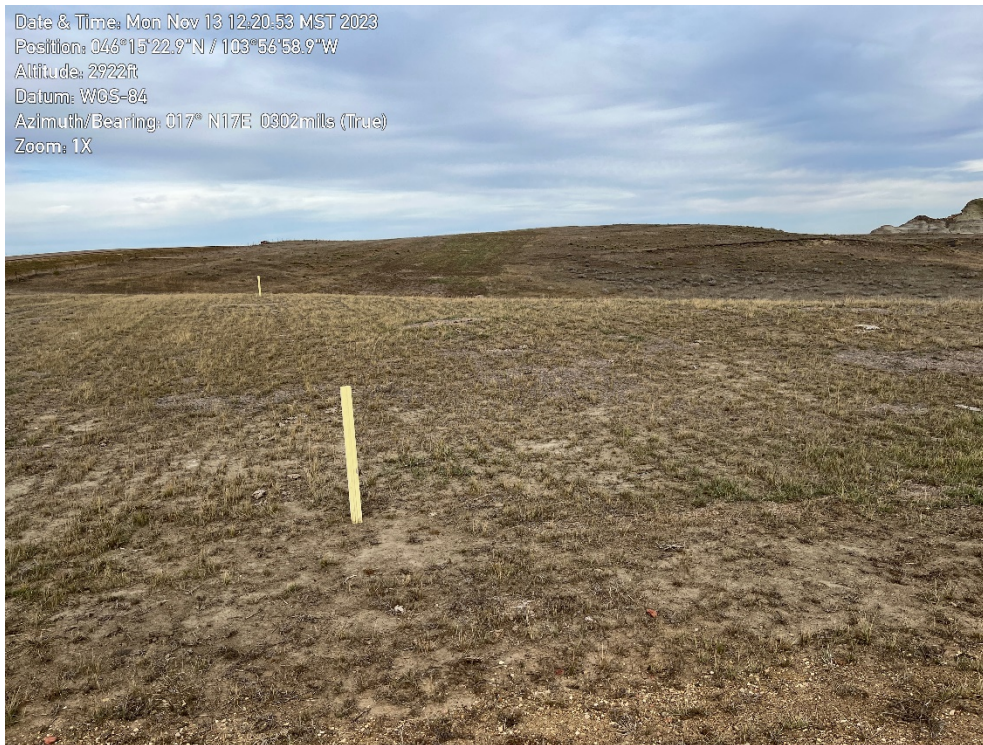
Report Photo #2: East Portion of Pipeline ROW with Revegetation Apparent

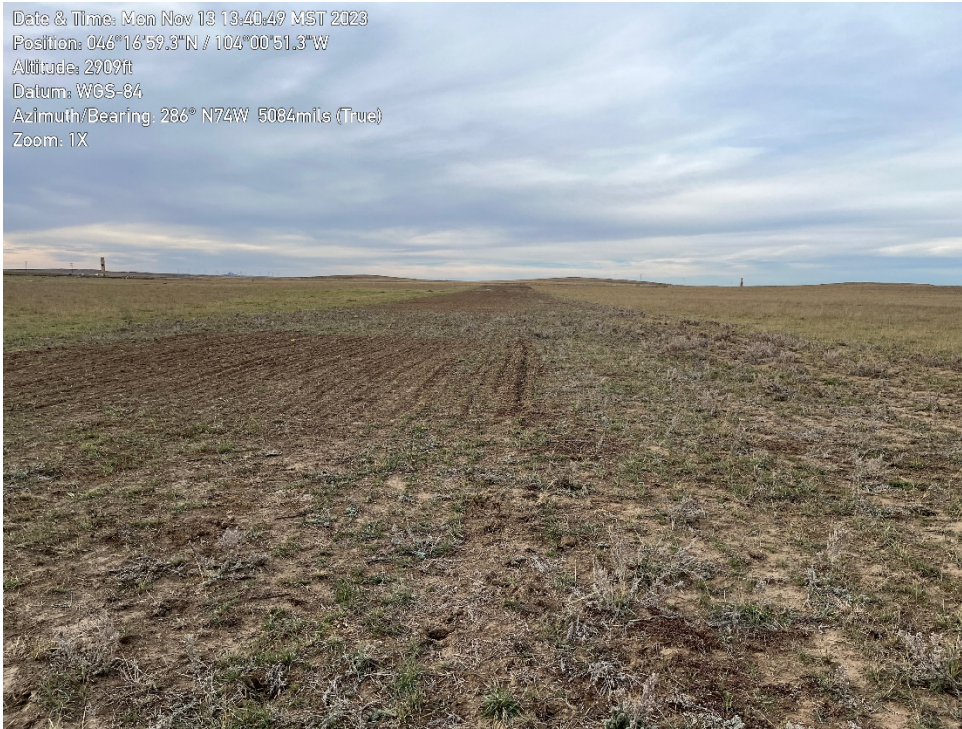
Area "A" 46° 17' 0" N, 104° 01' 07" W to 46° 16' 59" N, 104° 00' 51" W

Approximately 0.2 miles long, the entire right-of-way (ROW) is bare to the ground. Seeding rows are evident, indicative of either very recent seeding or possibly a lack of precipitation since planting. It is notable that a herd of pronghorn antelope were seen grazing within the ROW boundaries; and when departing, left by remaining exclusively within the boundaries of the ROW.

Report Photo #3: Area "A" Antelope-Favored Bare Ground and Surface Soil Rows

1. Maintenance should be done to encourage the revegetation of desirable species throughout the entire length of the Project until adequate vegetative cover is established.
2. The five identified areas should be re-evaluated for additional actions. Some areas may benefit from more aggressive erosion control cover such as crimped straw or grass blankets or even Curlex®; addition of topsoil, Leonardite or other organic matter, reseeding and/or additional weed control measures and reseeding with a suitable drought tolerant prairie mix.

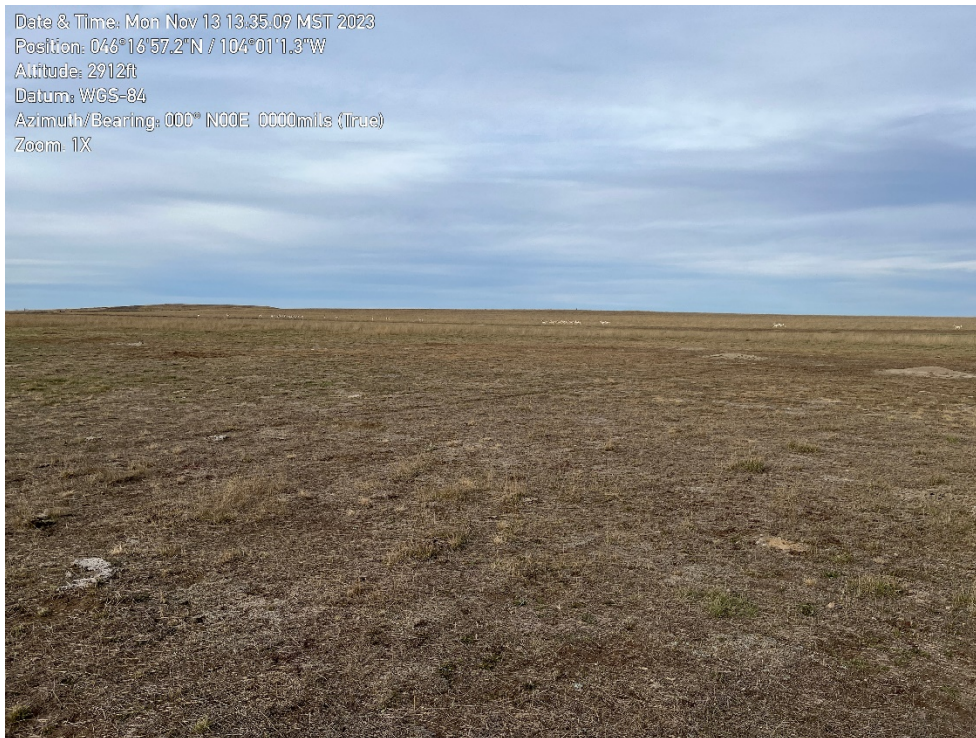
Report Photo #4: Area "A" Antelope Herd Moving Exclusively on ROW

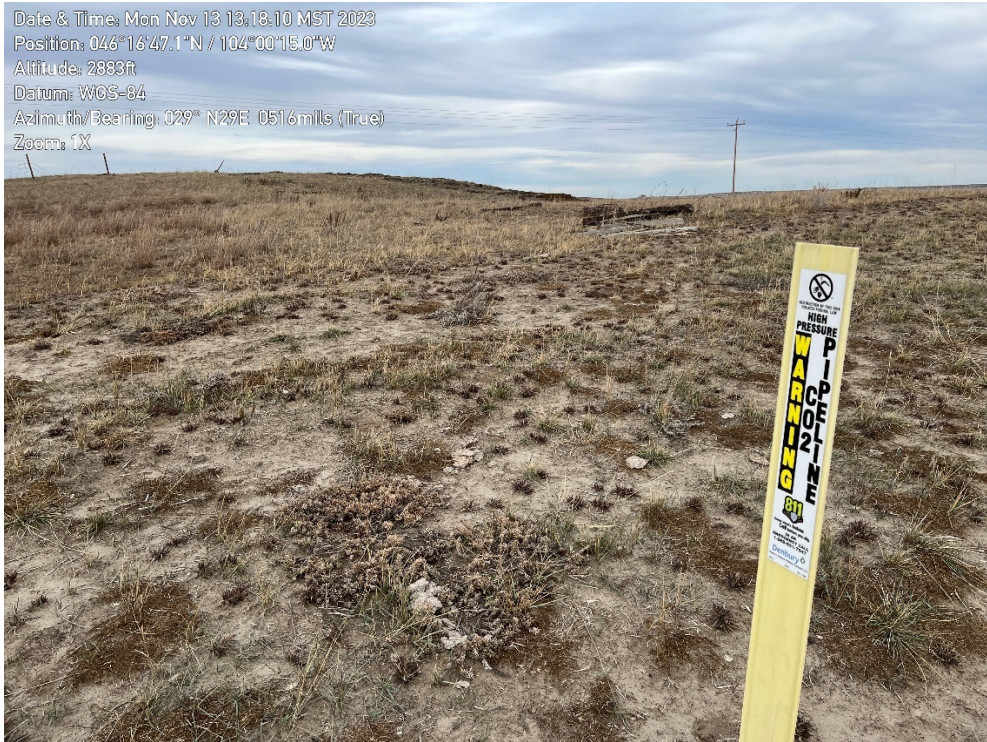
Area "B" 46° 16' 54" N, 104° 00' 26" W to 46° 16' 54" N, 103° 59' 50" W

Approximately 0.5 miles long, this area has sparse grass throughout the area but significant weeds and spotted with plants unique to this portion of the Project. Specific plant varieties are difficult to identify this late in the season, but appears to be a type of crabgrass. This plant is distributed throughout this portion of the ROW, and not noted anywhere else in the Project area. Accumulations of cut straw was noted intermittently in low area.

Report Photo #5: Area "B" Bare, Weeds and Crabgrass

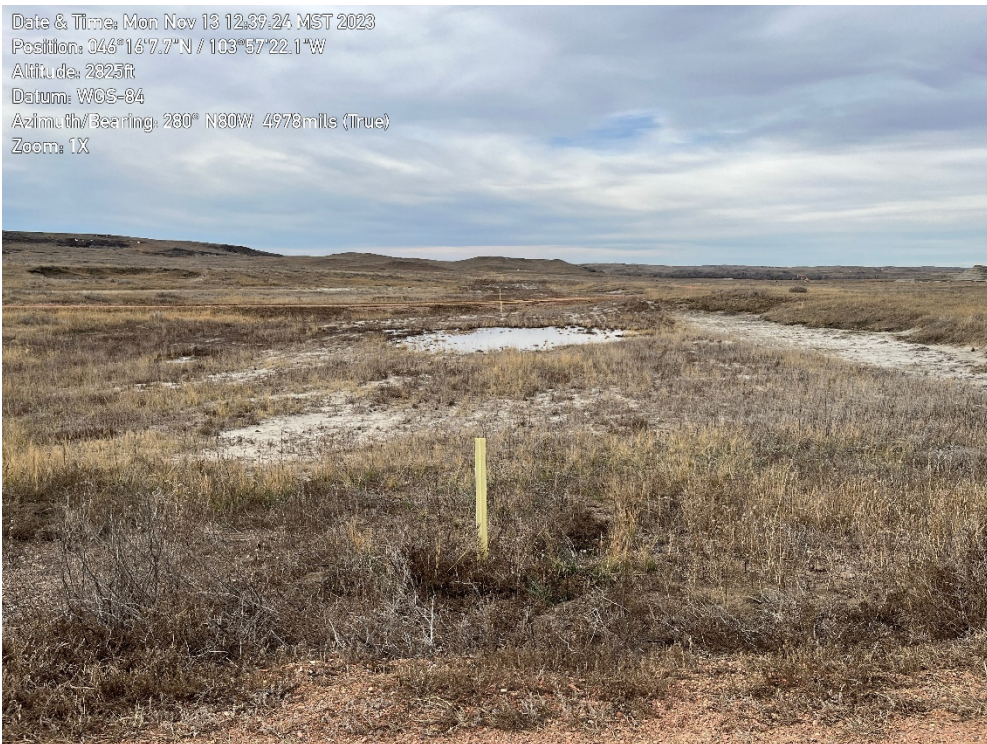
Area "C" 46° 16' 5" N, 103° 57' 3" W to 46° 16' 8" N, 103° 57' 22" W

Approximately 0.5 miles long, based on historical photographs soils in this area probably tight clays to the point holds water on a regular basis but without organic matter to support vegetative cover. The pre-construction condition of the site must be considered when setting expectations for reclamation and revegetation. So not expectedly, no vegetative cover exists in most areas, and what exists is largely weeds of one type or another.

Report Photo #6: Area "C" Bare Ground and Weeds

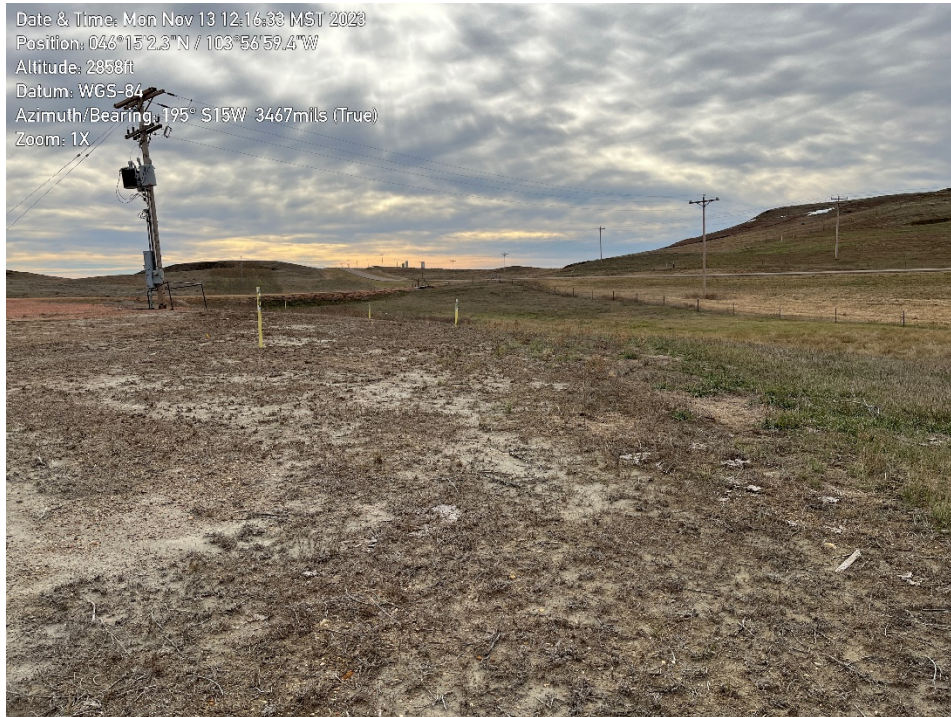
Area "D" 46° 15' 7" N, 103° 56' 59" W to 46° 15' 0" N, 103° 56' 59" W

Approximately 0.1 miles long, the pipeline runs west along the boundary of an oil production well and includes pipeline mile marker 15. A visual inspection of the soils indicates very little organic matter, which offers a challenge even before the disturbance associated with pipeline construction is added. Very little vegetative cover exists, and what exists are largely weeds.

Report Photo #7: Area "D" Bare Grounds and Weeds

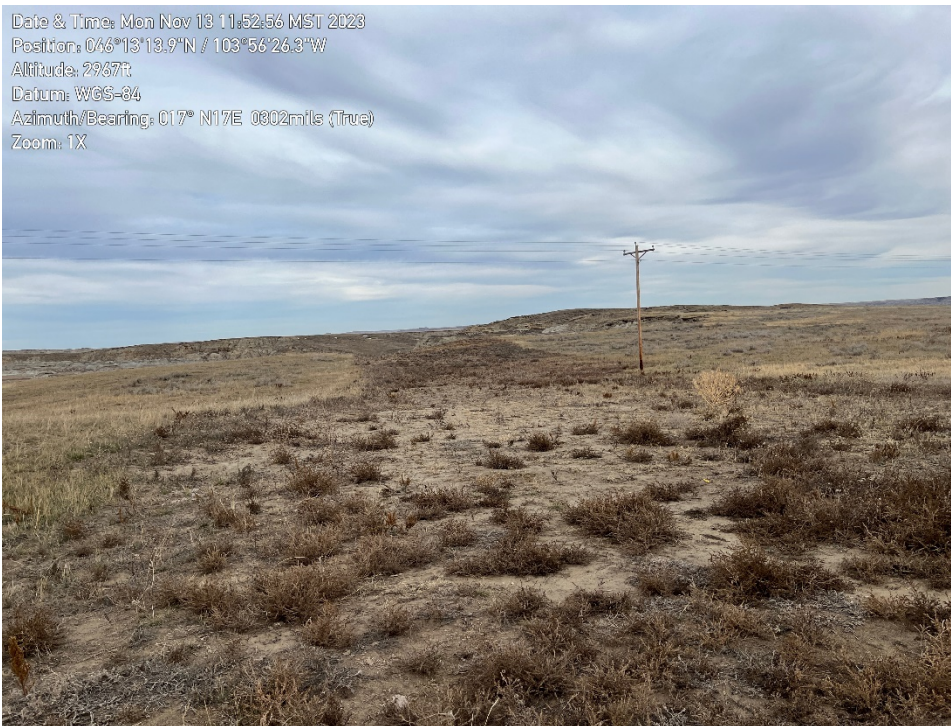
Area "E" 46° 14' 6" N, 103° 56' 47" W to 46° 13' 14" N, 103° 56' 26" W

Approximately 1.0 miles long and of specific interest, a very weedy portion of the ROW starts and ends at an existing fenceline. Adjacent land parcels exhibit adequate vegetation and reclamation progress.

Report Photo #8: Area "E" Bare Ground and Weeds
