PU-19-368
ONEOK Bakken Pipeline, L.L.C.
Tioga Lateral NGL Pipeline
Reclamation Inspection Report

File No. 227701547

August 2022

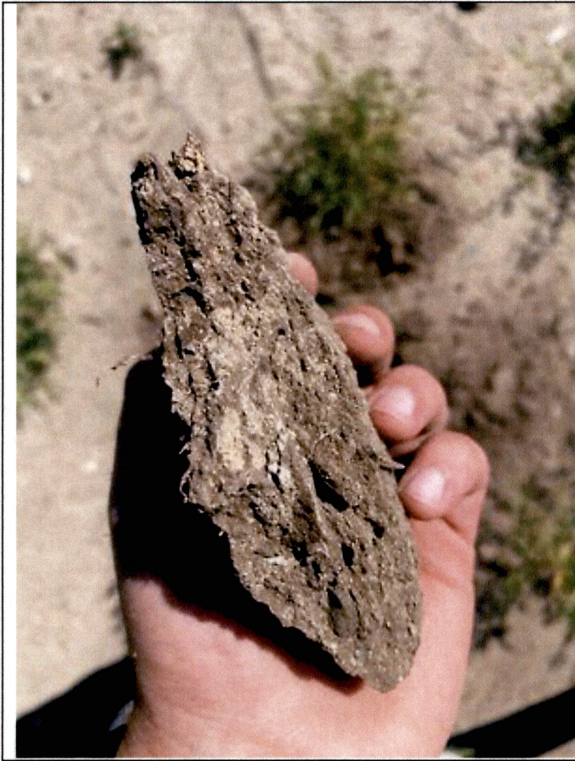
Observation Point: 4

Photo Description: Canola did not emerge or was unplanted. Kochia cover. No seeded vegetation observed. Subsoil common at surface. Soil is less compacted to the east but was either unplanted.

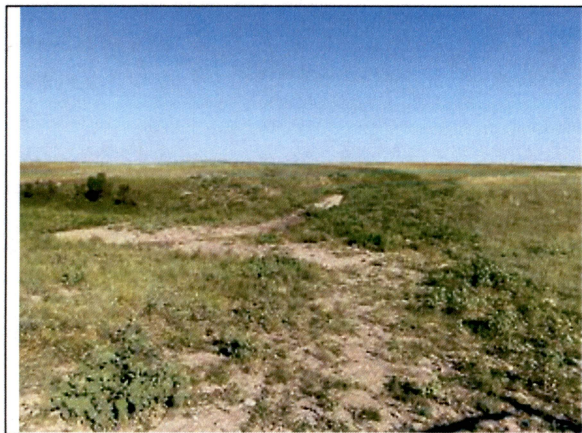
<p>Observation Point: 13 Date Taken: August 1, 2022 6:33 PM Direction Photo is Taken: Southeast Land Use: Rangeland</p> <p>Photo Description: Lack of vegetation in right of way. Stantec recommends reseeding efforts.</p> <p>Latitude: 48.30021004 Longitude: -103.71327055</p>
--	--

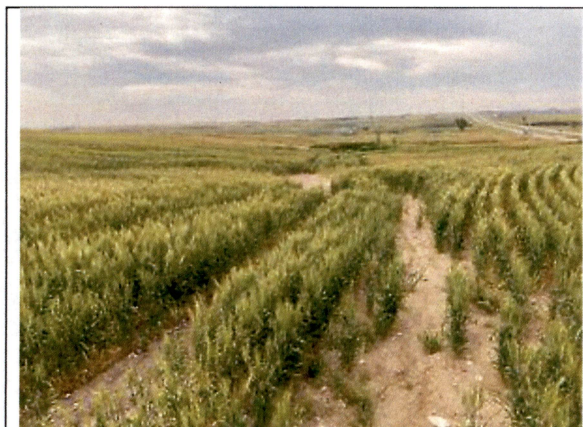
<p>Observation Point: 14 Date Taken: August 2, 2022 8:00 AM Direction Photo is Taken: Land Use: Cropland</p> <p>Photo Description: Erosional feature or subsidence on reclaimed right of way negatively affecting crops.</p> <p>Latitude: 48.29953506 Longitude: -103.62482077</p>
---	---

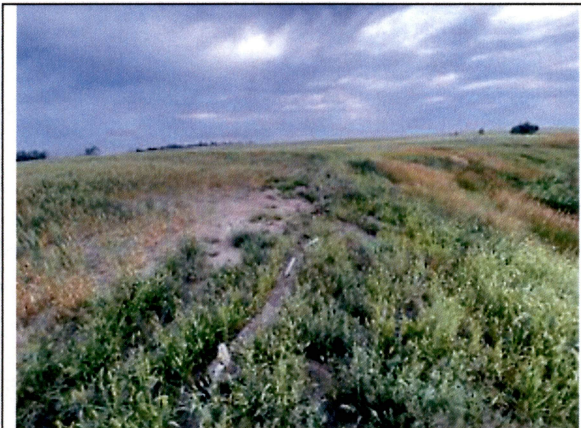
<p>Observation Point: 15 Date Taken: August 2, 2022 8:05 AM Direction Photo is Taken: North Land Use: Cropland</p> <p>Photo Description: Overall wheat growth is comparable to undisturbed area. Adequate reclamation. Topsoil is replaced. No Canada thistle visible.</p> <p>Latitude: 48.29956371 Longitude: -103.62272747</p>
---	---

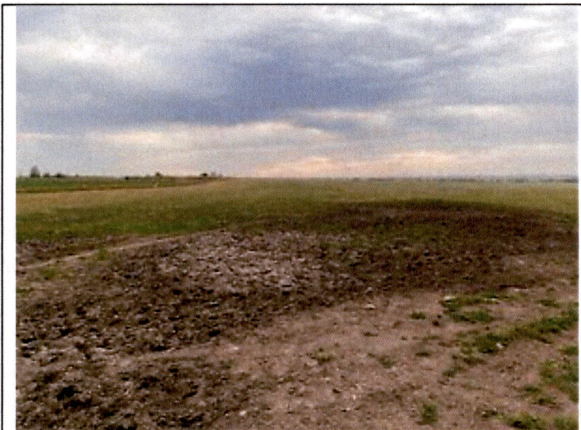
<p>Observation Point: 16 Date Taken: August 2, 2022 8:19 AM Direction Photo is Taken: Land Use: Rangeland</p> <p>Photo Description: Valve area well reclaimed. Pipeline corridor contains pasture vegetation with minor kochia cover.</p> <p>Latitude: 48.30591546 Longitude: -103.58254045</p>
--	--

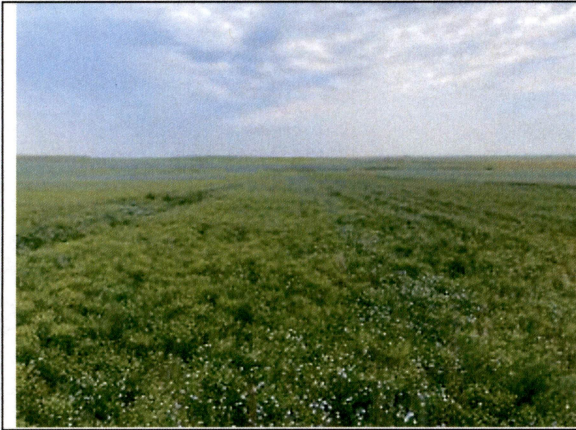
Observation Point: 26
Date Taken: August 2, 2022 10:20 AM
Direction Photo is Taken: Southwest
Land Use: Cropland

Photo Description: Satisfactory flax growth. No Canada thistle observed from As-Built inspection.

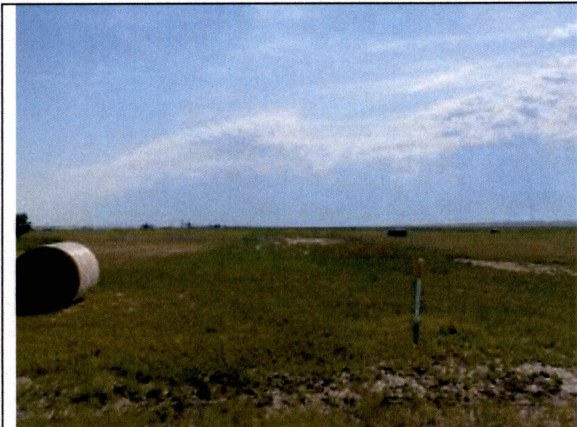
<p>Observation Point: 32 Date Taken: August 2, 2022 11:07 AM Direction Photo is Taken: East Land Use: Hay land</p> <p>Photo Description: Entire ROW well vegetated. Remains unharvested while other areas are. Kochia, foxtail barley, western wheatgrass present.</p> <p>Latitude: 48.25355943 Longitude: -103.33021784</p>
---	---

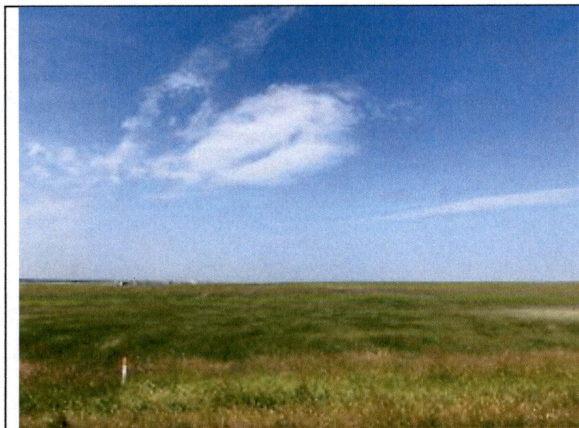
<p>Observation Point: 34 Date Taken: August 2, 2022 11:17 AM Direction Photo is Taken: West Land Use: Cropland</p> <p>Photo Description: Excellent crop stand in reclaimed ROW.</p> <p>Latitude: 48.25813722 Longitude: -103.28519812</p>
---	--

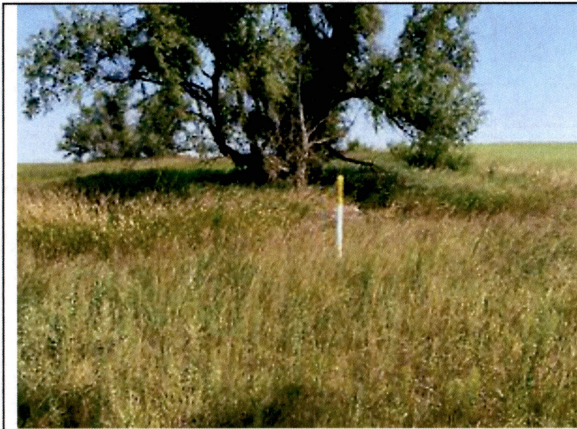
Observation Point: 38
Date Taken: August 2, 2022 11:54 AM
Direction Photo is Taken: North
Land Use: Tree Row

Photo Description: Tree row where it is unclear if any tree replacements occurred.

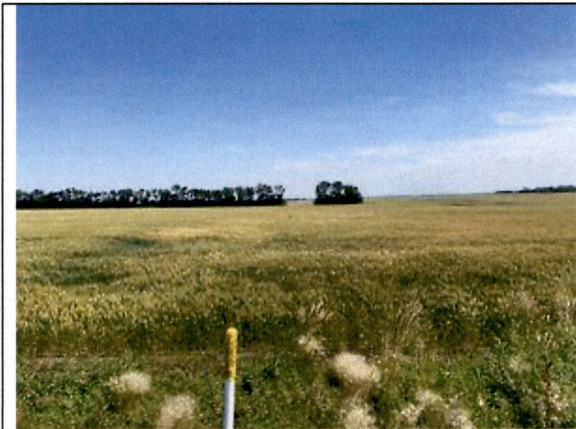
Observation Point: 52
Date Taken: August 2, 2022 2:00 PM
Direction Photo is Taken: East
Land Use: Cropland

Photo Description: Grain growth is satisfactory. Replaced topsoil observed and appropriate.
