PU-19-368 Tioga Lateral NGL Pipeline Project Topsoil Inspection Report

Prepared for:
**North Dakota
Public Service Commission**

PU-19-368 (ONEOK Tioga Lateral): Observation Point Photolog

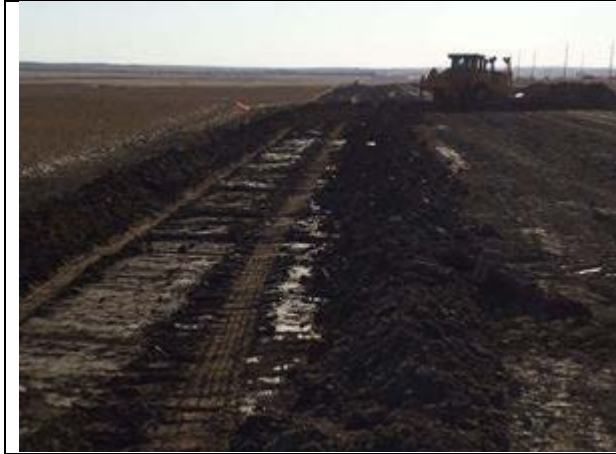
Observation Point: 1

Photo Description: Full 12 inches topsoil stripped.

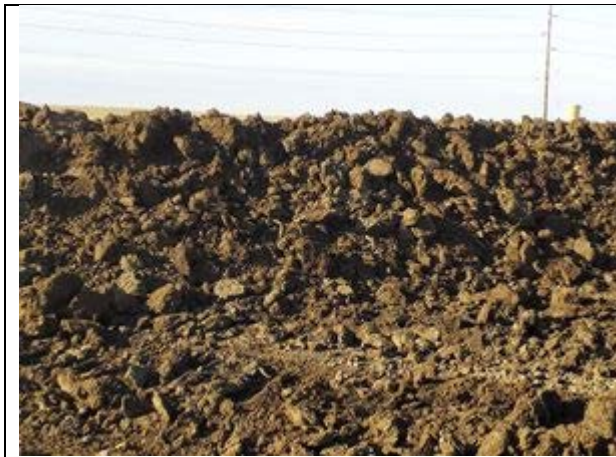
Observation Point: 2

Photo Description: Appropriately no presence of subsoil in the topsoil stockpile.

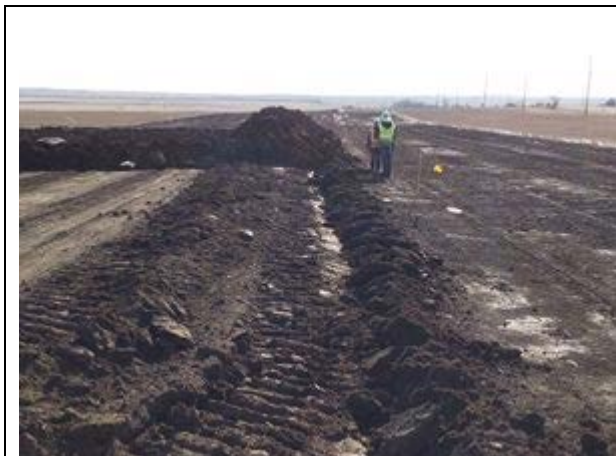
Observation Point: 3

Photo Description: Strip depth marking.

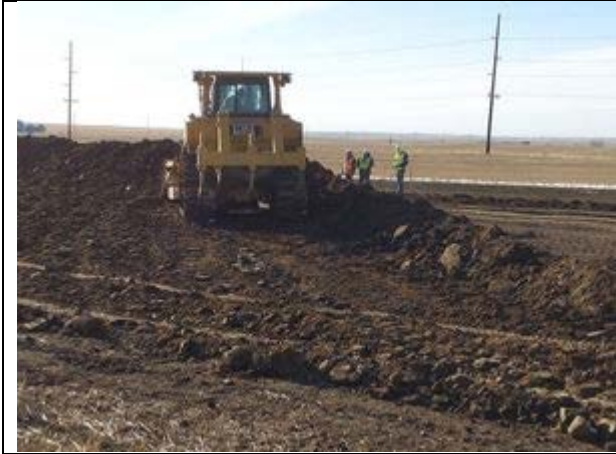
Observation Point: 4

Photo Description: Machinery actively Stripping towards stockpile.

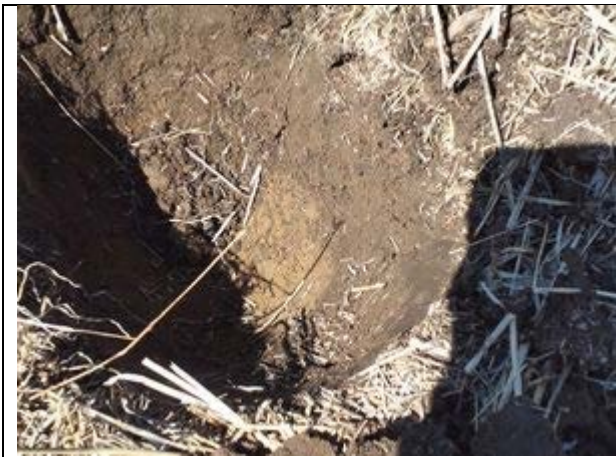
Observation Point: 5

Photo Description: Topsoil test pit. Adjacent to ROW. Average depth of topsoil 8 inches.

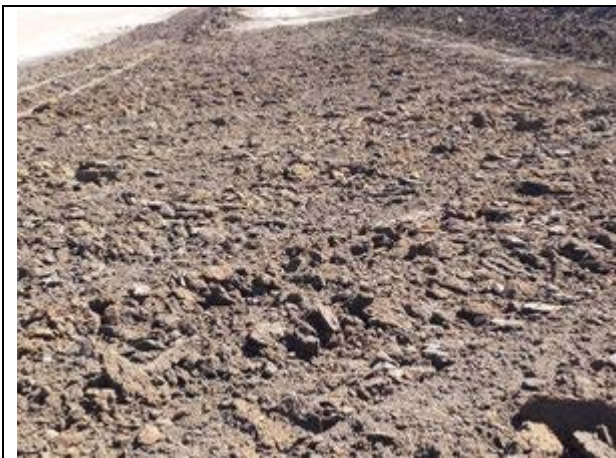
Observation Point: 6

Photo Description: Topsoil stripped to appropriate depth, exposing top extent of B1 Horizon. Adjacent to topsoil test pit 1.

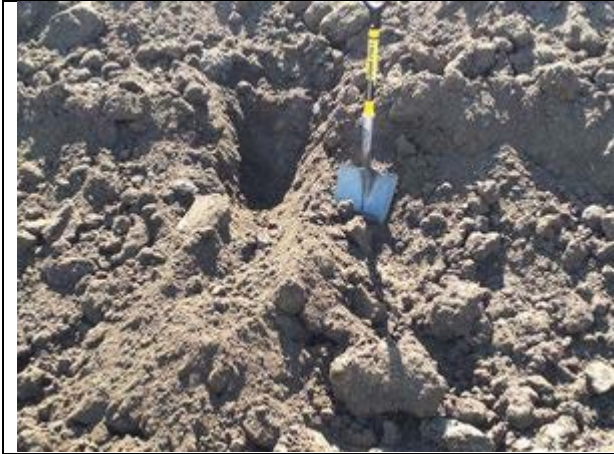
Observation Point: 7

Photo Description: Stockpile inspection adjacent to Observation Points 5 and 6. Proof of proper absence of subsoil mixing.

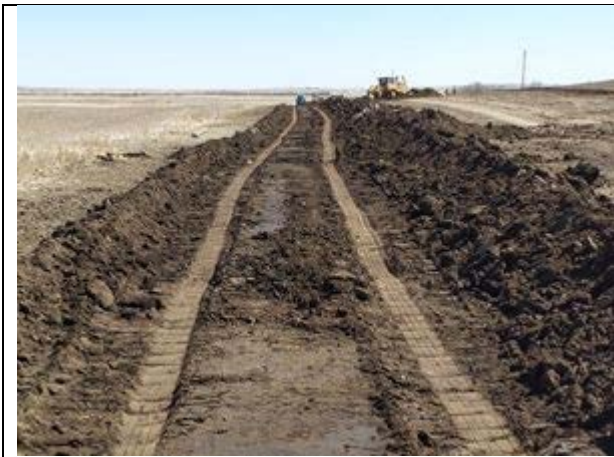
Observation Point: 8

Photo Description: Initial strip depth guide.

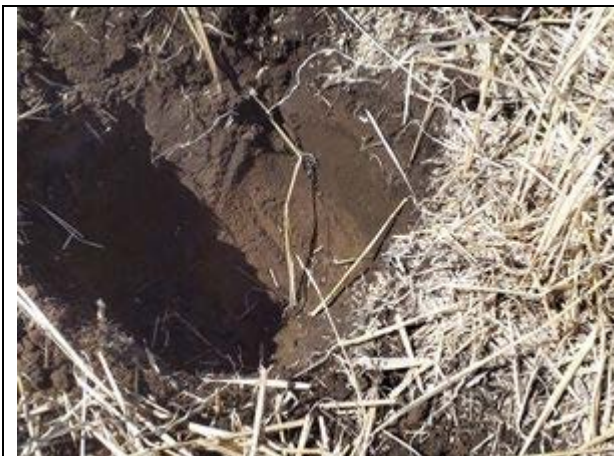
Observation Point: 9

Photo Description: Topsoil test pit. Topsoil average of 8 inches.

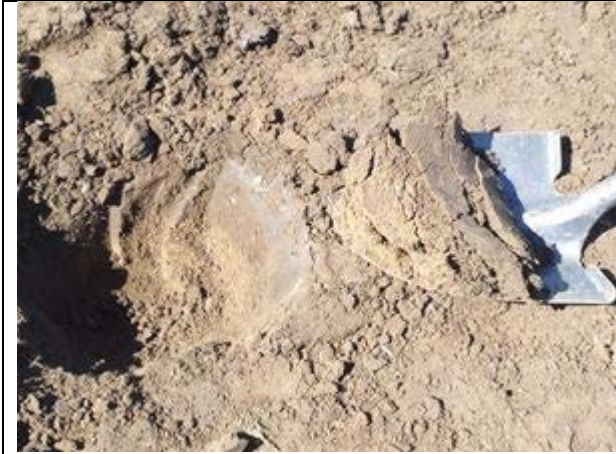
Observation Point: 10

Photo Description: Topsoil test pit in stripped ROW. Shows an additional 3 inches are left after initial pass. Operator states a second pass is made with grader to smooth surface and takes an additional few inches in the process.

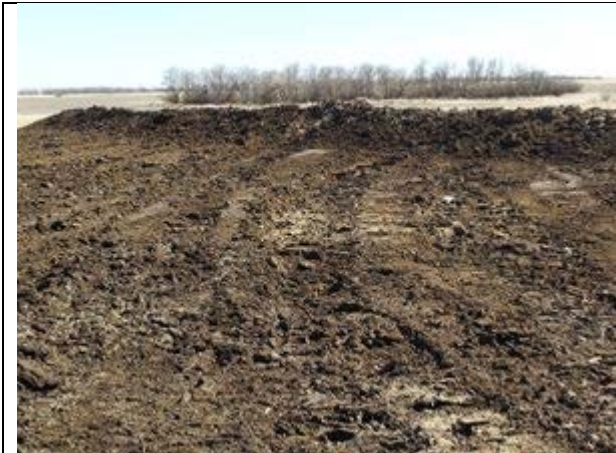
Observation Point: 11

Photo Description: Topsoil stripped to proper depth, exposing top extent of horizon B1.

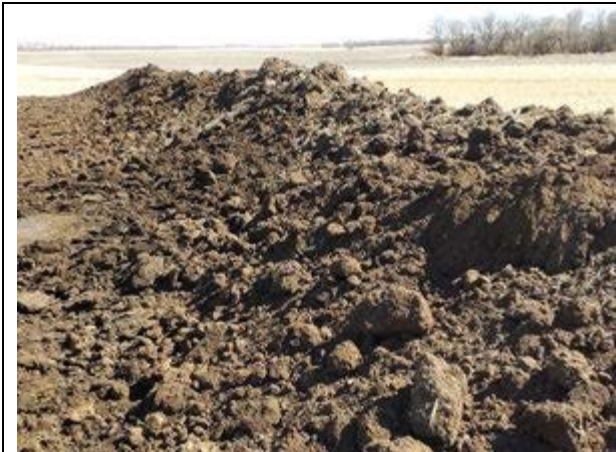
Observation Point: 12

Photo Description: Topsoil stockpile shows no signs of subsoil mixing.

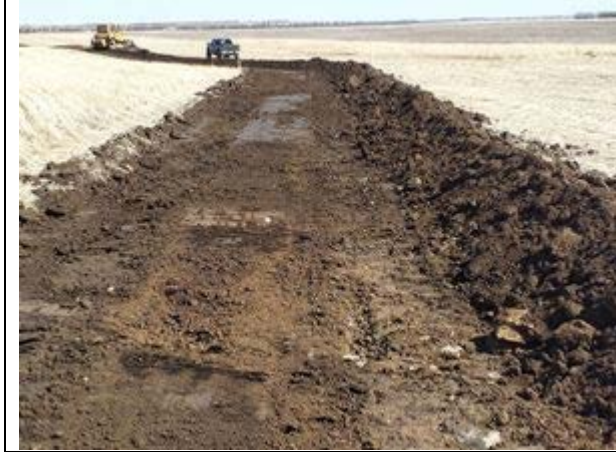
Observation Point: 13

Photo Description: Initial guide cut. Showing exposure of B1 horizon in some locations.

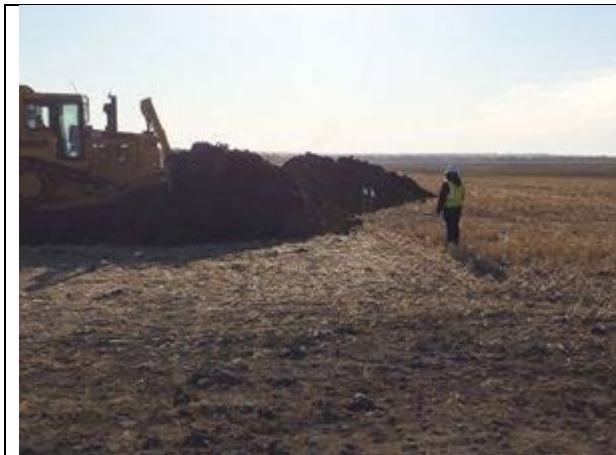
Observation Point: 14

Photo Description: ROW observer ensures stockpiling during stripping with dozer does not exceed ROW extent.

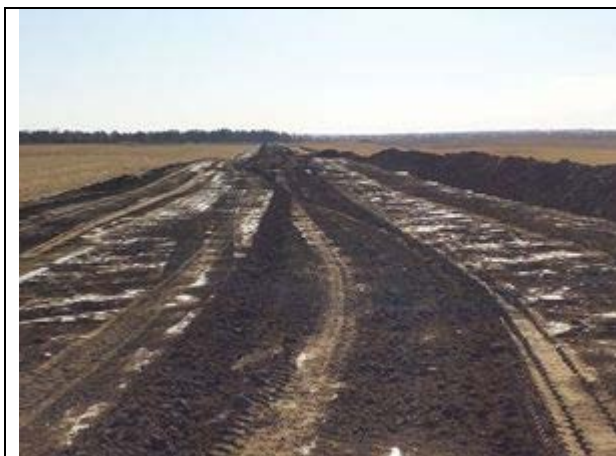
Observation Point: 15

Photo Description: First pass with grader. Prepares area for easier dozer operation. Topsoil segregation will be completed when dozer finishes.

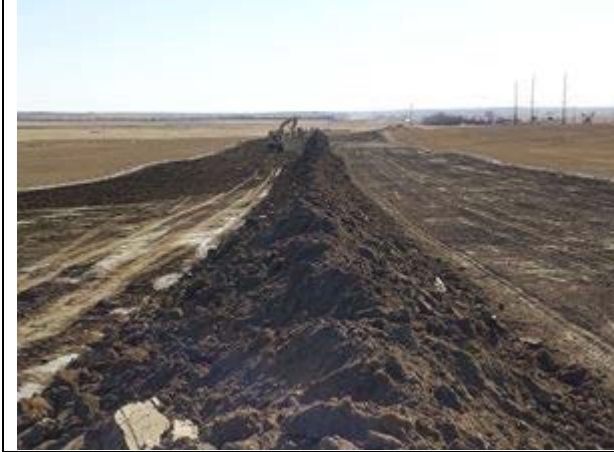
Observation Point: 16

Photo Description: Topsoil stockpile overview.

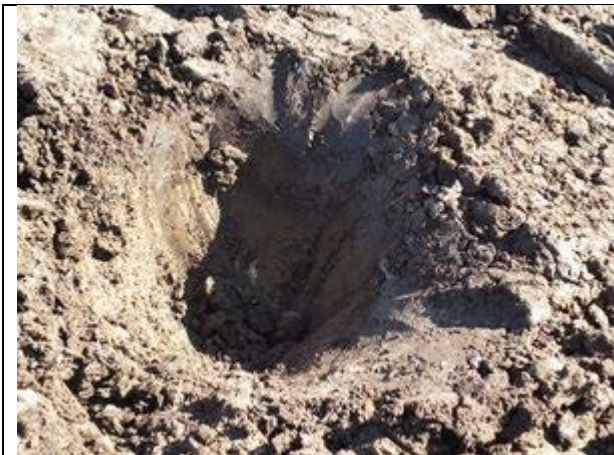
Observation Point: 17

Photo Description: Topsoil test pit shows approximately 1 inch of topsoil in finished stripped ROW, which is acceptable given variations across the landscape and equipment precision.

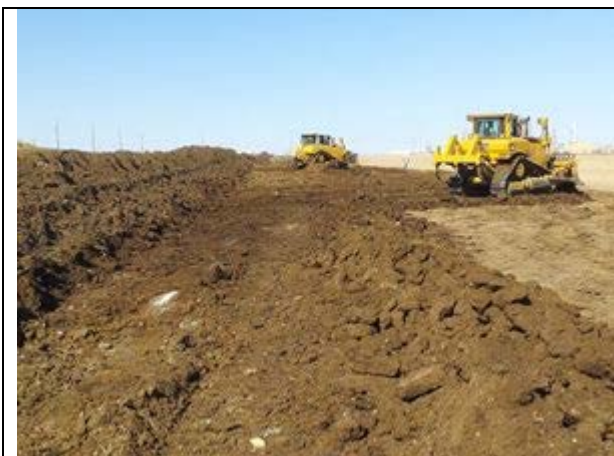
Observation Point: 18

Photo Description: Backhoe scrapes subsoil away from topsoil stockpile and dozers position to scrape subsoil toward north side of ROW.

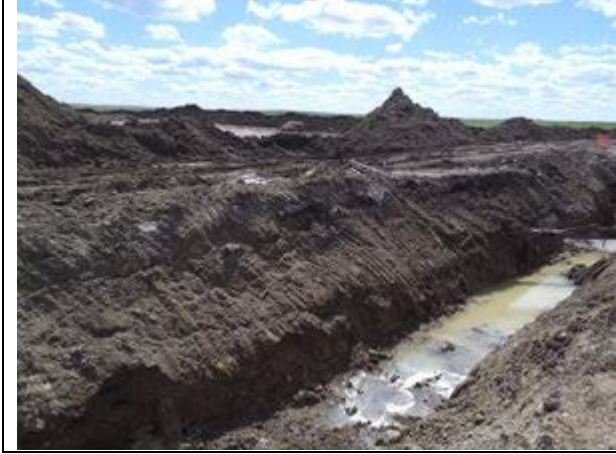
Observation Point: 19

Photo Description: HDD entry, little to no topsoil left in trench profile, stripping topsoil successful.

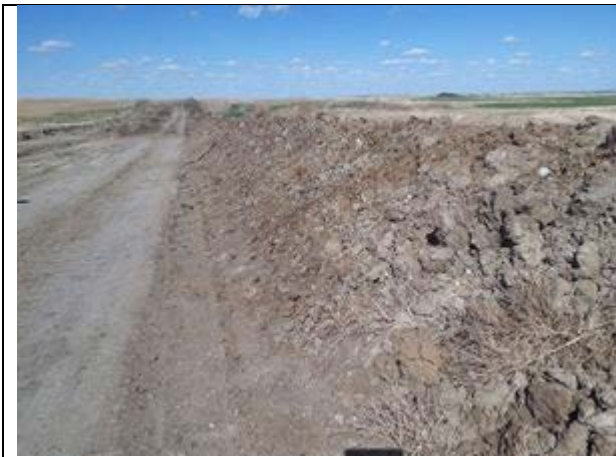
Observation Point: 20

On 28 May 2020, Mr. Sander and Mr. Mauch visited Spread 2 unaccompanied. Contact with Harlon Quinalty, Chief Inspector Spread 2, Epcon, was made over the phone, but was unable to accompany. While there were indications of successful topsoil and subsoil stripping and segregation (Point 19), there was also some evidence for a potential lack of topsoil and subsoil segregation during trenching at isolated locations near Point 20. (**Table 1, Observation Points 19-20**).

Photo Description: Potential topsoil and subsoil mixing in stockpile. Incident appears isolated.

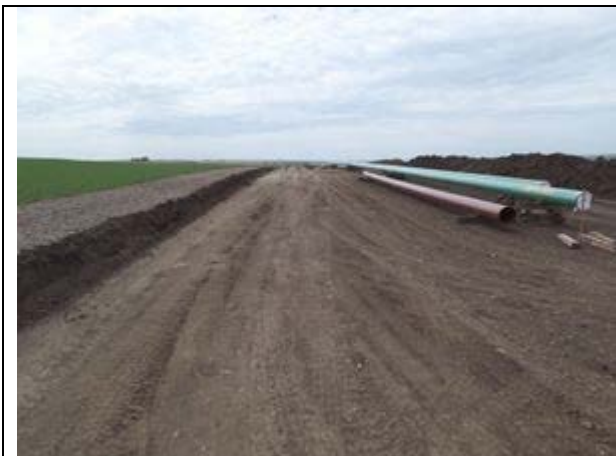
Observation Point: 21

Photo Description: Topsoil stripped to a depth greater than 12 inches. Remaining topsoil present at stripped depth, but this is allowable given maximum stripping requirements.

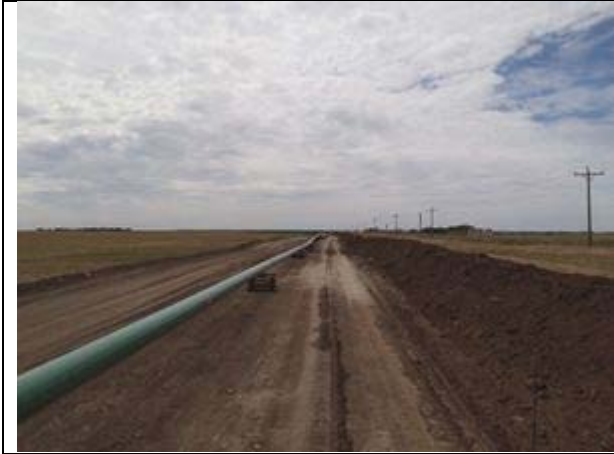
Observation Point: 22

Photo Description: Topsoil stripped to a depth of 8-12 inches. Stockpiles free of subsoil mixing.

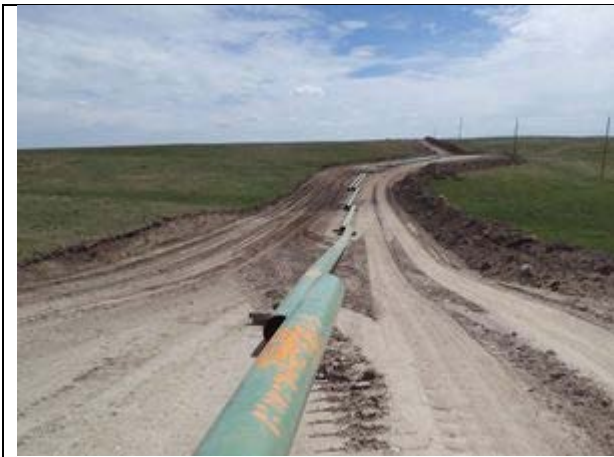
Observation Point: 23

Photo Description: Showing hillslopes are cut into subsoils.

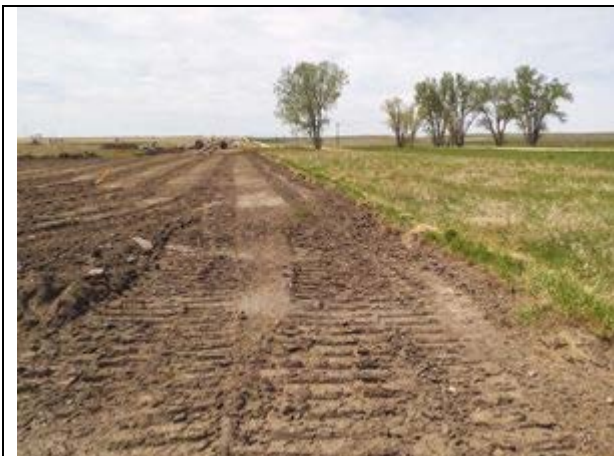
Observation Point: 24

On 29 May 2020, Mr. Sander visited Spread 1 unaccompanied. Contact with Beau Eddins, Chief Inspector Spread 1, Epcon, was made over the phone, but he was unable to accompany. One instance where topsoil thickness was stripped to approximately 6-inches, but corroboration showed that topsoil could have been stripped to a greater extent. (**Table 1, Observation Point 24**). Trenching and pipe backfill has been initiated along some portions of Spread 2. Trenching and some backfilling has occurred from the Spread 1 starting location trending eastward near Ray, ND and from the Hess Plant trending southwest of Tioga, ND. Construction at portions of the Project in-between these two points has largely not yet been initiated and was unstripped of topsoil at the time of the inspections.

Photo Description: Topsoil stripped to approximately 6 inches. Topsoil still present at surface. Remaining topsoil should be stripped to a greater extent.
