# PU-19-368 Tioga Lateral NGL Pipeline Construction Inspection Report

*Prepared for:*  
**North Dakota  
Public Service Commission**

**WENCK Associates, Inc.**  
3303 Fiechtner Drive Ste 100  
Fargo, ND 58103  
Phone: 701-297-9600  
Fax: 701-297-9601

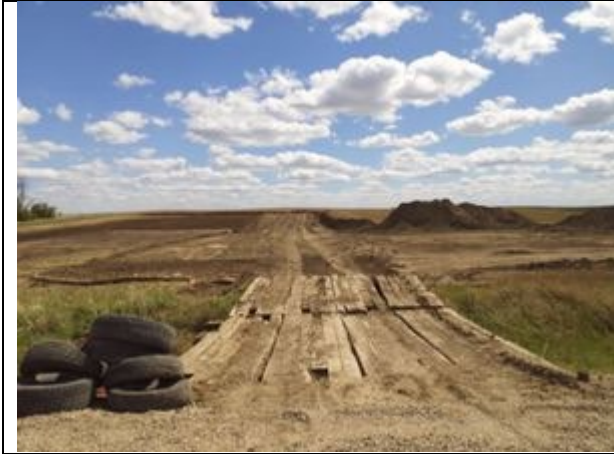
**Observation Point: 1**

Photo Description: Pipe has been installed and backfilled, timber mat access from road present.

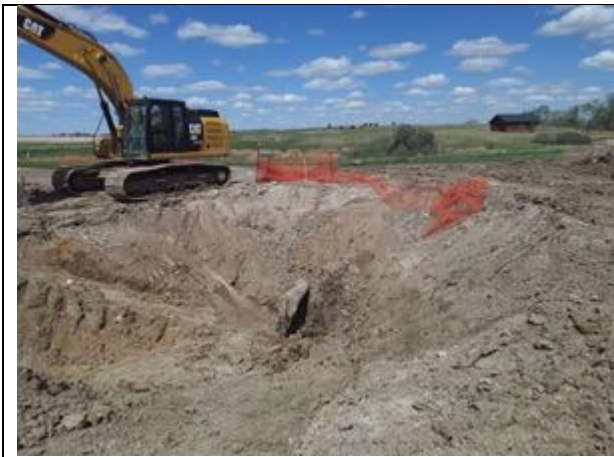
**Observation Point: 2**

1. A buried underground utility was severed during trenching operations (**Observation Point 2**).
  - a. Follow-up communications were made with Timothy Swan, inquiring about the scenario and if the notification protocol had been followed. Timothy responded that the line was unmarked by the one call system due to it being abandoned. He also stated that the contractor immediately called the line representatives for a statement of ownership; in this case, Mountrail-Williams Electric Cooperative stated "it could be ours" [sic]. Wenck is of the opinion, ONEOK followed the One-call Excavation Notice System requirements if the above statements from ONEOK are indeed correct; however, Wenck cannot prove compliance as proof of communications are not required to be submitted to the PSC. Wenck is also of the opinion, ONEOK is required to notify the PSC in compliance with the Certification Relating to Order Provisions – Transmission Facility Siting #34; however, notifications are not required to be submitted to the case files, therefore, Wenck cannot prove compliance with PSC notification. Wenck did not notify the PSC of the scenario due to the evident abandonment of the line and clear indication of work stoppage and ONEOK's response of compliance.

Photo Description: HDD entry point, appears to have severed underground utility. This line was understood to be abandoned.

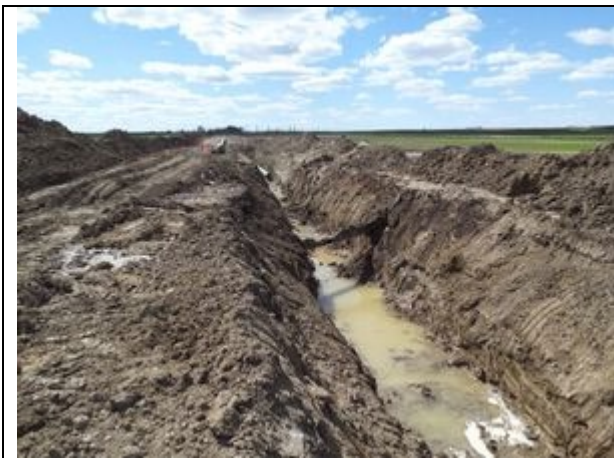
**Observation Point: 3**

Photo Description: Open trench prior to pipe install, existing saltwater pipe shown (black).

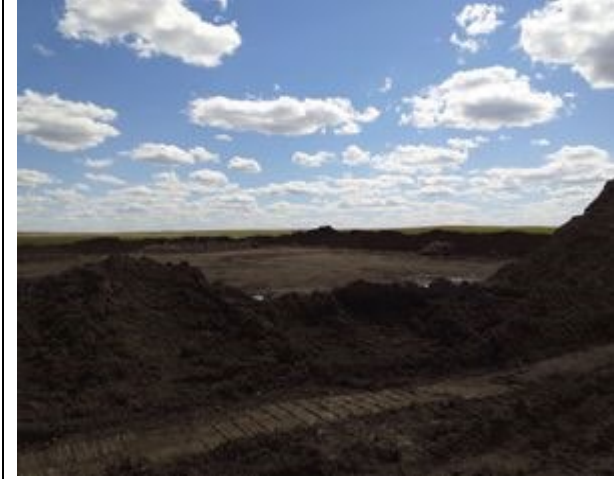
**Observation Point: 4**

Photo Description: Subsoils are stockpiled on south side of trench where the topsoil stockpiles are typically. In the background of the photo there is a small amount of topsoil stockpiled comparatively to the area stripped, potential compaction of topsoil.

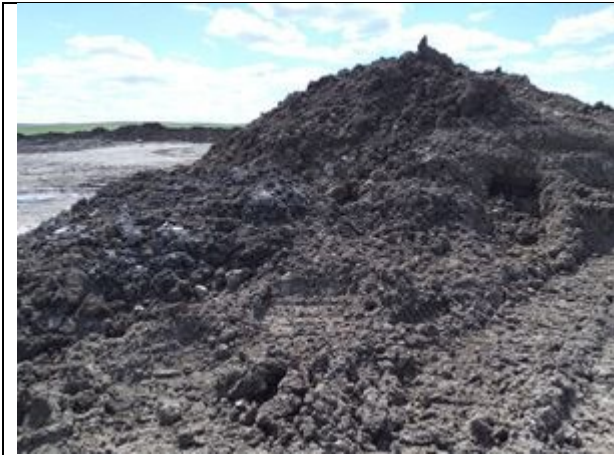
**Observation Point: 5**

7. Mixing of topsoil and subsoils was indicated near HDD entry/exit points (**Observation Points 5, 25**).

Photo Description: Subsoil mixing has occurred with topsoil from HDD bell hole excavation.

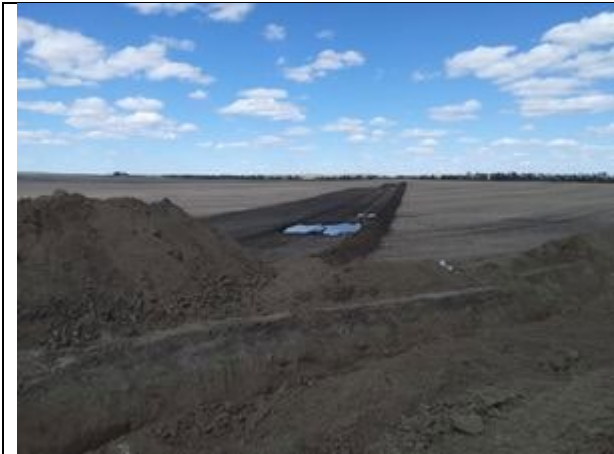
**Observation Point: 6**

2. A linear area of land had been stripped of topsoil occurring near a change of direction of the planned pipeline route, seemingly out of the ROW (**Observation Point 6**).

Photo Description: Soil stripping has apparently occurred off ROW, unknown if it relates to construction activity of project.

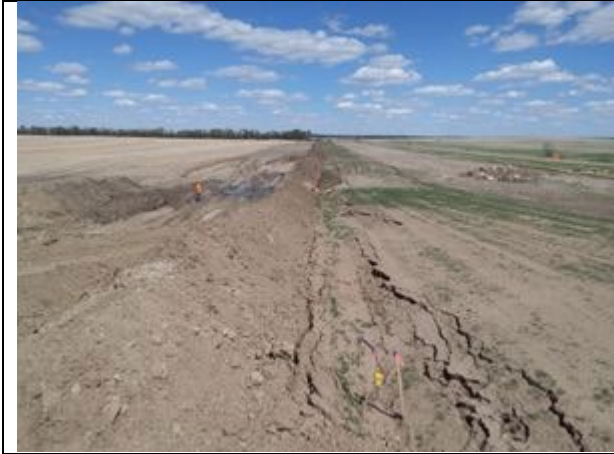
**Observation Point: 7**

Photo Description: No erosion controls present, erosion and sedimentation present along ROW boundary.

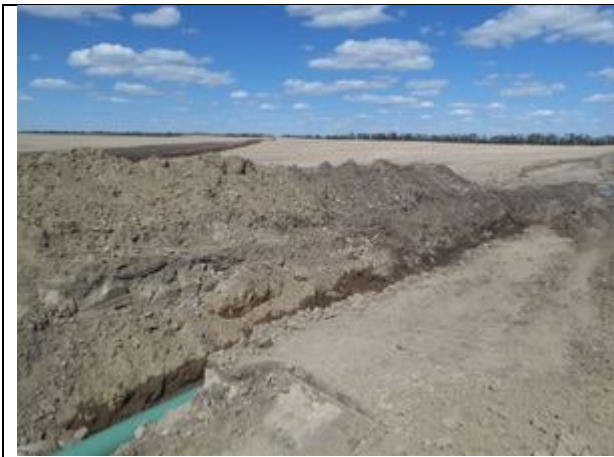
**Observation Point: 8**

Photo Description: Isolated minor mixture of topsoil and subsoil present in stockpile, on shoulder slope.

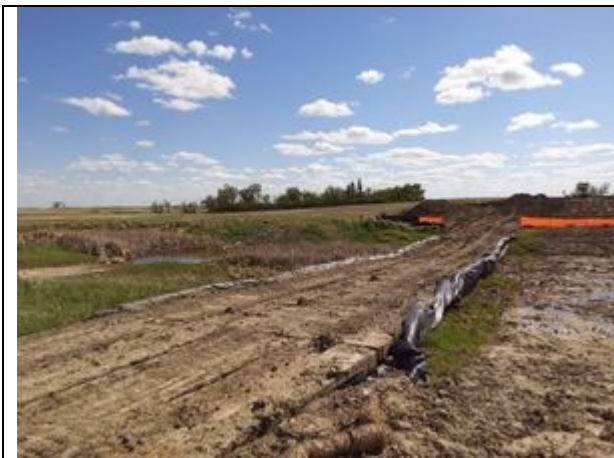
**Observation Point: 9**

3. A wetland crossing conducted via HDD, was subsequently crossed with equipment via a timber bridge; however, evidence of crossing through the wetland south of timber bridge without controls is evident, as well as subsoil stockpile erosion into the wetland (**Observation Point 9**).

Photo Description: Timber matting bridge wetland crossing. South of timber crossing, uncontrolled wetland crossing evident. HDD under wetland. Subsoil stockpile erosion into wetland.

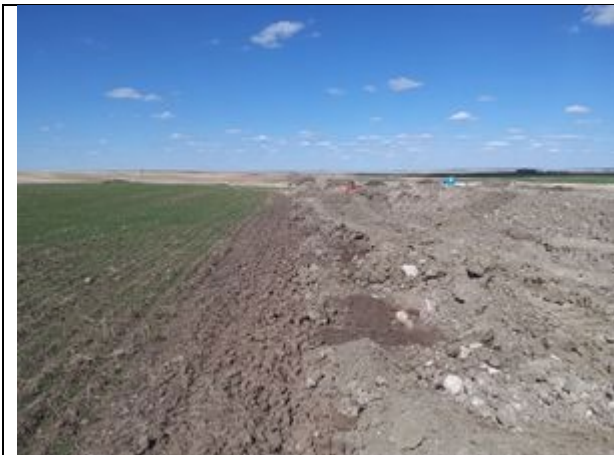
**Observation Point: 11**

Photo Description: Topsoil cut not present suggesting subsoil stockpile encroachment and potential mixing.

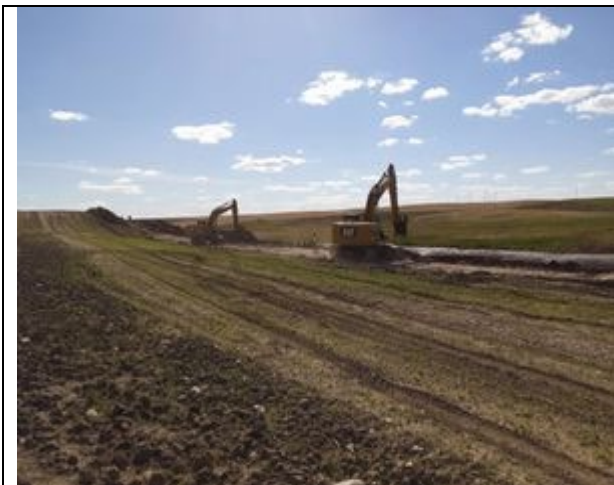
**Observation Point: 12**

Photo Description: Wetland open cut trench, backfilling, timber matting used to cross wetland. Erosion controls currently present are ineffective, need for greater erosion control. Does not appear that subsoil and topsoil were segregated during cut.

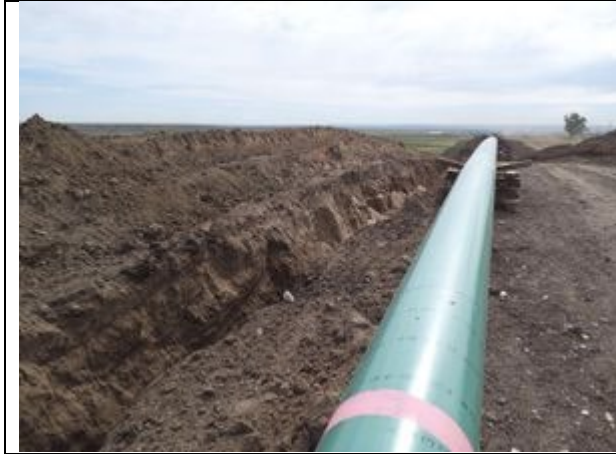
**Observation Point: 13**

Photo Description: Topsoil appropriately not present in trench profile. Stockpiles and stripped area free of mixing.

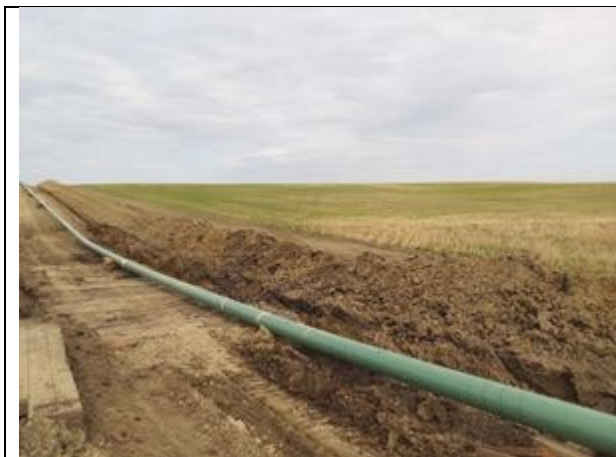
**Observation Point: 14**

Photo Description: Inadequate ESC (Erosion and Sediment Control) measures along slope and adjacent to wetland.

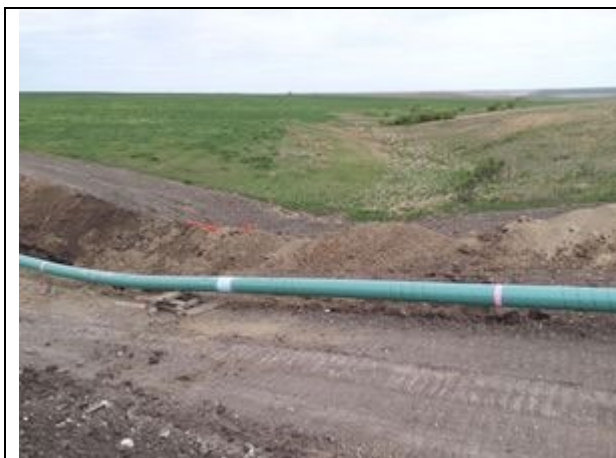
**Observation Point: 15**

Photo Description: BMPs inadequate to protect drainage and absent along slope.

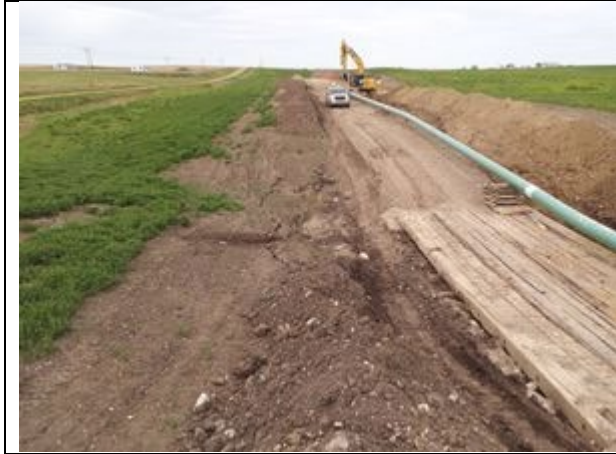
**Observation Point: 16**

Photo Description: Topsoil stockpile appropriately not placed within drainageway.

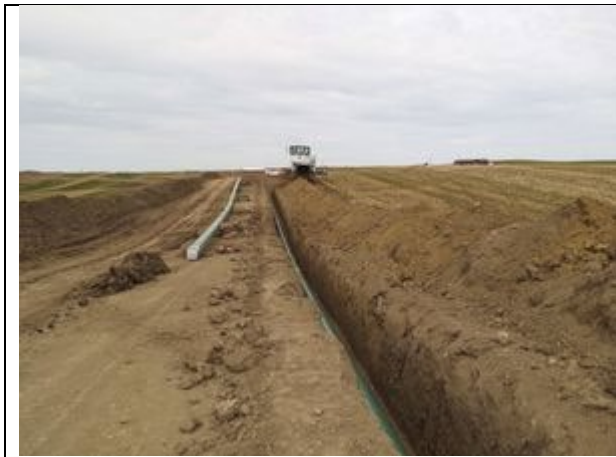
**Observation Point: 17**

Photo Description: Backfilling over laid pipe. Equipment and stockpile appropriately within ROW.

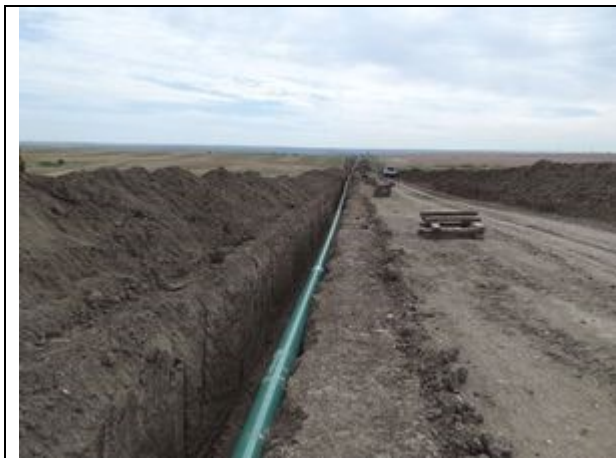
**Observation Point: 18**

Photo Description: Laid pipe depth greater than 60 inches below adjacent ground surface.

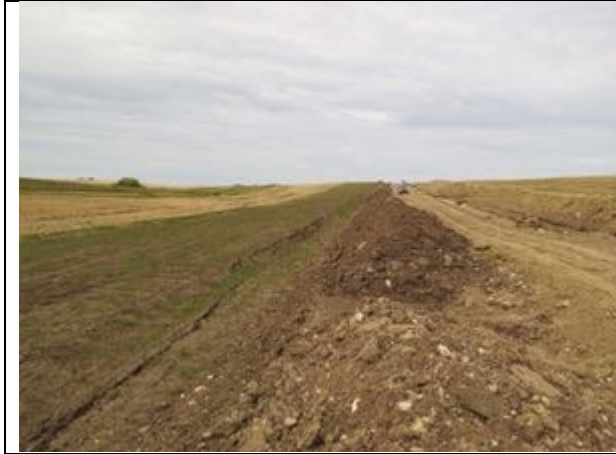
**Observation Point: 19**

Photo Description: Erosion present along southern boundary of topsoil stockpile.

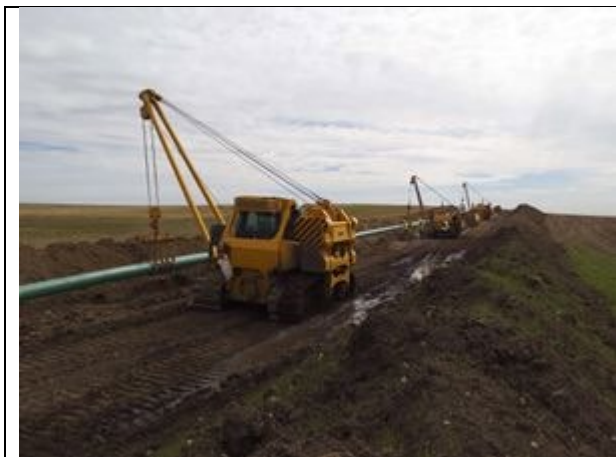
**Observation Point: 20**

Photo Description: Active pipe installation.

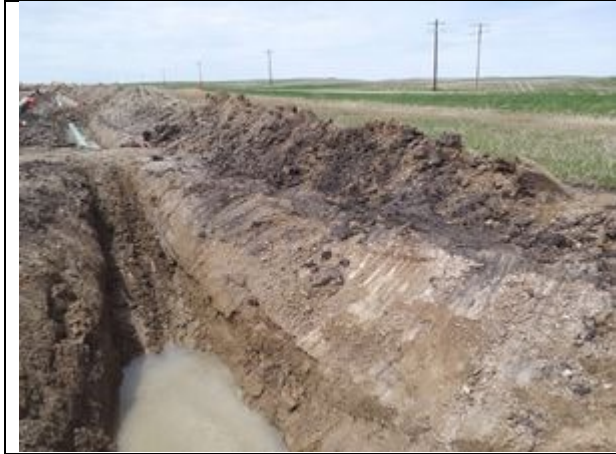
**Observation Point: 25**

Photo Description: HDD bell hole excavation area. Topsoil mixing present in subsoil stockpile.

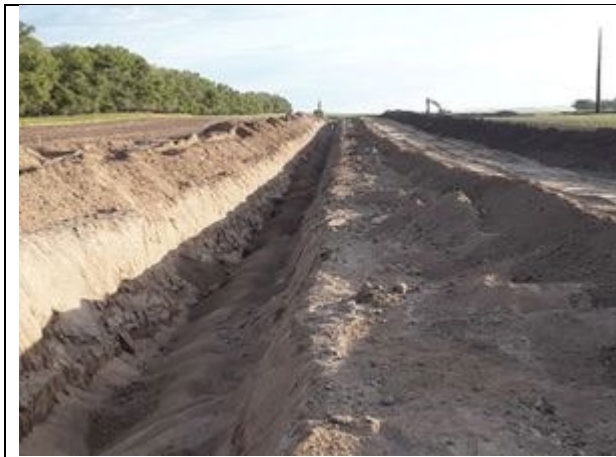
**Observation Point: 26**

Photo Description: Topsoil and subsoil segregated well. Top of pipe depth roughly 60" to top of trench prior to subsoil and topsoil backfill.

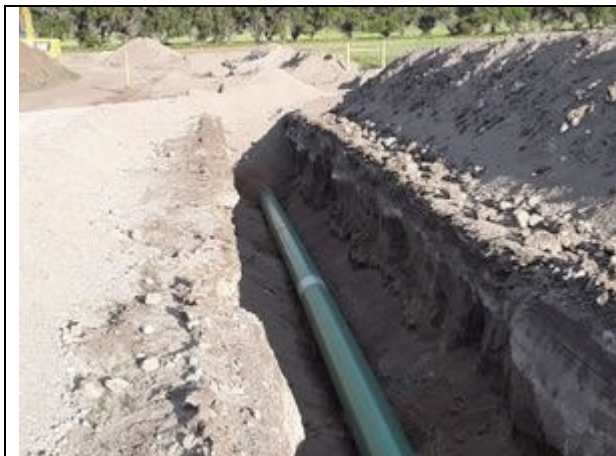
**Observation Point: 27**

Photo Description: Top of pipe depth roughly 70" to current top of trench near section line. Assume backfill and topsoil replacement will create minimum 72" total cover.
