**PU-19-368
ONEOK Bakken Pipeline, L.L.C.
Tioga Lateral NGL Pipeline
Reclamation Inspection Report**

File No. 227701547

August 2022

Stantec Consulting Services Inc.
3303 Fiechtner Drive, Suite 100
Fargo, ND 58103

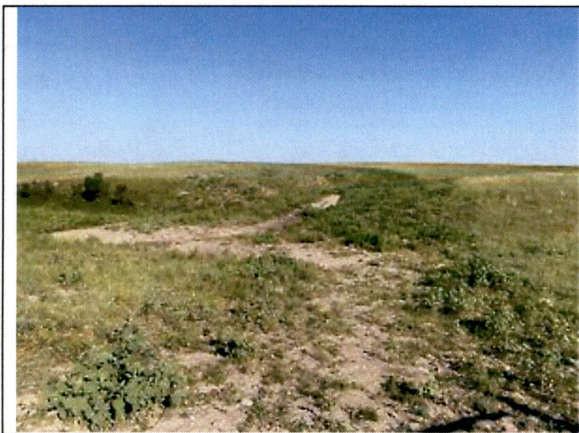
<p>Observation Point: 13 Date Taken: August 1, 2022 6:33 PM Direction Photo is Taken: Southeast Land Use: Rangeland</p> <p>Photo Description: Lack of vegetation in right of way. Stantec recommends reseeding efforts.</p> <p>Latitude: 48.30021004 Longitude: -103.71327055</p>
--	--

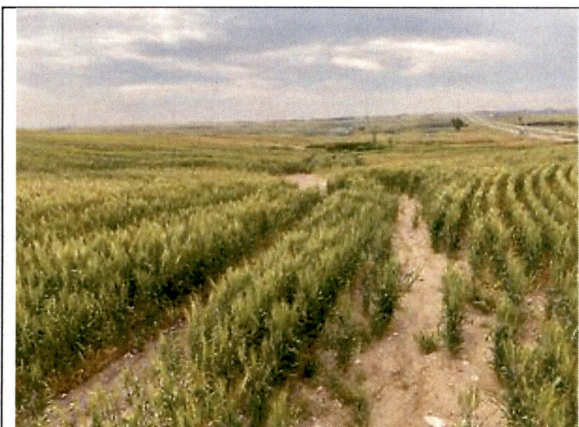
<p>Observation Point: 14 Date Taken: August 2, 2022 8:00 AM Direction Photo is Taken: Land Use: Cropland</p> <p>Photo Description: Erosional feature or subsidence on reclaimed right of way negatively affecting crops.</p> <p>Latitude: 48.29953506 Longitude: -103.62482077</p>
---	---

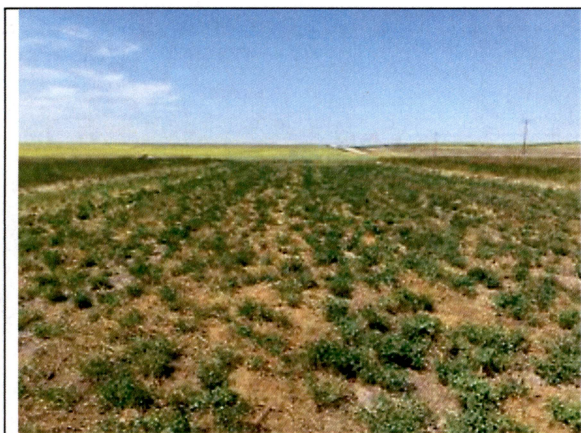
<p>Observation Point: 46 Date Taken: August 2, 2022 12:51 PM Direction Photo is Taken: West Land Use: Hay land</p> <p>Photo Description: Reclaimed hayfield dominated by planted alfalfa.</p> <p>Latitude: 48.31291067 Longitude: -103.08269478</p>
--	--

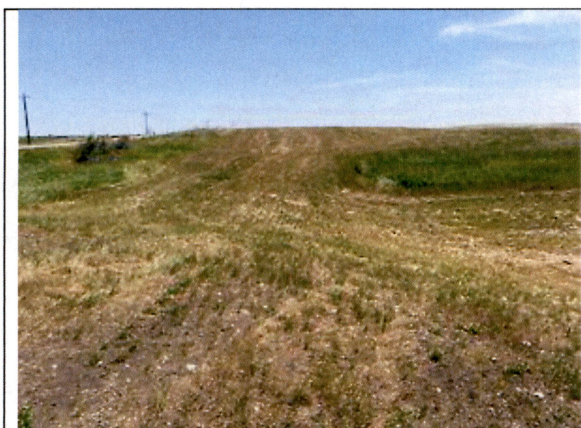
<p>Observation Point: 47 Date Taken: August 2, 2022 1:11 PM Direction Photo is Taken: East Land Use: Rangeland</p> <p>Photo Description: Seeded vegetation throughout reclaimed ROW. Canada thistle to south of picture location and has gone to seed. Stantec recommends treatment of noxious weeds.</p> <p>Latitude: 48.31284701 Longitude: -103.06617773</p>
---	--

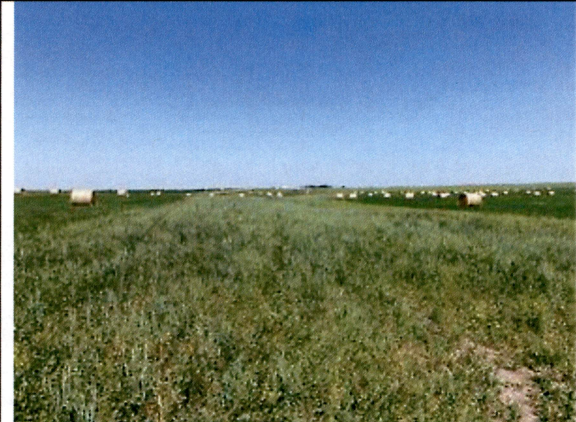
<p>Observation Point: 48 Date Taken: August 2, 2022 1:16 PM Direction Photo is Taken: North Land Use: Hay Land</p> <p>Photo Description: Lambsquarter, mustard, and foxtail. ROW seems to be under different vegetation or unseeded as surrounding land is alfalfa.</p> <p>Latitude: 48.3166945 Longitude: -103.06436246</p>
---	---

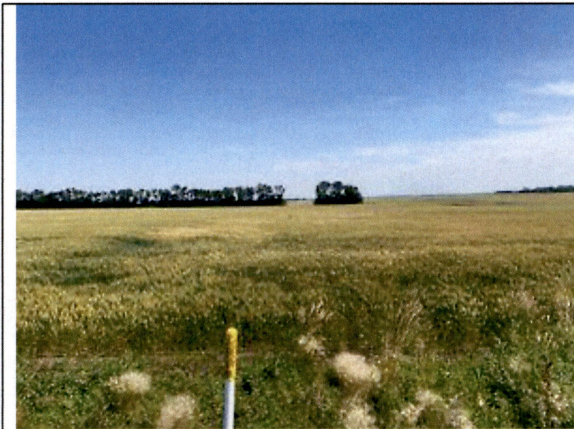
Observation Point: 52
Date Taken: August 2, 2022 2:00 PM
Direction Photo is Taken: East
Land Use: Cropland

Photo Description: Grain growth is satisfactory. Replaced topsoil observed and appropriate.
