Whiting Oil and Gas Corporation  
Robinson Lake Oil Conditioning – Mountrail County  
Case No. PU-19-369  
As-Built Construction and Reclamation Inspection Report

RE: Case No. PU-19-369  
Whiting Oil and Gas Corporation  
Robinson Lake Oil Conditioning –  
Mountrail County  
As-Built Construction and Reclamation  
Inspection Report

Project: Whiting Oil and Gas - Robinson Lake Oil Conditioning

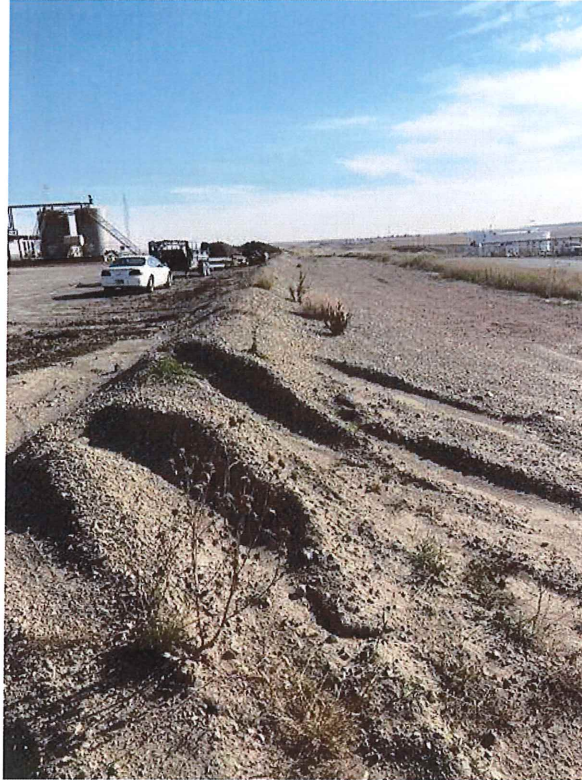
**Photo ID:** 14

- Site inspection indicated that existing earthen berm used for erosion containment had erosion issues where berm was deteriorating from water erosion. Berm needs repair in multiple locations to perform intended operation of erosion control. See pictures 14 and 20.

**Notes:** Erosion berm between construction site and roadway ditch

- Erosion Berm on SE corner requires maintenance to be brought back to optimal conditions.

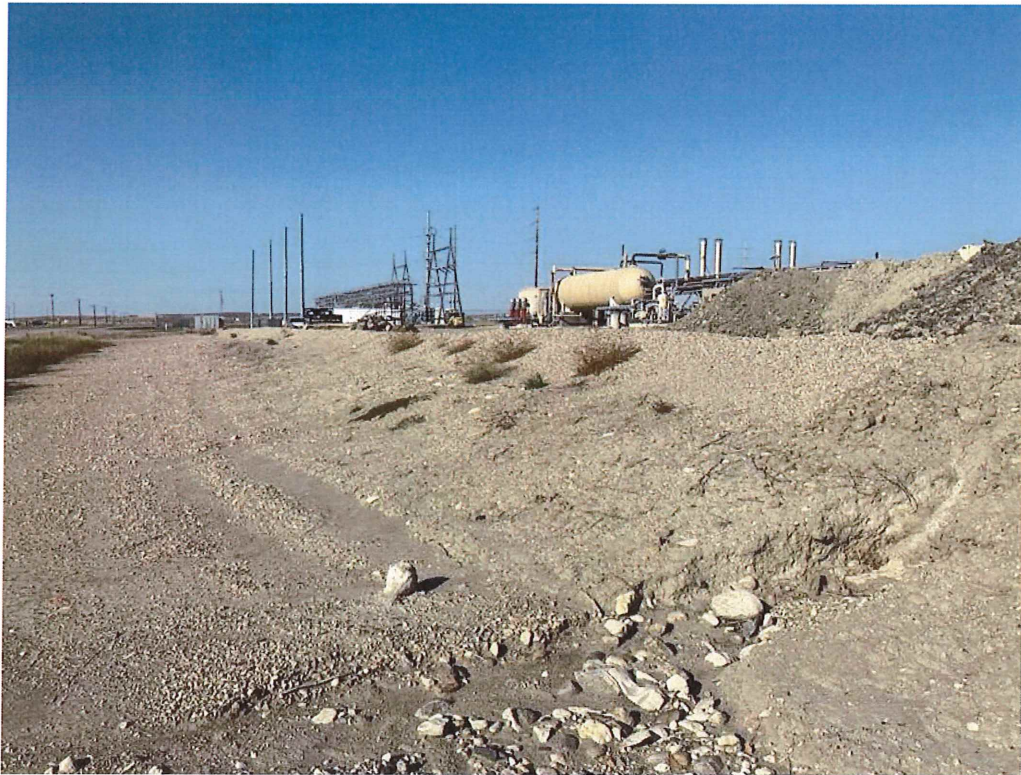
**Photo ID:** 20

**Notes:** Erosion taking place, requires attention to berm

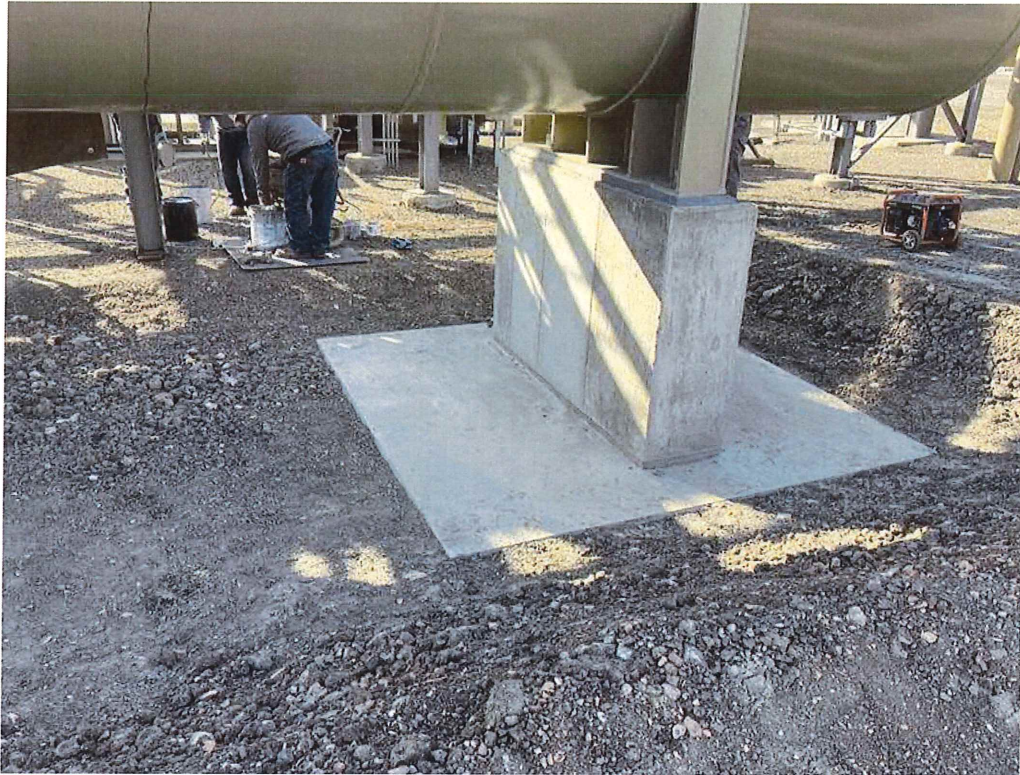
**Photo ID:** 25

- Gravel surfacing was leveled around site except near concrete bases. See photos 25 and 28. No site earthwork, gravel base work showed any issues. Site gravel matched existing gravel base of the construction pad area. See photo 25 as example of gravel base.

**Notes:** Sufficient backfilling completed around new concrete pad.
