**Site/Project Location:** Divide Wind Energy Center

**Date of Inspection:** 2 July 2020

Keitu staff visited the Divide Wind Energy Center Project for a start of project topsoil inspection for the wind turbine construction portion of the wind farm project. Inspection of construction sites to focus on (1) confirming surface disturbance/work occurring within ND PSC-approved work corridor and/or route; (2) topsoil segregation occurring; (3) vegetation removal consistent with tree & scrub mitigation plan.

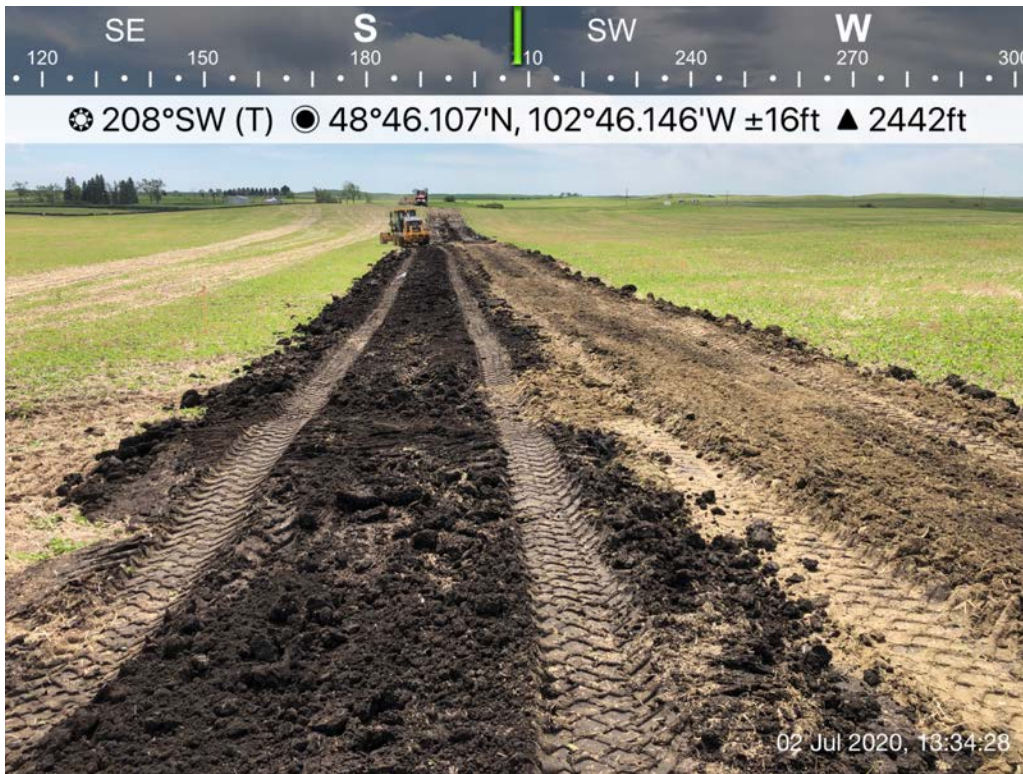
Two bulldozers started stripping topsoil on the south side of the laydown yard which was located in a planted crop field. Topsoil depth varied from 6-10 inches deep on the south side of the laydown yard. The west side of the laydown yard was being stripped using a grader. The lower lying areas of the west side of the laydown yard had topsoil depth of 12 inches or more, while the areas of higher elevation had topsoil depth of 6 inches or less in some areas. The dozers on the south side of the yard pushed the topsoil into piles to be picked up with a grader and used as a perimeter berm for the laydown yard. The grader was segregating topsoil along the western edge of the yard while the dozers stripped the south side.

**Report Photo #1 "Grader stripping soil on west side of laydown yard"**

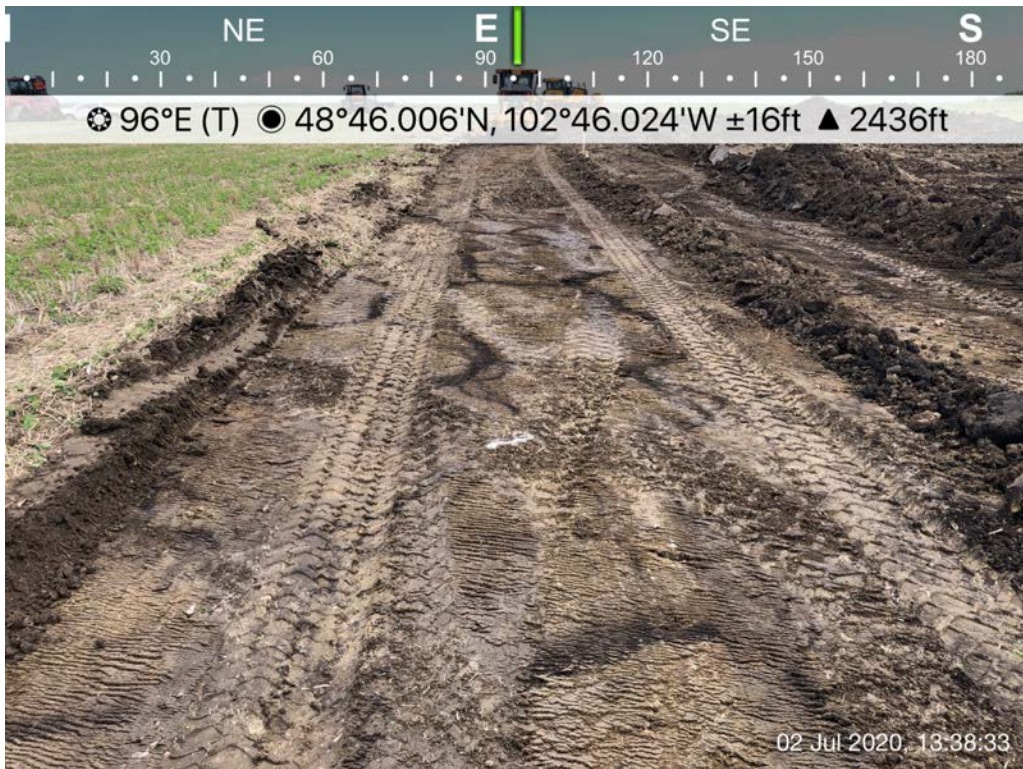
**Report Photo #2 "Topsoil stripped by bulldozers on south side of laydown yard"**

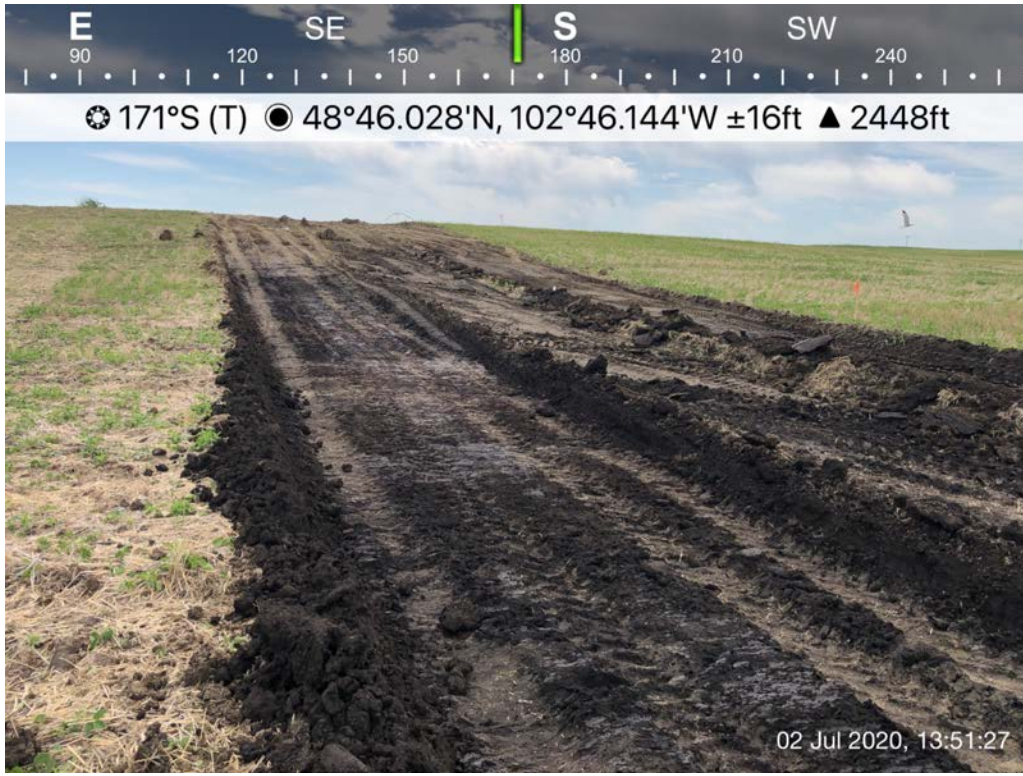
**Report Photo #3 “Varying topsoil depth on hill slope of the laydown yard”**
