Site/Project Location: Northern Divide Wind Energy Center

Date of Inspection: 21 October 2020

Keitu staff visited the Northern Divide Wind Energy project for a construction inspection. Inspection of construction sites focused on (1) confirming surface disturbance/work occurring within ND PSC-approved work corridor and/or route; (2) topsoil segregation occurring; (3) vegetation removal consistent with tree & scrub mitigation plan; and (4) storm water runoff and sediment control.

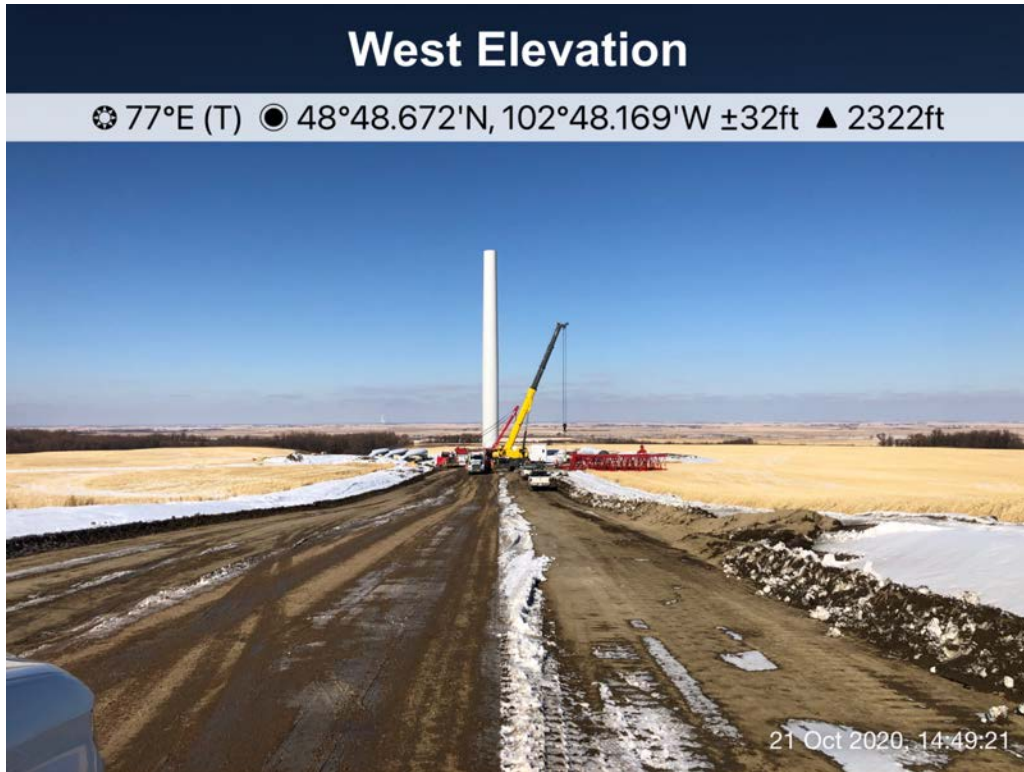
Report Photo #1 "Turbine Components being Constructed with Crane"

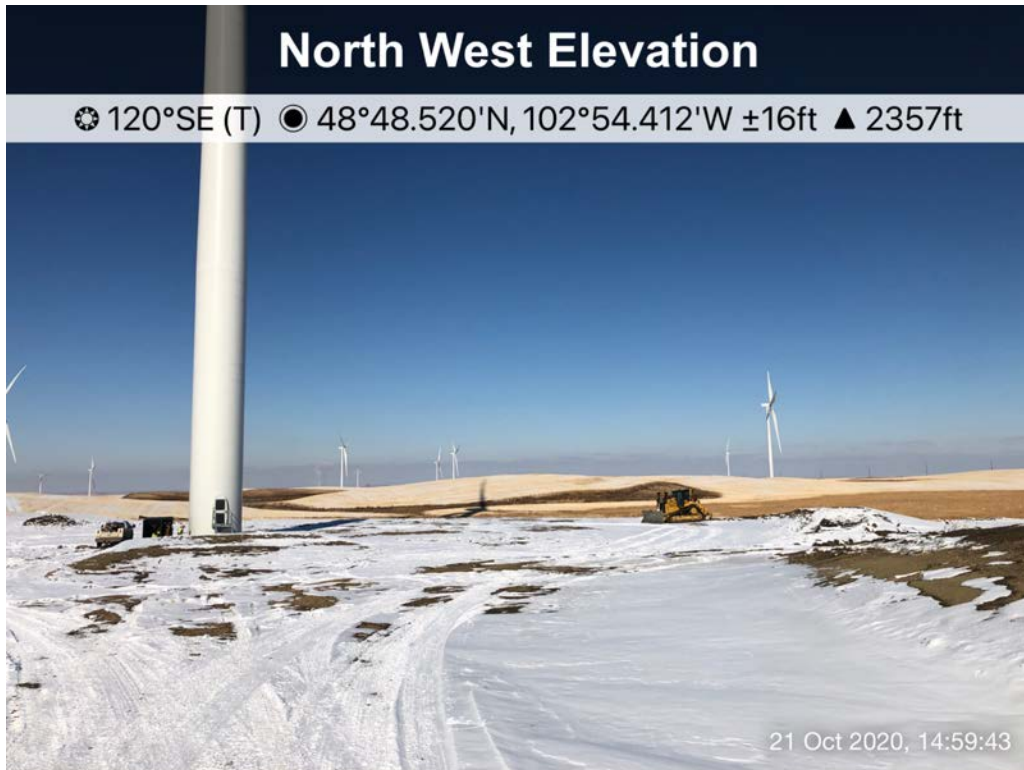
Report Photo #2 "Recently Completed Turbines"

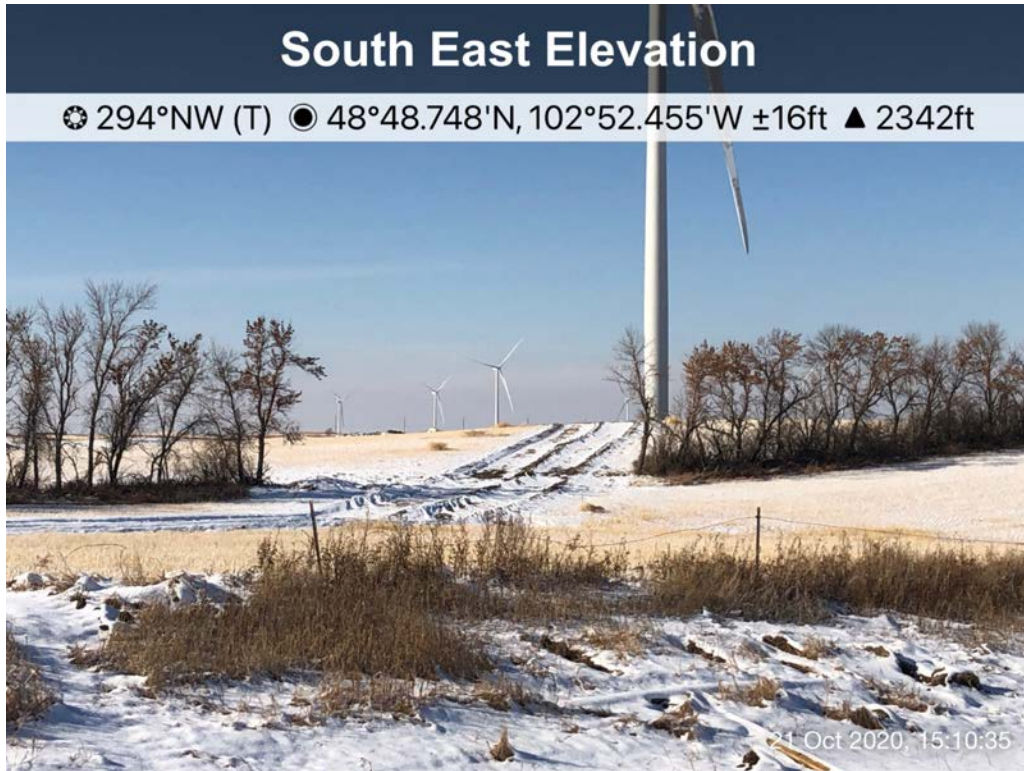
There were locations where trees were removed from single row shelterbelts for string roads and collection lines to turbine sites. The number of trees removed was minimal. NextEra Energy will follow the tree and shrub mitigation plan submitted as part of their Application for Certificate of Site Compatibility. In several locations, string roads to turbine sites were constructed through agricultural fields currently in crop production.

Report Photo #3 "Trees Cleared for Collection Line"

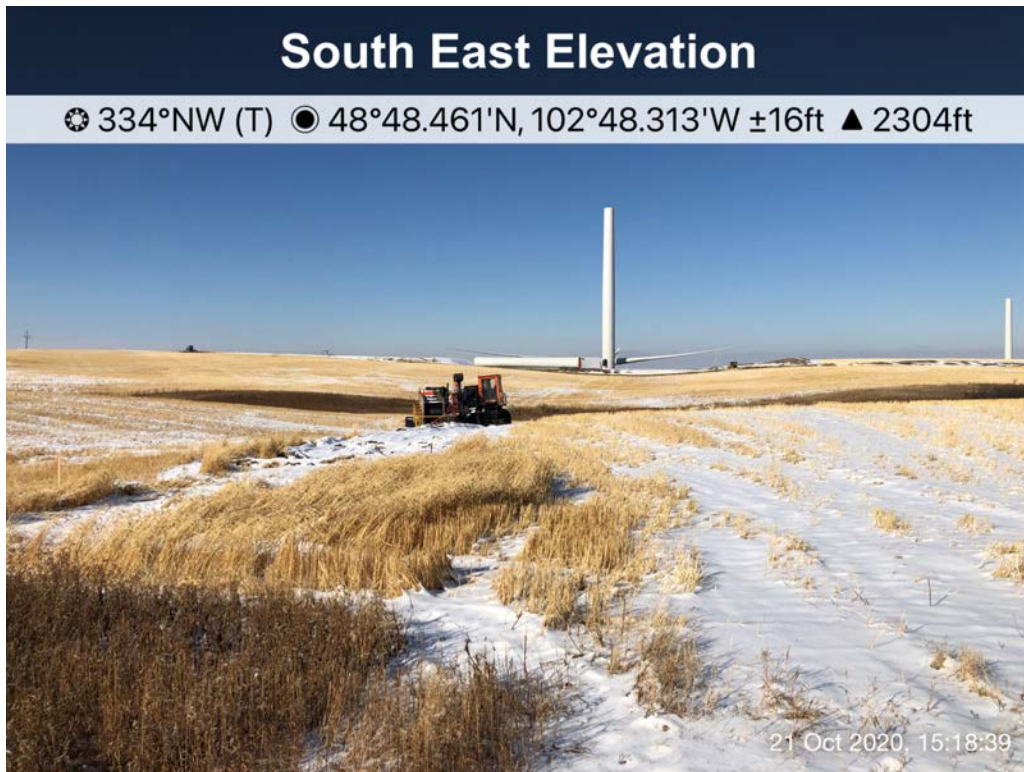
Report Photo #4 "Trenching Machine for Collection Line"
