Site/Project Location: Northern Divide Wind Energy Center

Date of Inspection: 24 November 2020

Keitu staff visited the Northern Divide Wind Energy project for a construction inspection. Inspection of construction sites focused on (1) confirming surface disturbance/work occurring within ND PSC-approved work corridor and/or route; (2) topsoil segregation occurring; (3) vegetation removal consistent with tree & scrub mitigation plan; and (4) storm water runoff and sediment control.

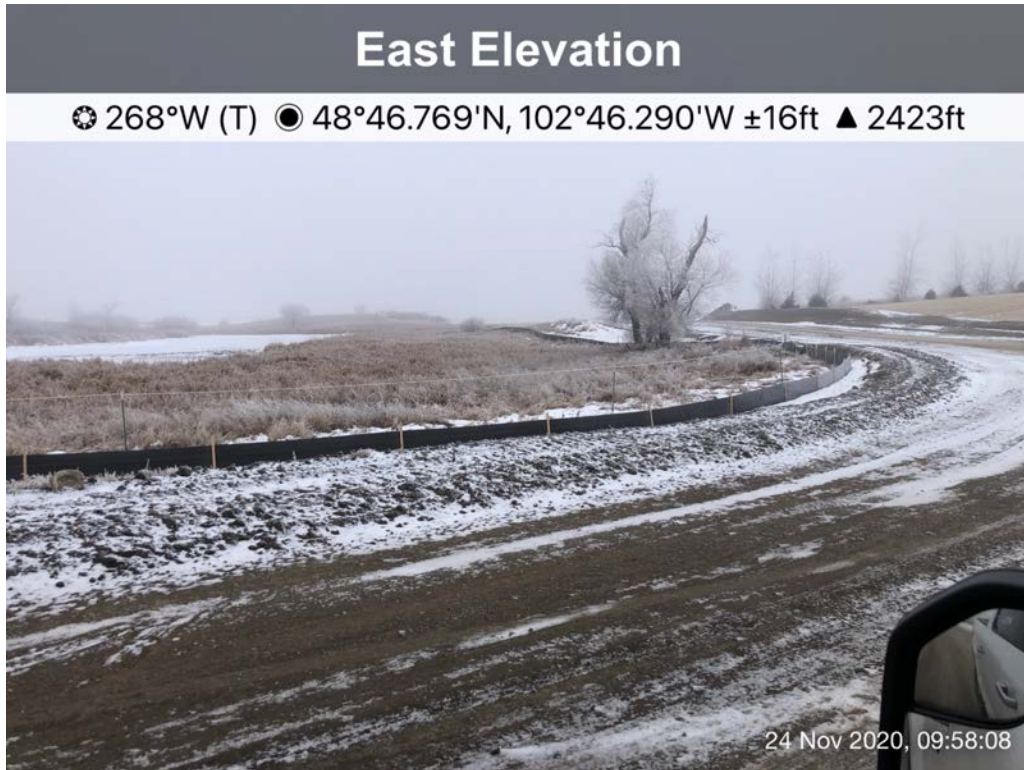
There were locations where trees were removed from single row shelterbelts for string roads and collection lines to turbine sites. Wetlands and cultural sites were marked off with signs and silt fences. The number of trees removed was minimal. NextEra Energy will follow the tree and shrub mitigation plan submitted as part of their Application for Certificate of Site Compatibility. In several locations, string roads to turbine sites were constructed through agricultural fields currently in crop production.

Report Photo #1 "Wetland Boundary Along Access Road"

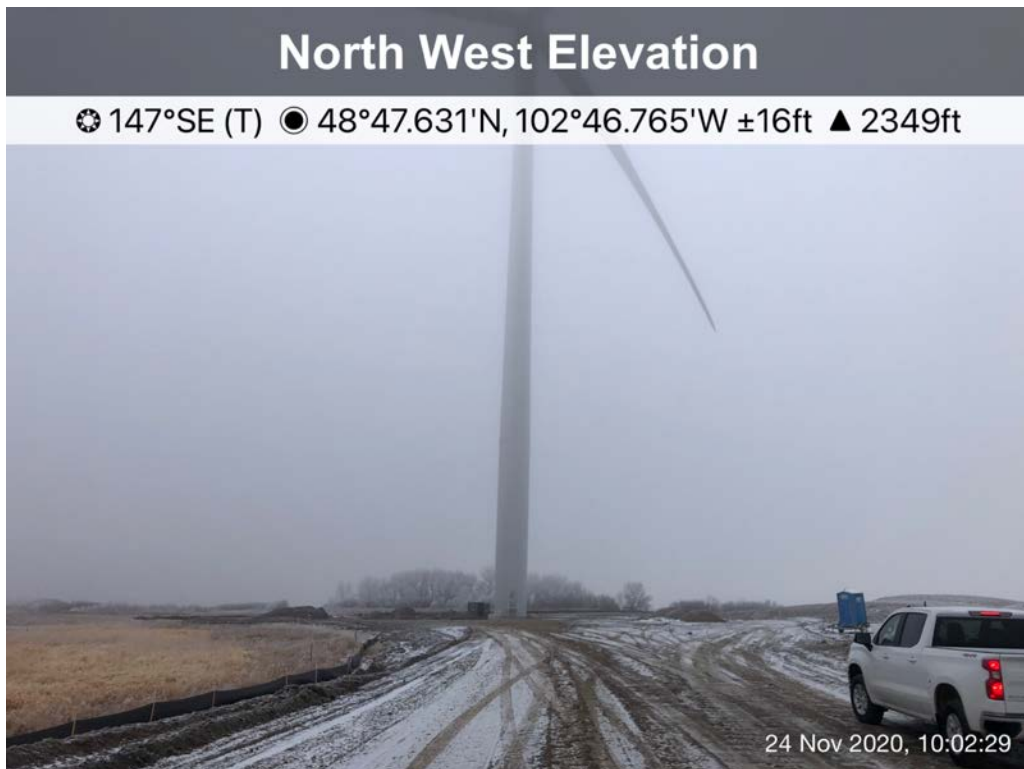
Report Photo #2 "Recently Completed Turbine"

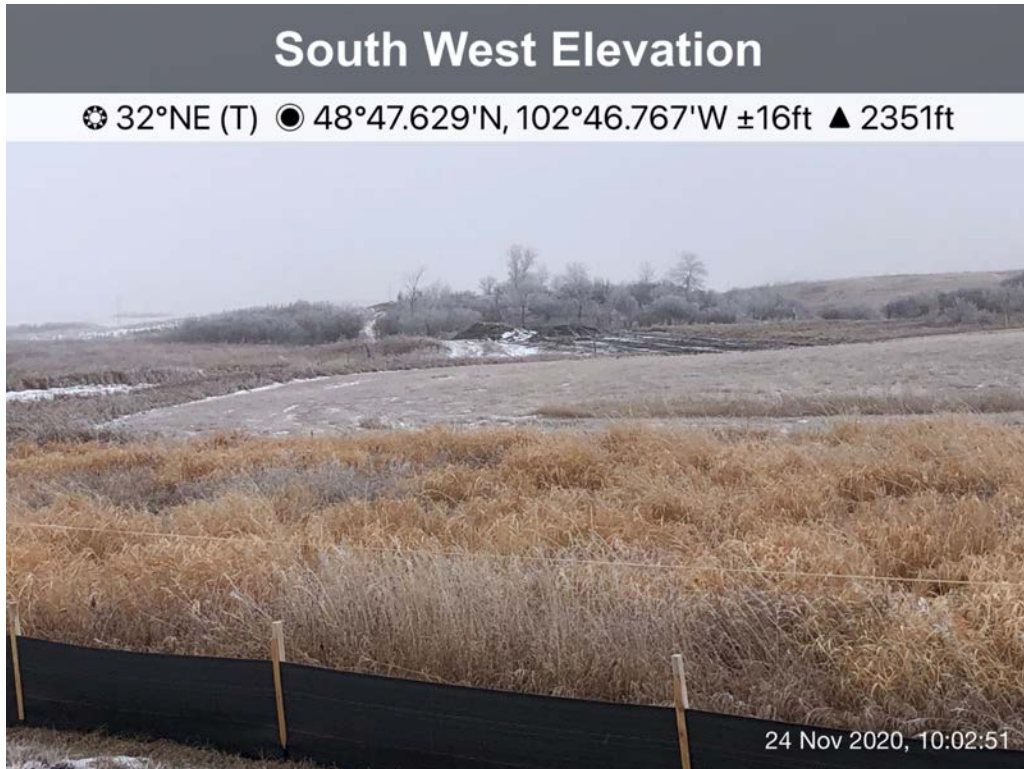
During the inspection, stripped topsoil was noted along string roads and at turbine sites. Topsoil was appropriately segregated from the subsoil with it being piled along the opposite side of string roads and in separate piles at turbine sites. Erosion control and stormwater management BMPs were in good condition and working effectively; although the ground was frozen at the time of the inspection.

Report Photo #3 "Topsoil Pile Along Collection Line"

Reclamation and revegetation seeding will be completed in the spring of 2021 after the ground thaws. Topsoil piles will be used to revegetate areas not used for permanent roads or turbine pads.

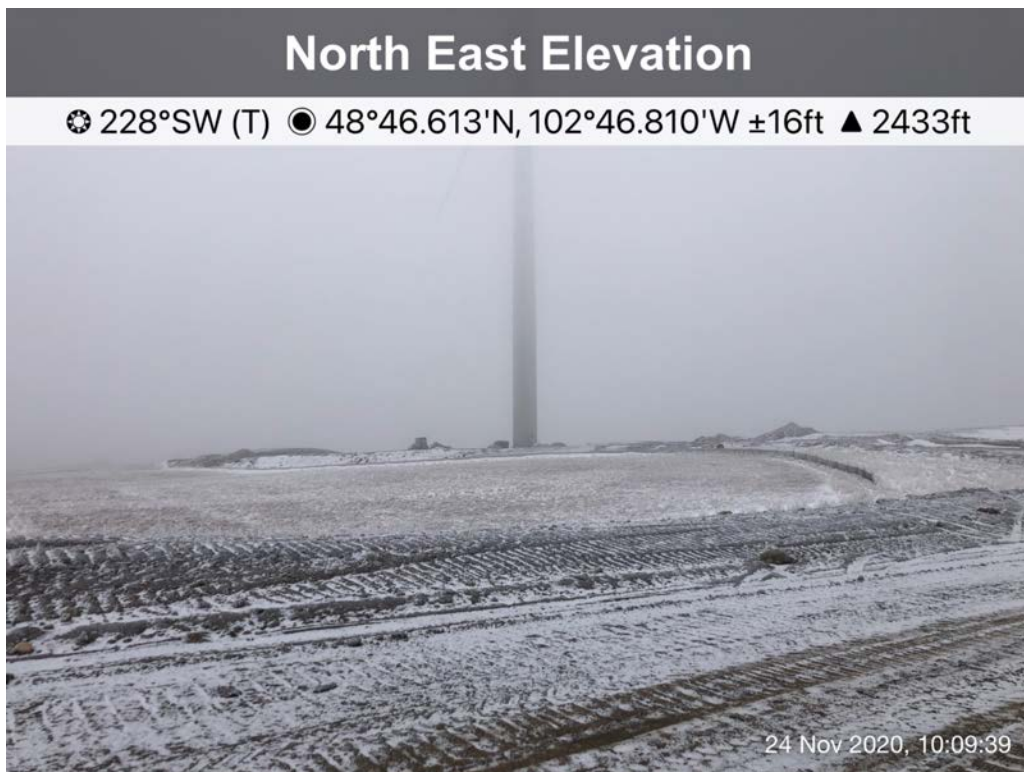
Report Photo #4 "BMPs and Topsoil Piles Near Recently Completed Turbine"
