Reclamation and Revegetation Inspection Report

Northern Divide Wind Energy Center

Northern Divide Wind, LLC

ND PSC Case No. PU-19-376

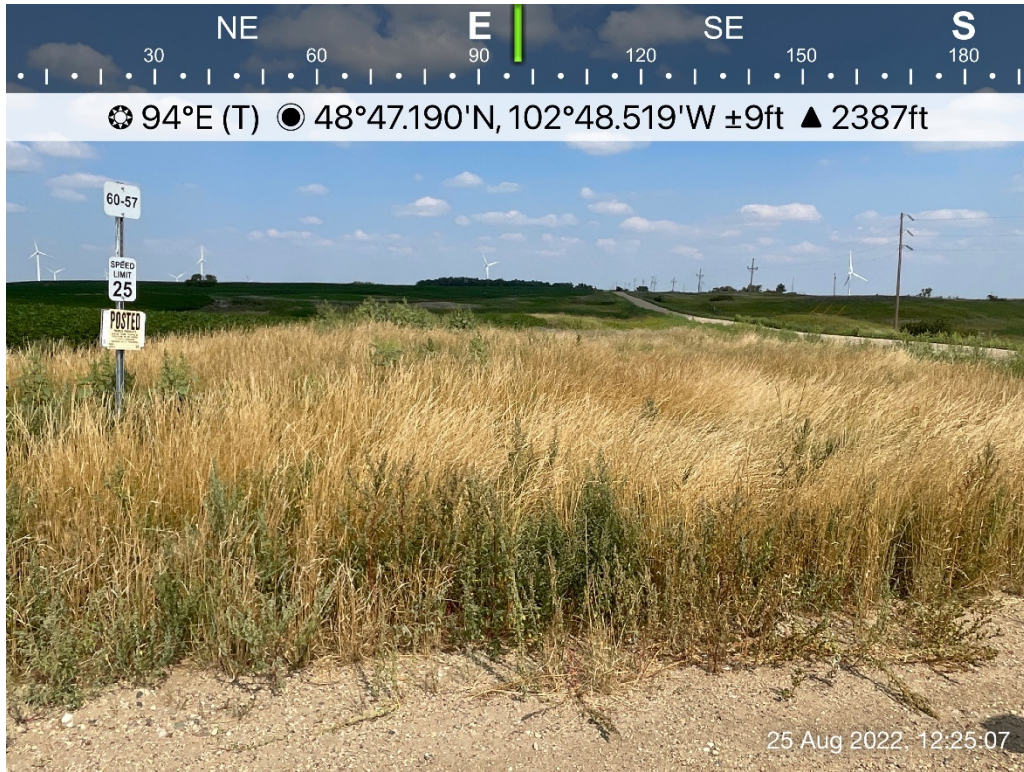
Report Photo #1: Established Grasses along Access Road

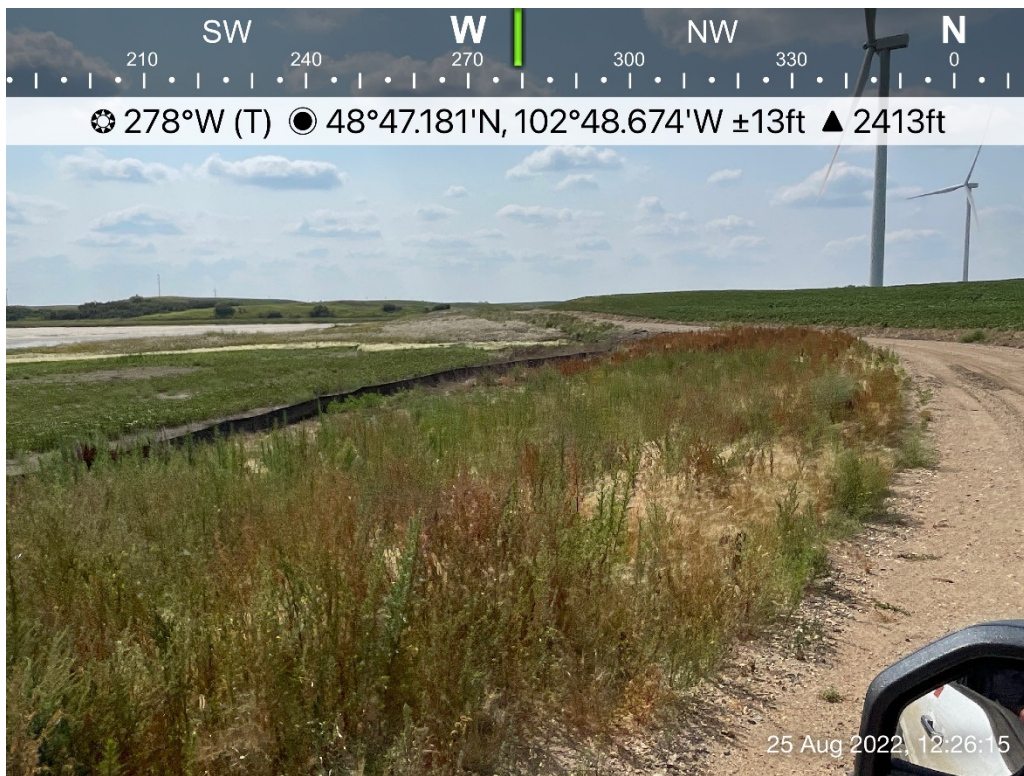
Project areas occurring in crop lands appeared to be returned to pre-construction conditions at the time of visit. Crop density appeared to be similar to areas adjacent to the Project area. Portions of the Project occurring in range or pasture land had approximately 80-100% ground cover, but were mostly weeds and nonnative species. Even though they were undesirable species, the disturbed areas appeared to be stabilized.

Report Photo #2: Undesirable Vegetation and Silt Fence along Access Road

1. Continual maintenance should be done to encourage the revegetation of desirable species.

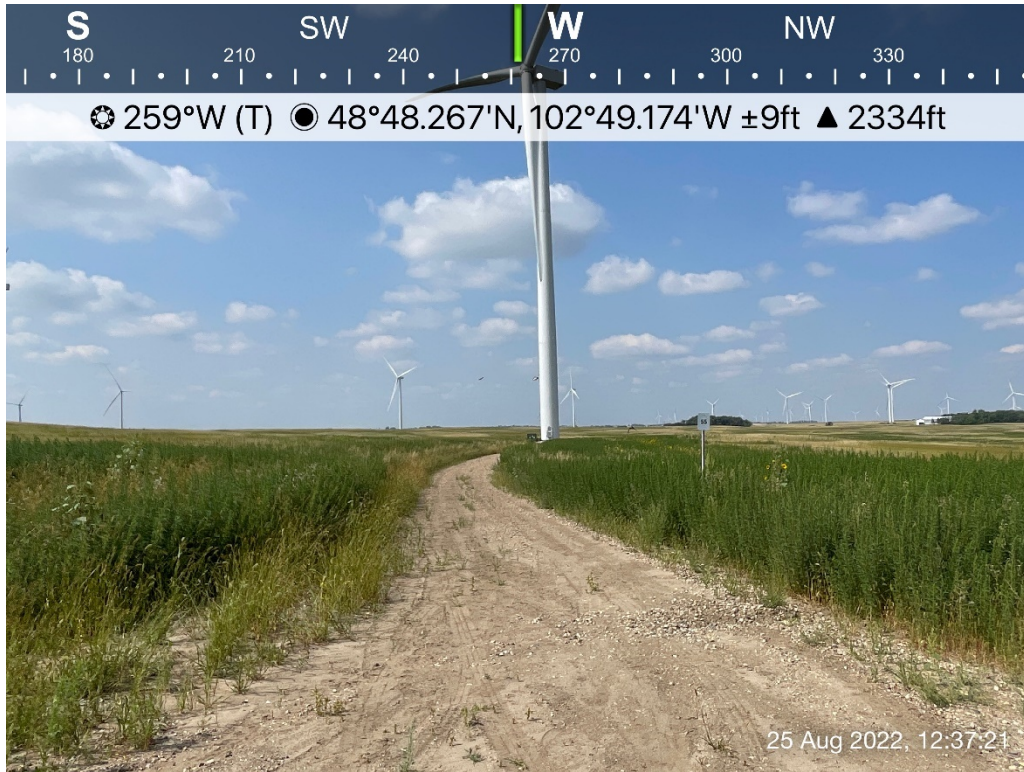
Report Photo #3: Undesirable Vegetation near Turbine Site 55

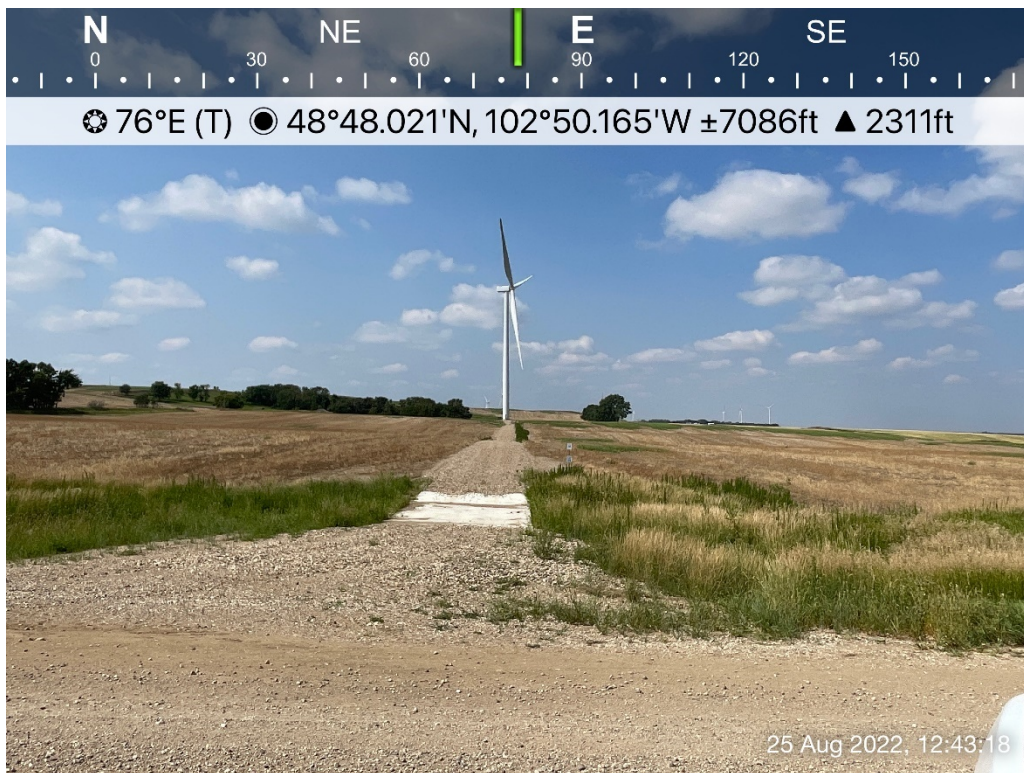
Report Photo #4: Cropland on both Sides of Access Road
