Site/Project Location: Divide 345 kV Transmission Line

Date of Inspection: 27 July 2020

182 PU-19-377 Filed 08/11/2020 Pages: 3
Topsoil Inspection Report
Keitu Engineers & Consultants, Inc.

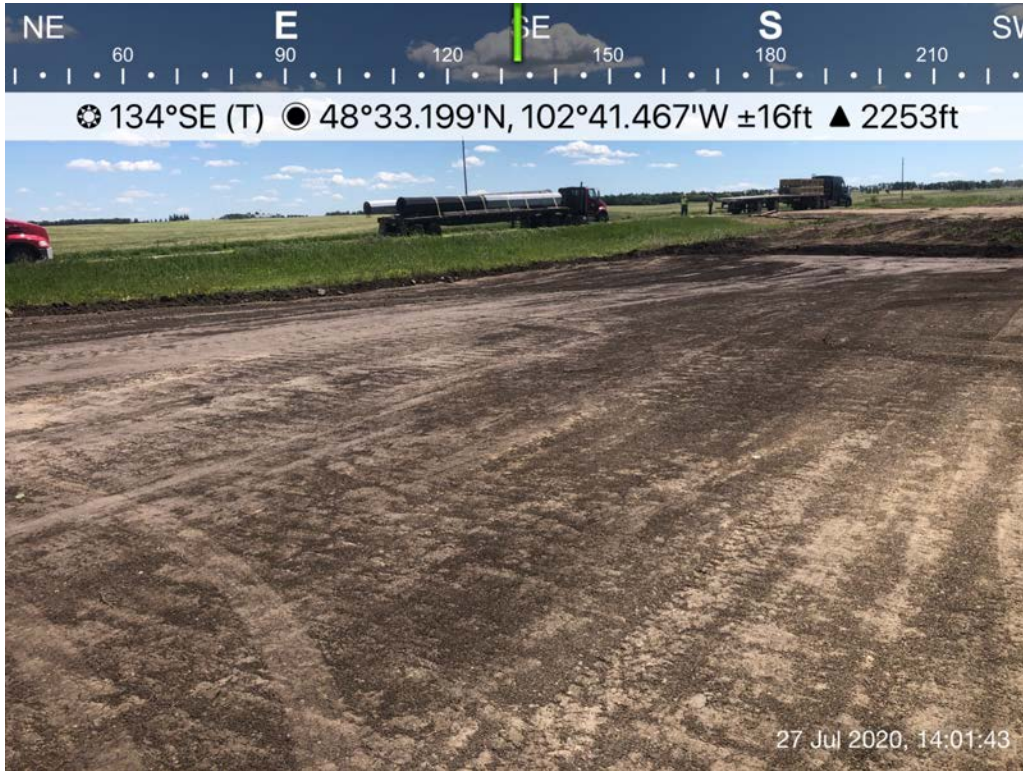
Report Photo #1 "Topsoil stripped off laydown yard"

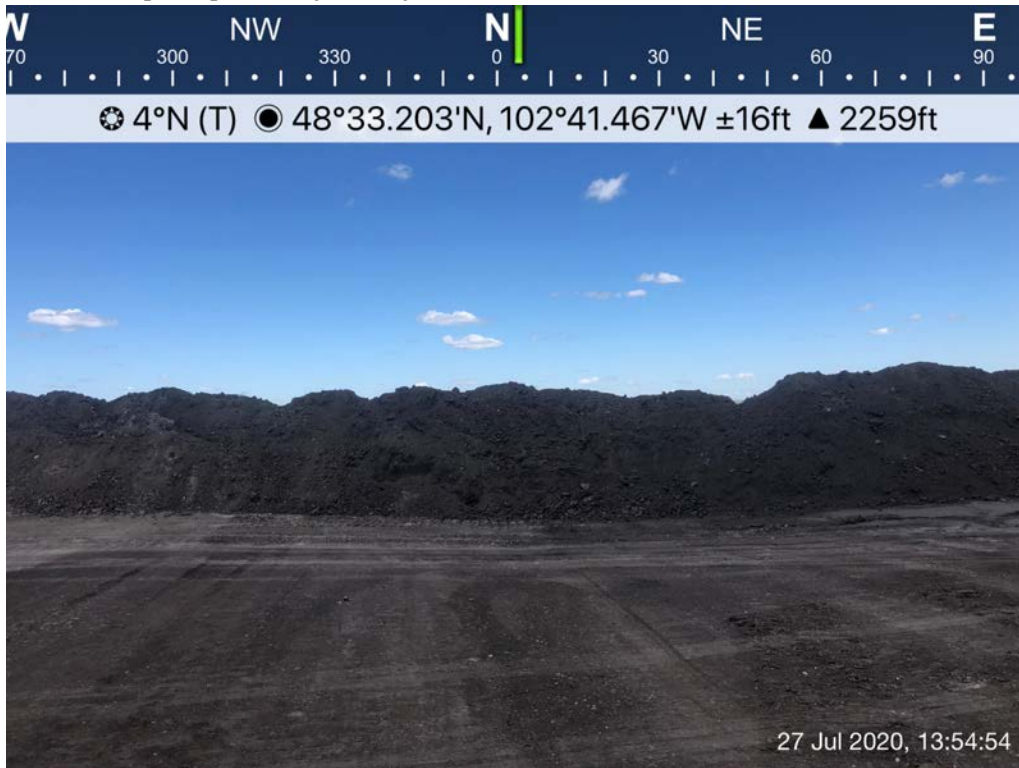
Report Photo #2 "Topsoil pile at laydown yard"

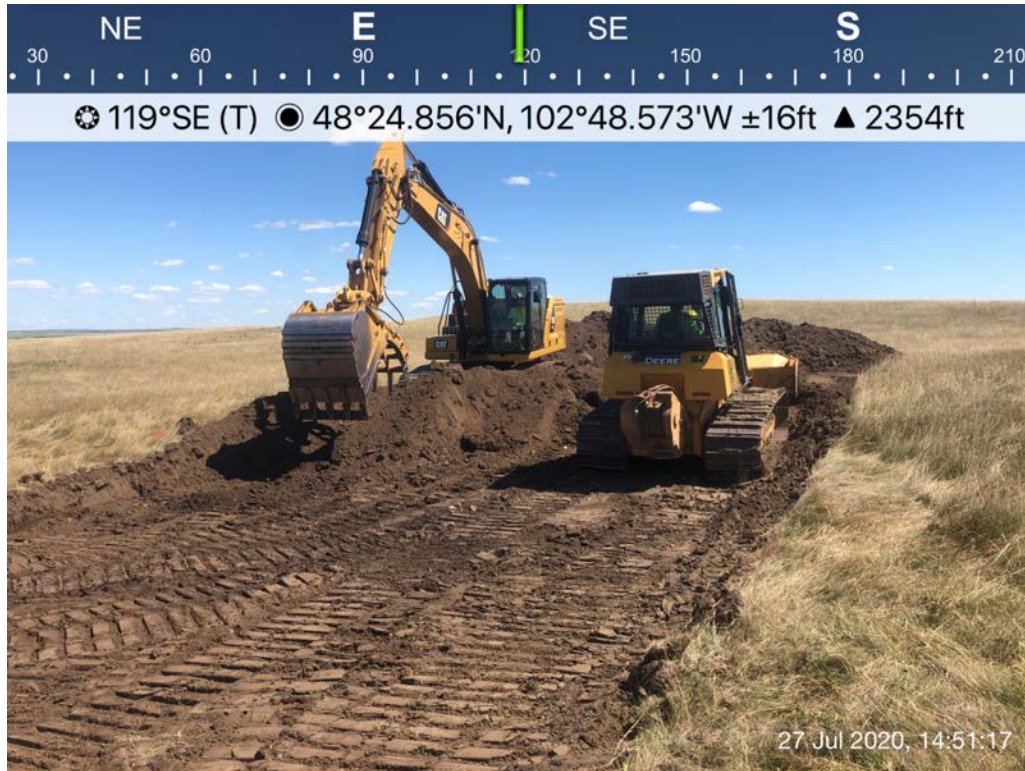
Report Photo #3 "Topsoil being stripped for a transmission line structure."
