Site/Project Location: Northern Divide Wind Transmission Line **Date of Inspection:** 21 October 2020

184 PU-19-377 Filed 11/13/2020 Pages: 4
Construction Inspection Report
Keitu Engineers & Consultants, Inc.

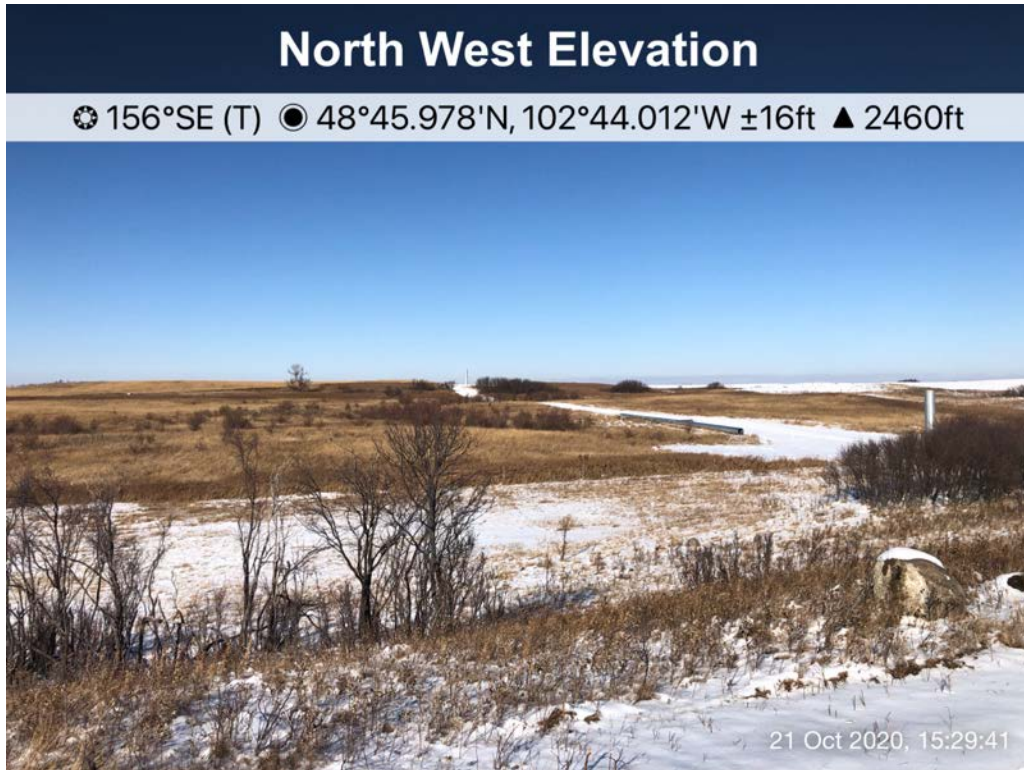
Report Photo #1 "Transmission Line ROW with Structures under Construction"

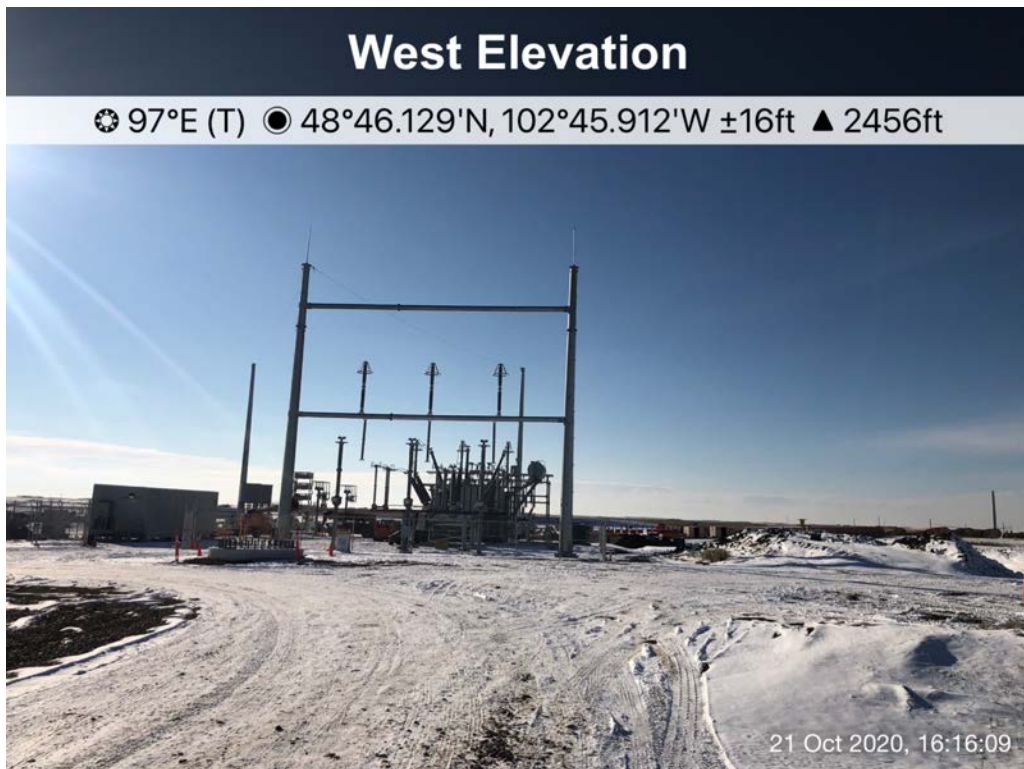
Report Photo #2 "Project Substation nearing Completion"

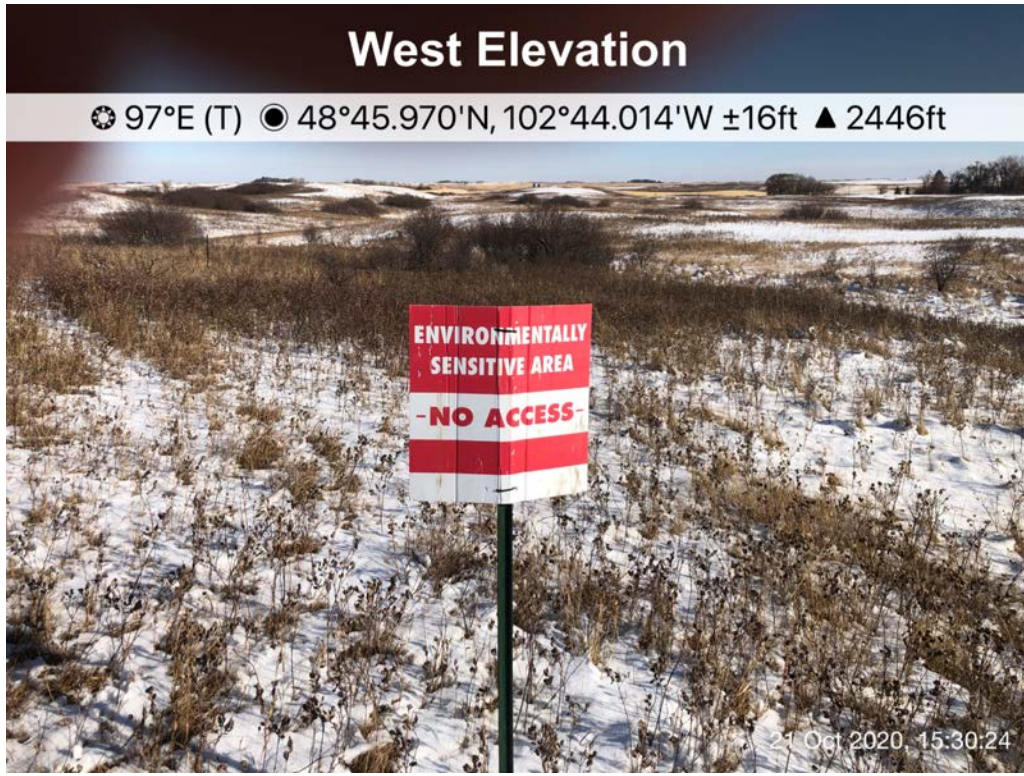
Report Photo #3 “Sign Marking Cultural and Environmental Exclusionary Zones”

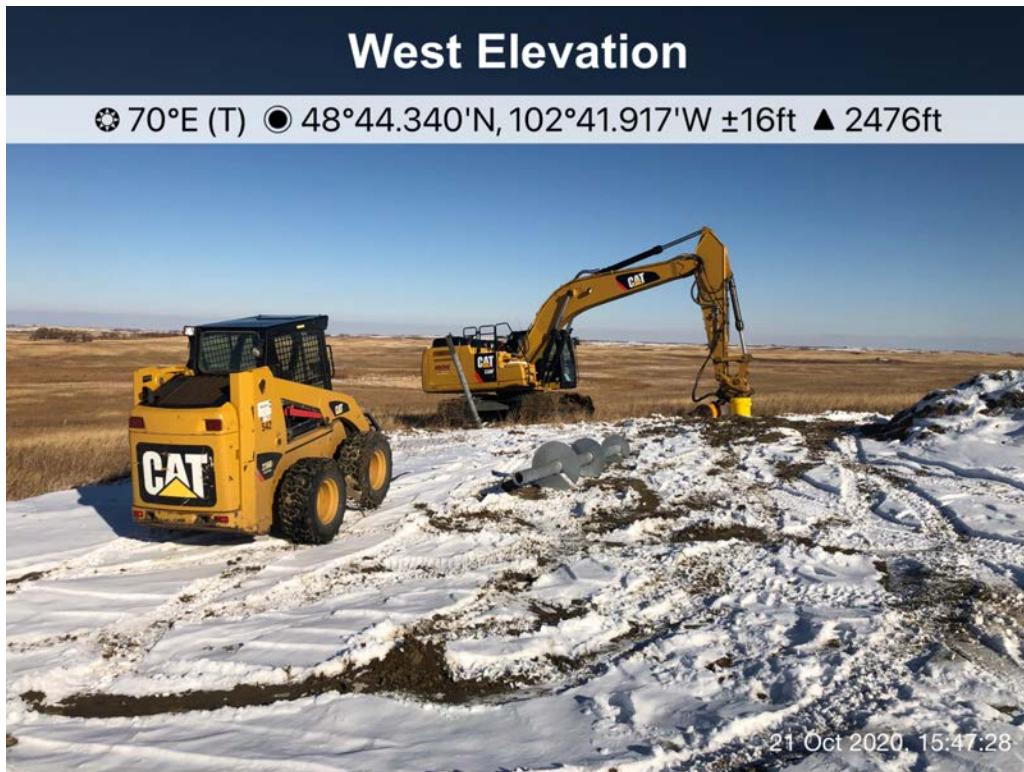
Report Photo #4 “Equipment in for Transmission Line Structure Construction”
