# Reclamation and Revegetation Inspection Report

Northern Divide Wind Energy Center 345 kV Transmission Line

ND PSC Case No. PU-19-377

September 2022

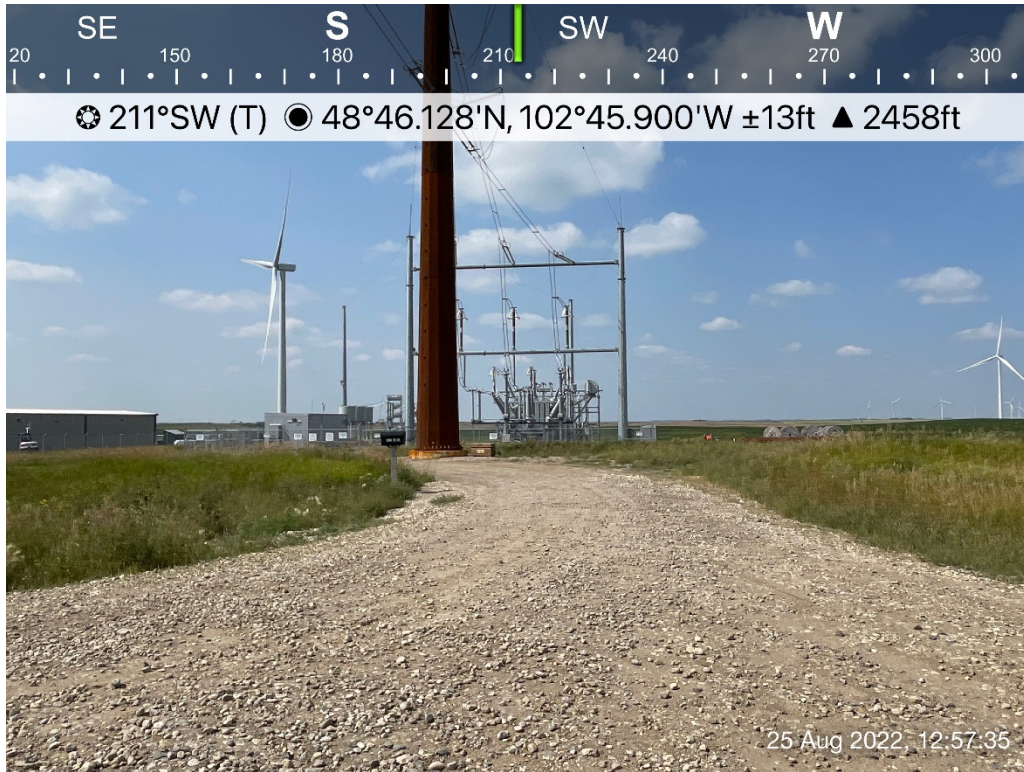
**Report Photo #1:** Reclamation surrounding Substation

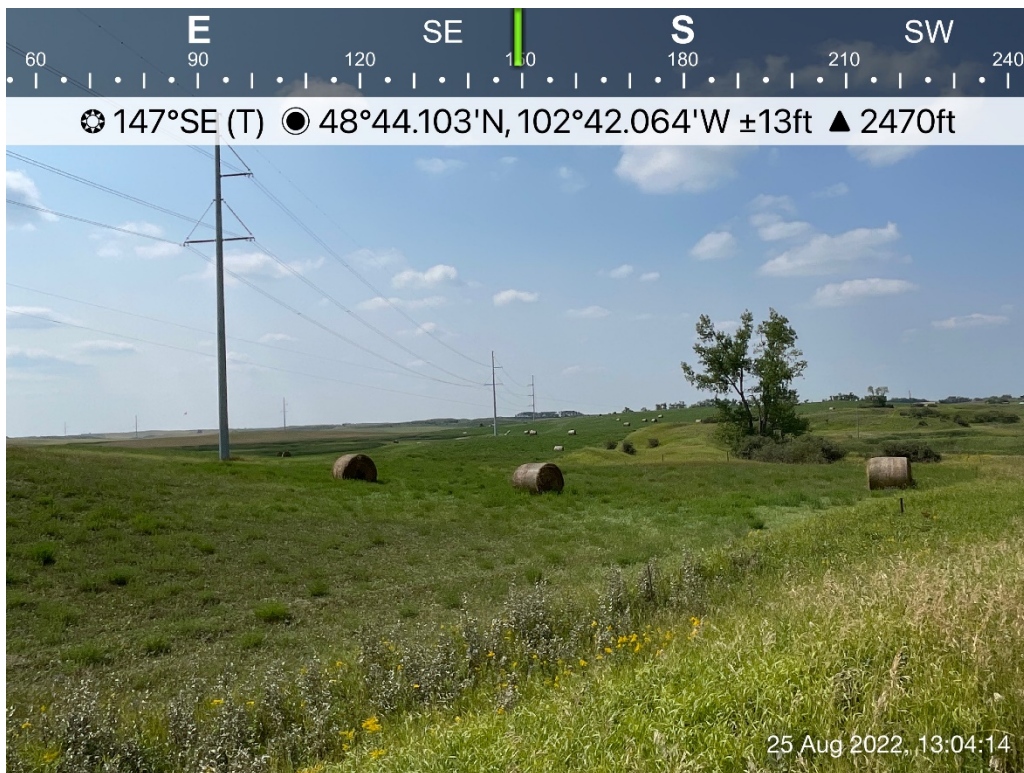
**Report Photo #2:** Transmission Poles in Pastureland

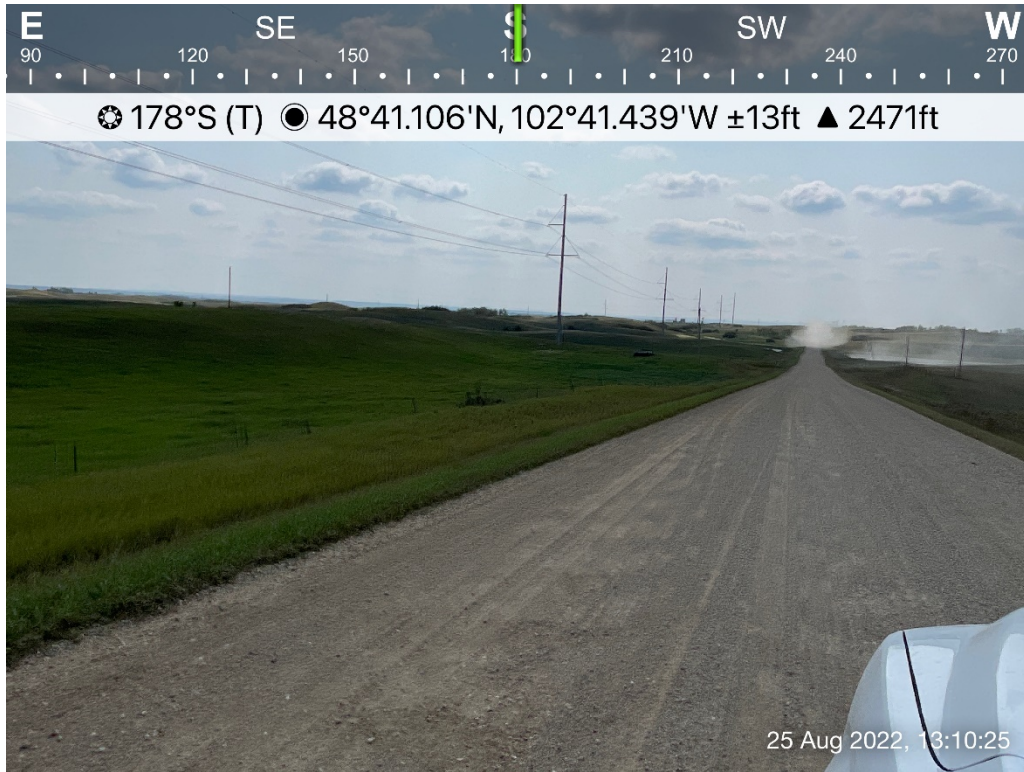
**Report Photo #3:** Transmission Poles along Road in Pastureland

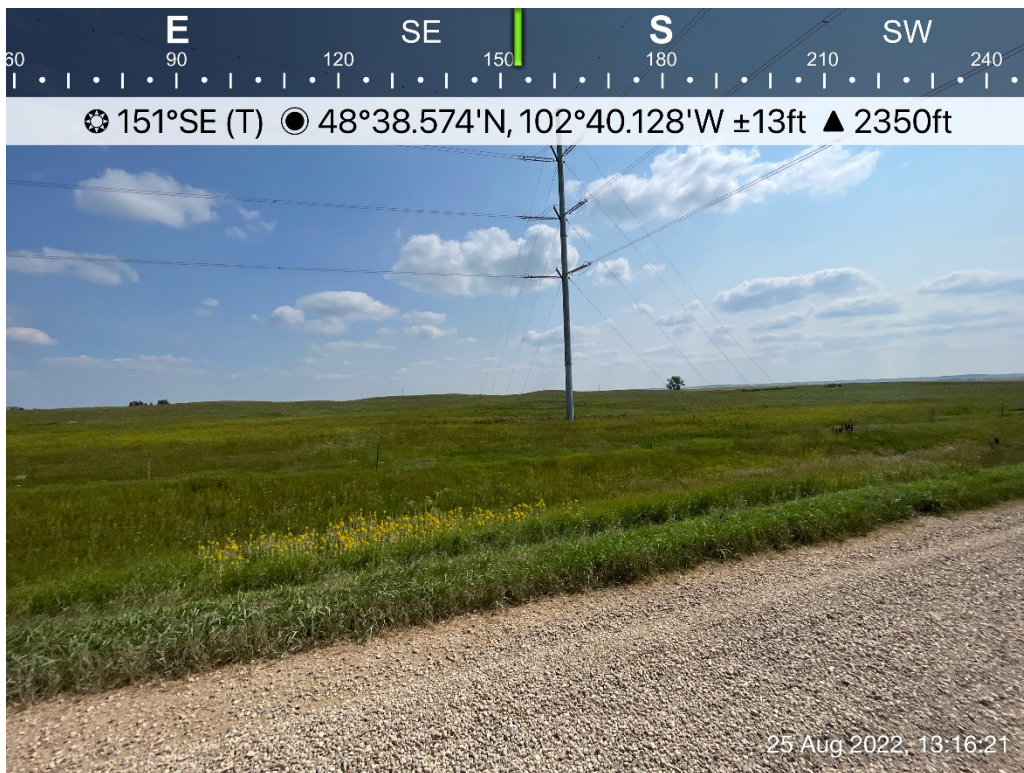
**Report Photo #4:** Guyed Structure in Pastureland
