ONEOK Bakken Pipeline

Pump Station Additions – McKenzie & Dunn Counties

Case No. PU-20-018

As-Built Construction Inspection and Reclamation Report – Big Gulch

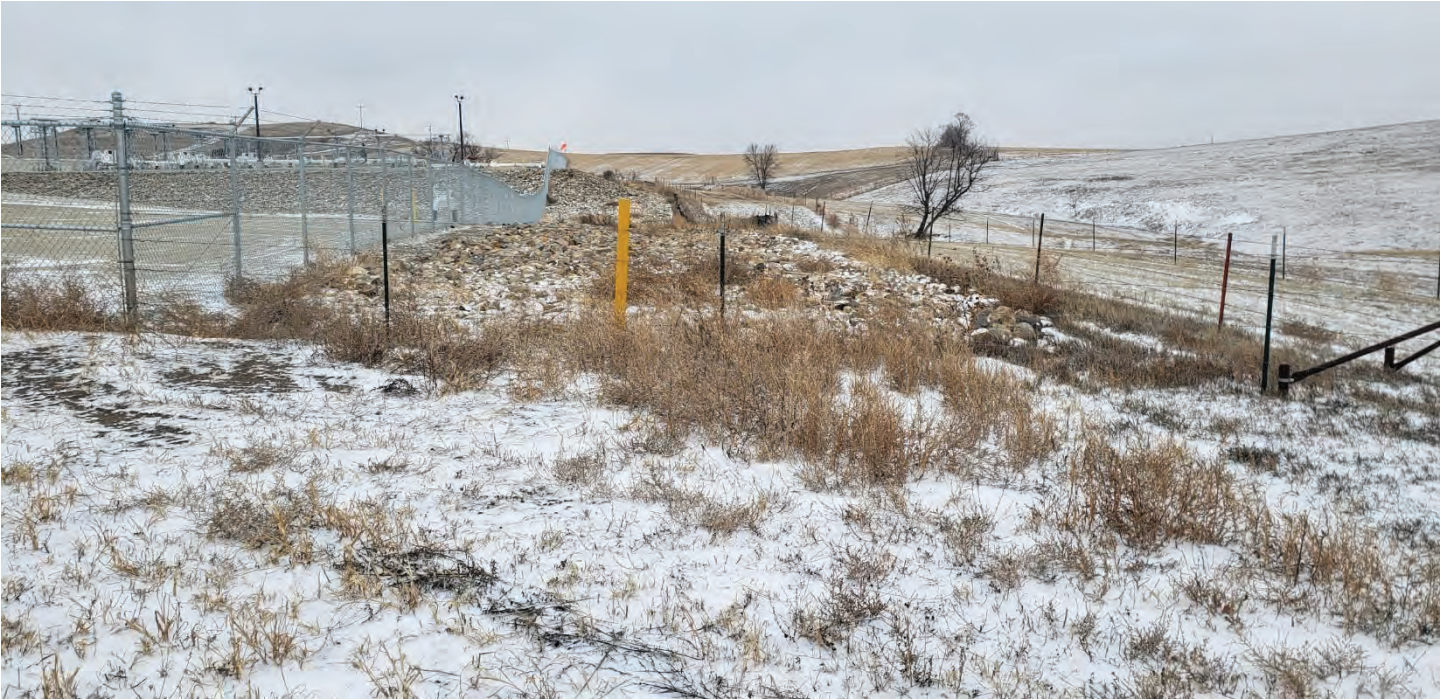
P5 – NW Corner Facing South

Exterior portion of fence area included multiple practices of BMPs including extensive riprap drainage channels, installment of silt fence, and re-establishment of a vegetation buffer protecting the west line of the project where the majority or all of water drains to (See P5-P7, P15-P22). Observed vegetation growth matches surrounding native vegetation.

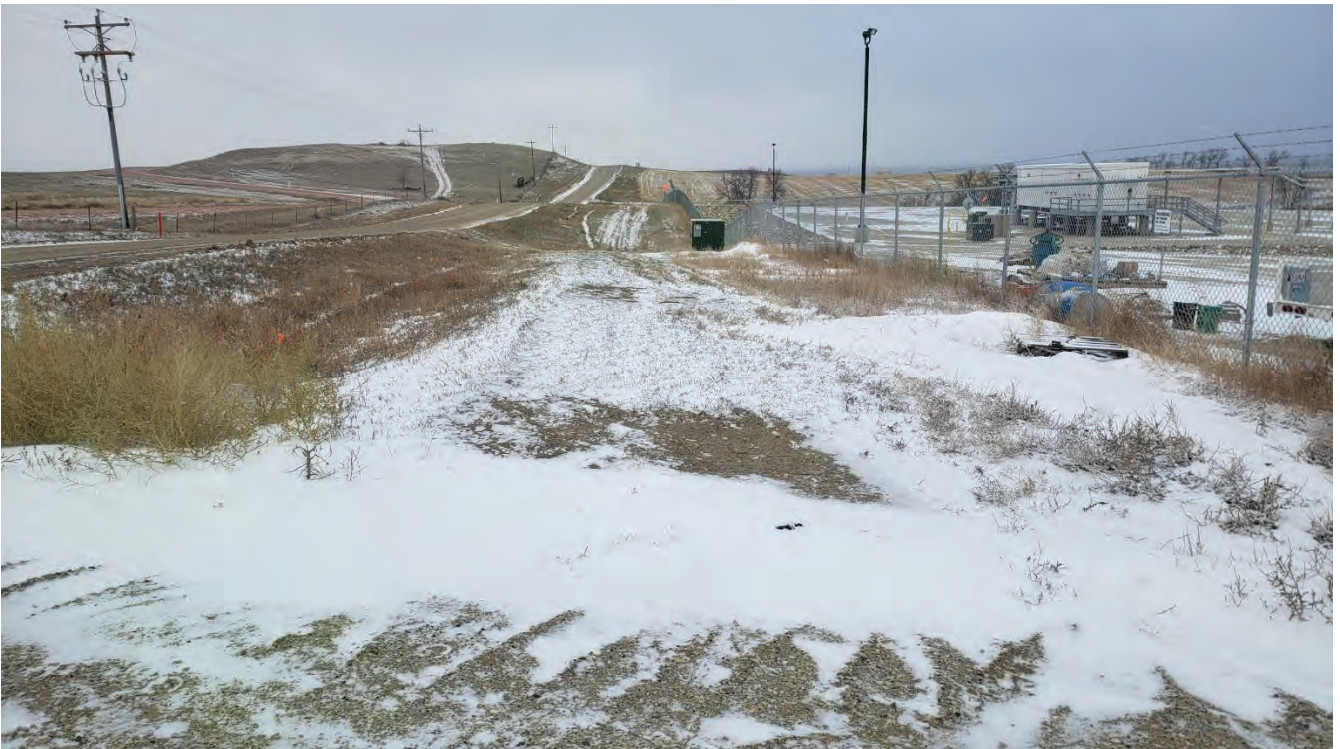
P8 – NE Corner Facing South

- Silt Fence that is located at west boundary where site drains has damaged silt fence allowing potential sediment deposition offsite (See P22, P23).
- An area along east boundary gravel road and Right-of-Way appears to be missing topsoil and re-vegetation practices (see P8, P10, and P11).

- North of Main Entrance in Southeast corner (See P10) and South of Secondary Entrance (See P8) within gravel road Right of Way, it appears that vegetation has not been established. In photo P10, the area appears to of been disturbed to bring power to site. Resurfacing with topsoil seeding and mulching appears to not have been completed in this area. Inspector scratched surface of said area and was able to confirm topsoil did not appear to be present (See P11).

- Fix silt fence to working order.
- Re-establish spread of topsoil seeding and mulching.

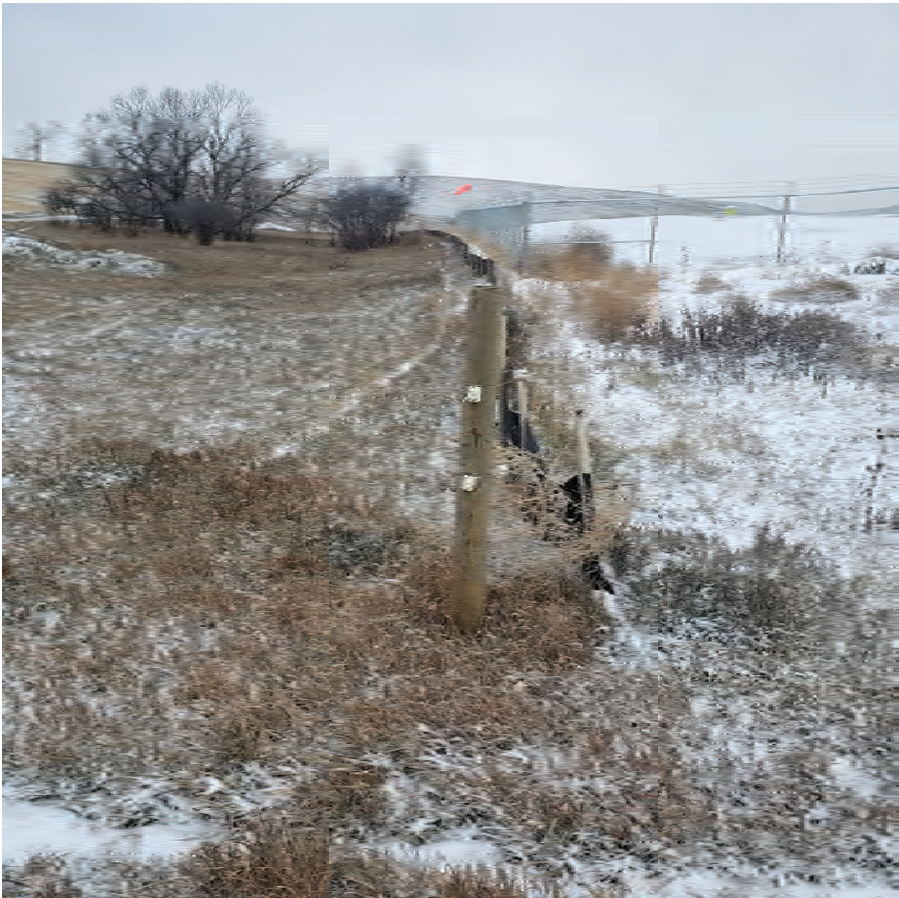
P13 – SE Corner Facing West

- SILT FENCE - Inspector walked along the South and West sides of the site where silt fence was located. Silt Fence located along the South side is up and in good standing (See P13, P15-P17). Silt Fence along the West side of the site was inspected and is in good standing (See P18-P21), but there is one area where support stakes are broken. Area is located at low elevation point of site protecting major drainage way off site (See P6-P7, P22, P23). No noticeable erosion is seen on either side of Silt Fence. Existing agriculture surface appears to have no disturbance.
