Bill Sanderson Gas Processing Plant Project

Reclamation Inspection Report

Docket Number: PU-20-082

Prepared for North Dakota Public Service Commission

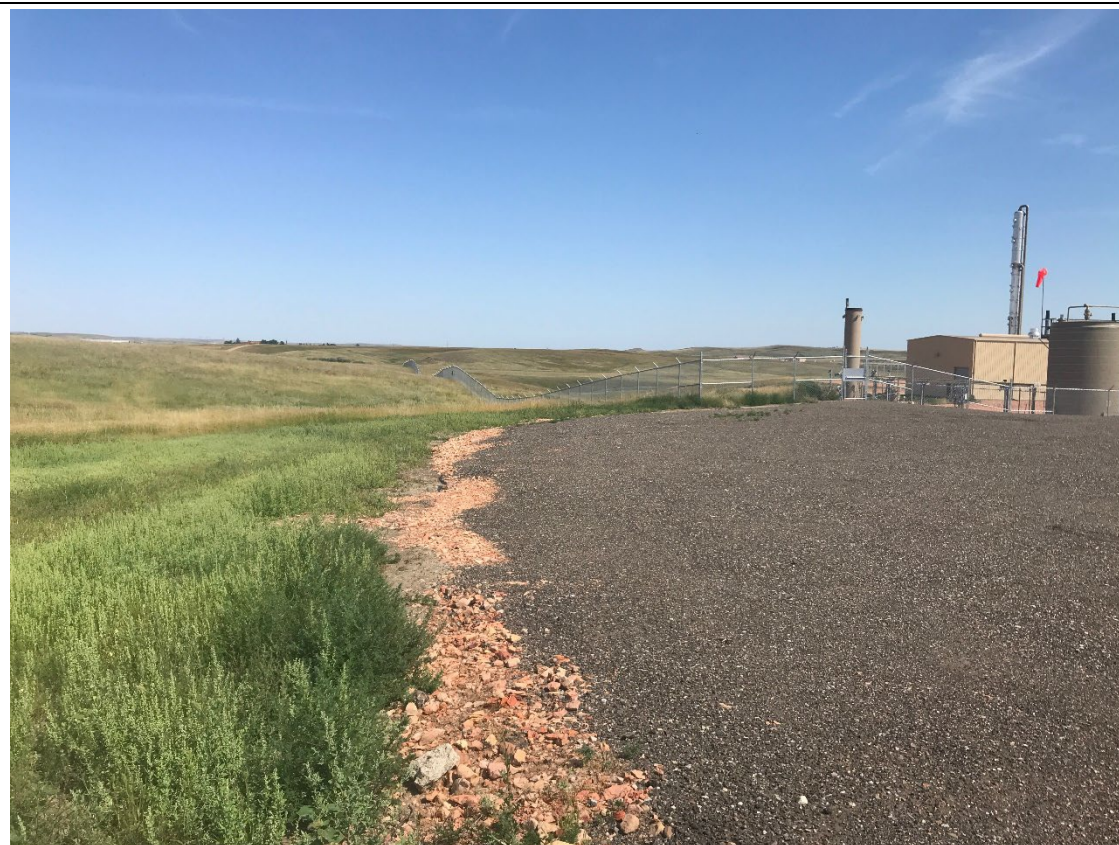
Photo #: 3

The inspection confirmed that the plant and surrounding reclaimed area were free of debris and waste, and fences and gates had been repaired or replaced. A chain link fence and safety and security signs are in place surrounding the plant (Photos 1, 3, 4).

Description: SW corner of plant showing edge of surfaced area and shallow backslope. No erosion issues. Plant cover was dominated by annual weeds, though it planted grasses were at least 30% cover. Note the fence and signage around the plant facility.

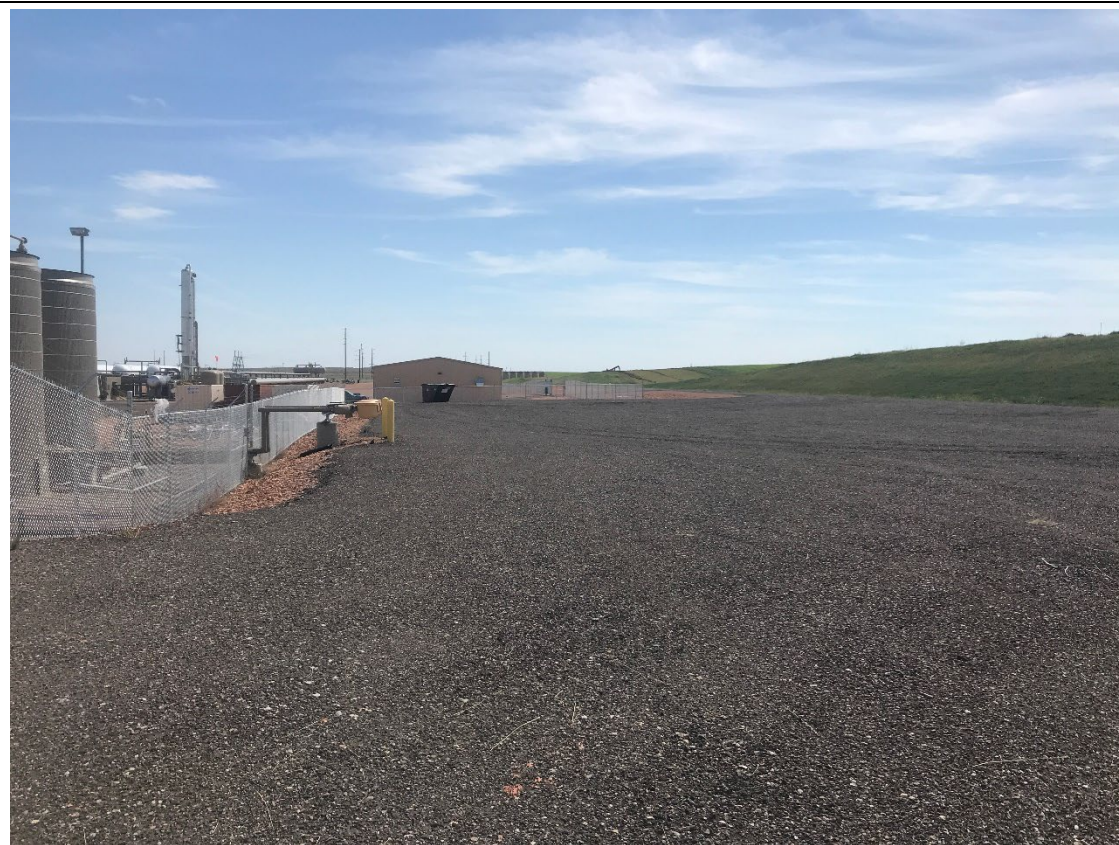
Photo #: 4

Description: Surfaced area to west of plant office in southwest corner of facility. Note truck loading valve outside of fenced area.

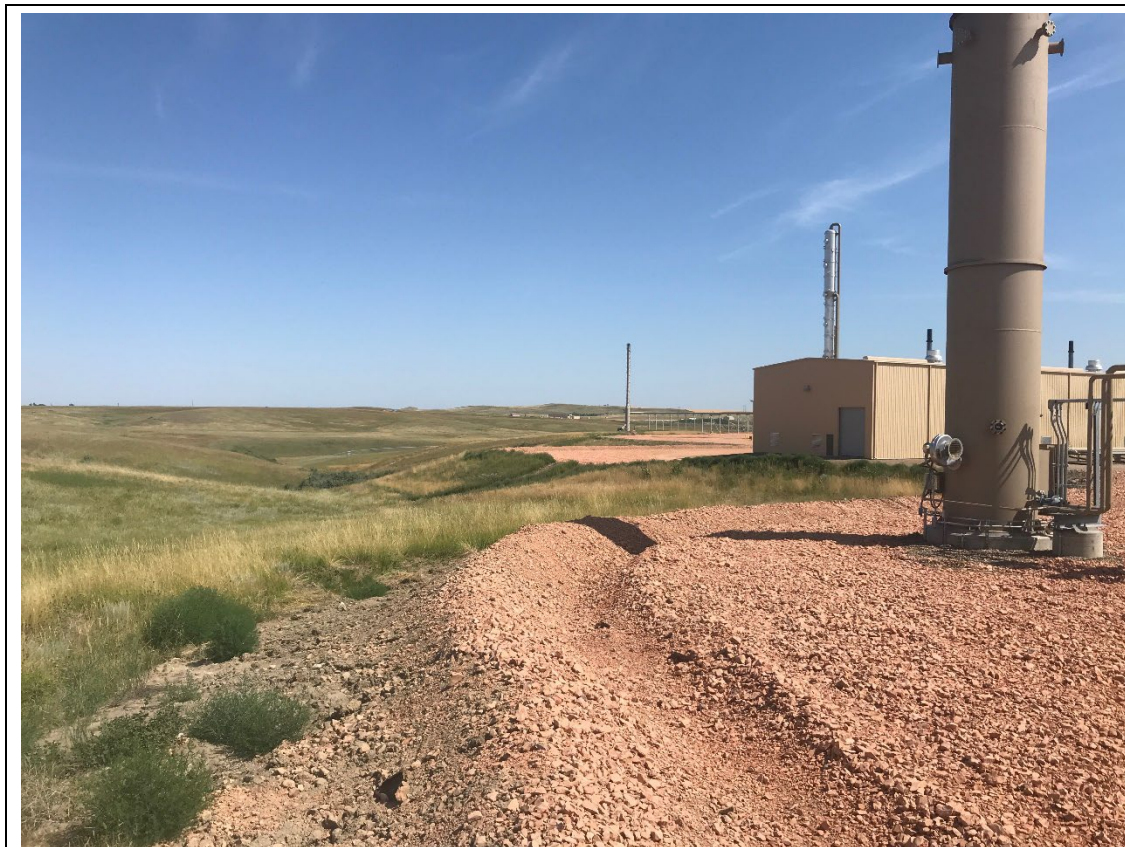
Photo #: 5

Description: West edge of pad. Natural slope was not disturbed during construction. Scoria-surfaced area abuts native undisturbed prairie.

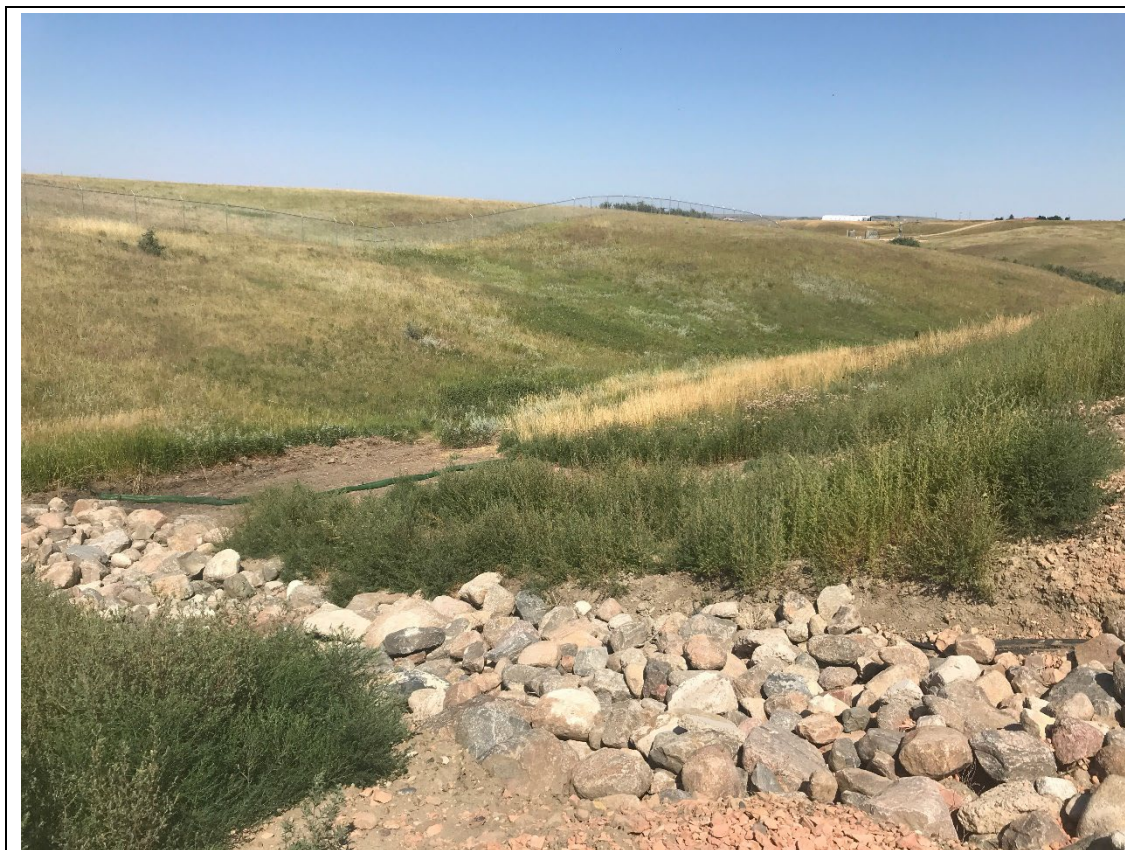
Photo #: 6

Soils had been replaced, respread, and re-seeded. A few areas with bare soil are being monitored and maintained to prevent erosion (Photo 6). There have also been erosion issues in several of the ditches surrounding the plant boundary off the south and east sides; reclamation seedings had not established and the ditch slopes were experiencing erosion. After several attempts at different erosion control methods, in July 2022 Jomax re-seeded these areas and then installed a coconut fiber erosion control blanket, with seeds also within the material (Photos 2, 16, 17). Small areas of annual weeds are present in these areas. With the lack of precipitation in July and August, the seeds of the desired species have not yet sprouted. Once the area receives adequate precipitation, the seeds should germinate and the areas can be monitored for adequate establishment.

Several on-site stormwater features and erosion control areas were documented during the inspection. Past erosion issues prompted the installation of rip rap in several large channels that direct stormwater off-site into a retention pond (Photos 6, 11, 12). These features are functioning very well; stormwater is directed toward the channels and is able to move through the rip-rap without creating cuts in the soil of the steep backslopes. In general, stormwater management on- and off-site has been well-blended with adjacent natural drainage systems and drainage patterns have been maintained.

Description: Stormwater drainage channel off west edge of site which was reinforced with rip-rap to prevent erosion. The channel joins a natural upland drainage bordering the west edge of the site.

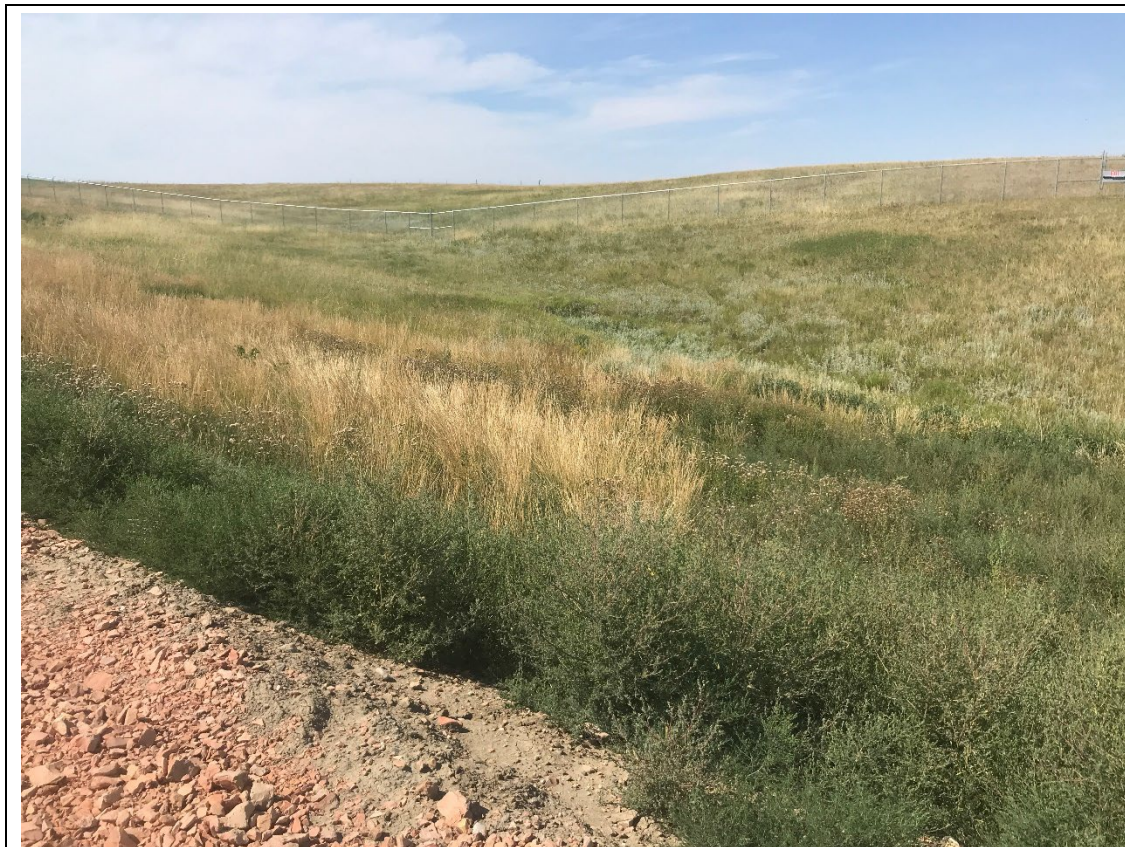
Photo #: 7

Several areas were noted of the noxious weed Canada thistle (*Cirsium arvense*) on reclaimed backslopes (Photos 7, 8). Chemical control is recommended as soon as Fall 2022 for these populations, per OE2's Weed Management Plan. Canada thistle populations were observed in the natural drainages adjacent to the plant which were not disturbed as part of construction. It is likely that these areas were the seed source for the populations now present in the disturbed and reclaimed areas. These populations could also be sprayed; otherwise, they will continue to colonize the reclaimed areas.

Description: Natural upland drainage bordering the west edge of the site, flowing northward. Canada thistle noted in this area.

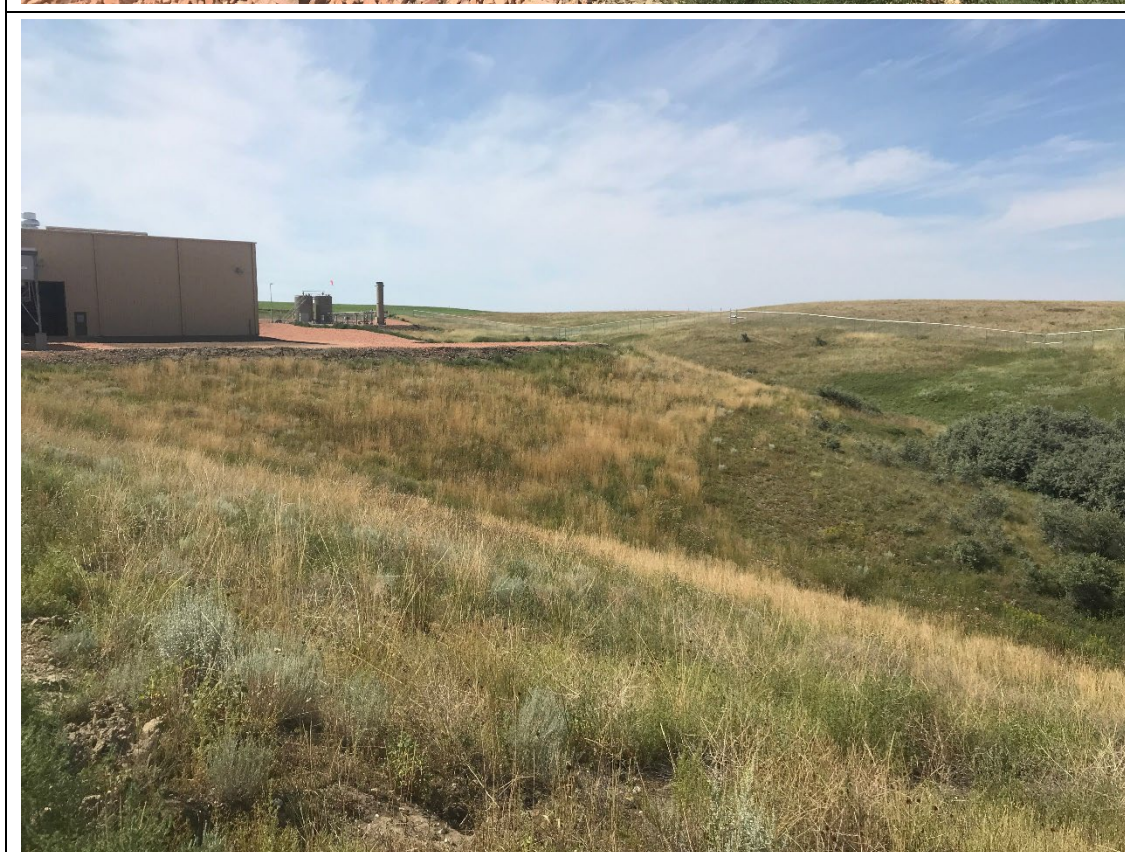
Photo #: 8

Description: View of steep backslope along the west edge of the site. The reclamation was done well, with dominant planted grass cover, though some areas have annual weeds and Canada thistle.

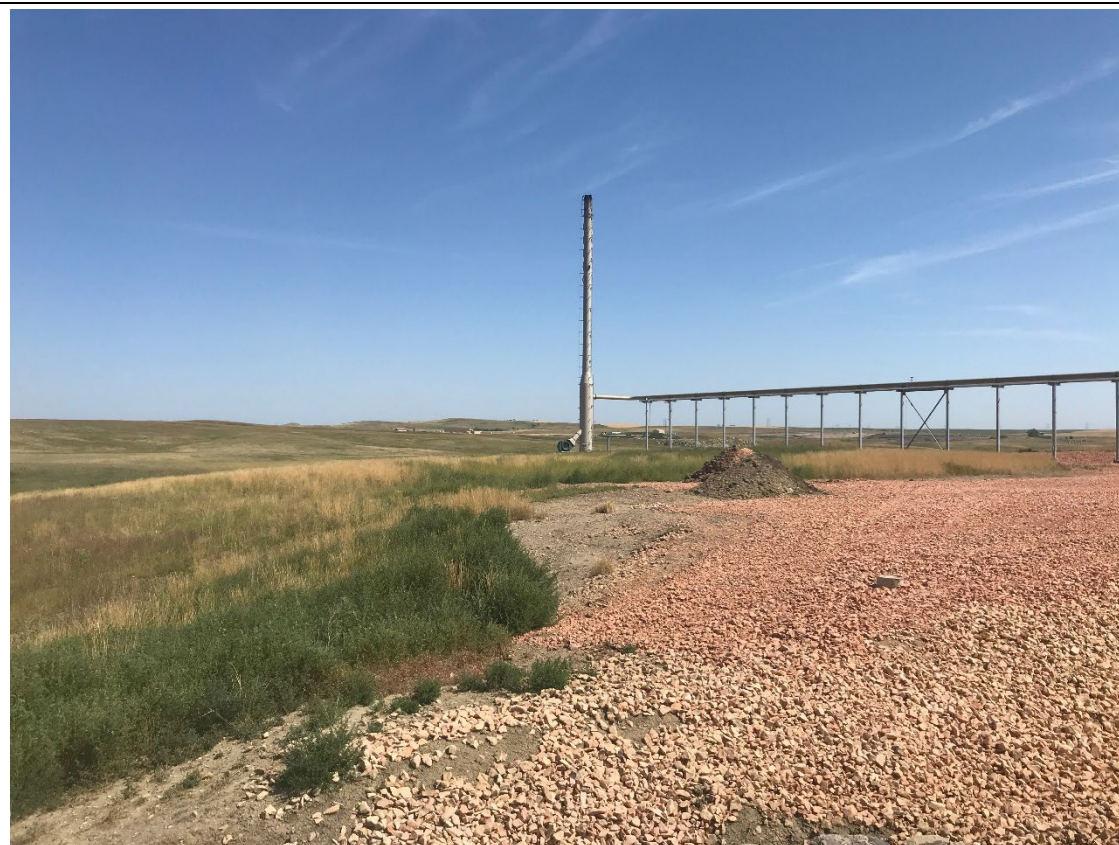
Photo #: 9

Description: Northwest corner of plant site showing reclaimed backslope with adequate grass cover.

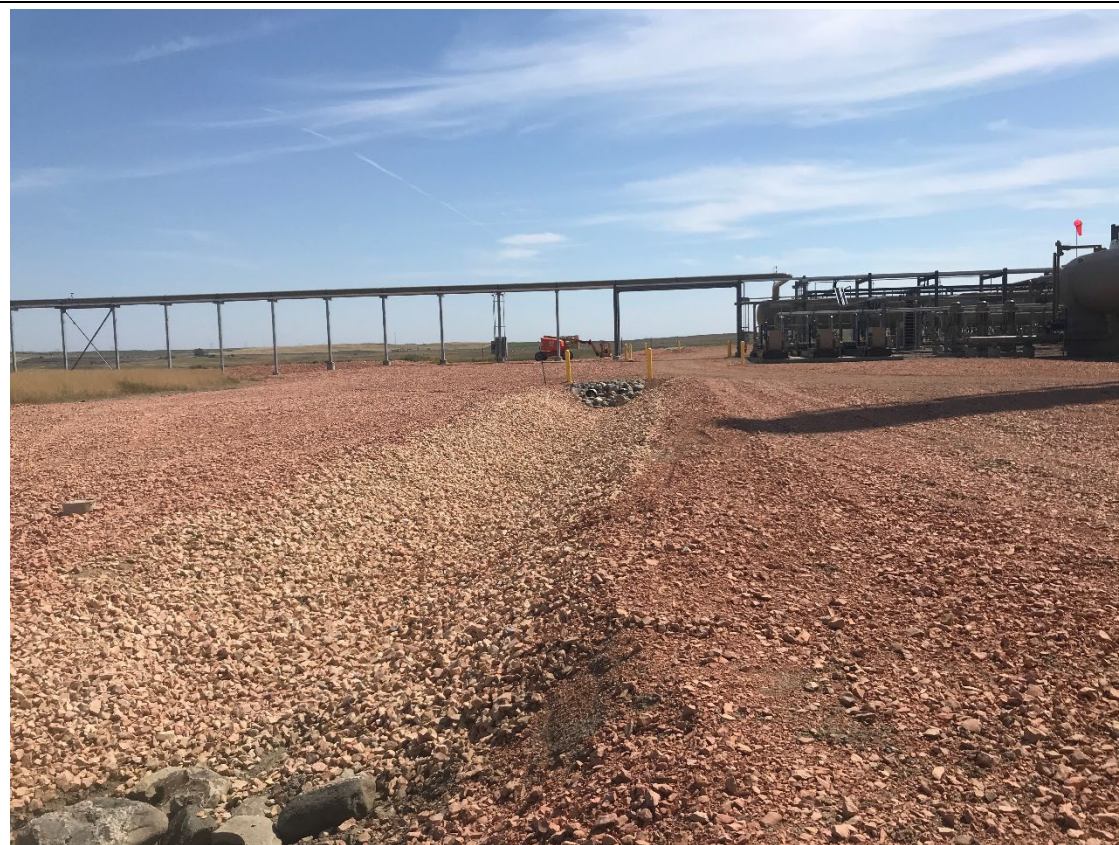
Photo #: 10

Description: Stormwater drainage channel feature on the plant site, which drains west to channel in Photo 11.

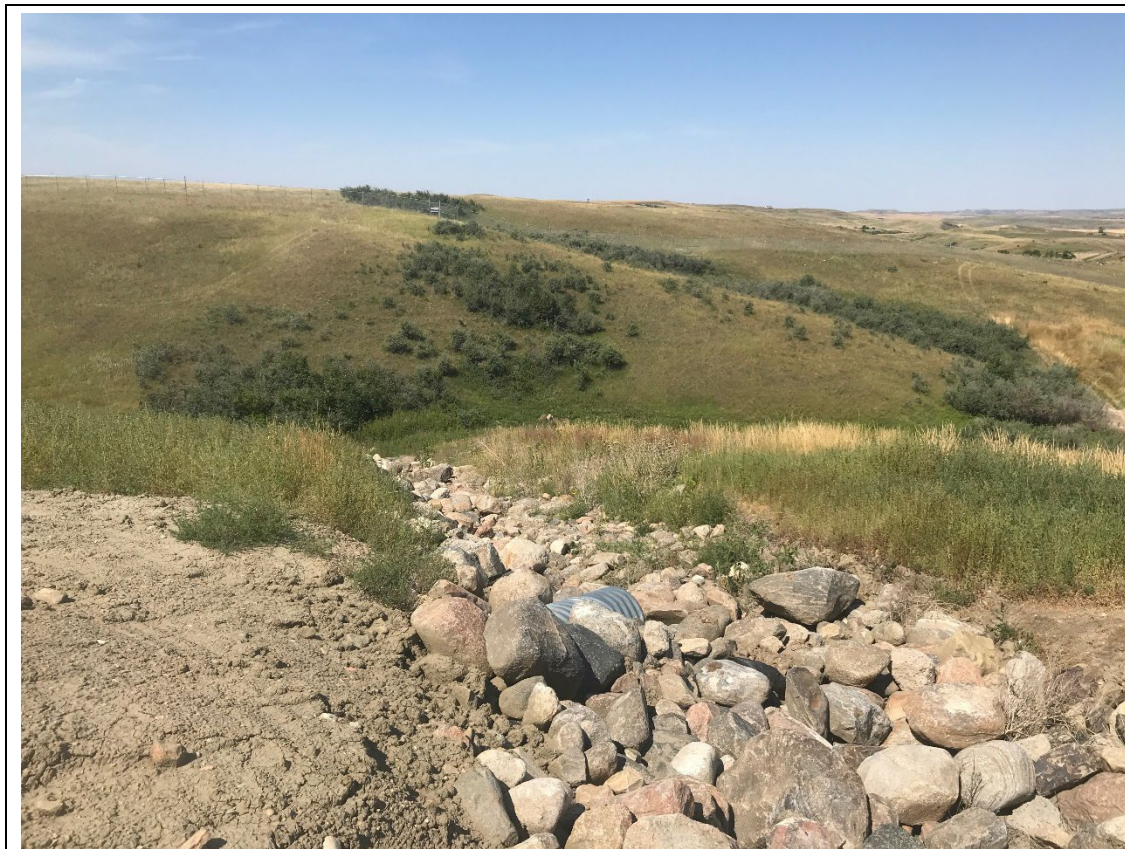
Photo #: 11

Description: Stormwater drainage channel off west edge of site, reinforced with rip-rap to prevent erosion which was a past issue here. The channel joins the natural upland drainage that runs northward, bordering the west edge of the site.

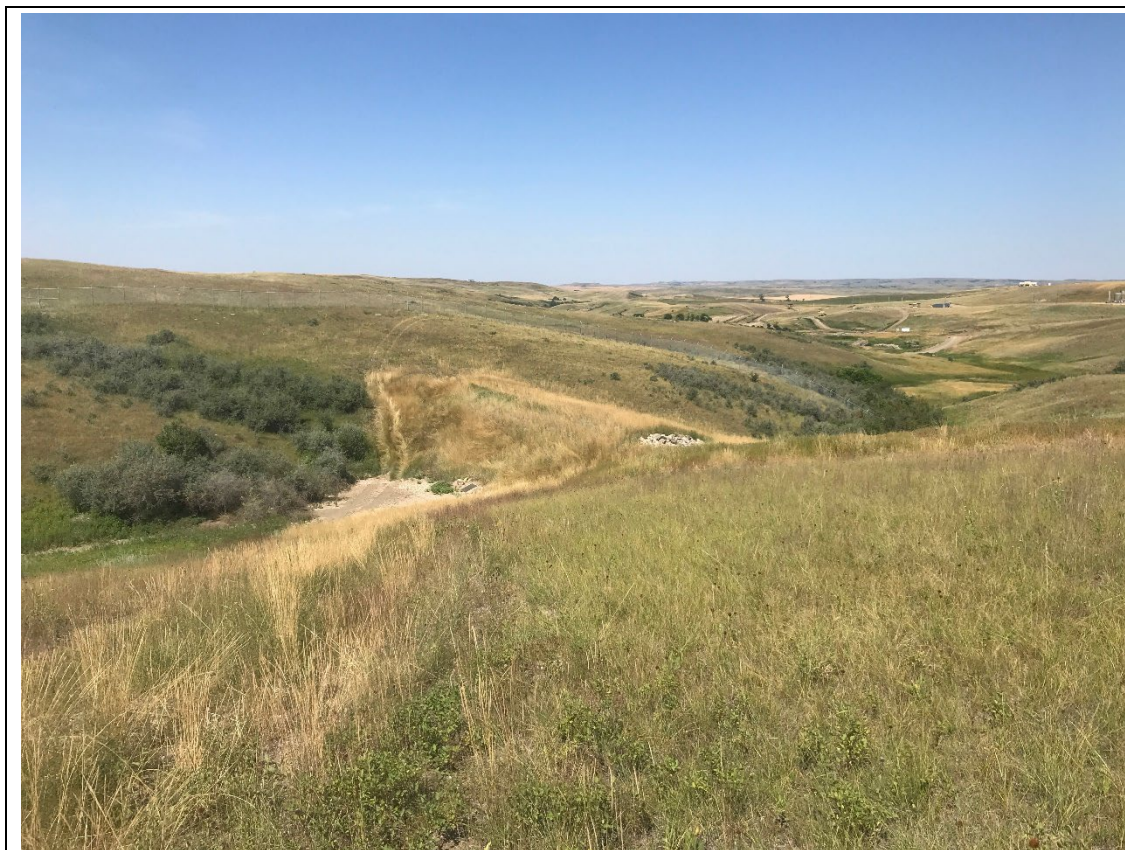
Photo #: 12

Description: Reclaimed backslope off west edge of plant in foreground. Retention berm in background which is part of stormwater and spill containment system for the site.

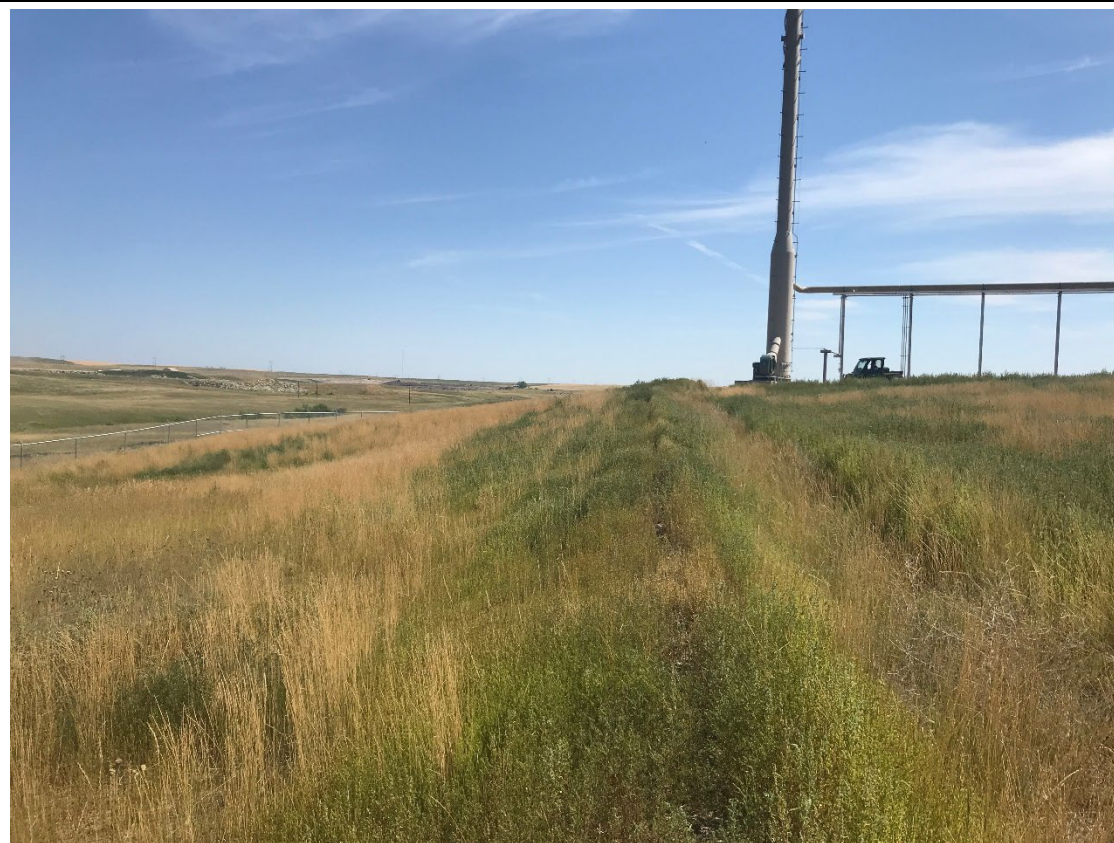
Photo #: 13

Description: Containment berm on north edge. Seeded grasses were dominant in this area and to the north, though areas of annual weeds were evident. A sediment fence was observed outside of fence from previous erosion issues.

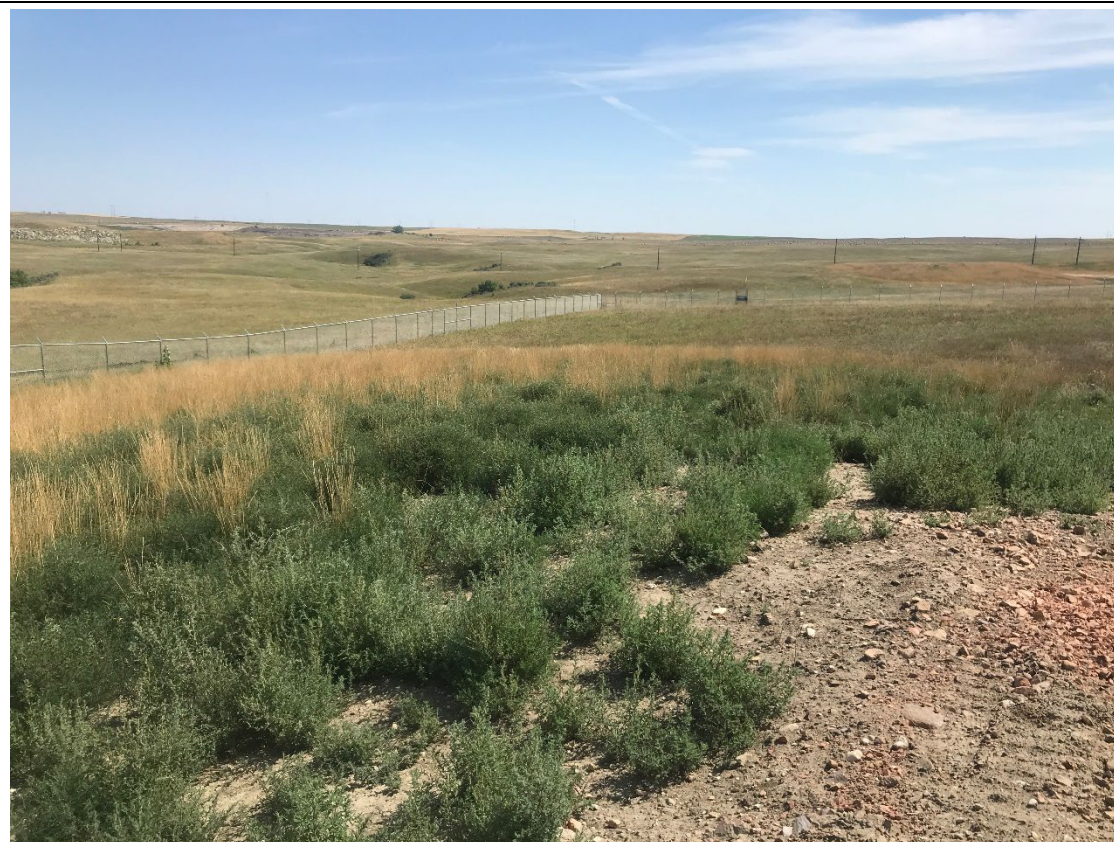
Photo #: 14

Description: Reclaimed area off northeast corner of site. Grass cover of green needlegrass and slender wheatgrass was about 50% with 50% annual weeds (kochia).

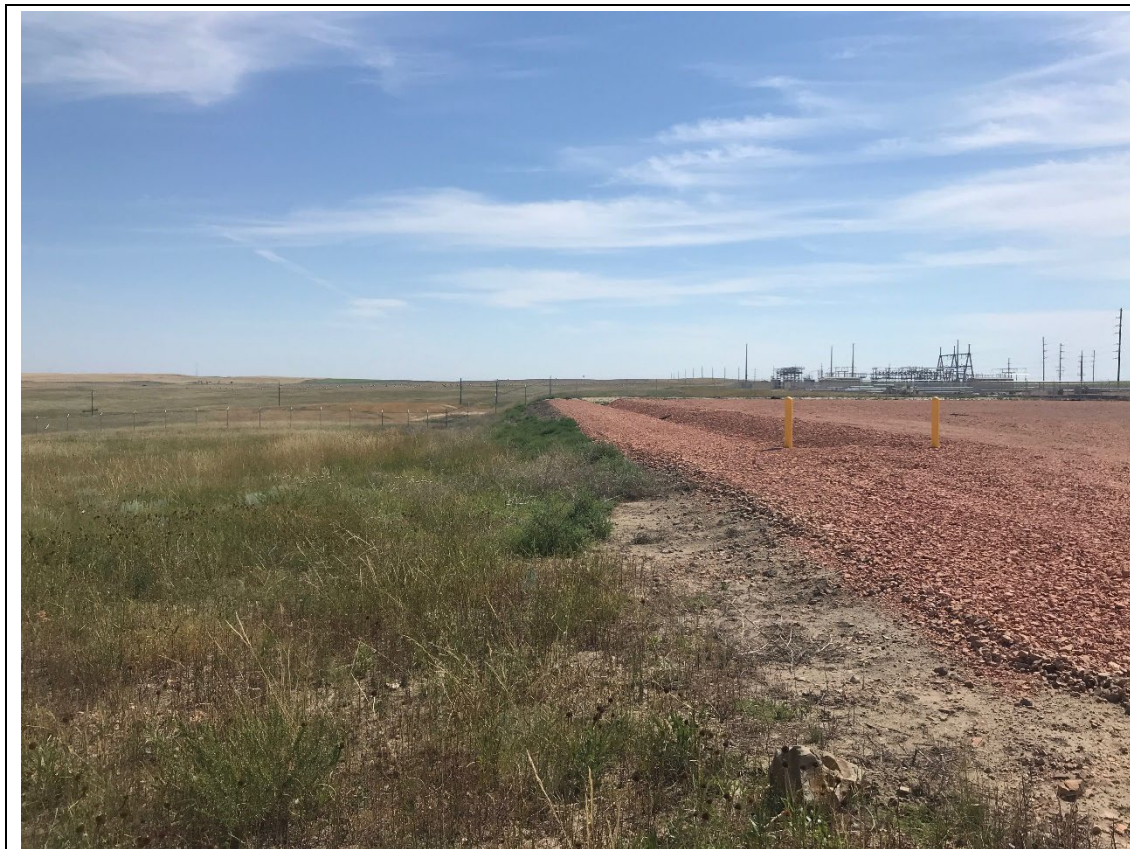
Photo #: 15

Description: Native grass up to edge of site with annual weeds dominant on the slope.

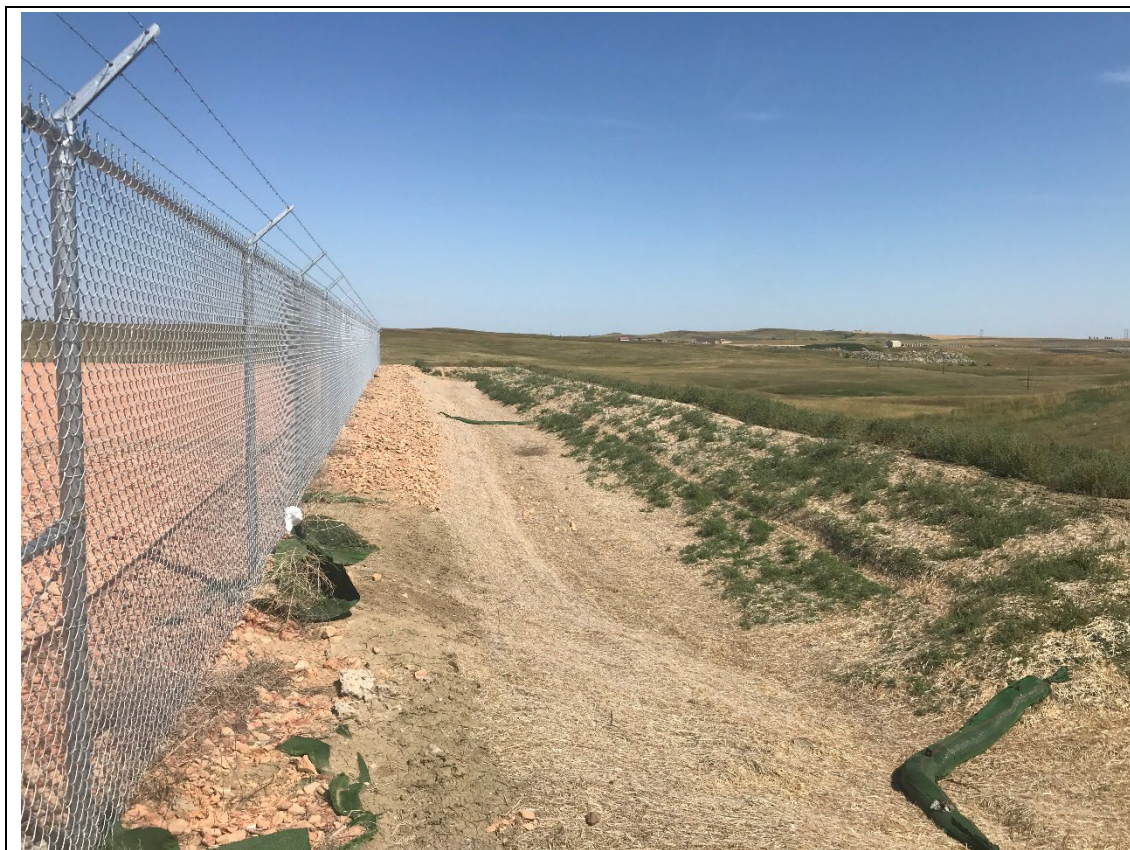
Photo #: 16

There is a large area on the northeast corner of the plant that was disturbed as part of the cut and fill of subsoils for constructing the plant site (Photo 16; Exhibit 2). This area includes a retention pond that had been constructed to hold hydrostatic test water at the end of pipeline construction until the water could be tested and deemed safe to discharge into a natural drainage running north from the plant in this area. The retention pond was approved to remain after construction and is used as part of the stormwater management of the site. The pond did not have standing water at the time of the inspection but it appeared wetland vegetation was present in the basin. The area surrounding the pond was reclaimed and had well-established, dense grass cover. However, the backslopes along the northeast corner of the plant, sloping down to the pond, had dominant annual weed cover, primarily kochia. Further monitoring and management is recommended to promote the establishment of the seeded grasses. Periodic mowing may be necessary to decrease the seed set of the annual weeds.

Description: Channel and berm along east edge of pad. Previous erosion issues were addressed in July 2022 when Jomax seeded and installed same fiber mat as on the south side (as described in Photo 2). Note low area in distant right of photo.

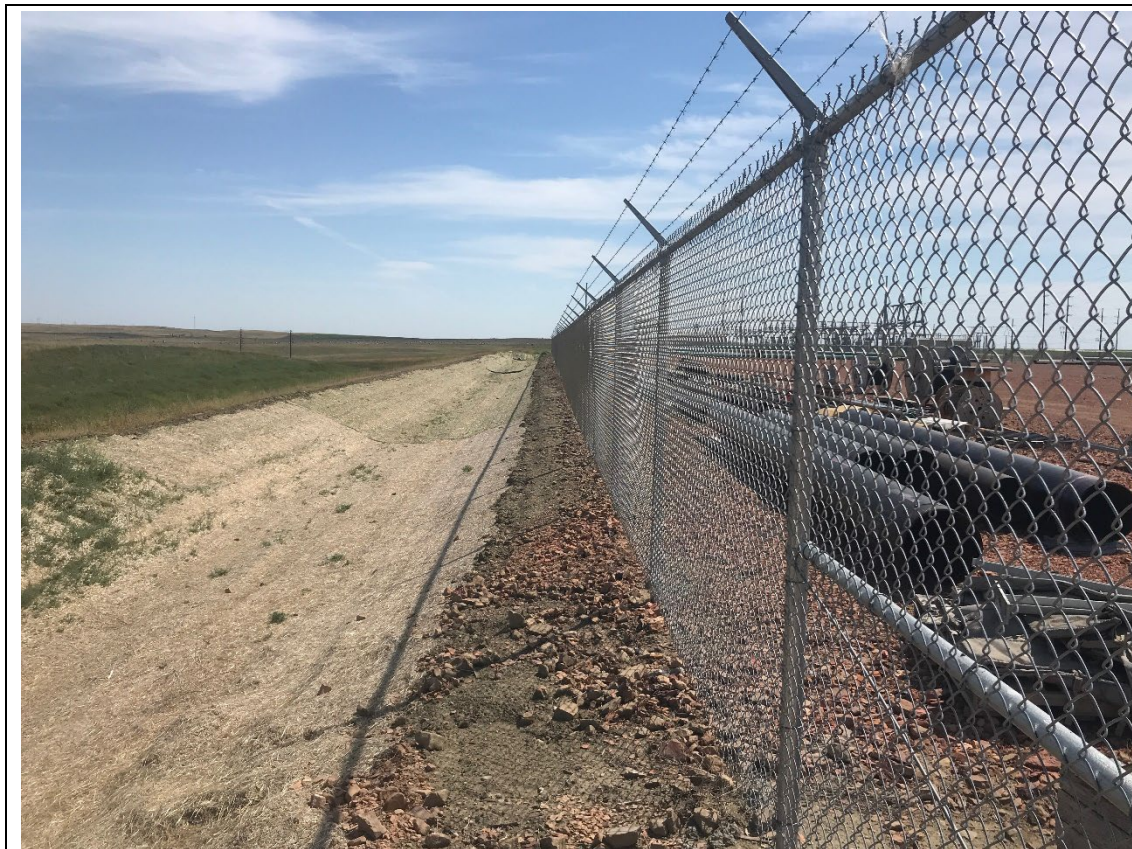
Photo #: 17

Description: Channel and berm along north/east edge of pad. Previous erosion issues were addressed in July 2022 when Jomax seeded and installed same fiber mat as on the south side (as described in Photo 2).
