Bill Sanderson Residue and NGL Pipelines Project

Construction Inspection Report

Docket Number: PU-20-247

Prepared for North Dakota Public Service Commission

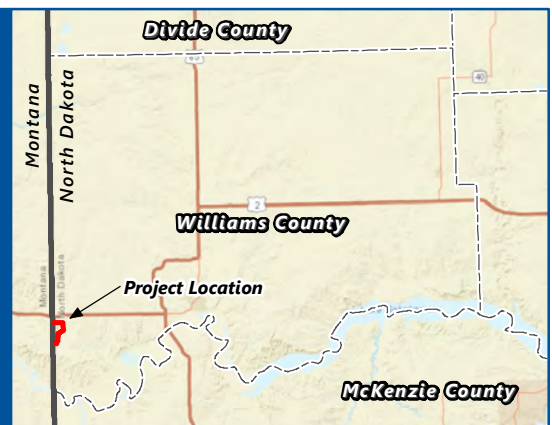
Map 3 of 11
**BILL SANDERSON NGL PIPELINES
 CONSTRUCTION INSPECTION**
PU-20-247
 North Dakota Public Service Commission
 Williams County, North Dakota

Date: 10/7/2020
 Photo Direction: West
 Comment: Depth of cover measured 7 feet.
 Latitude: 48.125982
 Longitude: -104.0151
 Coordinates are in the WGS84 datum.

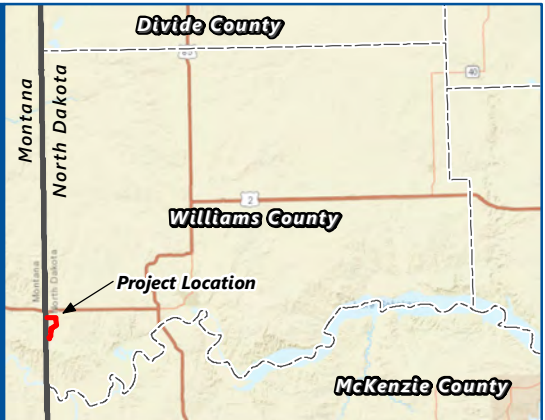
Map 8 of 11
**BILL SANDERSON NGL PIPELINES
 CONSTRUCTION INSPECTION**
PU-20-247
 North Dakota Public Service Commission
 Williams County, North Dakota

Date: 10/7/2020
 Photo Direction: Southwest
 Comment: 6' depth of cover.

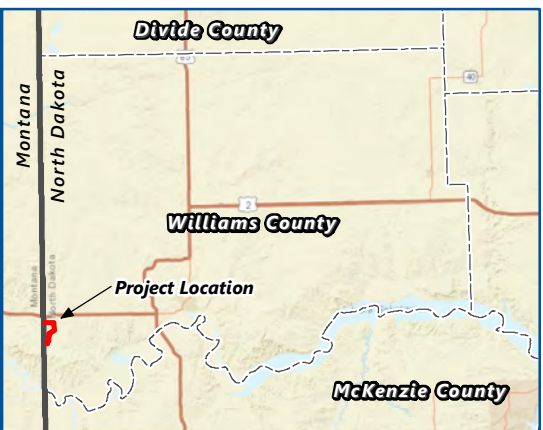
Map 9 of 11
**BILL SANDERSON NGL PIPELINES
 CONSTRUCTION INSPECTION**
PU-20-247
 North Dakota Public Service Commission
 Williams County, North Dakota

Date: 10/7/2020
 Photo Direction: South
 Comment: Typical separation of topsoil and subsoil.

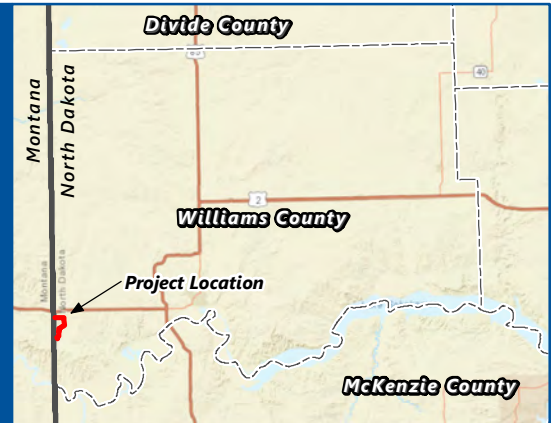
Map 10 of 11

Date: 10/7/2020
Photo Direction: South
Comment: Silt fence installation.

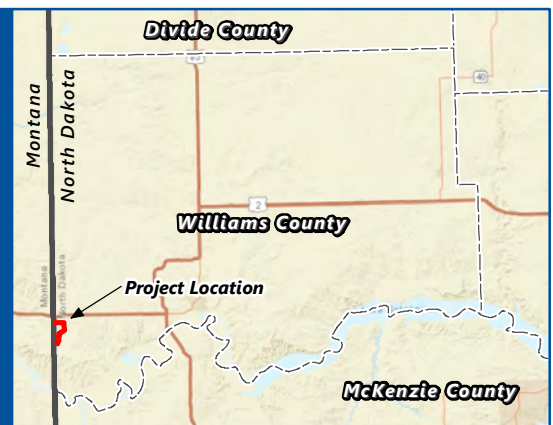
Map 11 of 11

Date: 10/7/2020
 Photo Direction: North
 Comment: 6' depth of cover.
