Bill Sanderson Residue and NGL Pipelines Project

As-Built Inspection Report

Docket Number: PU-20-247

Prepared for North Dakota Public Service Commission

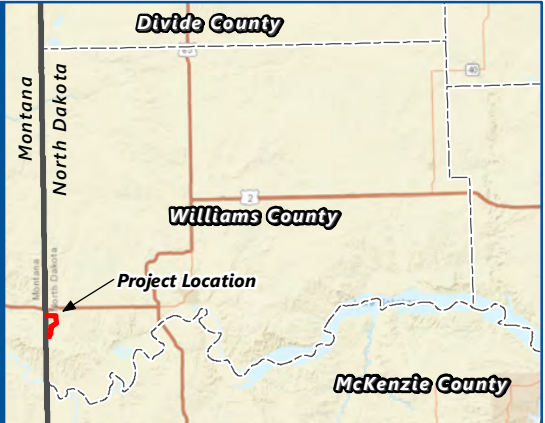
Map 3 of 10

Date: 12/11/2020
 Photo Direction: South
 Comment: Crimped properly, no visible issues, silt fences installed.

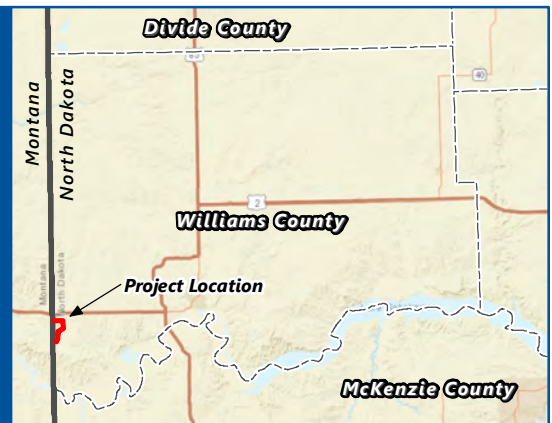
Map 4 of 10
**BILL SANDERSON NGL PIPELINES
 RECLAMATION INSPECTION**
PU-20-247
 North Dakota Public Service Commission
 Williams County, North Dakota

Mr. Unbehaun met with Palmer inspector Andrew Polk at the Jomax yard. Mr. Polk and Mr. Unbehaun then proceeded to the Project construction area. Recent weather conditions interfered with observation of reseeding, but in locations where it was visible, reseeding appeared to be in accordance with Natural Resources Conservation Service guidelines. The straw mulch placement and crimper punching also appeared to be in compliance with NRCS guidelines. Mr. Polk stated that Jomax had encountered issues with strong winds blowing away straw mulch and that the area had to be crimp punched more than once to ensure the straw mulch stayed in place. On one steep slope, matting was applied per NRCS guidelines (See Map 4 in **Appendix A**).

Date: 12/11/2020
 Photo Direction: North
 Comment: Mat in place, no visible issues.
 Latitude: 48.113814
 Longitude: -104.014636
 Coordinates are in the WGS84 datum.

Potential Issues	Recommendations
Erosion of straw-mulch covered areas	Monitor entire length of construction area with regular visual inspections. Repair any areas where straw mulch is damaged or removed by wind until revegetation is complete.
Slippage or damage to mat on steep slope	Regularly inspect mat to ensure integrity of mat and holding devices. Repair any tears, holes, or slippage as necessary.
Additional potential issues	Refer to project Storm Water Pollution Prevention Plan (SWPPP) for additional post-construction recommendations

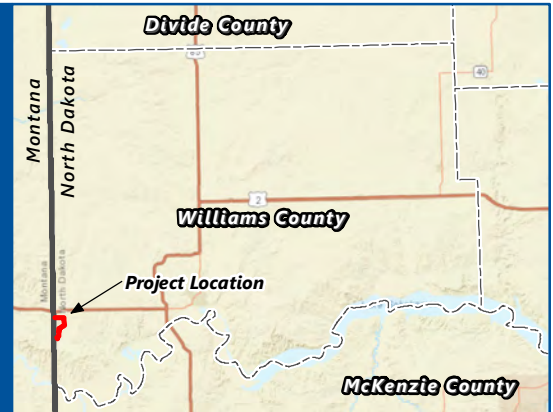
Map 5 of 10

Date: 12/11/2020
Photo Direction: North
Comment: No visible issues.

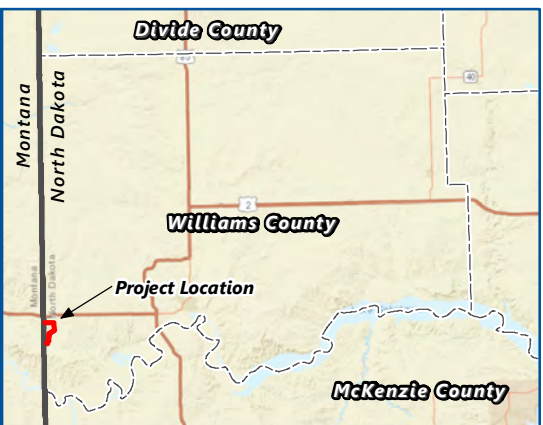
Map 7 of 10

Date: 12/11/2020
 Photo Direction: Southwest
 Comment: No visible issues.

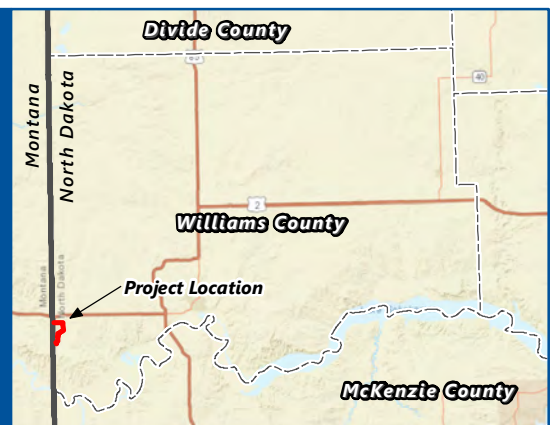
Map 8 of 10
**BILL SANDERSON NGL PIPELINES
 RECLAMATION INSPECTION**
PU-20-247
 North Dakota Public Service Commission
 Williams County, North Dakota

Date: 12/11/2020
 Photo Direction: Northeast
 Comment: No visible issues.
 Latitude: 48.104117
 Longitude: -104.029773
 Coordinates are in the WGS84 datum.

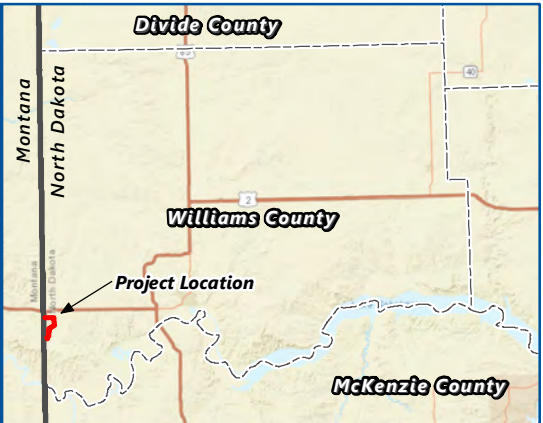
Map 9 of 10

Date: 12/11/2020
 Photo Direction: North
 Comment: No visible issues.
