OE2 North 8" NGL and 20" Residue Gas Pipelines

Reclamation Inspection Report

Docket Number: PU-20-247

Prepared for North Dakota Public Service Commission

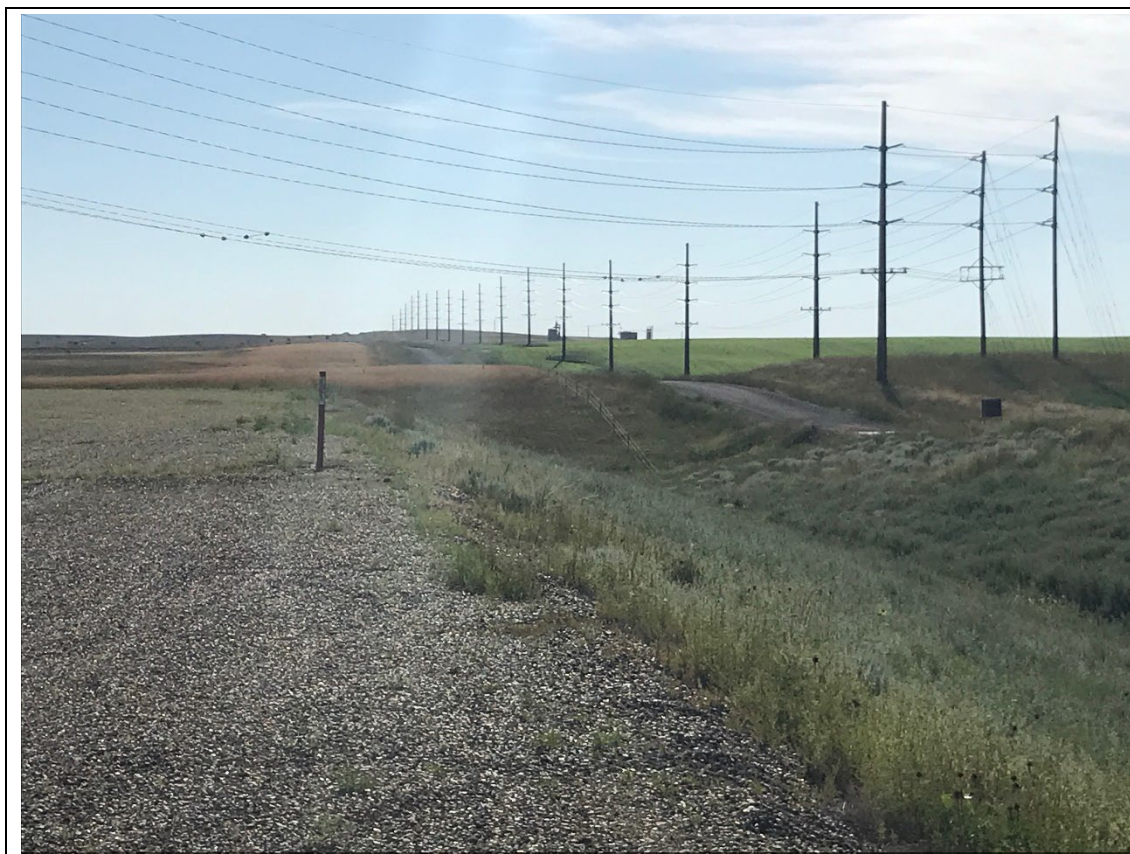
Photo #: 1

The majority of the reclaimed pipeline routes went through adjacent native grassland/rangeland and had dense stands of seeded grasses, with 75% cover or more, minimal annual weeds, and minimal bare ground (Photos 1, 3, 8, 9). These areas appeared to have overall good plant establishment with adequate cover to stabilize soils. It appeared these areas had been re-seeded with a grass cultivar seed mix. Intermediate wheatgrass and slender wheatgrass were dominant on the co-located segment of the pipeline routes. The remainder of the reclamation of the residue pipeline through native rangeland was dominated by western wheatgrass, slender wheatgrass, and green needlegrass. Reclamation seeding appeared to be in accordance with NRCS guidelines.

The steep drainage and stream features avoided by HDD bores were in good condition (Photos 1, 2, 4, 10, 13). The workspace areas on either side of the bore were reclaimed well. Disturbance to erosive slopes and areas of minimal topsoil, as well as aquatic resources, was avoided through the use of this technique.

Description: West end of shared route for both the 8-in NGL and 20-in Residue lines. (Red marker in foreground is another line.) The pipelines were bored across a drainage past the edge of the gravel-surfaced area.

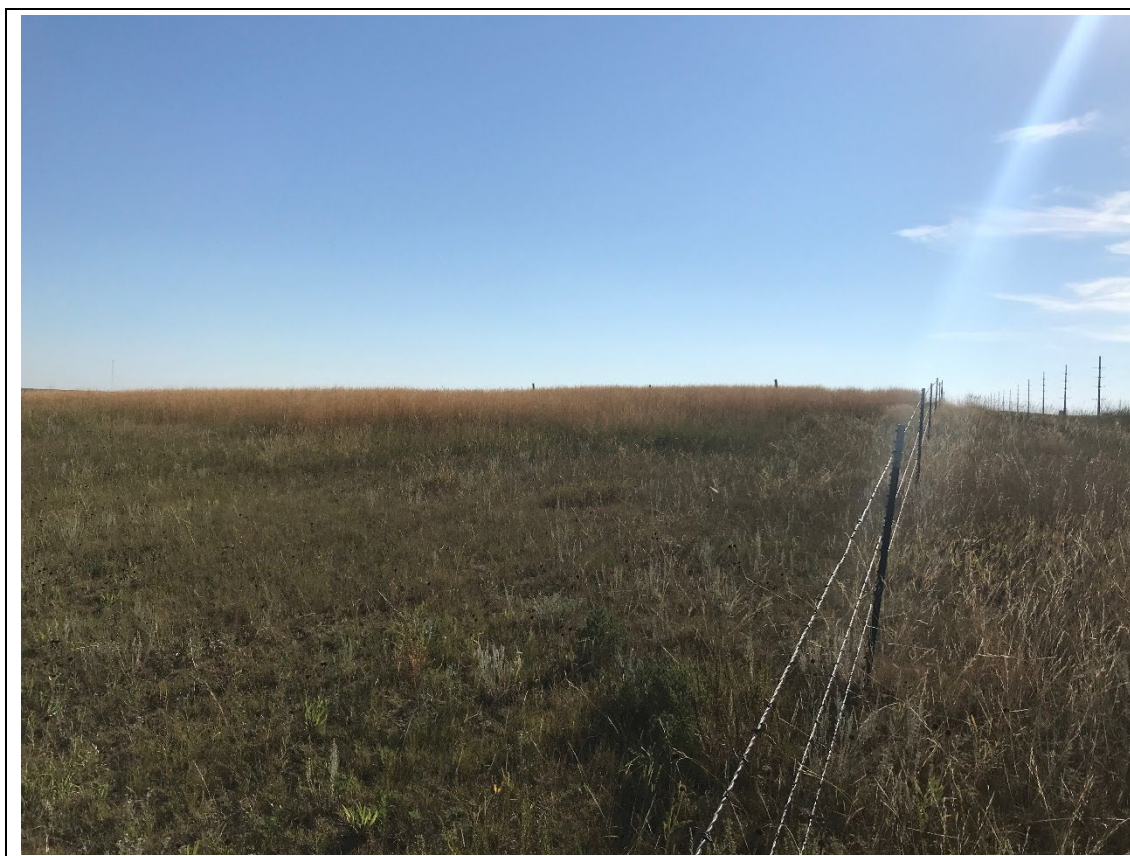
Photo #: 2

Description: Markers on horizon for the two pipelines at the bore exit area. Dense stand of reclaimed grasses.

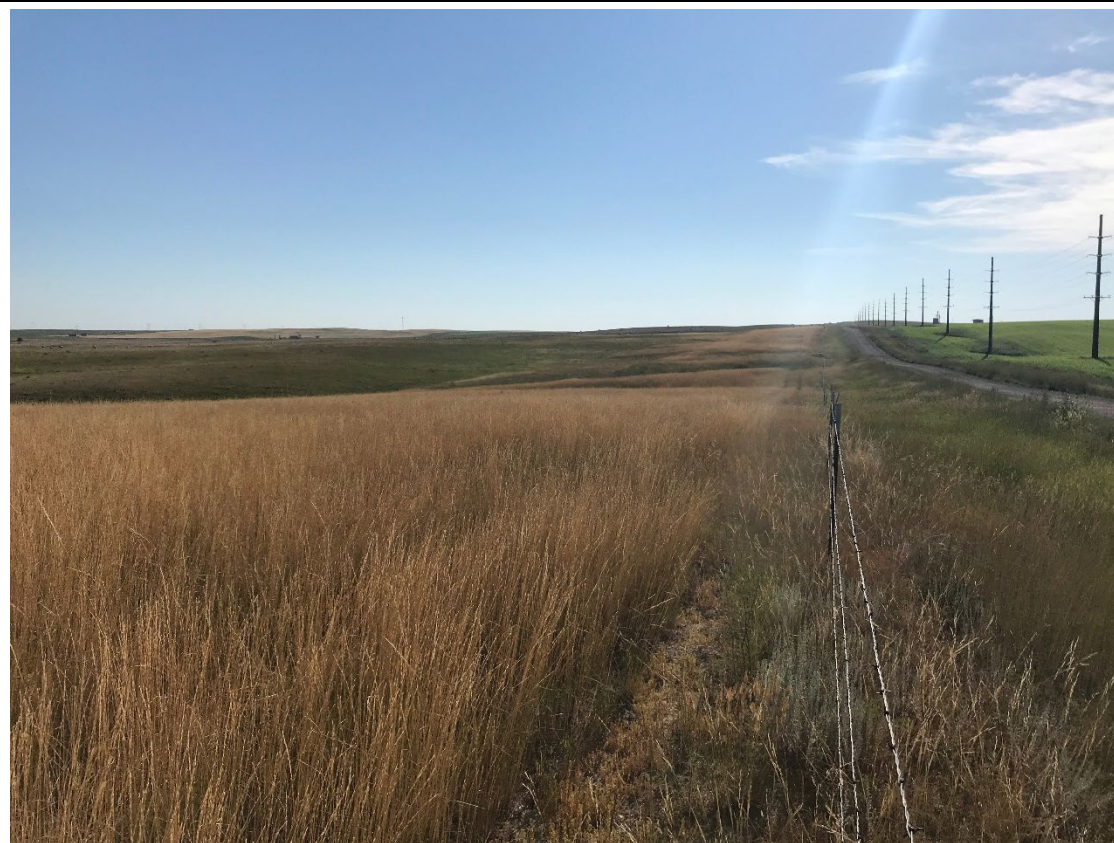
Photo #: 3

Description: Shared route continues east, showing dense stand of reclaimed grasses, with over 80% cover of intermediate and slender wheatgrass. Temporary fence installed along north edge of reclaim; to be removed for fall grazing.

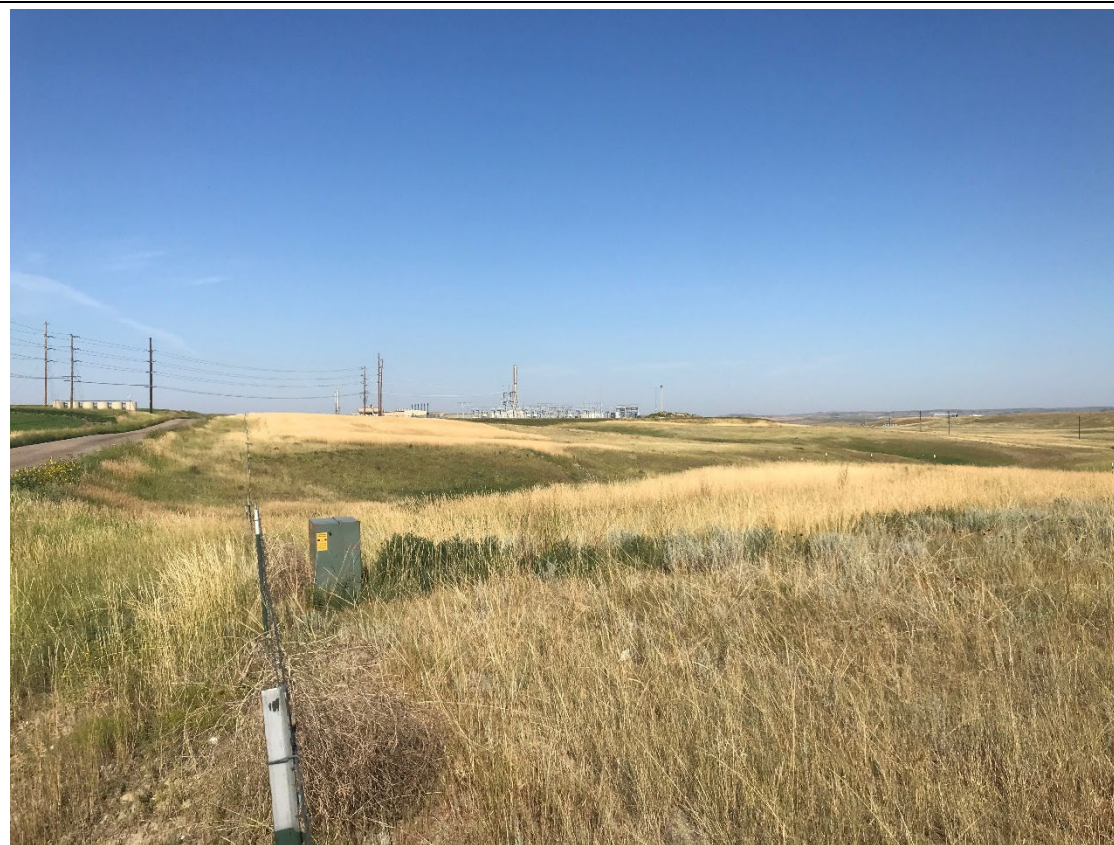
Photo #: 4

Description: View back toward the gas plant along shared route of 8-in NGL and 10-in Residue pipelines, on the east side of another drainage crossed using HDD.

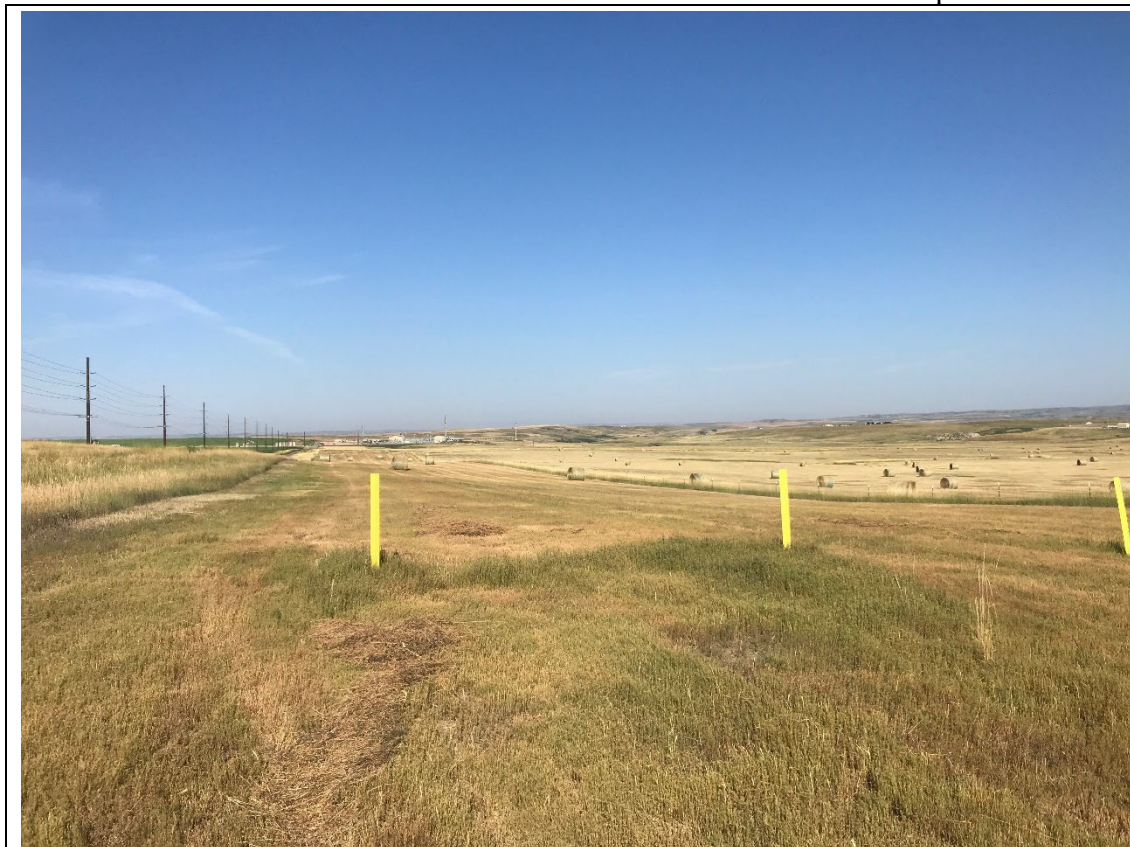
Photo #: 5

Reclamation success through hayland and cropland was not as successful as through the native rangeland. Generally, cover of hay or crop (safflower) was roughly 50%, with the remainder of the cover in annual weeds such as kochia or Russian thistle (Photos 5, 14, 15, 16). In contrast, annual weeds were not a problem in soybean cropland (Photos 17, 18). The cause of the high cover of annual weeds is unclear. Dominant annual weed cover is expected within the first few years of reclamation. Over time, annual weeds should decrease. The practices of the

landowner may also be a factor, and the landowner should be consulted to discuss how he wants this issue addressed. Spraying or mowing in the early parts of the growing season could help to reduce the seed set of the annual weeds. No noxious weed populations were noted during the inspection.

Description: Shared route through hayland. This portion of the route had approximately 50% cover of the planted grasses and about 50% cover of annual weeds (kochia, Russian thistle).

Potential Issues	Recommendations
Areas with dense, extensive cover of annual weeds, primarily through hayland and cropland.	Monitor and manage these areas to promote the establishment of hay and crops. Consult with landowner to determine course of action. Spraying or periodic mowing in the early growing season may be necessary to decrease the seed set of the annual weeds.
Additional potential issues	Refer to project Storm Water Pollution Prevention Plan (SWPPP) for additional post-construction recommendations.

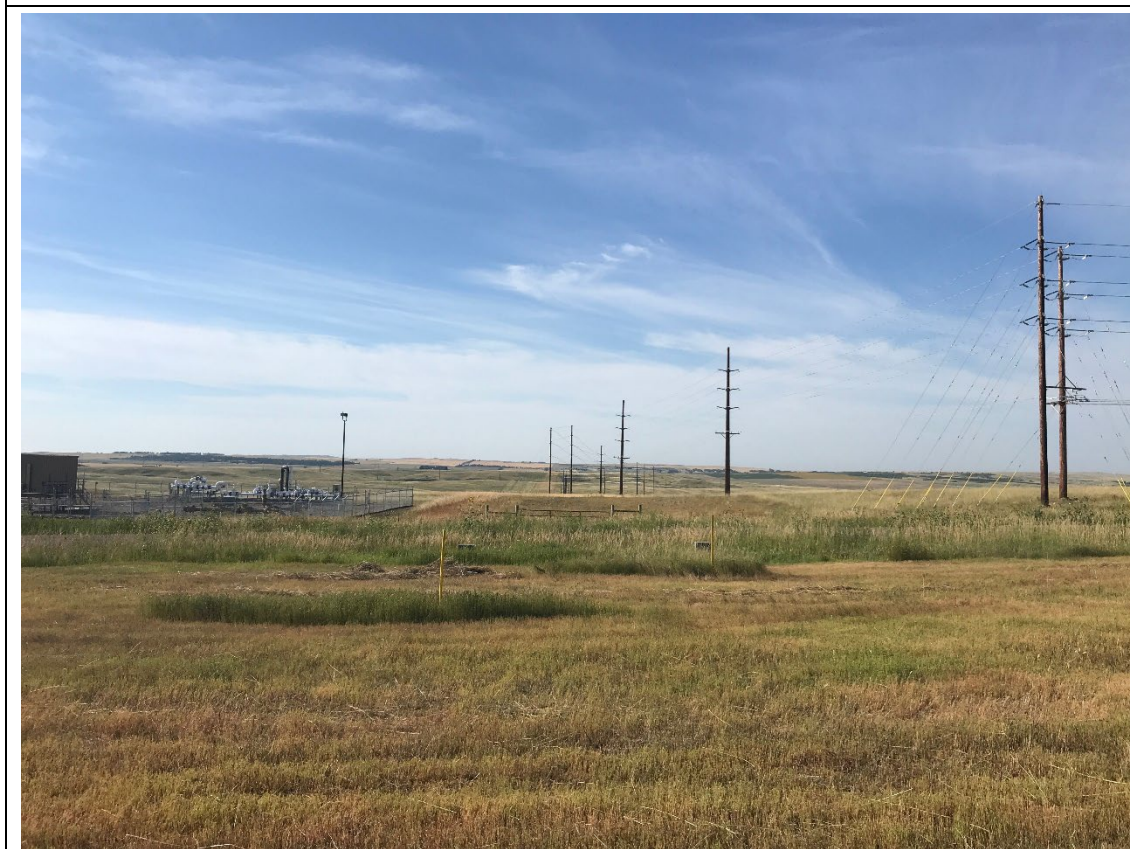
Photo #: 6

Interconnections to pipeline end points appeared to be in good condition. Fences around aboveground valves and fences and gates throughout the project route were repaired or replaced. The inspection confirmed that the project route was free of debris and waste (Photos 6, 7, 19). The reclamation of the project appears to meet all siting laws, rules, and Commission Orders.

Description: Point where routes turn south. Both were bored under road. The 8-in NGL pipeline ends here, where it ties into the Oneok station visible on the left.

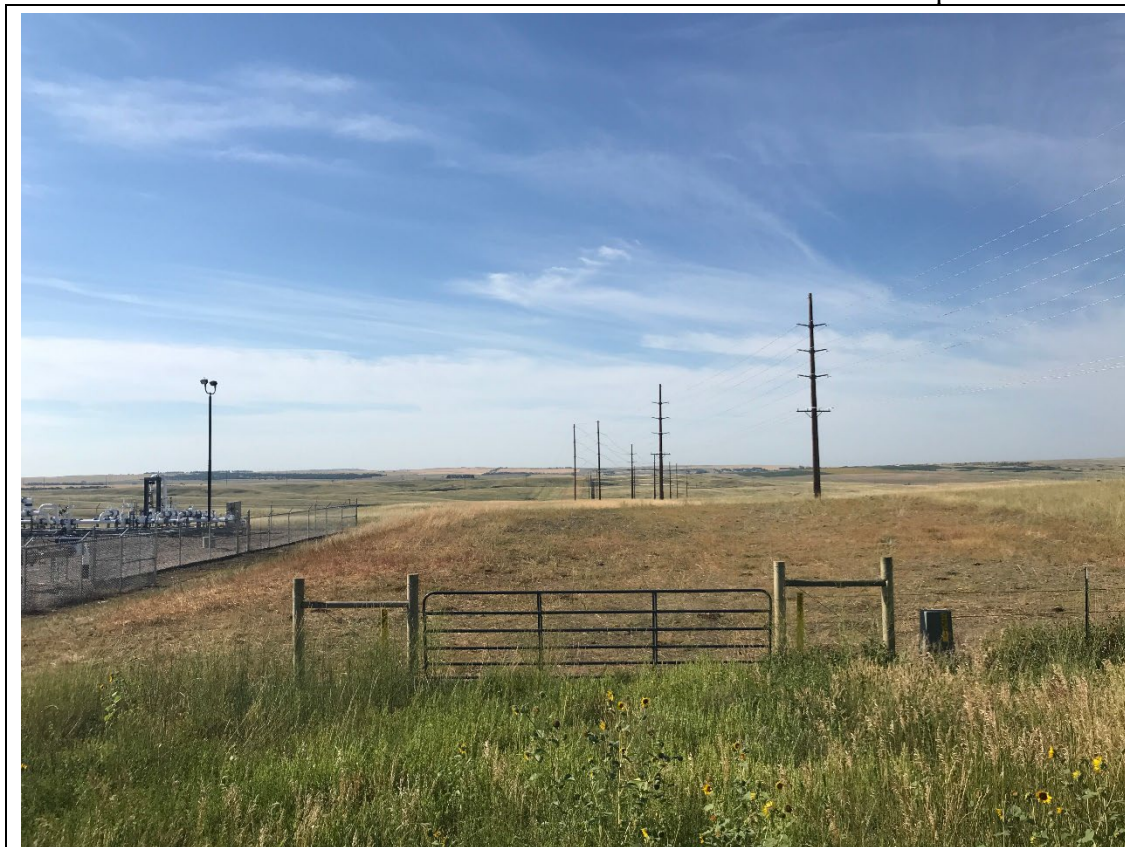
Photo #: 7

Description: South side of road showing bore exit workspace area on the south side of road. The area was weedy and had high use by cattle, as it is also in the corner of a pasture. The 20-in residue pipeline route continues south.

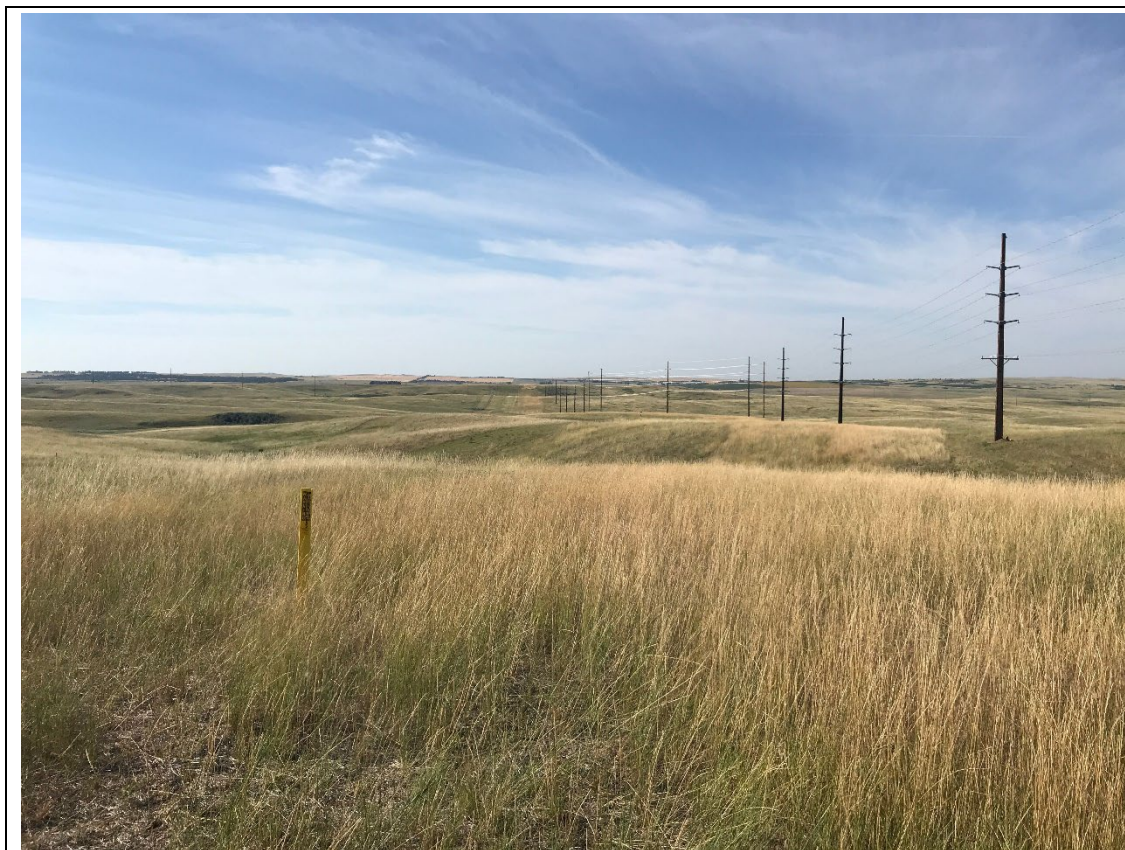
Photo #: 8

Description: The 20-in Residue line continues south across native rangeland. The reclamation was in good condition, with over 75% cover of western wheatgrass, slender wheatgrass, and green needlegrass.

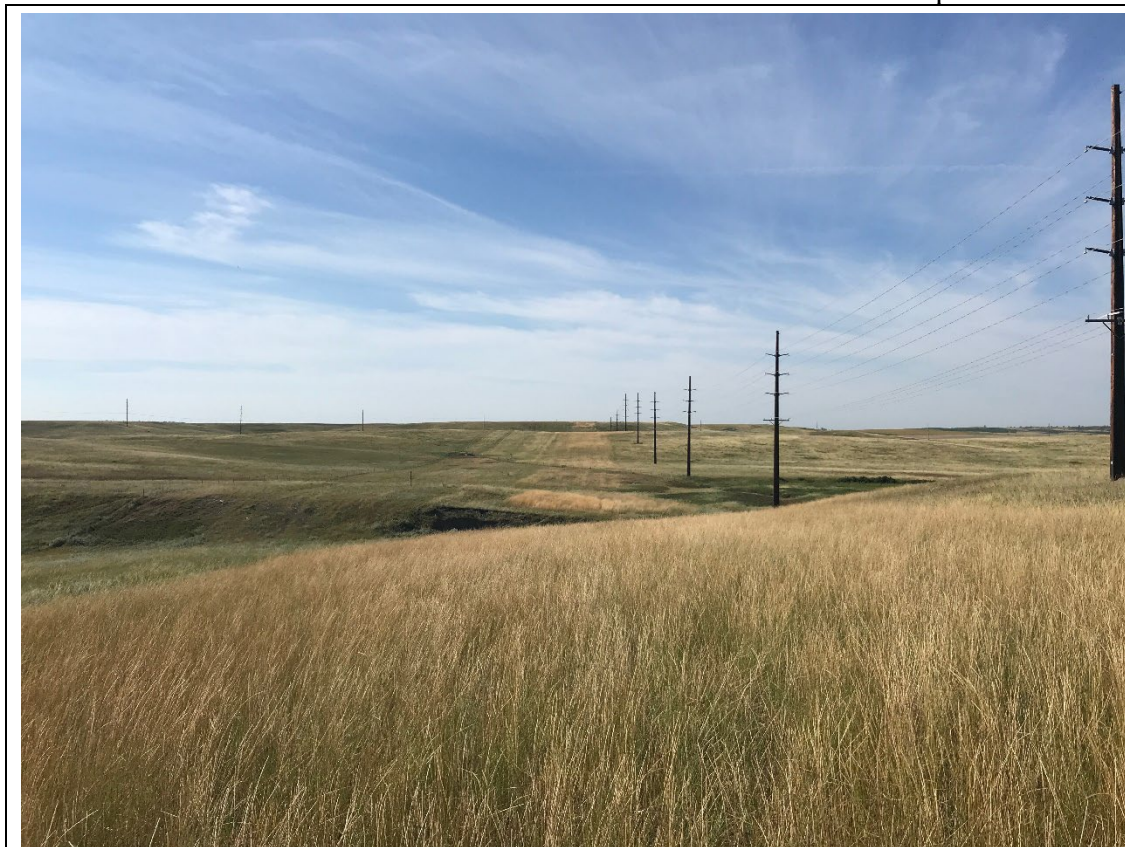
Photo #: 9

Description:
Continuation of route south across native rangeland (rightmost area within corridor, to the left of the overhead transmission line).

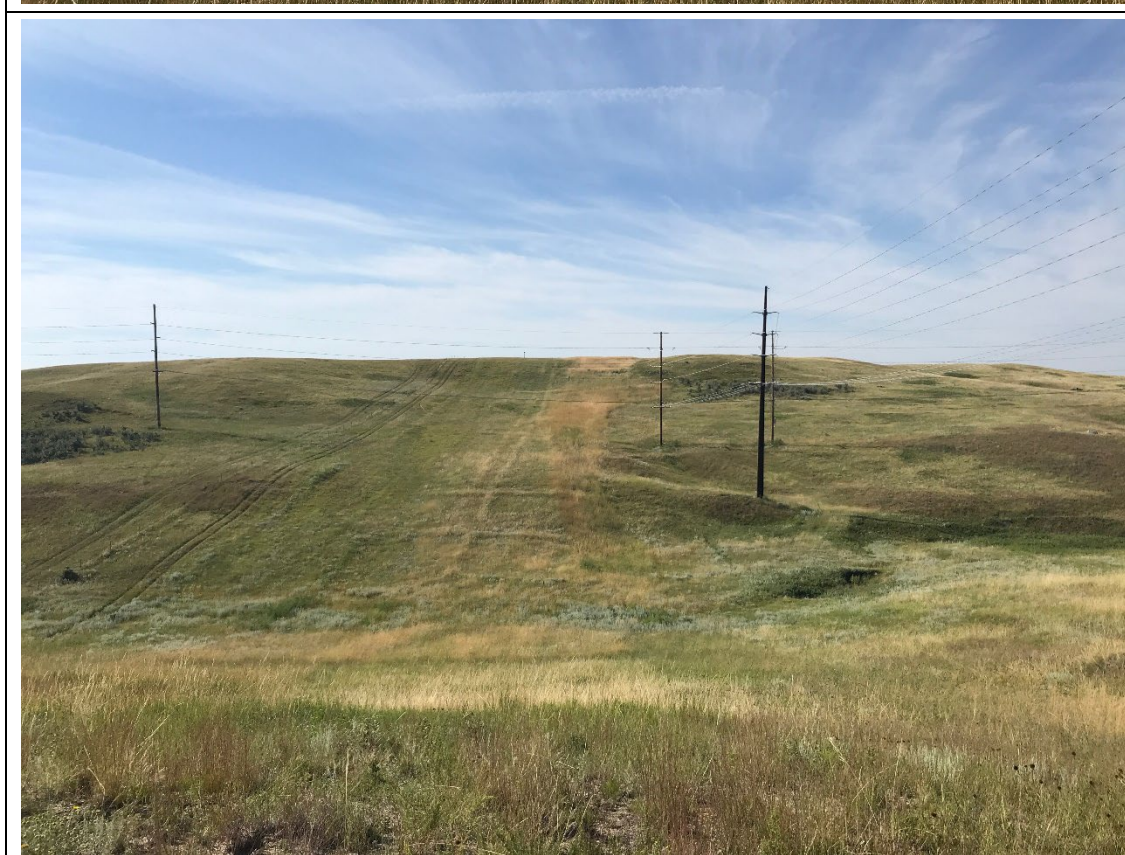
Photo #: 10

Description: Steep upland drainage ravine crossed by HDD bore. Erosive slopes with natural areas of bare ground and minimal topsoil were avoided. Reclamation is in good condition on either side of the bore.

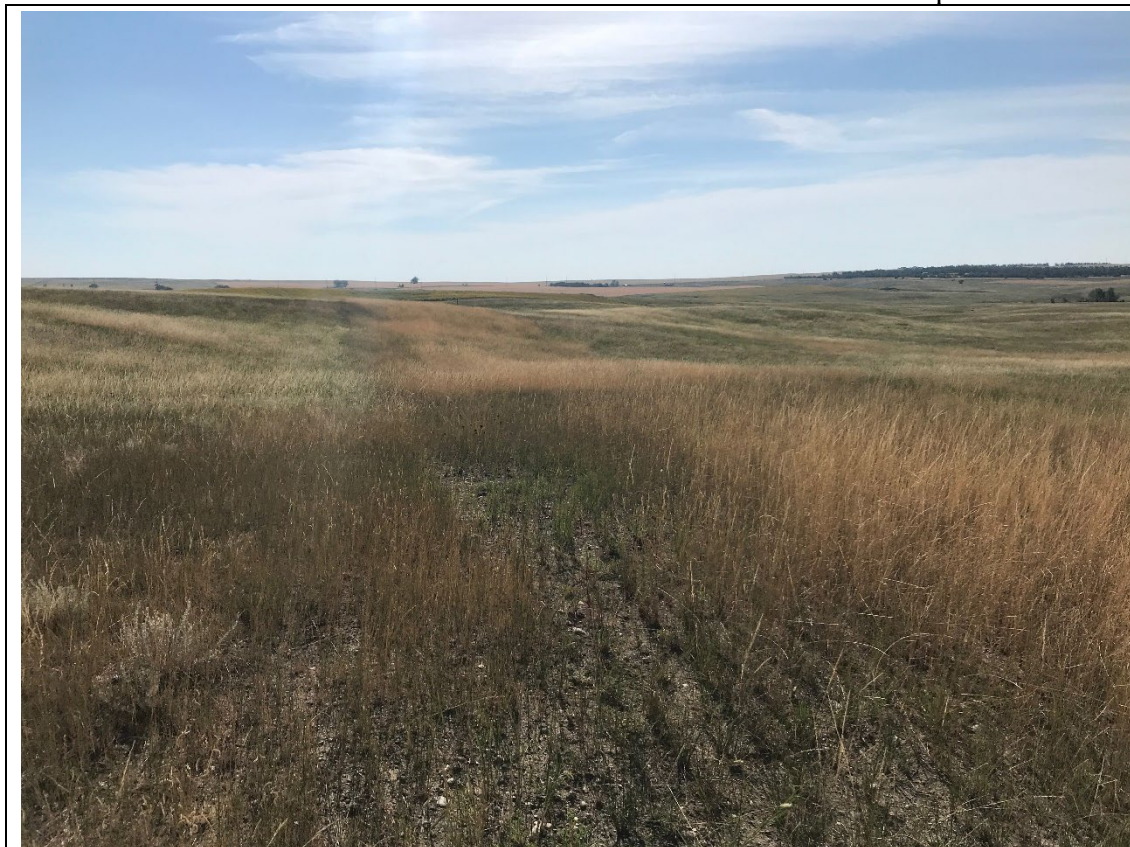
Photo #: 11

One segment of the residue pipeline where it angled southwest across rolling hills had areas of bare soil (Photos 11, 12). However, the stand of reclaimed grasses was adequate and no erosion problems were apparent. Further, the adjacent undisturbed native grassland hilltops also naturally had bare soils and minimal topsoil development. The reclamation matches the surrounding area.

Description: Area where route angles southwest across rolling hills. The hilltops had areas of bare soil, which matched with adjacent native hilltops with bare soils. The reclaimed grass stand has adequate cover.

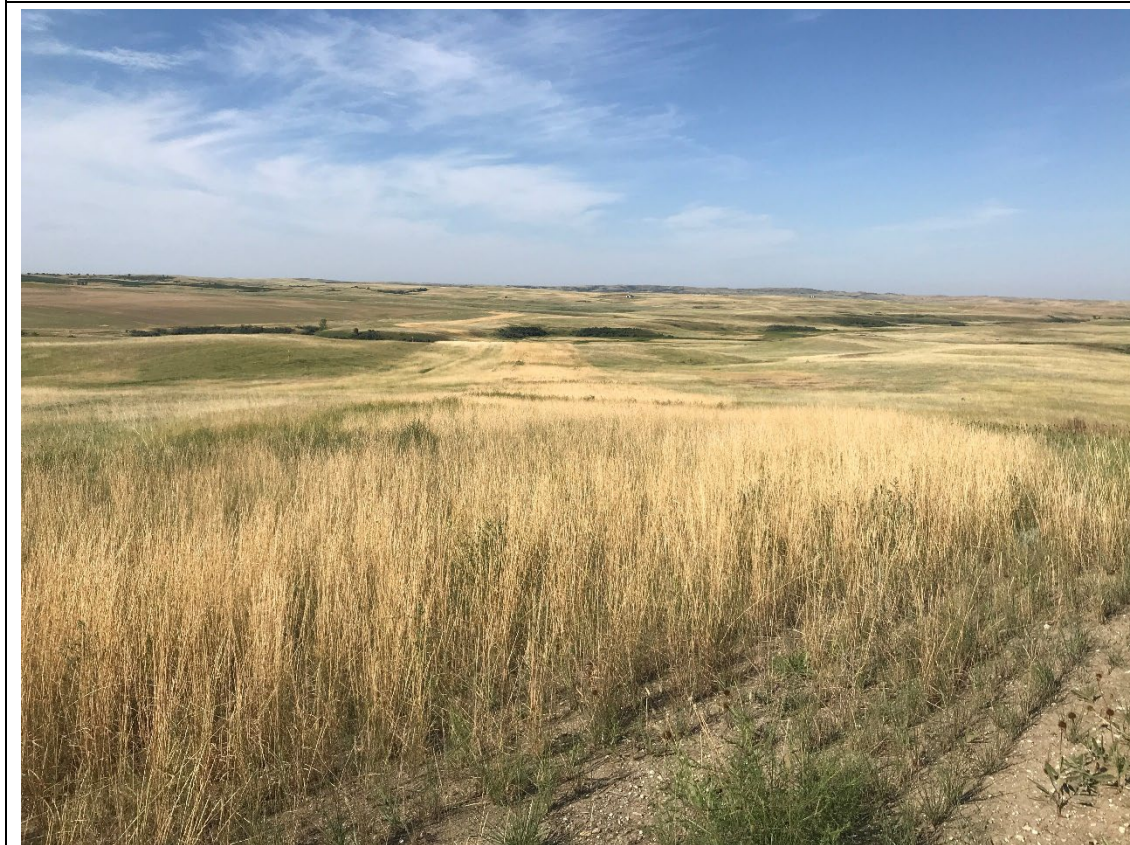
Photo #: 12

Description: Route runs at angle to a large HDD crossing of Horse Tied Creek, visible as line of dark trees in distance. Reclamation is in good condition here, with a few small areas of bare soils.

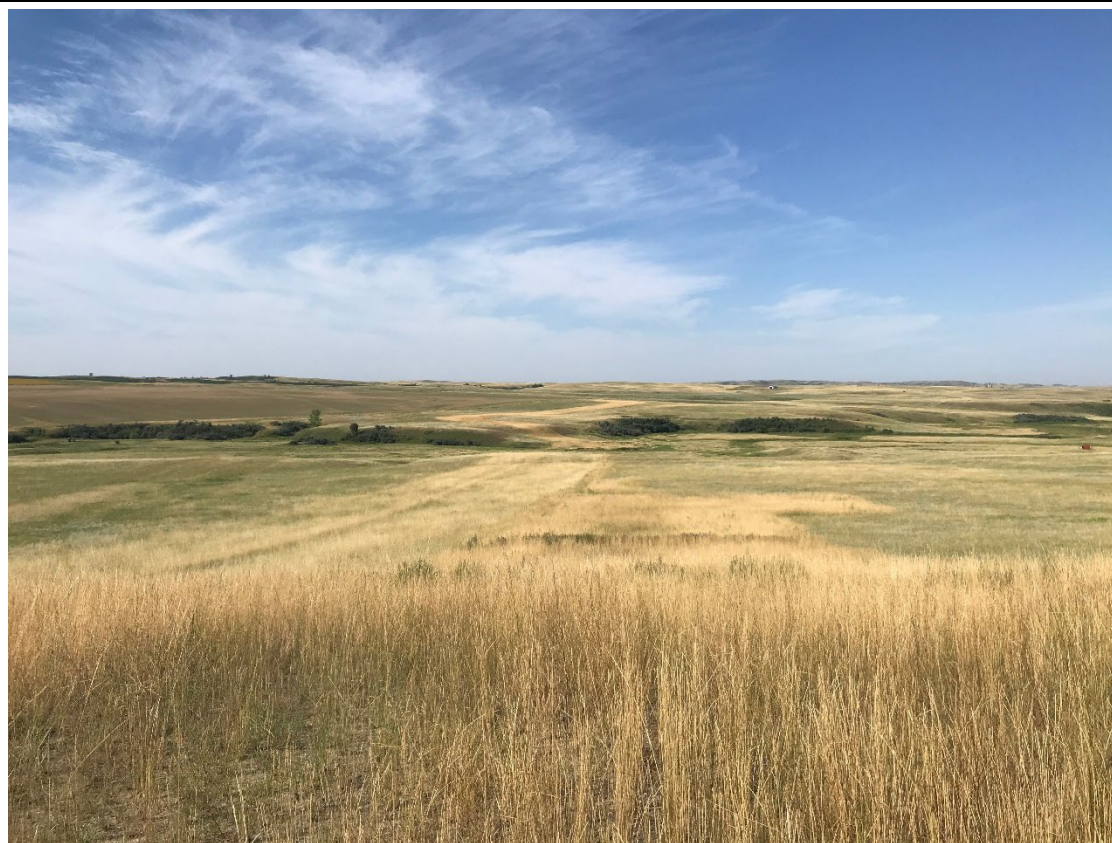
Photo #: 13

Description: View of HDD bore crossing of Horse Tied Creek. Workspace of 20-in Residue Line is in the foreground on the right. The restored route on the left is a Oneok line, which had a workspace closer to the creek.

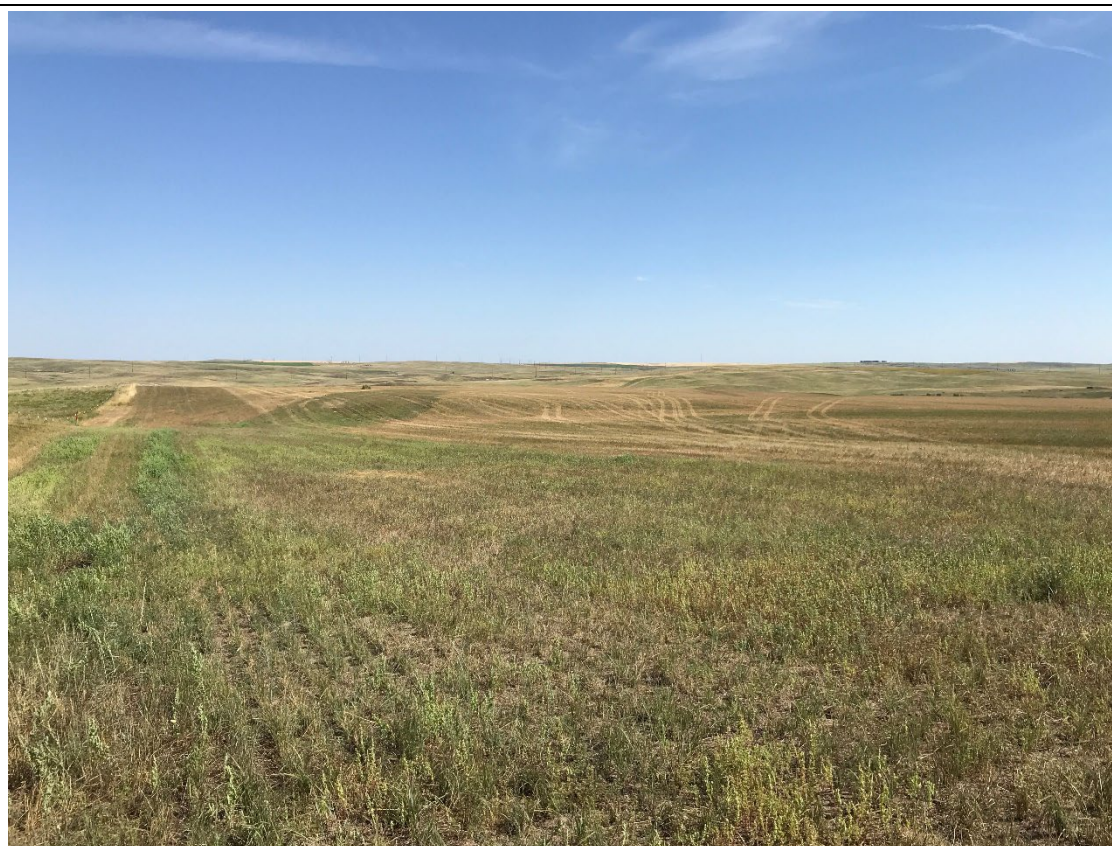
Photo #: 14

Description: View of route across hayland which had already been cut at the time of the inspection. Reclaimed area was approximately 50% seeded grass and 50% annual weeds.

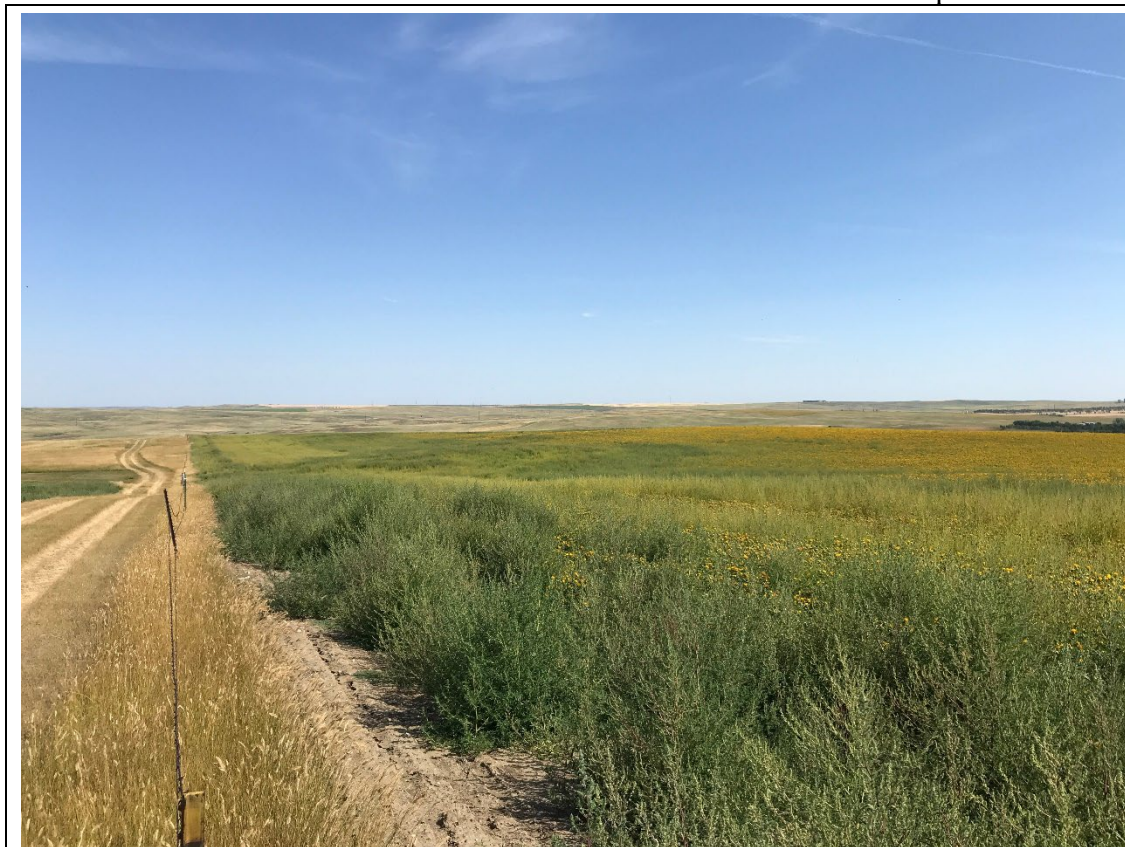
Photo #: 15

Description: Route through cropland, planted in safflower. The pipeline route was dominated by annual weeds.

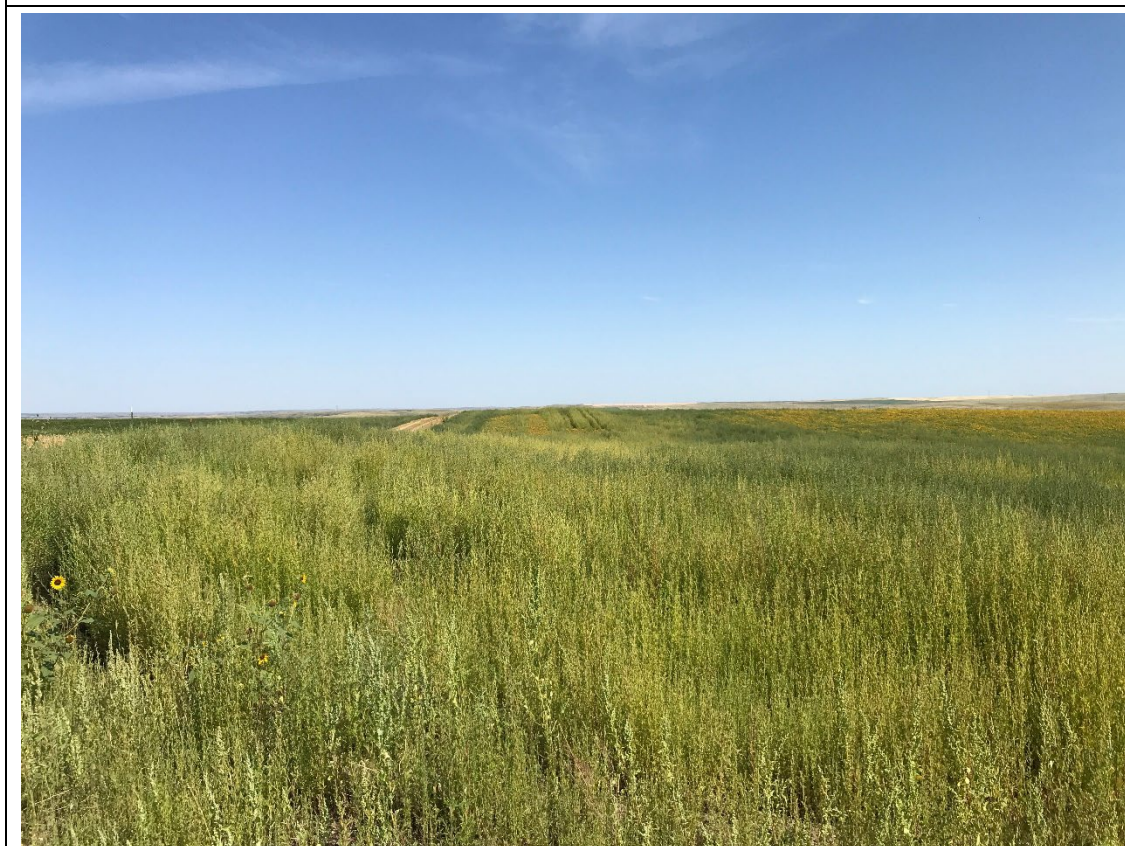
Photo #: 16

Description: Route through cropland, planted in safflower. The pipeline route was dominated by annual weeds, though the crop was present throughout the annual weed cover.

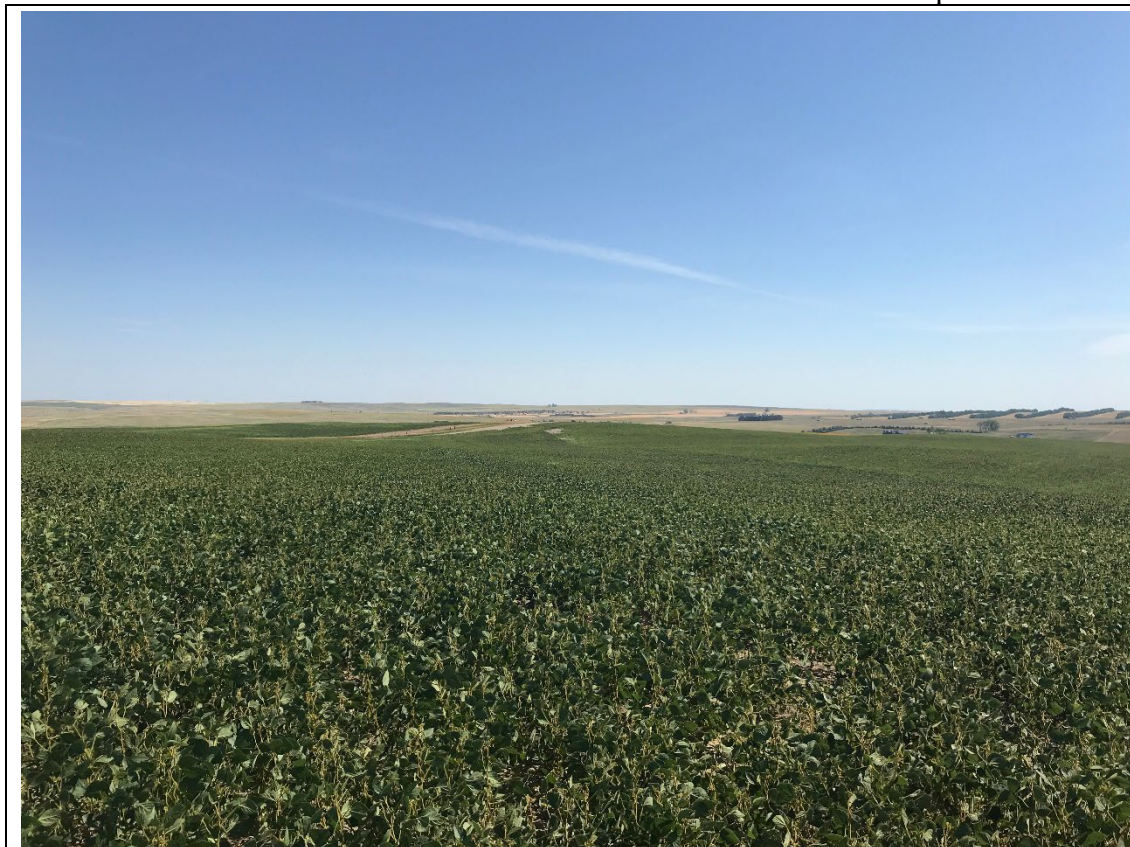
Photo #: 17

Description: Route through cropland of soybeans. Difference between pipeline route and adjacent cropland is minimal. A few bare patches are present within parallel pipeline routes.

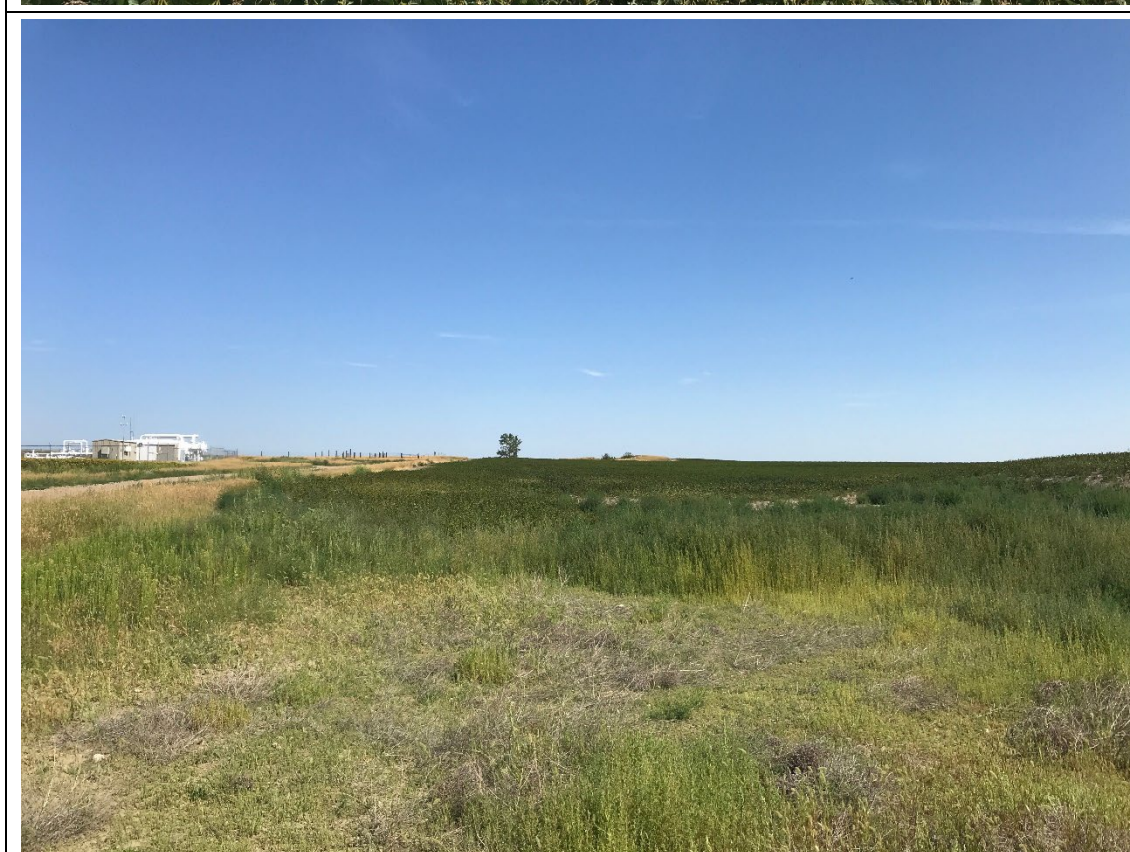
Photo #: 18

Description: Route through cropland of soybeans, along west edge of field. The crop growth within the pipeline ROW is slightly shorter compared to the adjacent cropland.

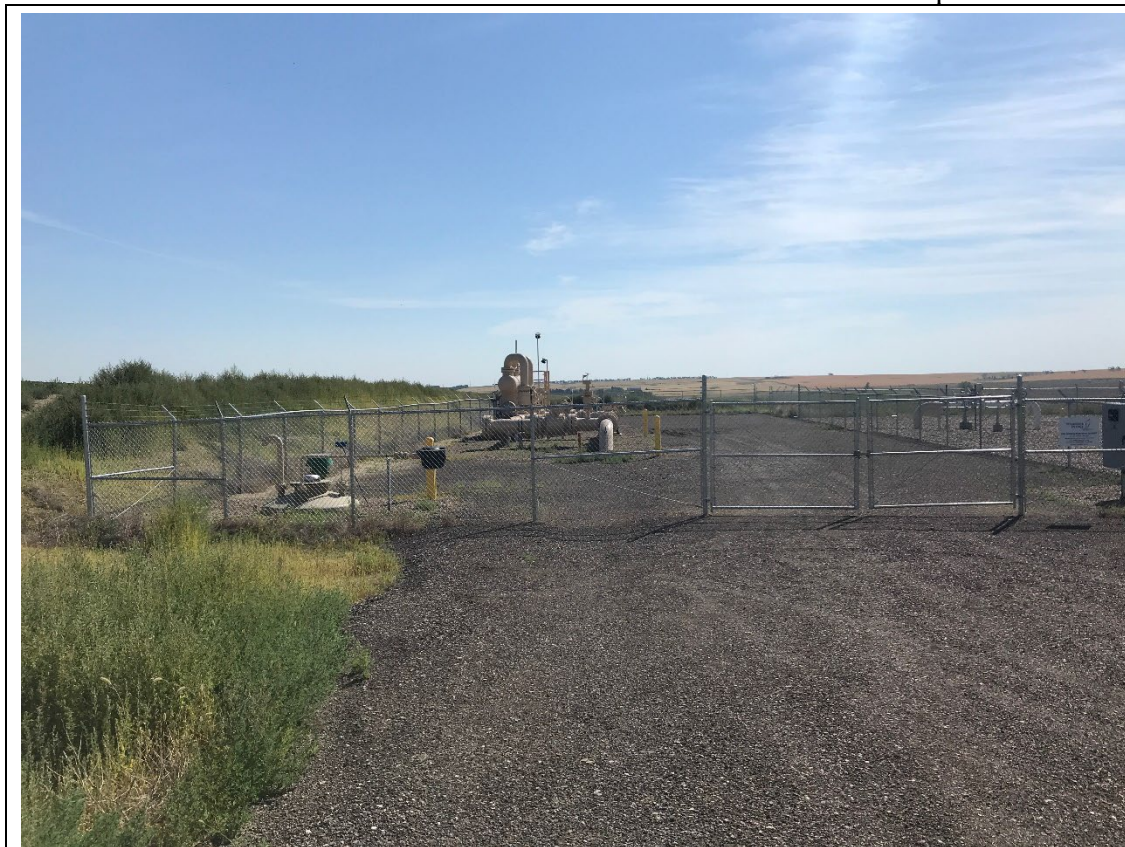
Photo #: 19

Description: South end of 20-in Residue Pipeline at the delivery point, where it connects to a Northern border/TransCanada pipeline at the aboveground valve visible in the fenced area.
