# **NuStar 10" Pipeline Relocation Project**

## ***Construction Inspection Report***

***Docket Number: PU-20-381***

Prepared for North Dakota Public Service Commission

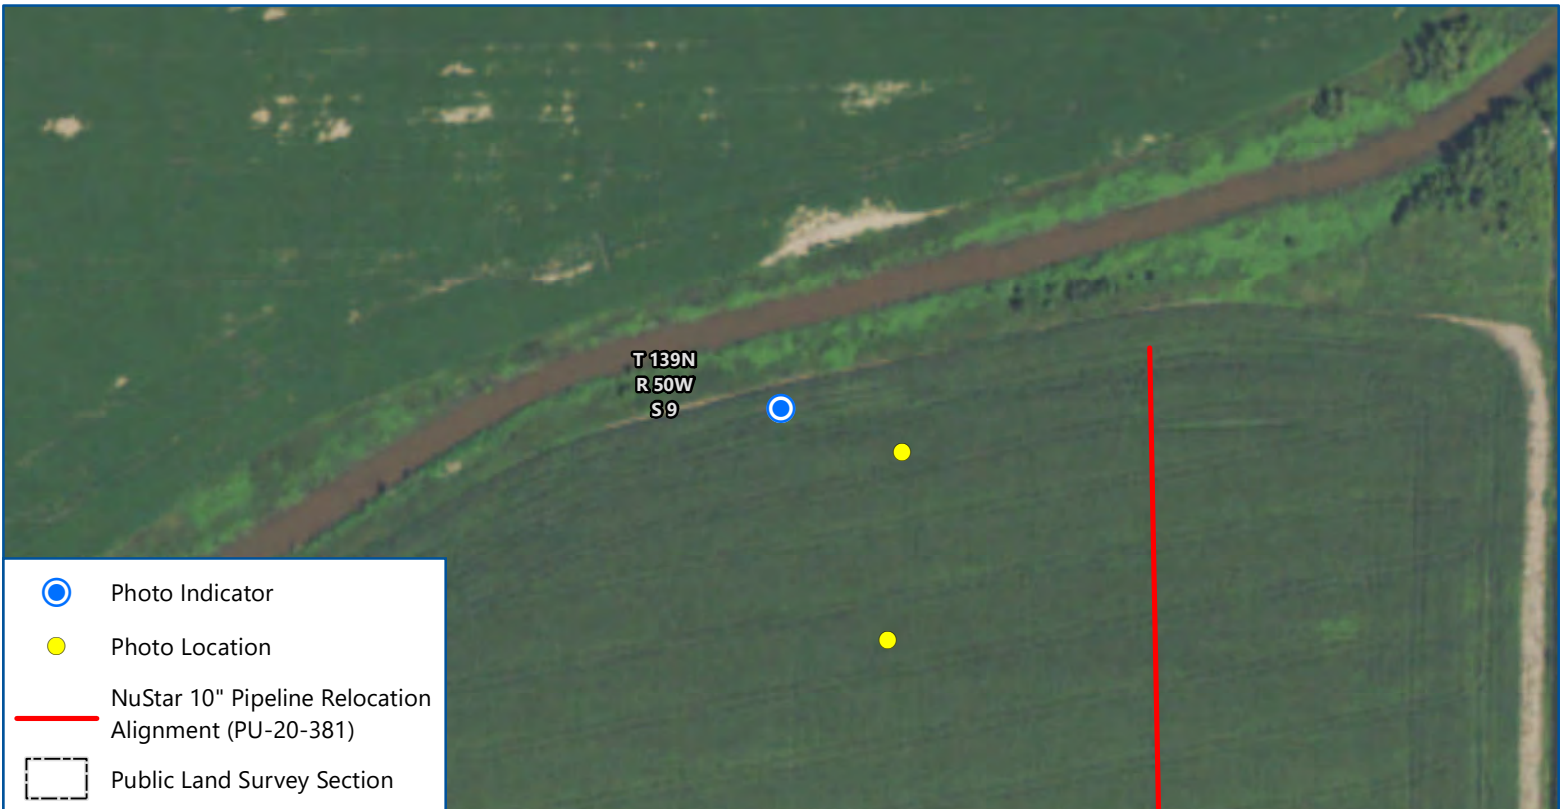
Map 1 of 18

Date: 7/13/2021  
 Photo Direction: South  
 Comment: Silt fence near topsoil stockpile;  
 no erosion observed

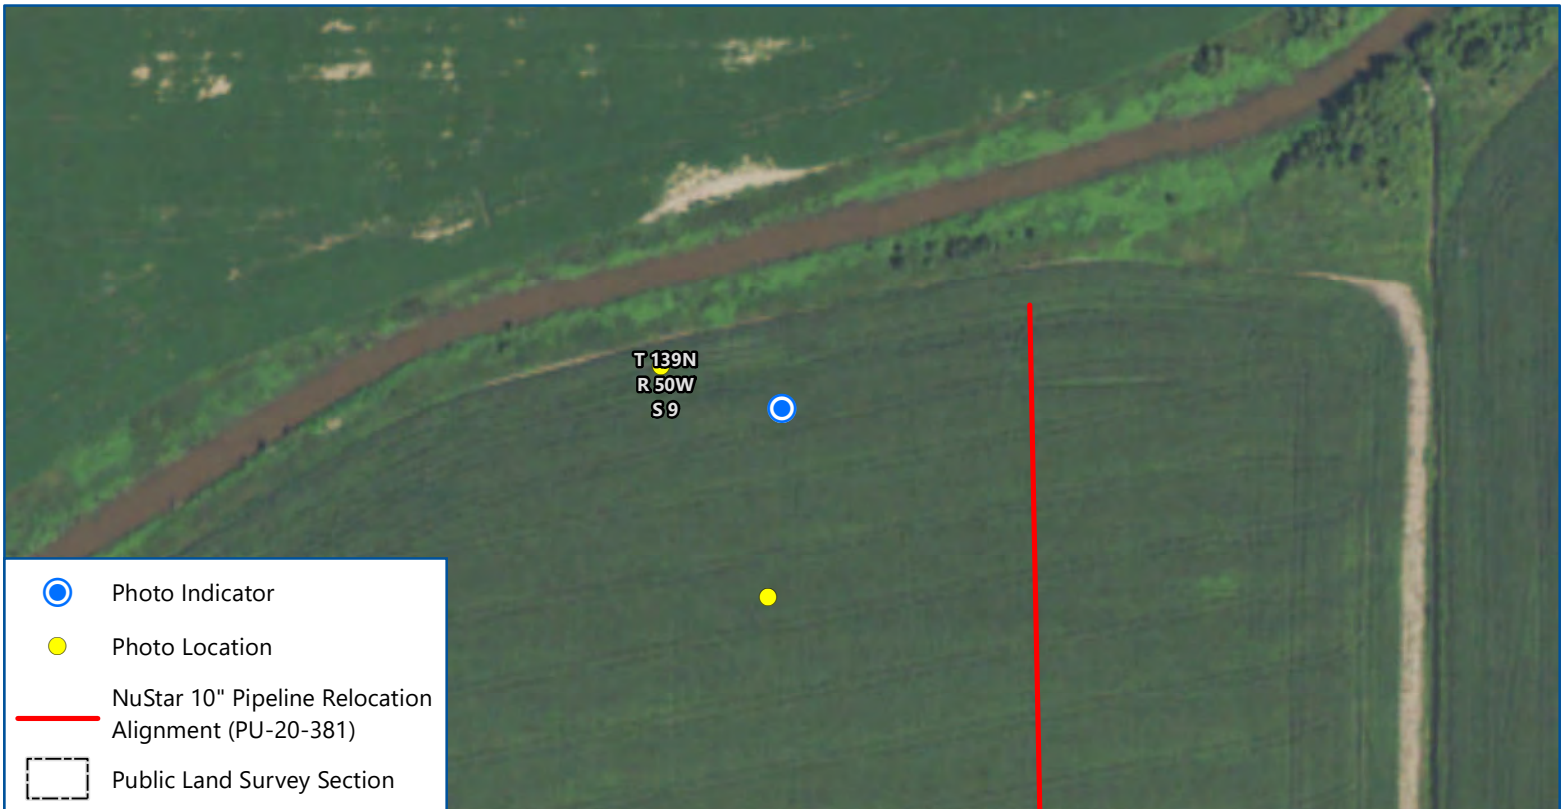
Map 2 of 18

Date: 7/13/2021  
 Photo Direction: North  
 Comment: Silt fence at south end of drilling stage area; no erosion observed

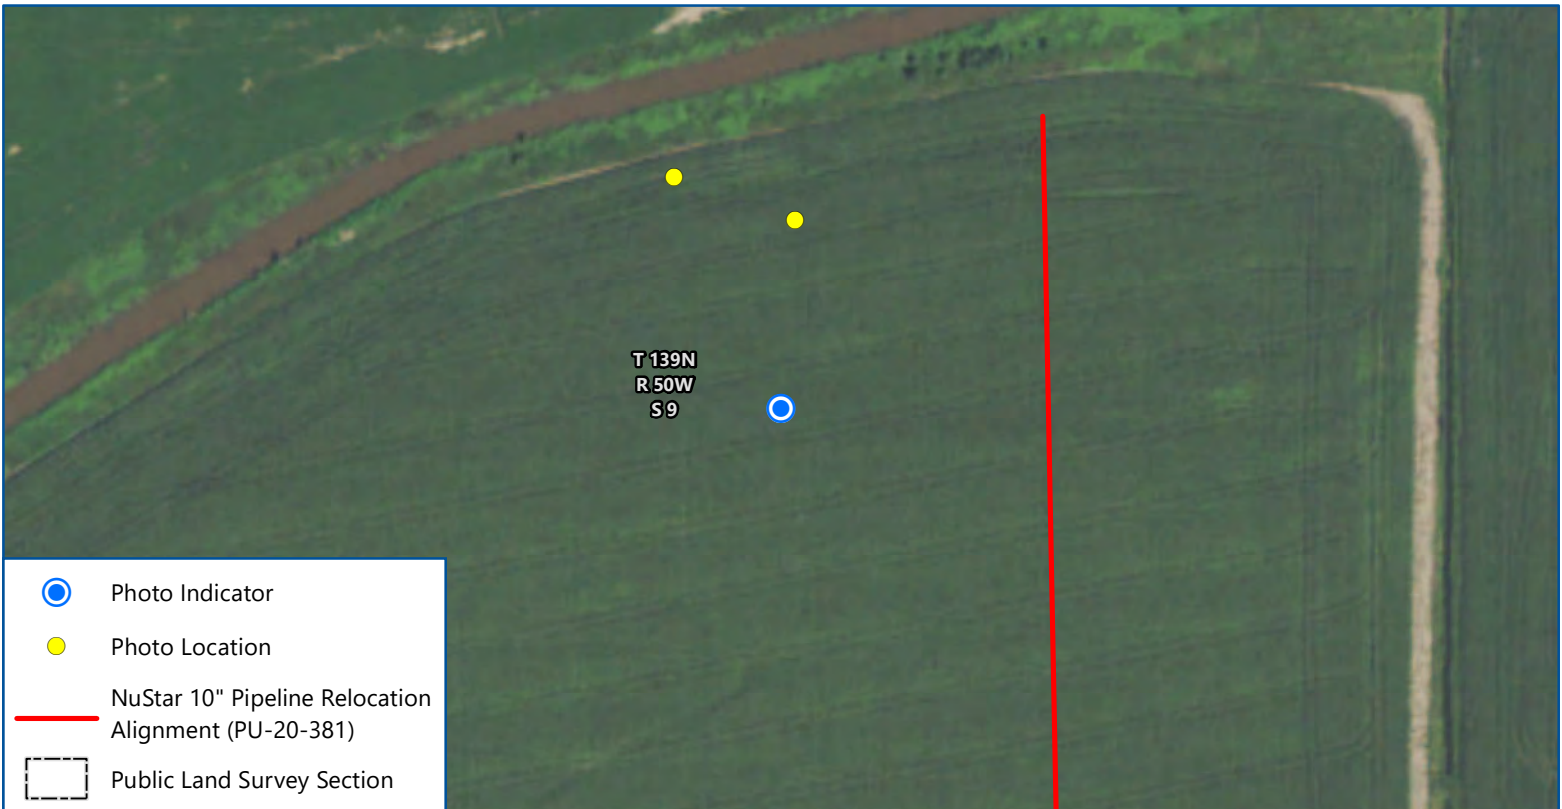
Map 3 of 18

Date: 7/13/2021  
 Photo Direction: South  
 Comment: Small subsoil stockpile near  
 topsoil stockpile with inadequate  
 separation

Issues	Recommendations
<b>Isolated locations of inadequate physical separation of subsoil and topsoil</b>	Create further separation of stockpiles. Where this is not feasible, install silt fence to separate piles until soils are replaced.
<b>Isolated locations of small amounts of topsoil remaining in place during trench excavation.</b>	Ensure that all topsoil has been stripped before excavating and stockpiling subsoil through increased inspections.

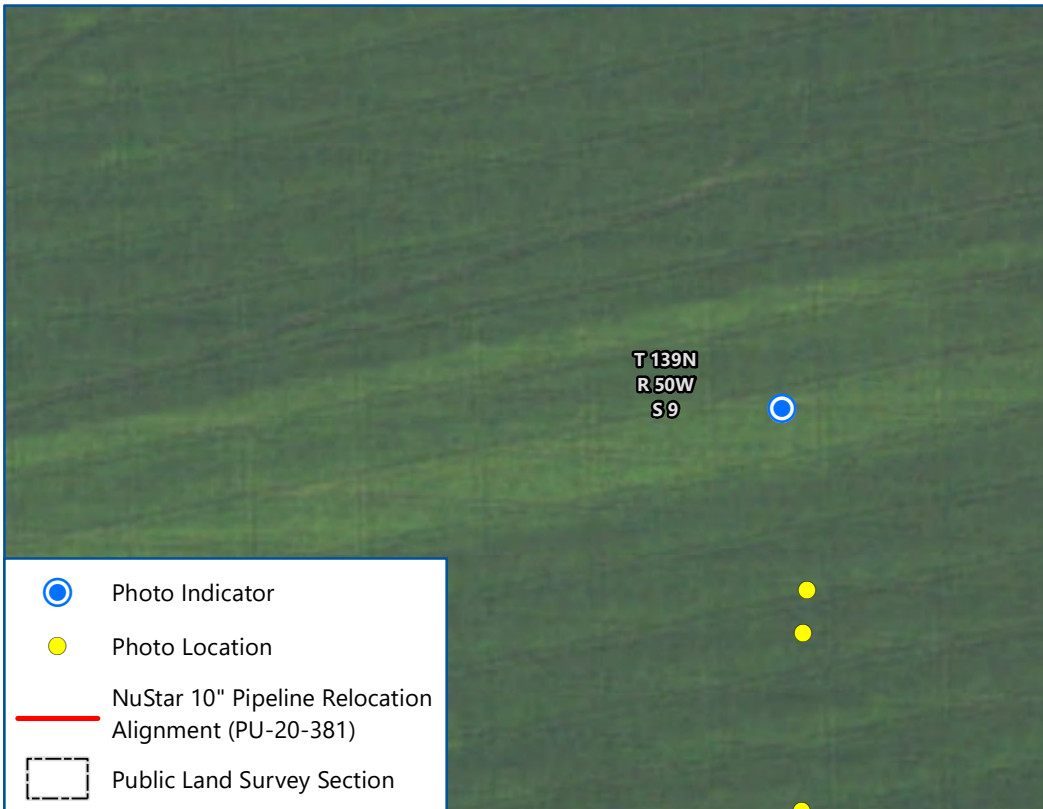
Map 4 of 18

Date: 7/13/2021  
 Photo Direction: West  
 Comment: Silt fence; no erosion observed

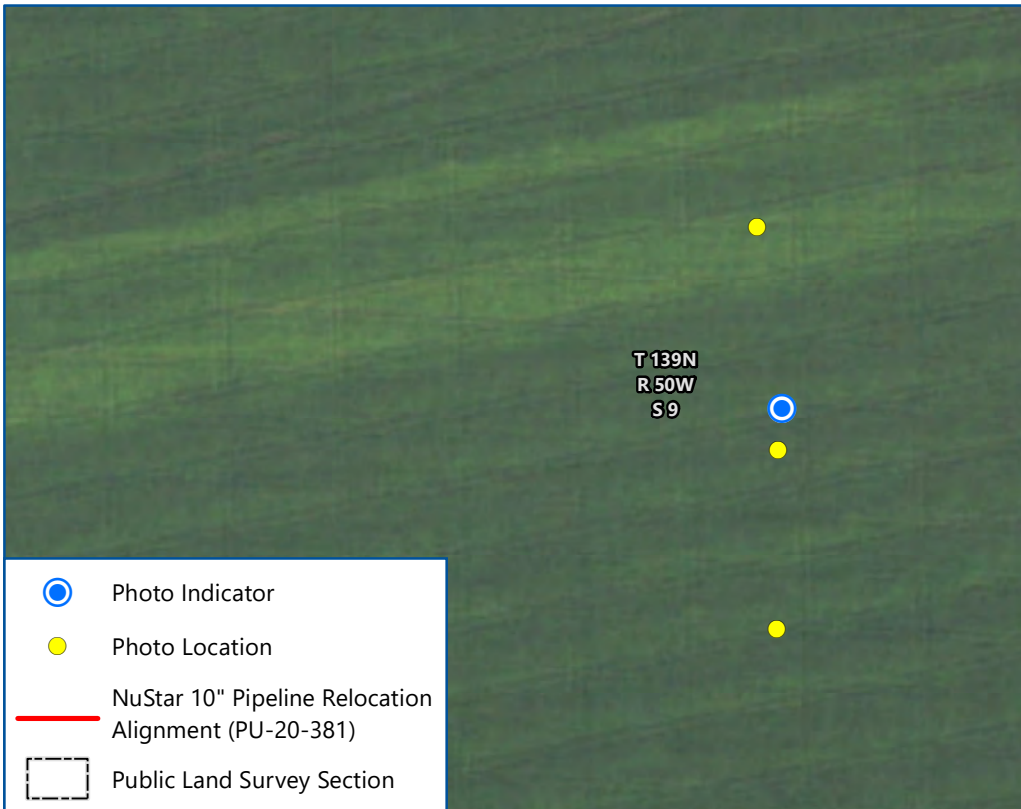
Map 5 of 18

Date: 7/13/2021  
 Photo Direction: South  
 Comment: Topsoil stockpile with no silt fence due to flat grade; no erosion observed

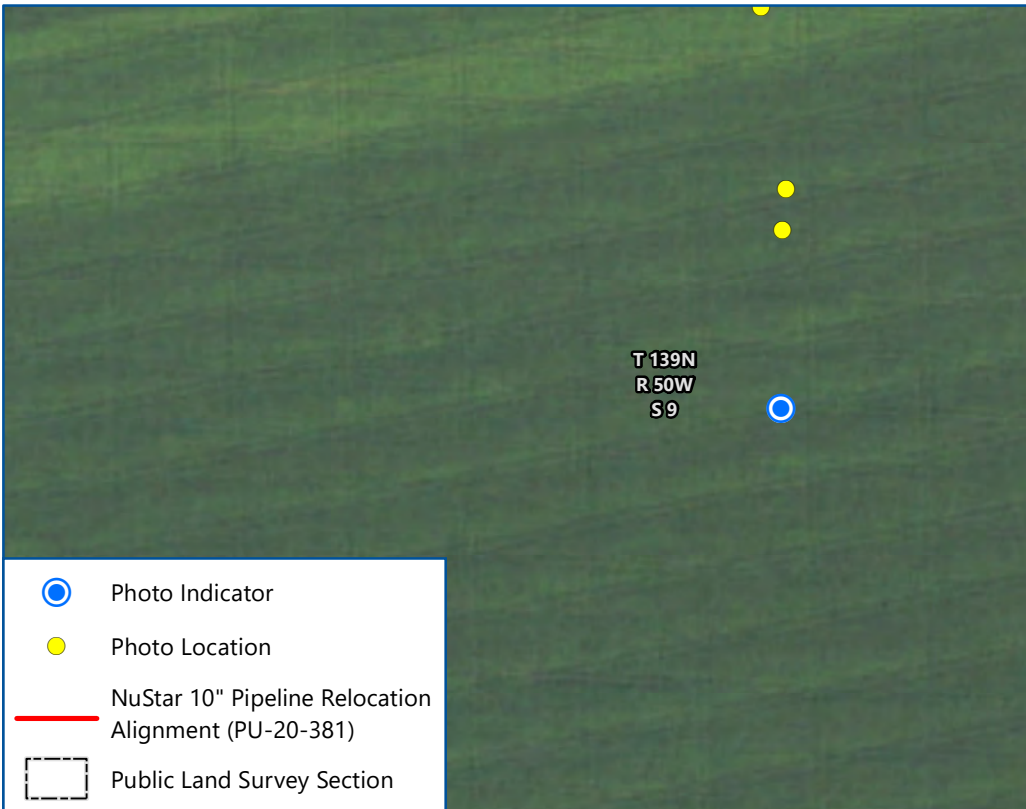
Map 6 of 18

Date: 7/13/2021  
 Photo Direction: South  
 Comment: Backfilled pipeline 6 feet below ground surface

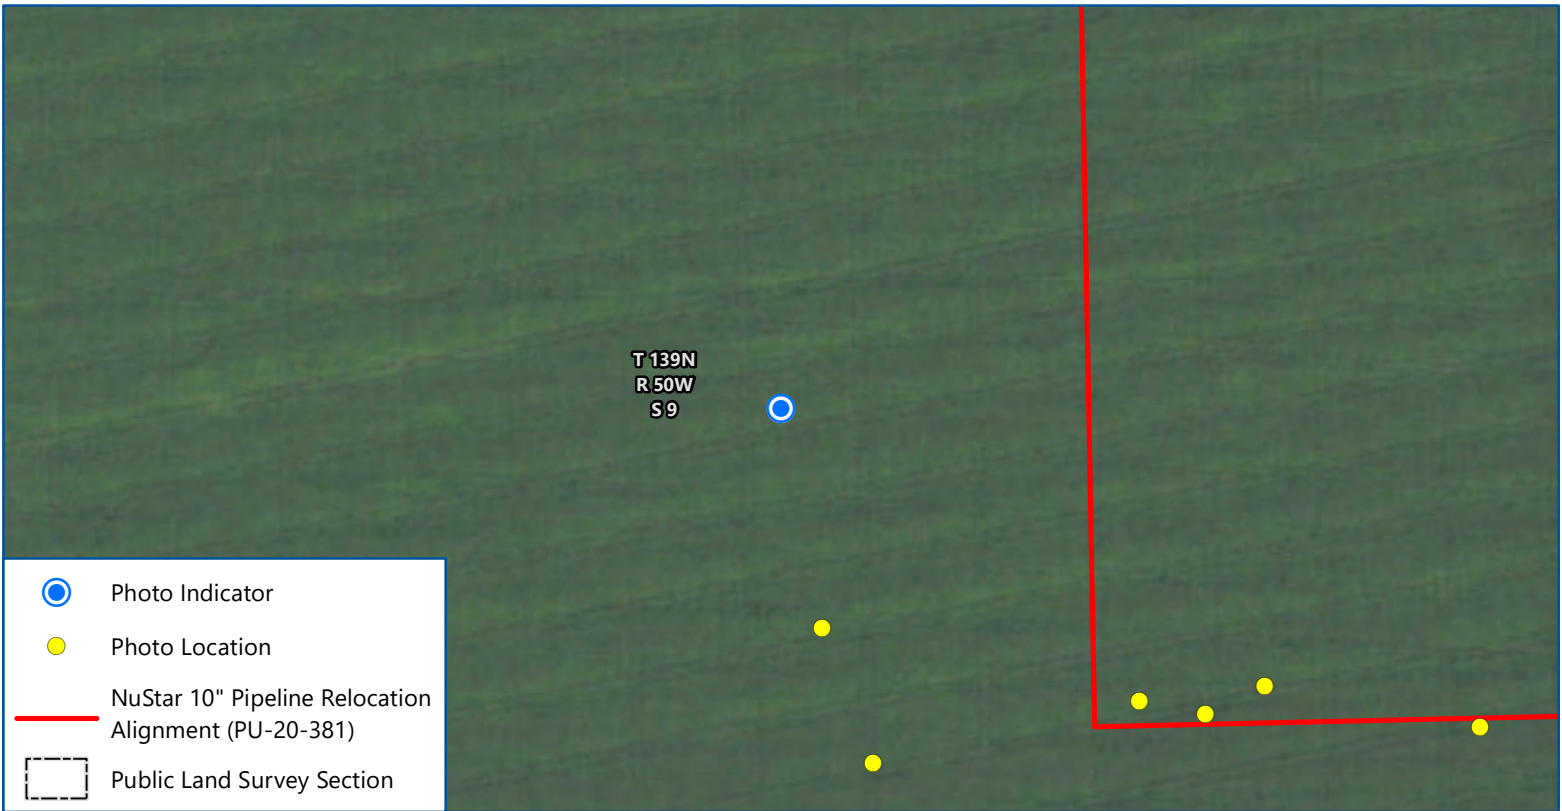
Map 7 of 18

Date: 7/13/2021  
 Photo Direction: South  
 Comment: Topsoil and subsoil stockpile segregation next to staged pipeline for boring

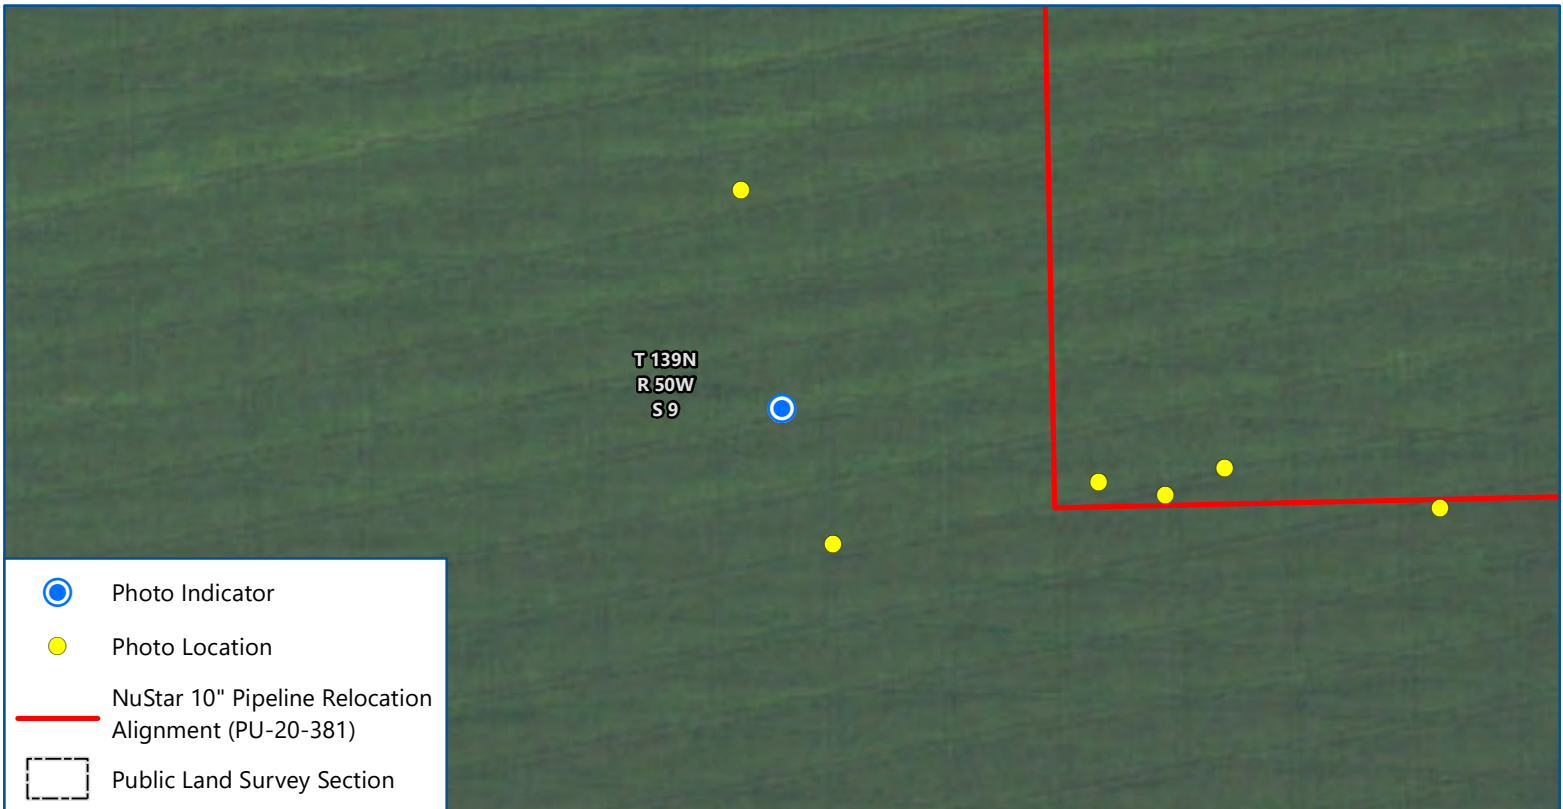
Map 8 of 18

Date: 7/13/2021  
 Photo Direction: North  
 Comment: Erosion berm within excavation footprint

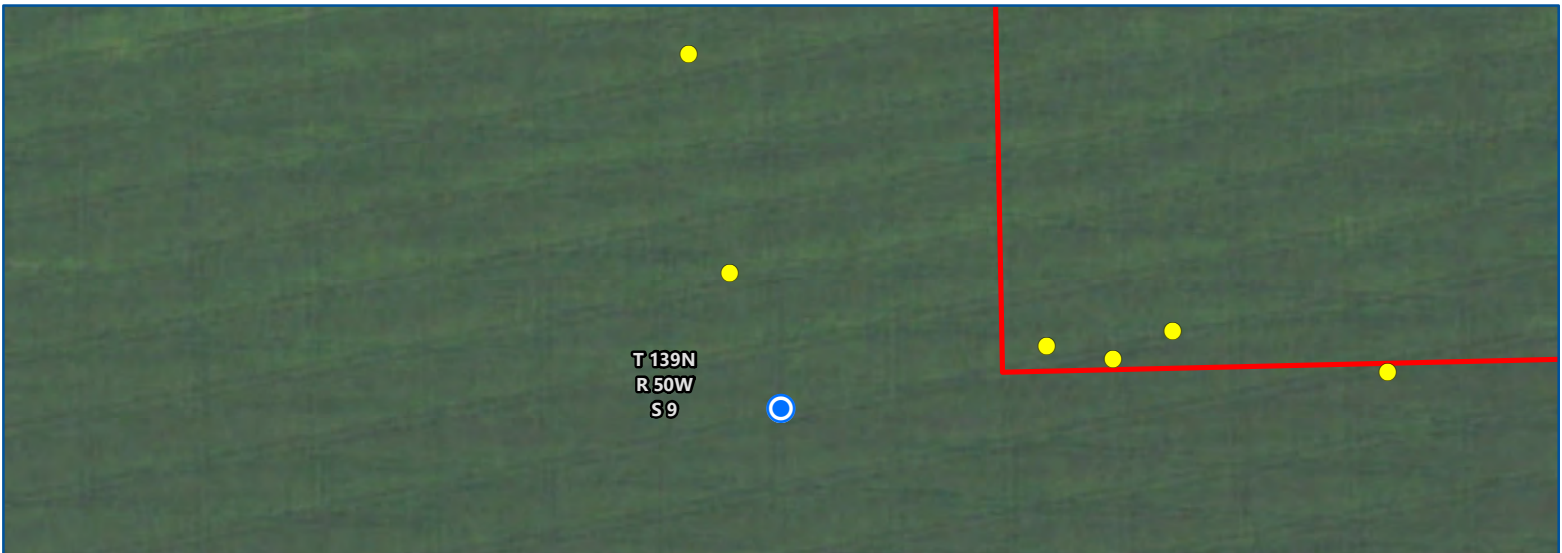
Map 9 of 18

Date: 7/13/2021  
 Photo Direction: North  
 Comment: Backfilled pipeline 7 feet below ground surface

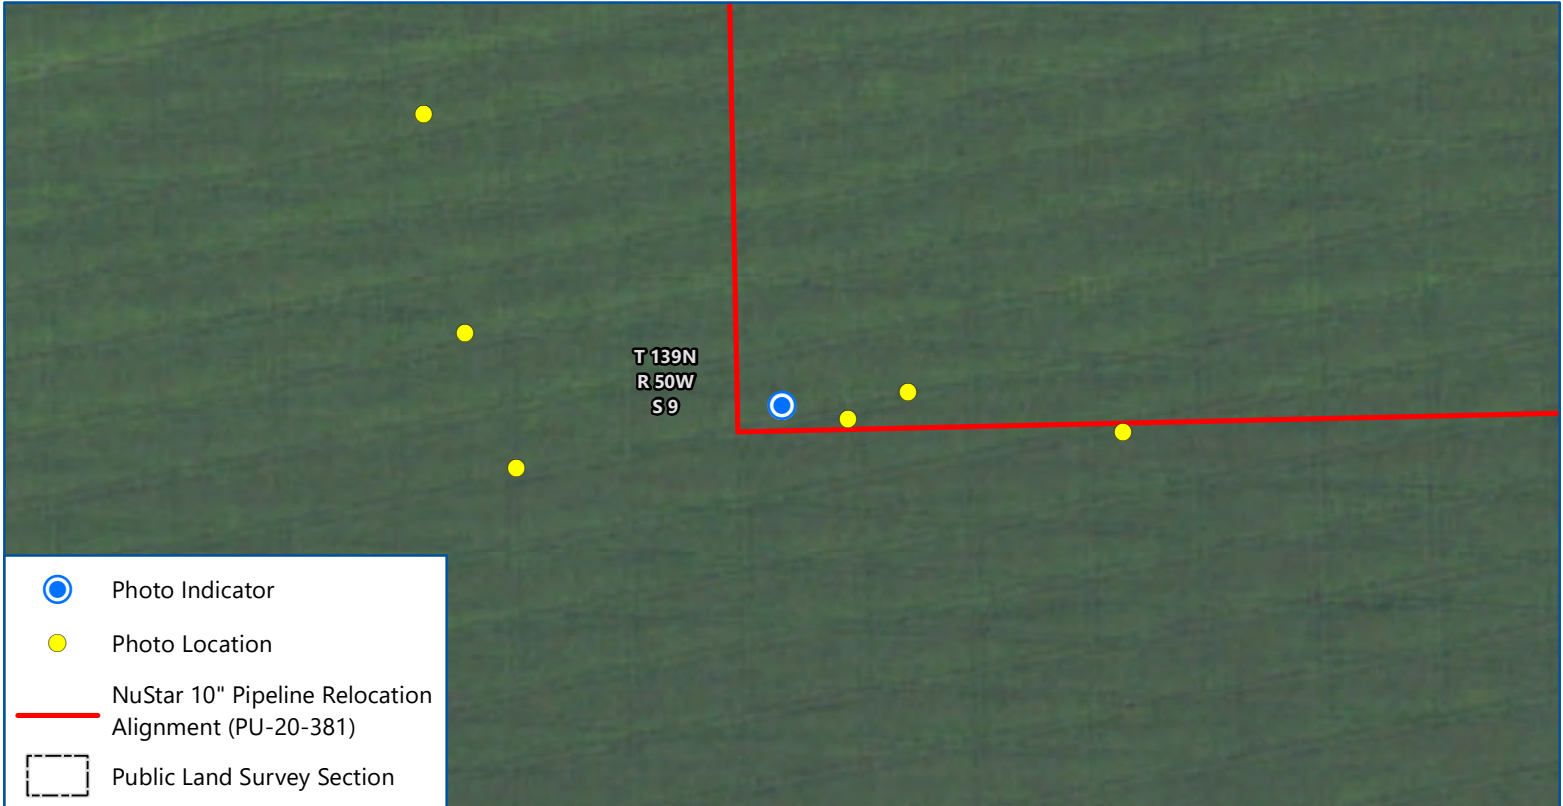
Map 10 of 18

Date: 7/13/2021  
 Photo Direction: West  
 Comment: Topsoil stockpile without silt fence due to flat grade; no erosion observed

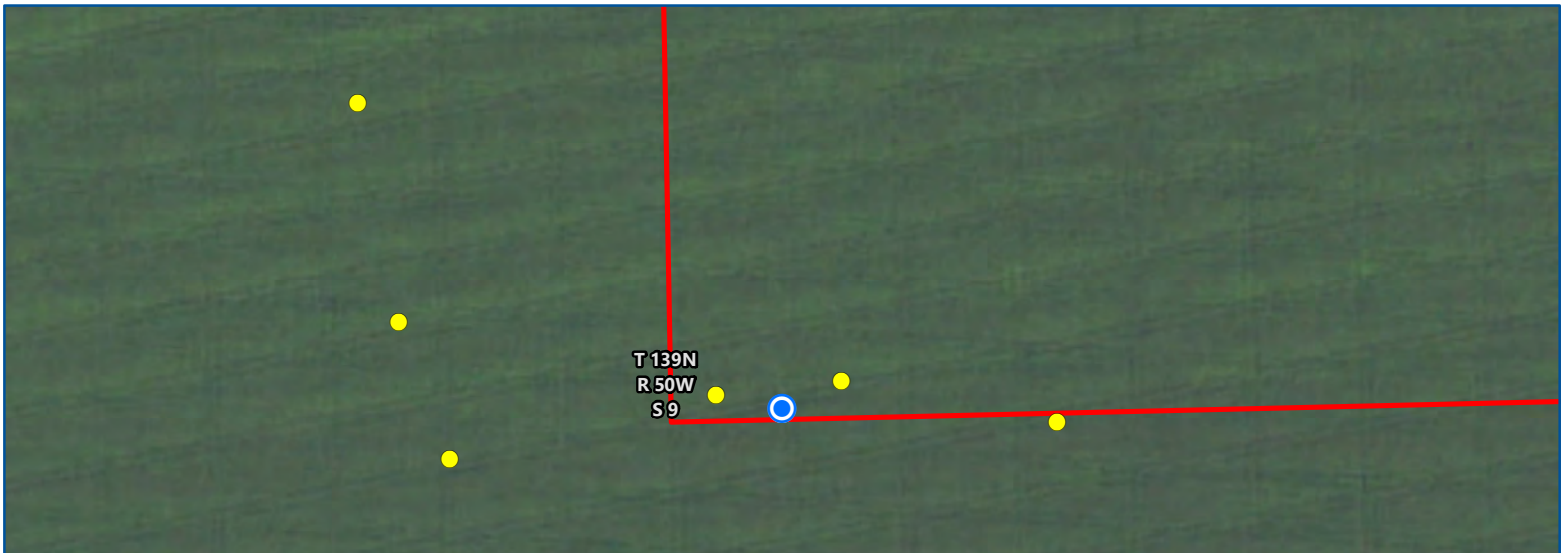
Map 11 of 18

Date: 7/13/2021  
 Photo Direction: East  
 Comment: Top of subsoil after topsoil stripping

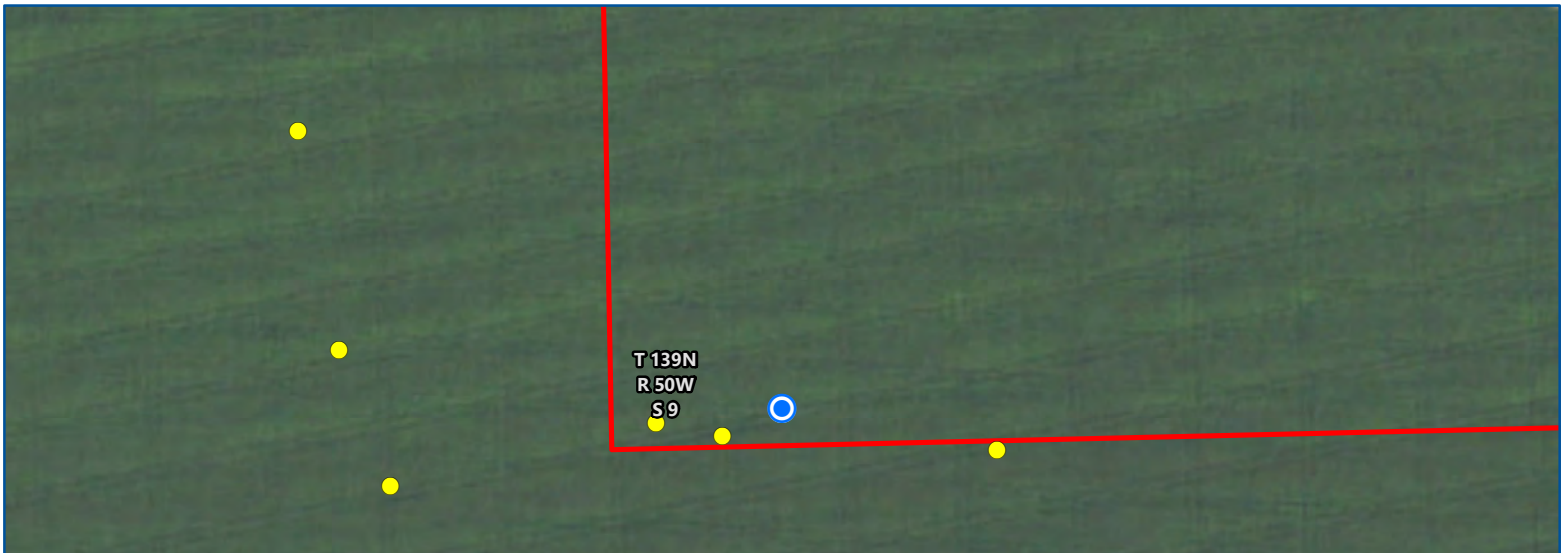
Map 12 of 18

Date: 7/13/2021  
 Photo Direction: East  
 Comment: Small amounts of topsoil within subsoil stockpile

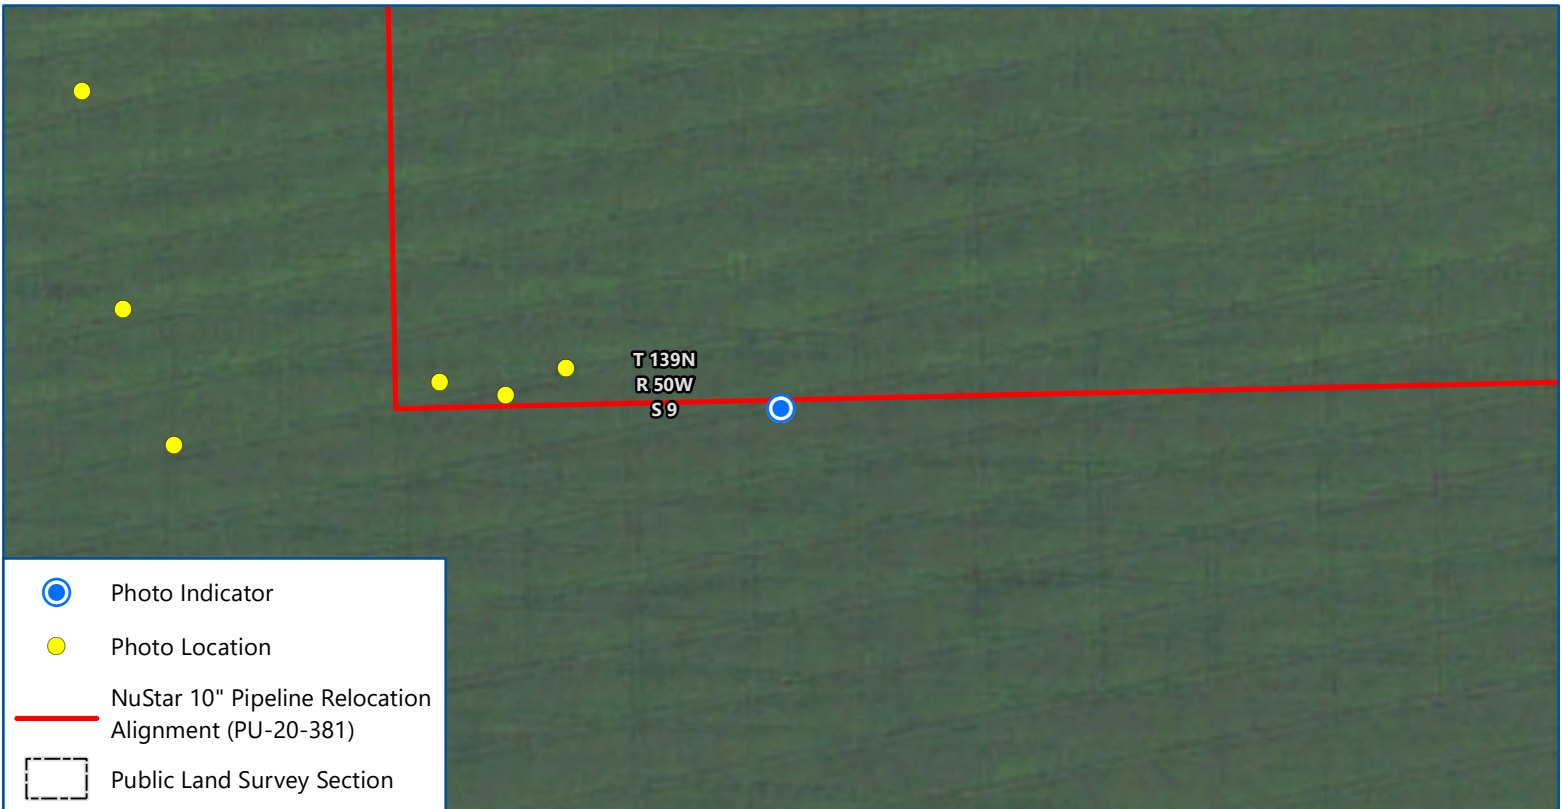
Map 13 of 18

Date: 7/13/2021  
 Photo Direction: East  
 Comment: Pipeline excavation with topsoil and subsoil segregation

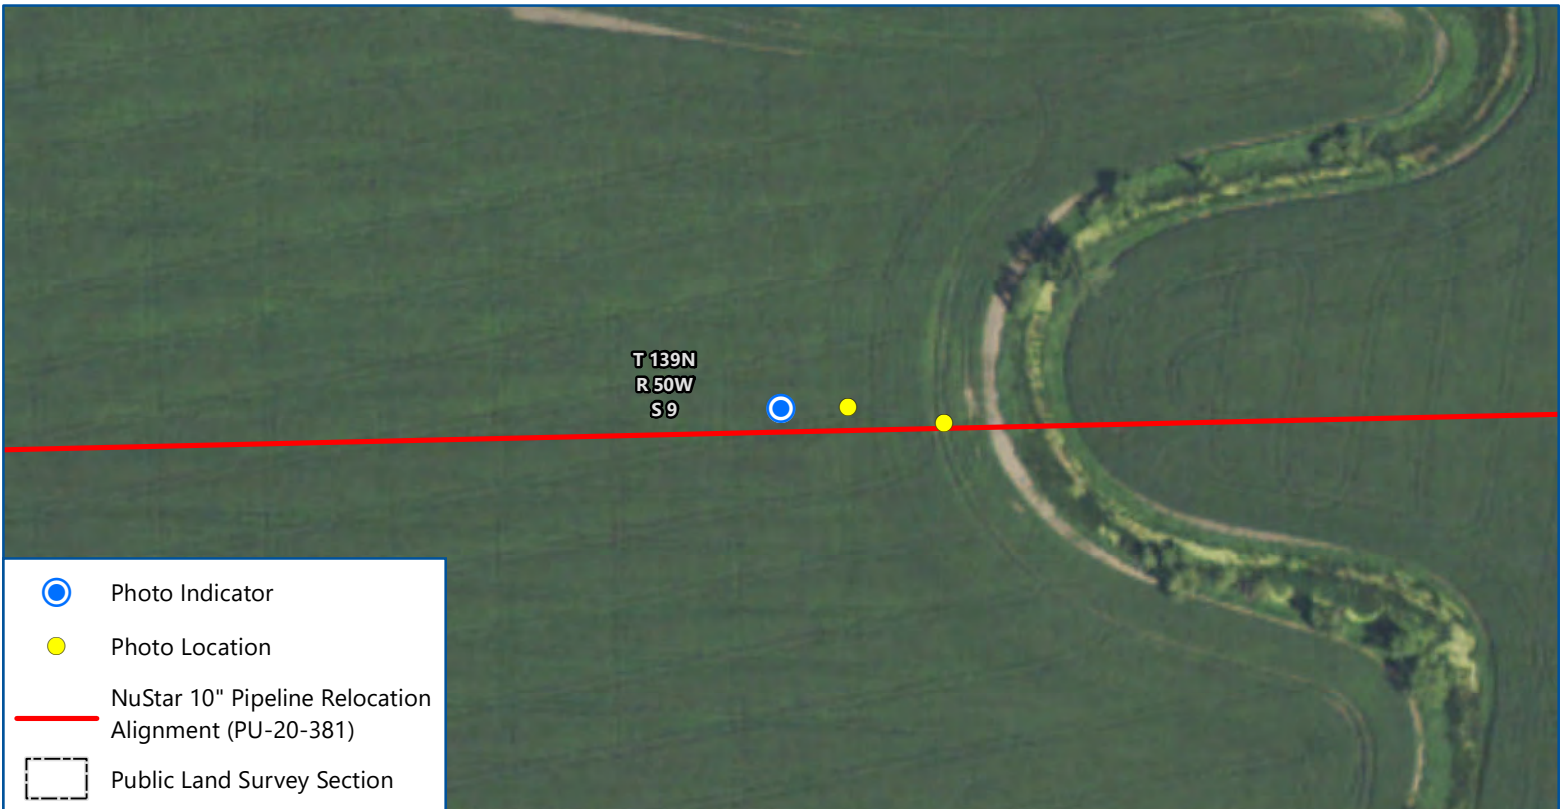
Map 14 of 18

Date: 7/13/2021  
 Photo Direction: East  
 Comment: Erosion berm and subsoil stockpile

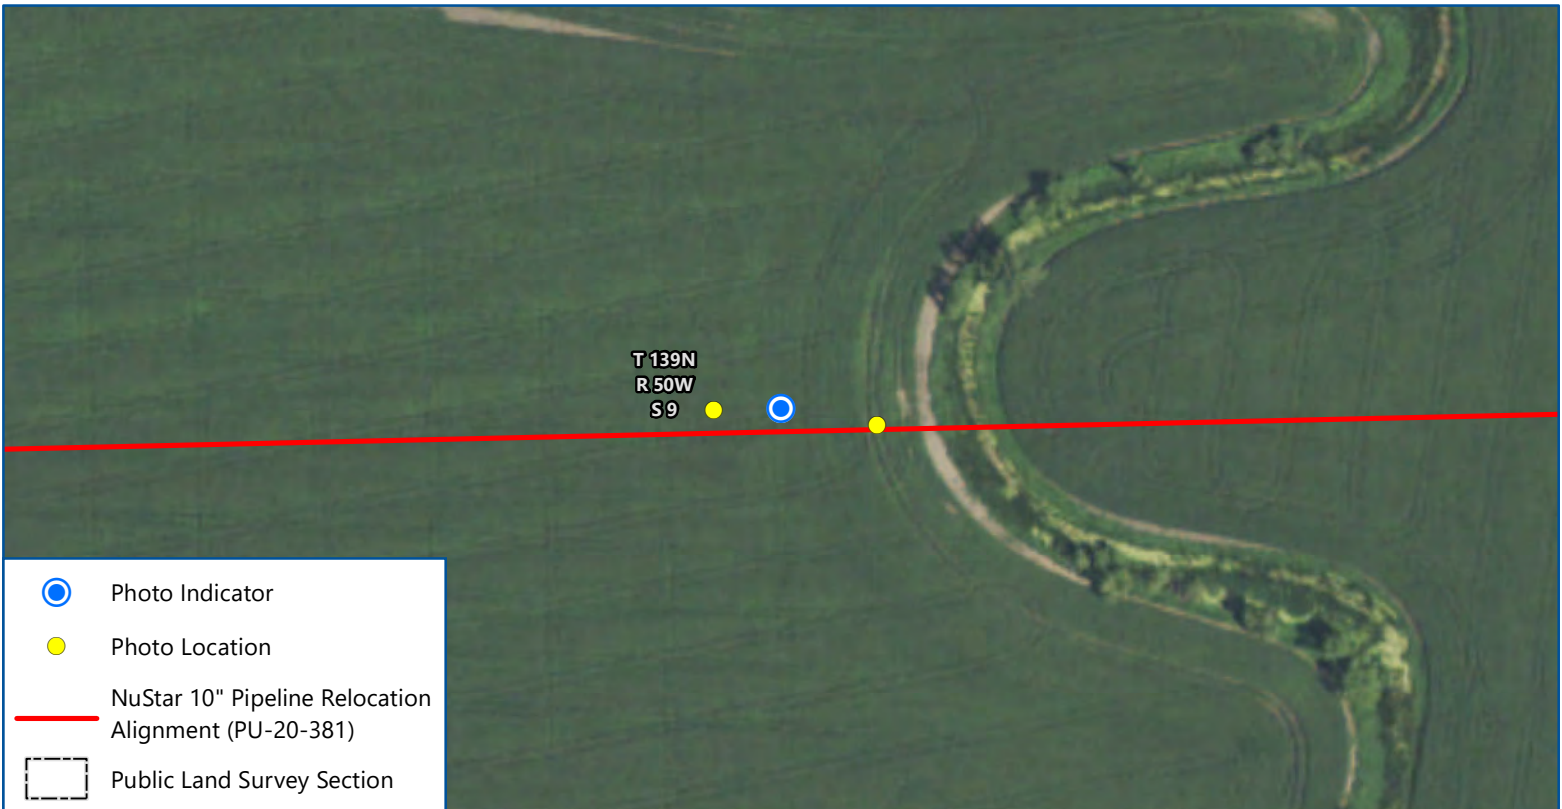
Map 15 of 18

Date: 7/13/2021  
 Photo Direction: West  
 Comment: Subsoil and topsoil segregation;  
 active excavation 9 feet below ground  
 surface

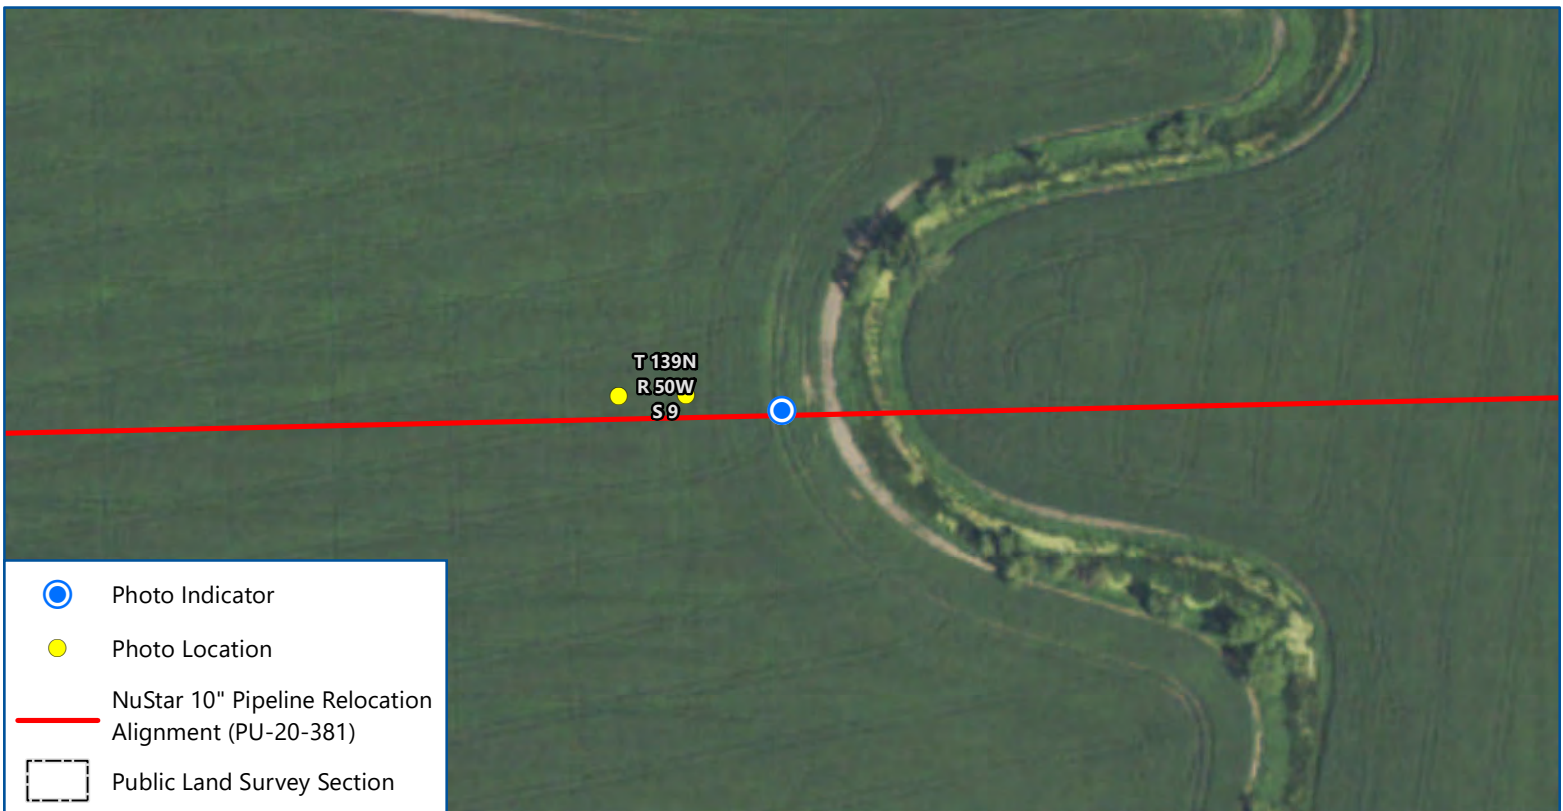
Map 16 of 18

Date: 7/13/2021  
 Photo Direction: West  
 Comment: Pipeline staging area

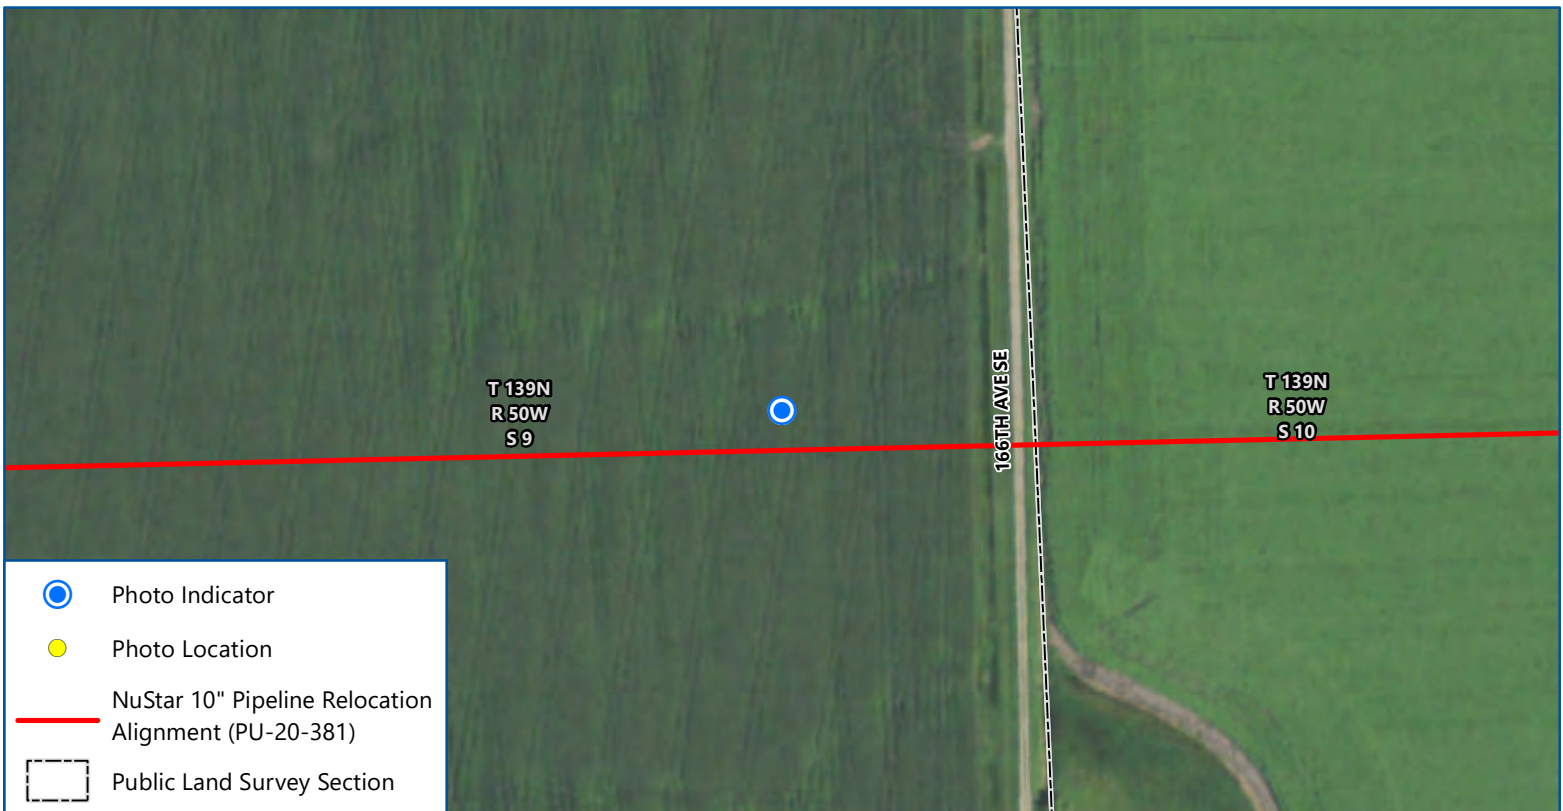
Map 17 of 18

Date: 7/13/2021  
 Photo Direction: East  
 Comment: Silt fence up gradient of wetland; no erosion observed
