+NuStar 10" Pipeline Relocation Project

As-Built Inspection Report

Docket Number: PU-20-381

Prepared for North Dakota Public Service Commission

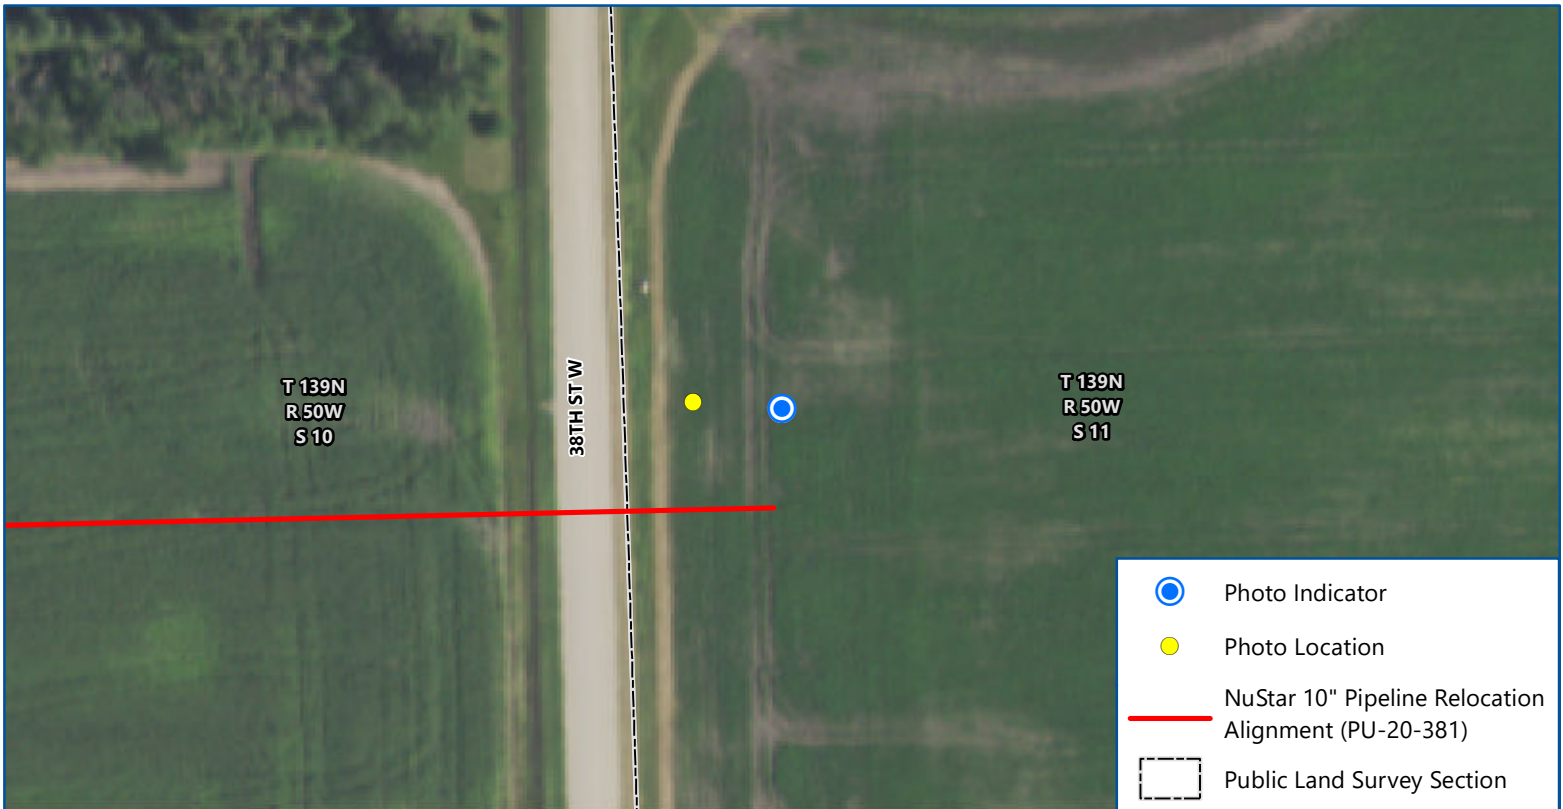
Map 1 of 24
**NUSTAR 10" PIPELINE RELOCATION
 AS-BUILT INSPECTION**
PU-20-381
 North Dakota Public Service Commission
 Cass County, North Dakota

Date: 8/26/2022
 Photo Direction: East
 Comment: Tie in location

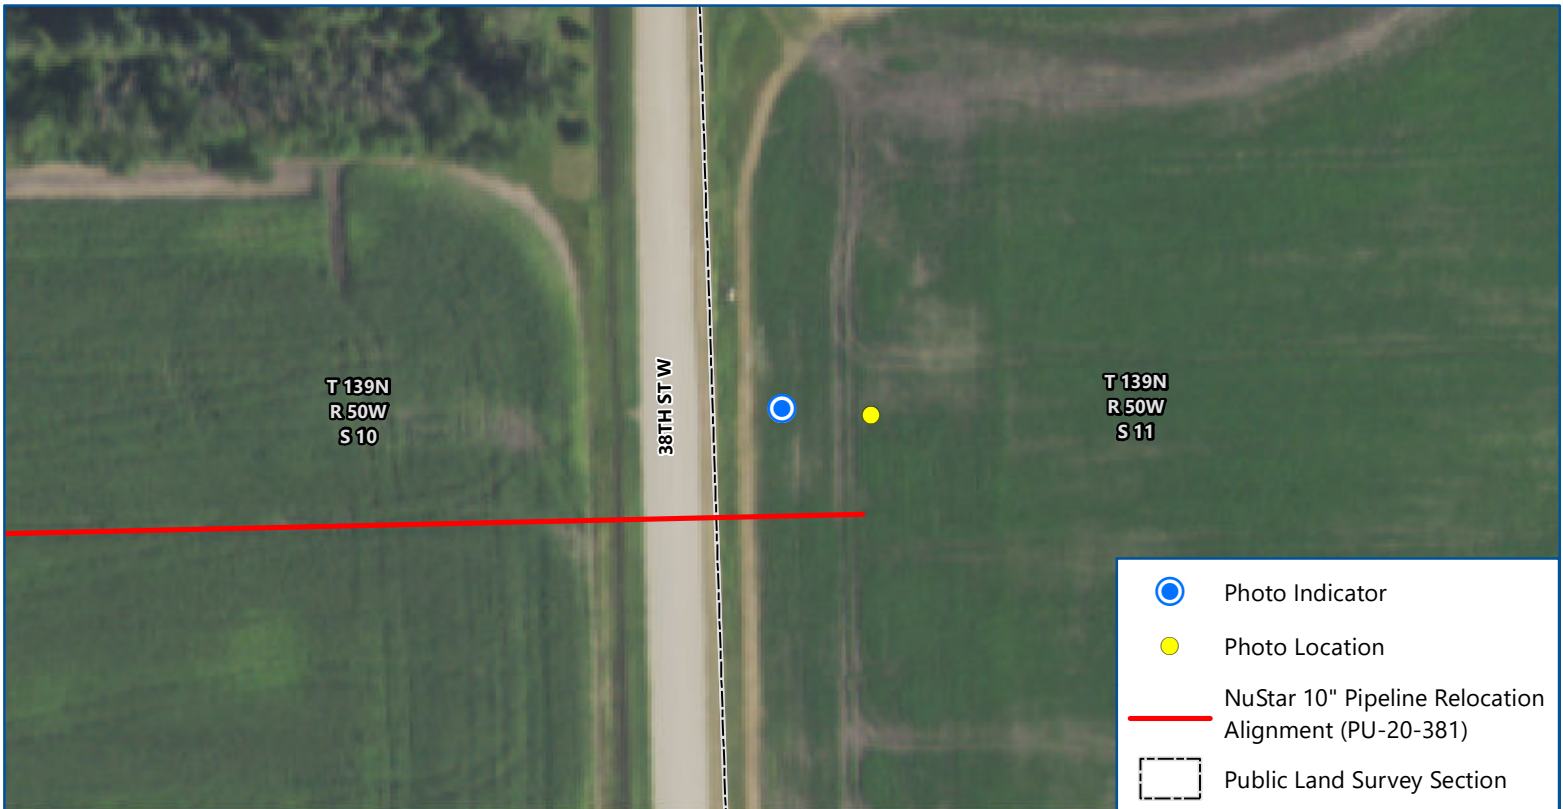
Map 2 of 24

Date: 8/26/2022
 Photo Direction: West
 Comment: No visible issues

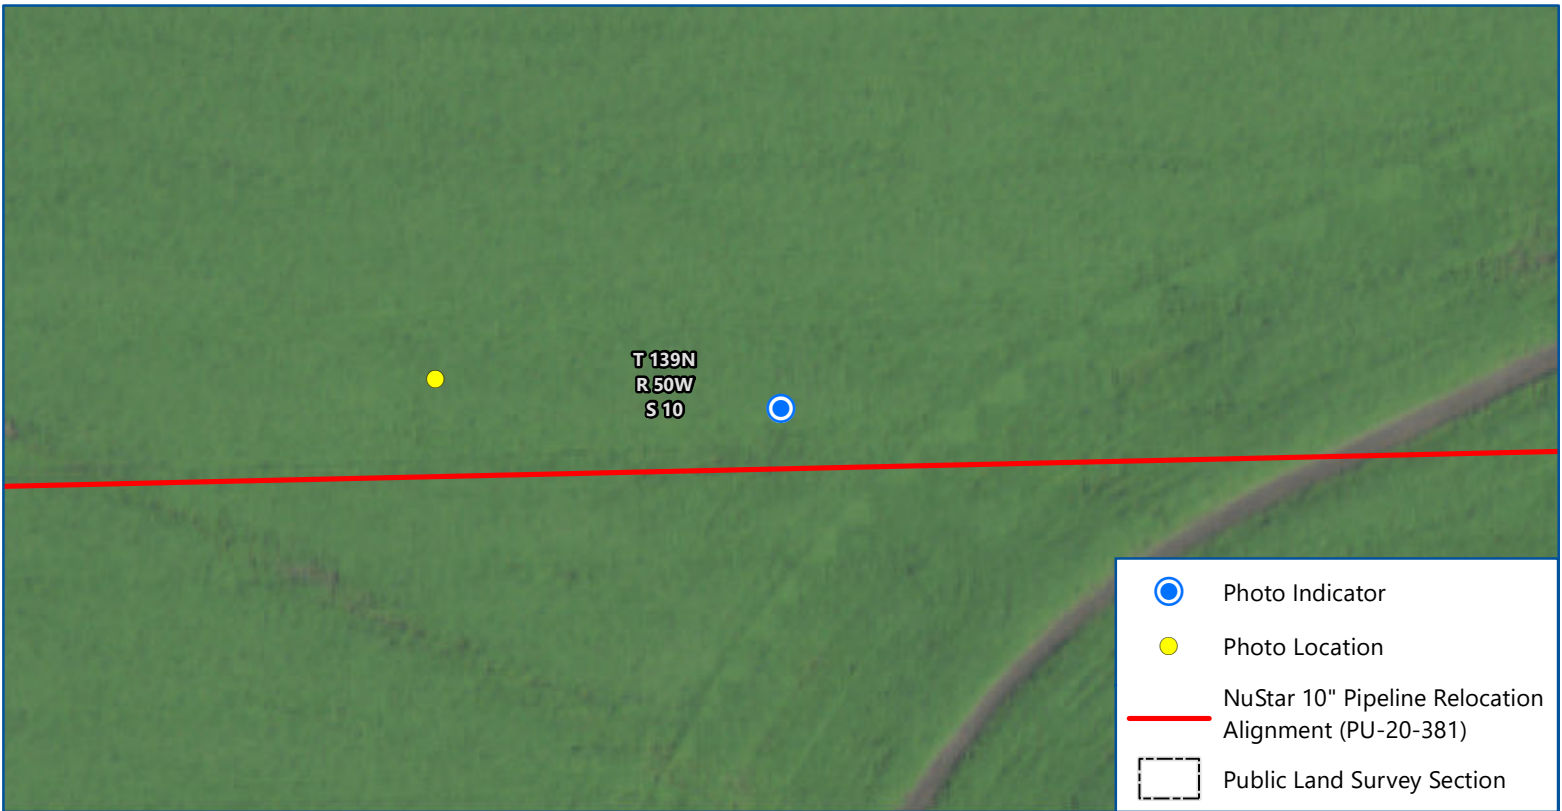
Map 3 of 24

Date: 8/26/2022
 Photo Direction: East
 Comment: No visible issues, corn planted over pipeline

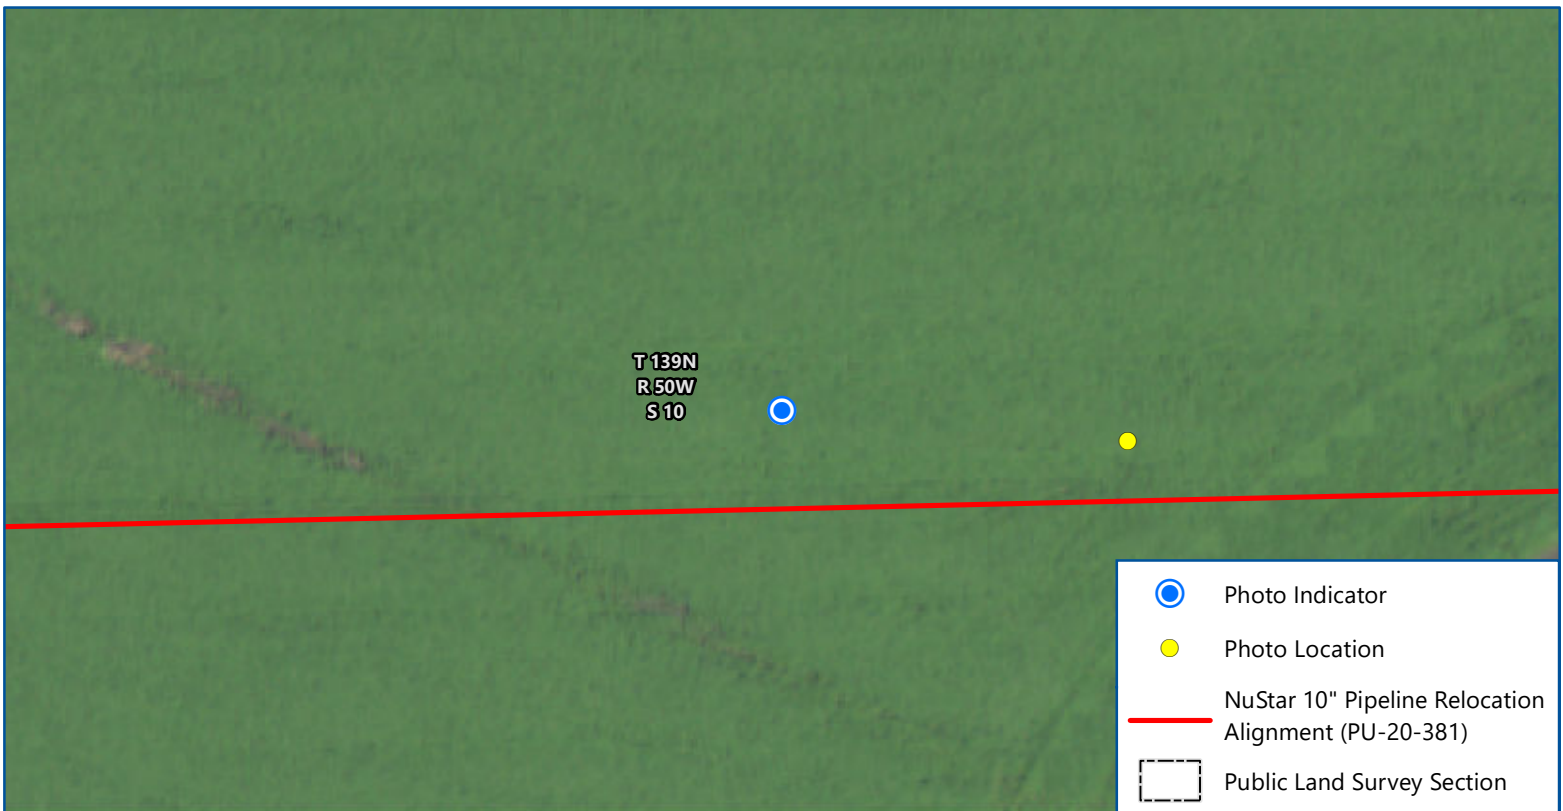
Map 4 of 24

Date: 8/26/2022
 Photo Direction: East
 Comment: No visible issues

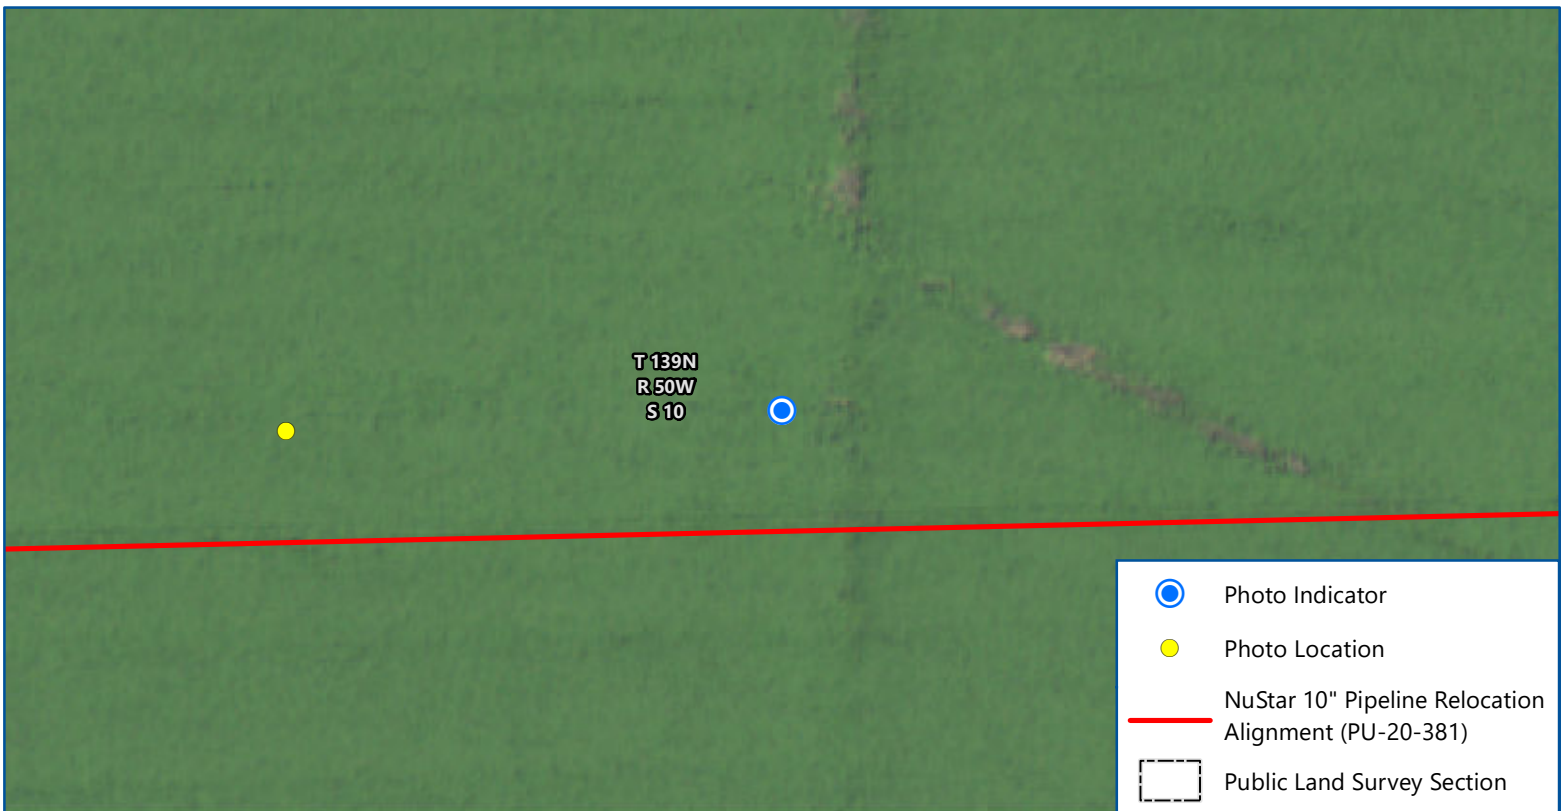
Map 5 of 24

Date: 8/26/2022
 Photo Direction: East
 Comment: No visible issues, cropland adjacent was flooded

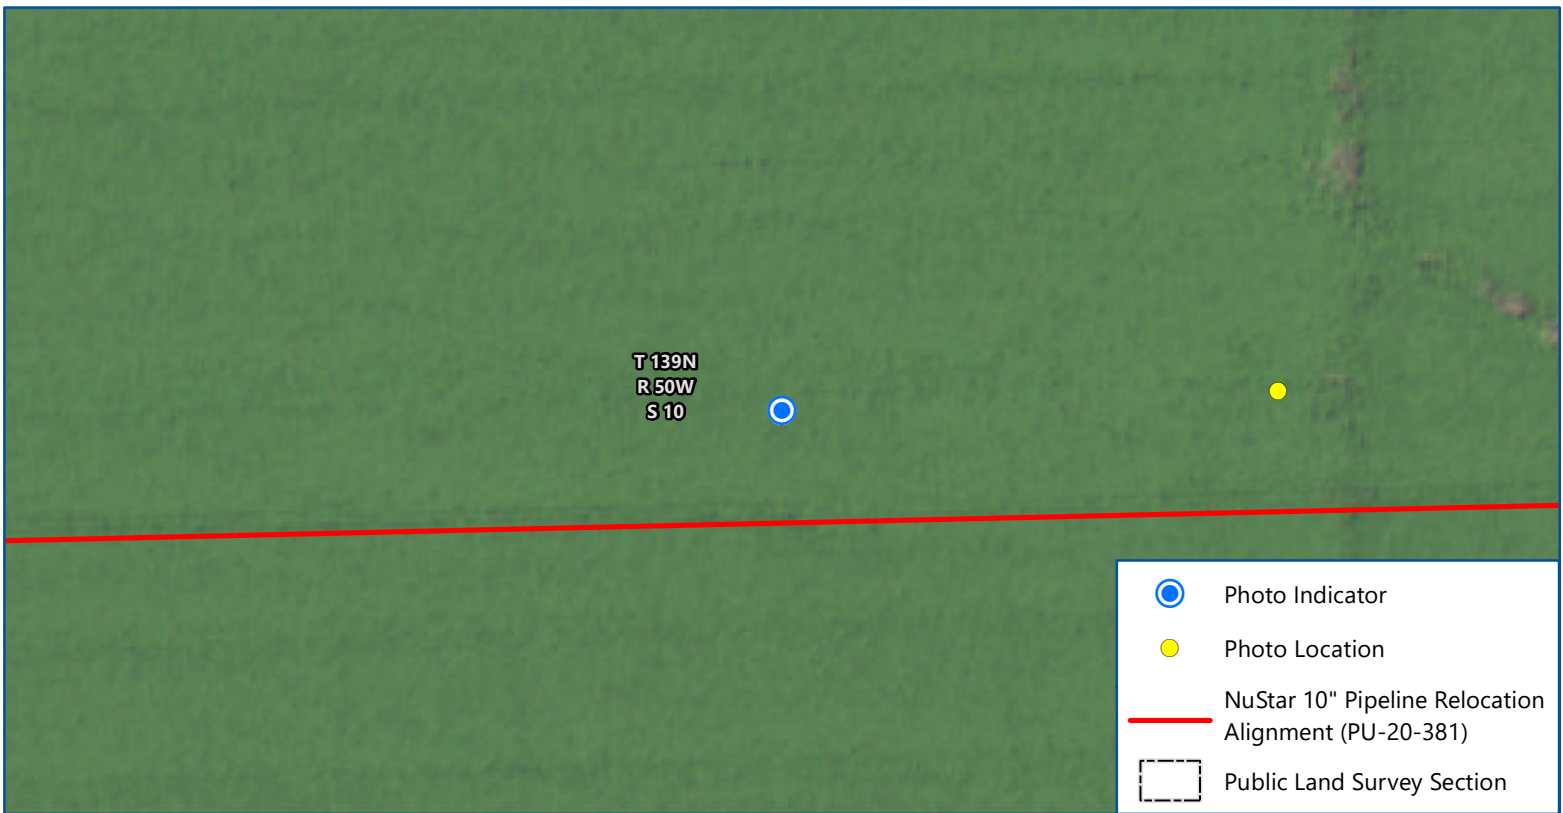
Map 6 of 24

Date: 8/26/2022
 Photo Direction: West
 Comment: No visible issues

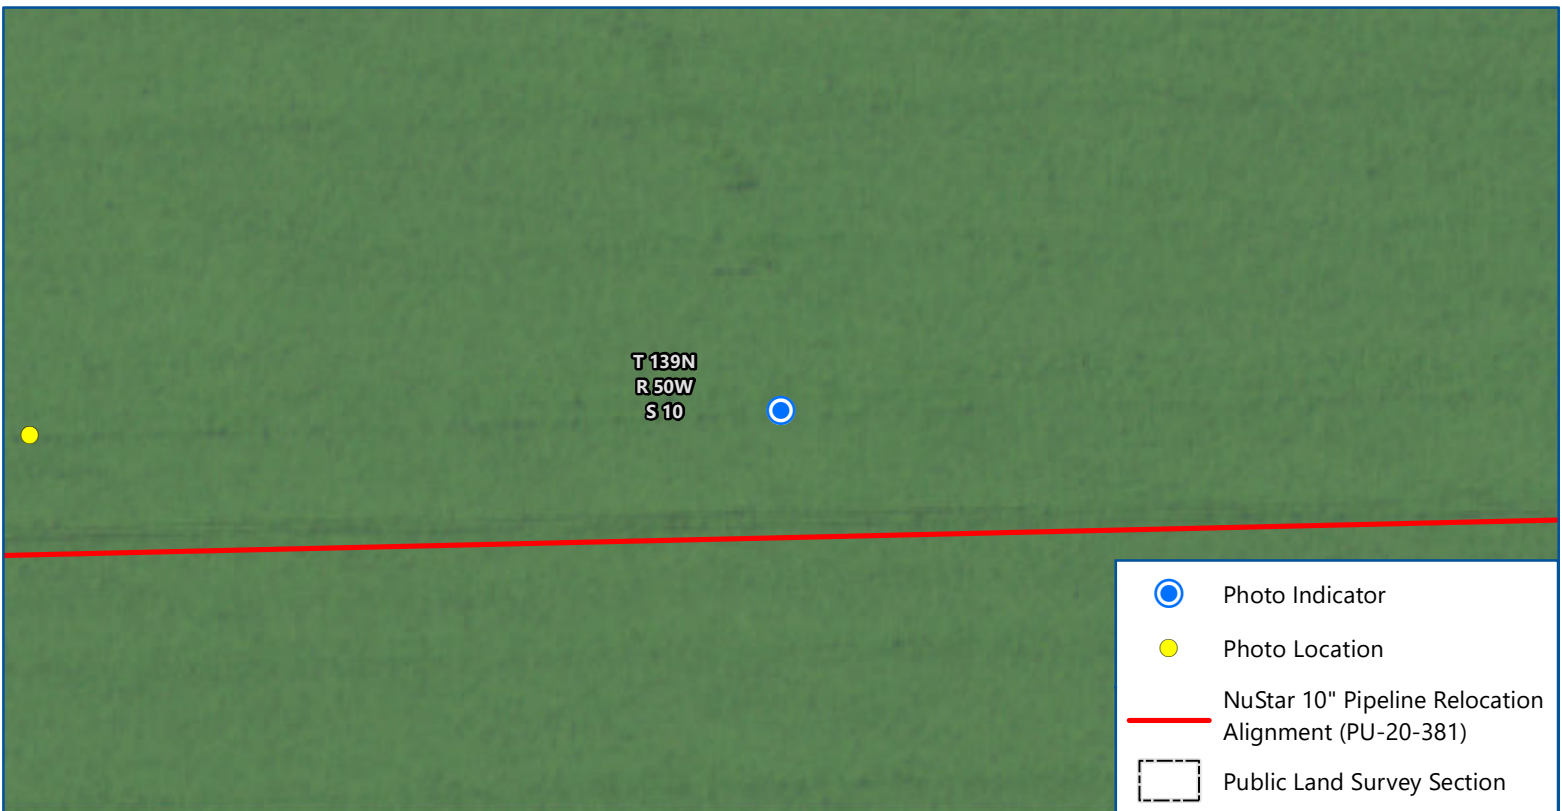
Map 7 of 24
**NUSTAR 10" PIPELINE RELOCATION
 AS-BUILT INSPECTION**
PU-20-381
 North Dakota Public Service Commission
 Cass County, North Dakota

Date: 8/26/2022
 Photo Direction: East
 Comment: No visible issues

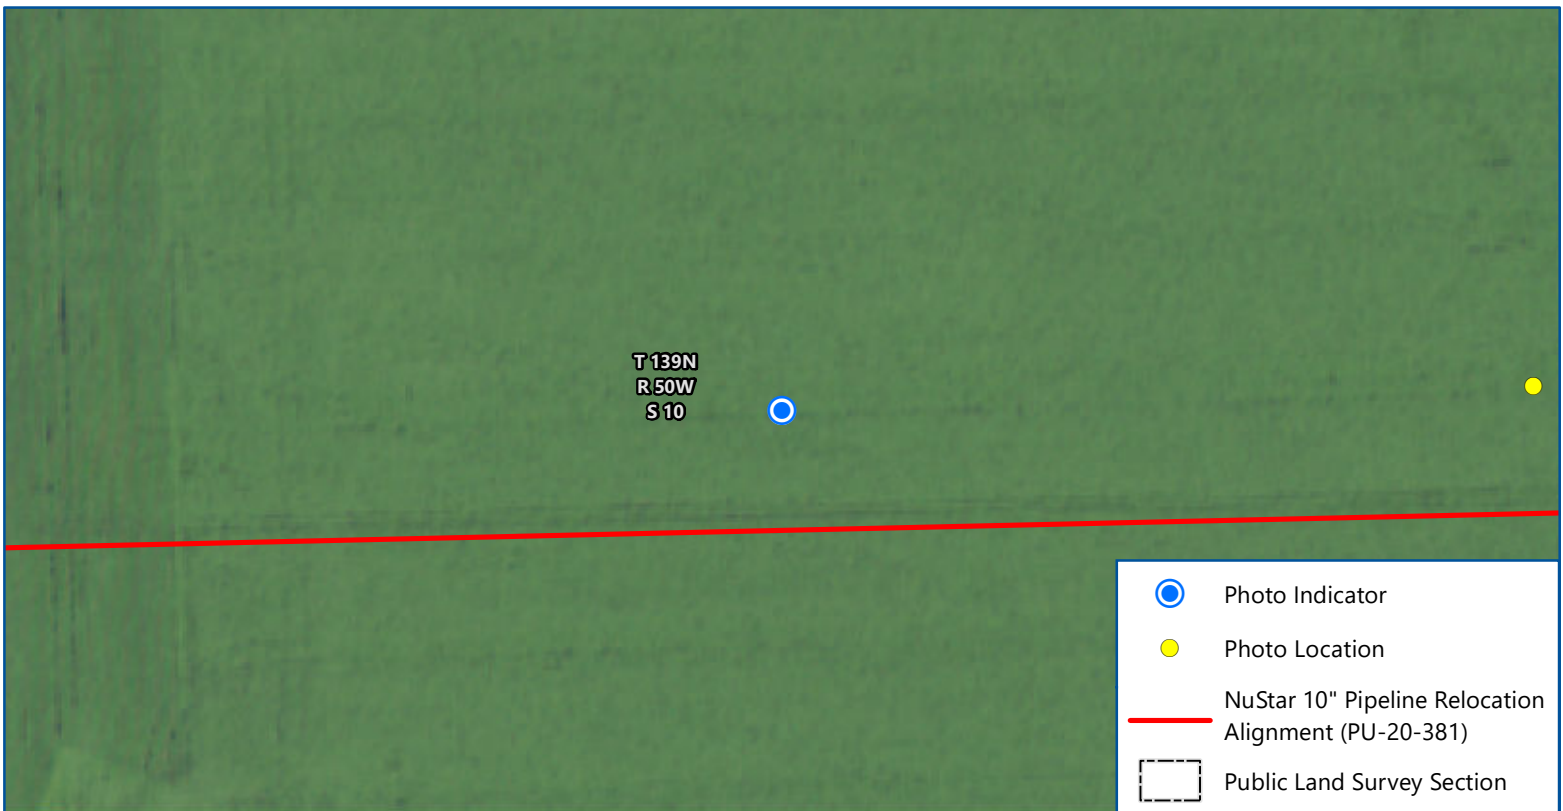
Map 8 of 24

Date: 8/26/2022
 Photo Direction: East
 Comment: No visible issues

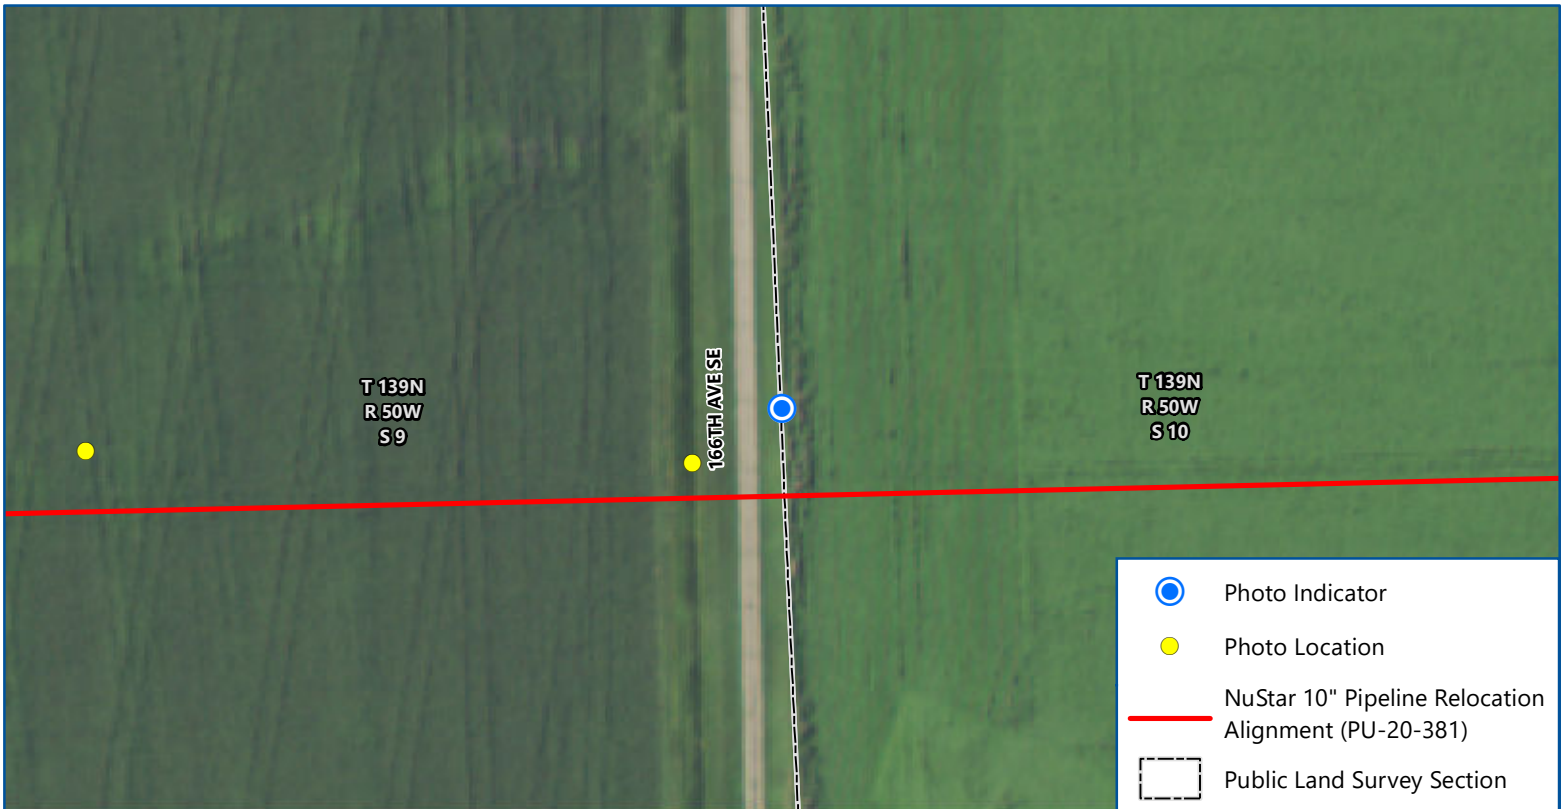
Map 9 of 24

Date: 8/26/2022
Photo Direction: East
Comment: No visible issues

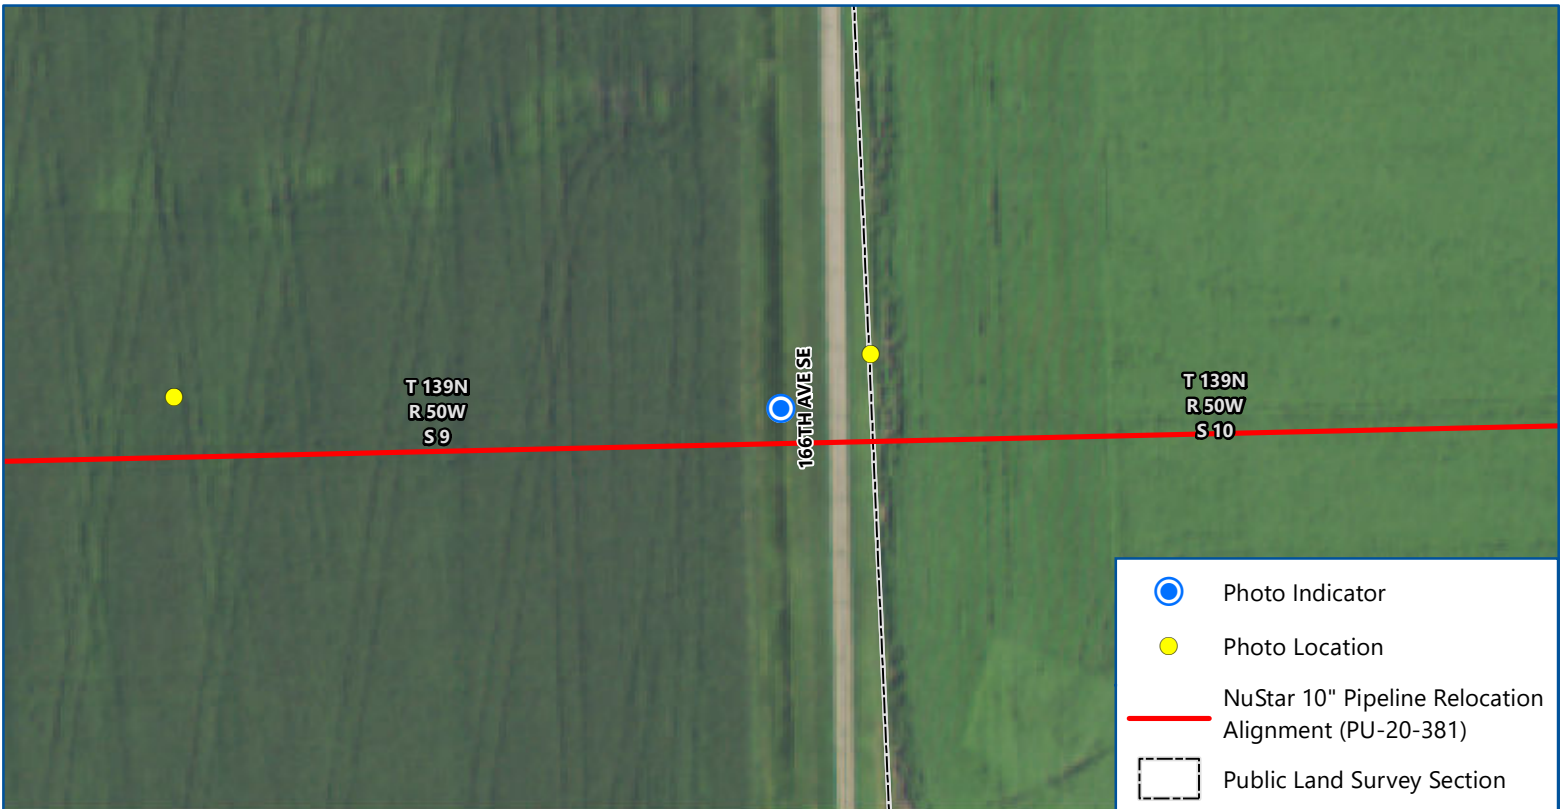
Map 10 of 24
**NUSTAR 10" PIPELINE RELOCATION
 AS-BUILT INSPECTION**
PU-20-381
 North Dakota Public Service Commission
 Cass County, North Dakota

Date: 8/26/2022
 Photo Direction: West
 Comment: No visible issues

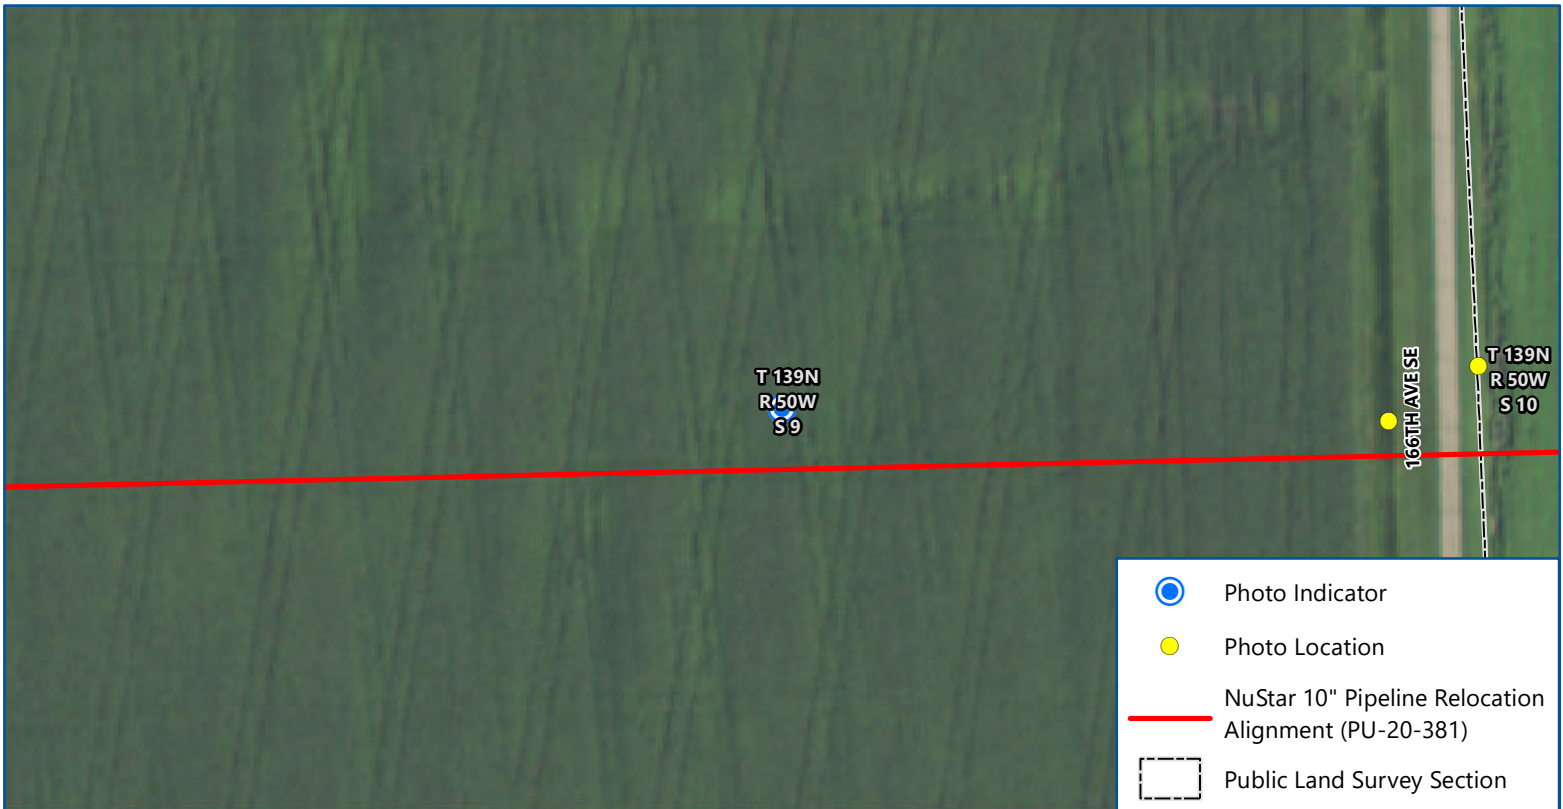
Map 11 of 24

Date: 8/26/2022
 Photo Direction: West
 Comment: No visible issues

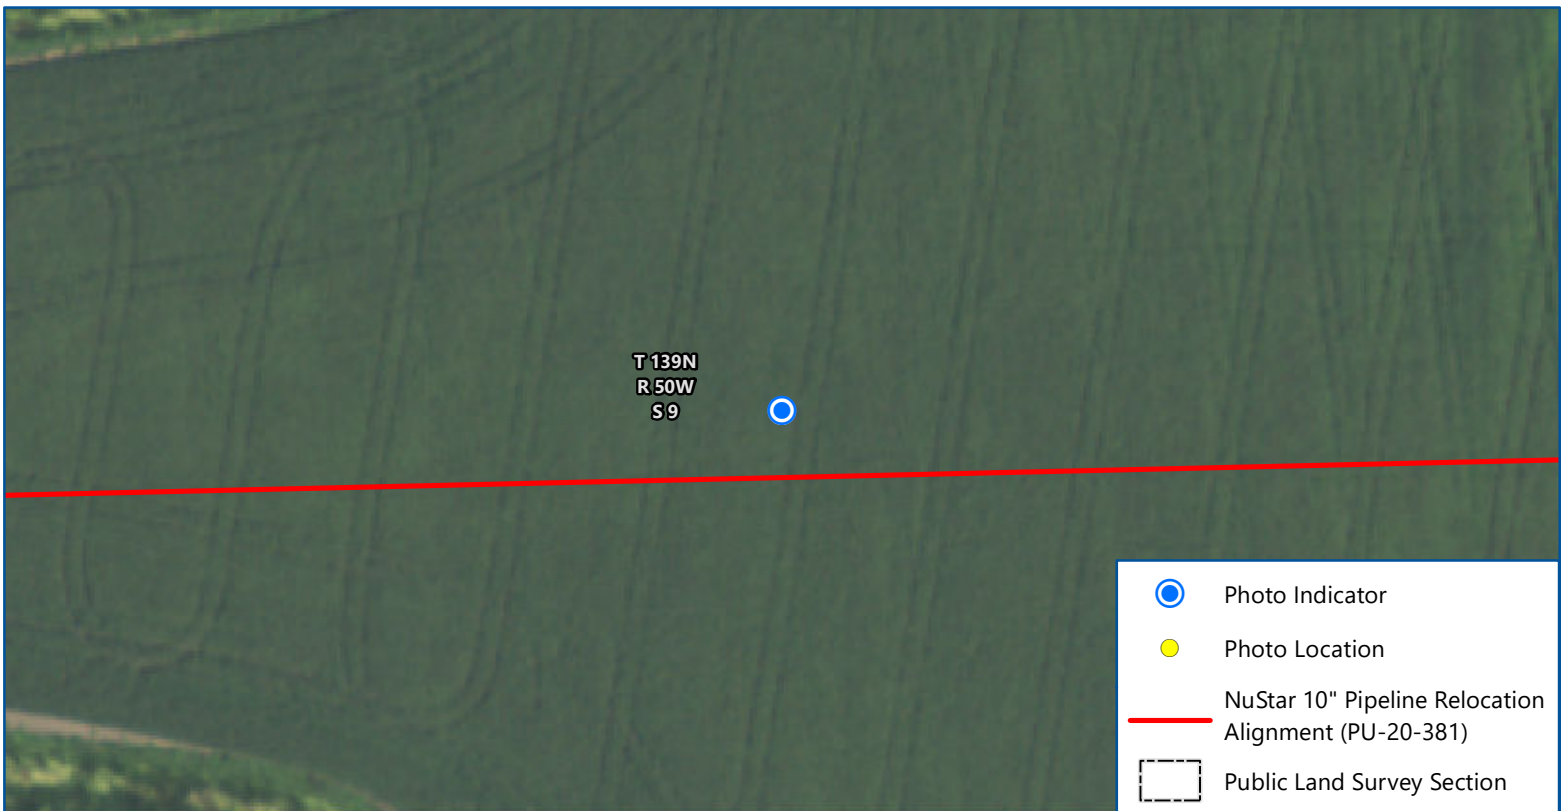
Map 12 of 24

Date: 8/26/2022
 Photo Direction: West
 Comment: No visible issues

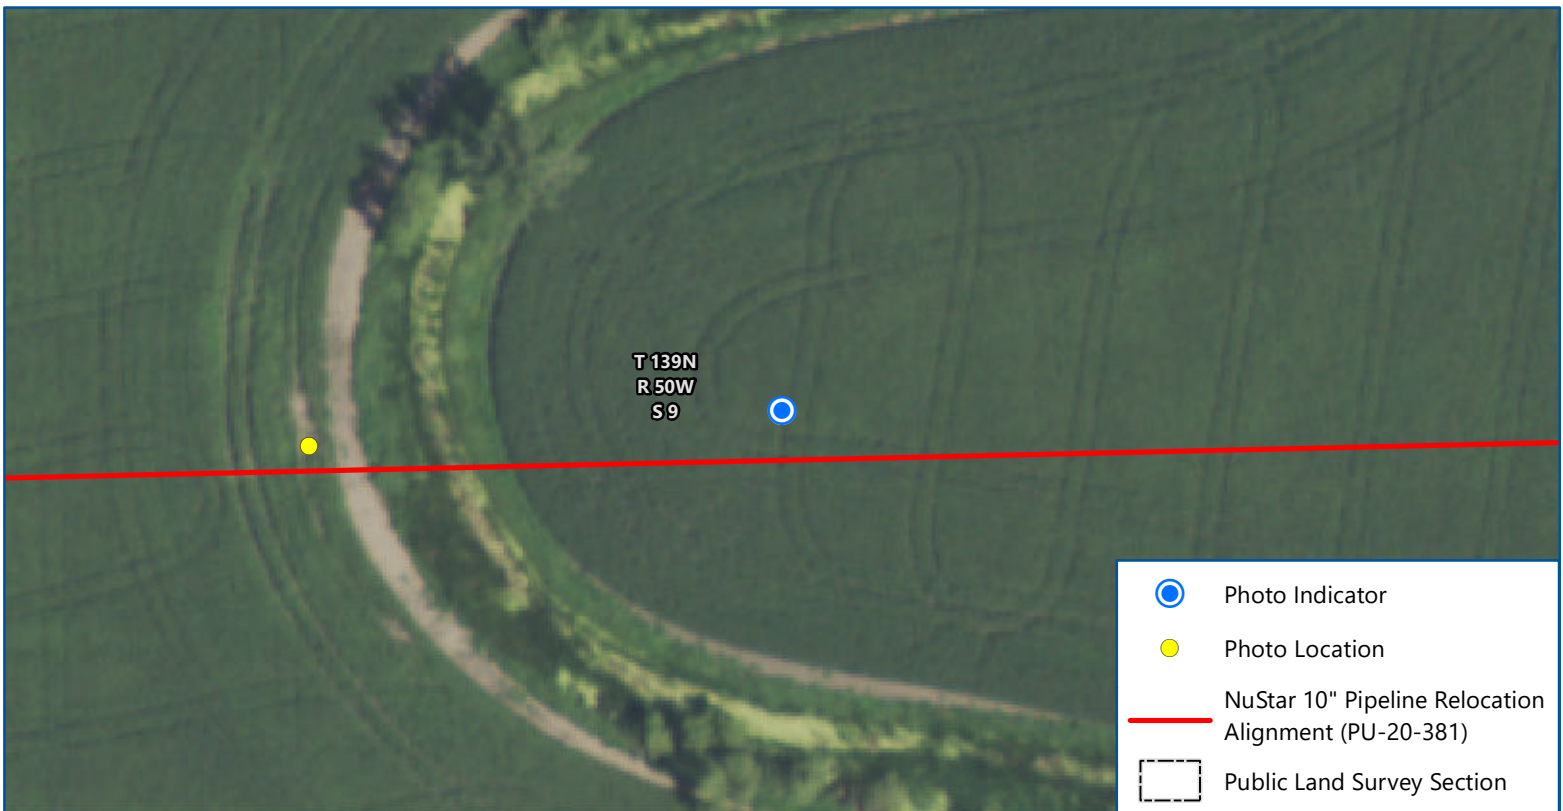
Map 13 of 24

Date: 8/26/2022
 Photo Direction: West
 Comment: No visible issues

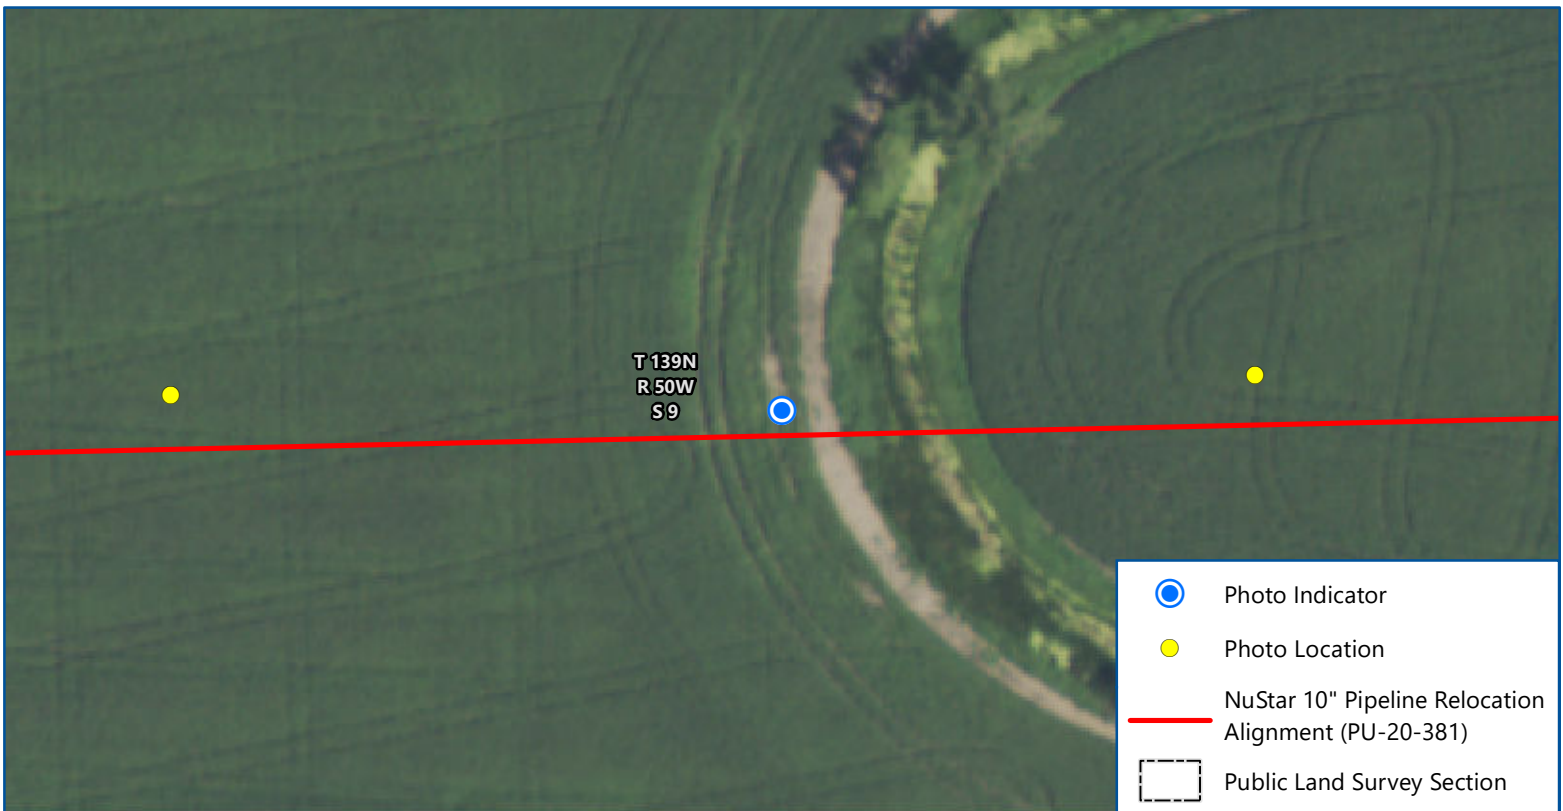
Map 14 of 24

Date: 8/26/2022
 Photo Direction: East
 Comment: No visible issues, drainage

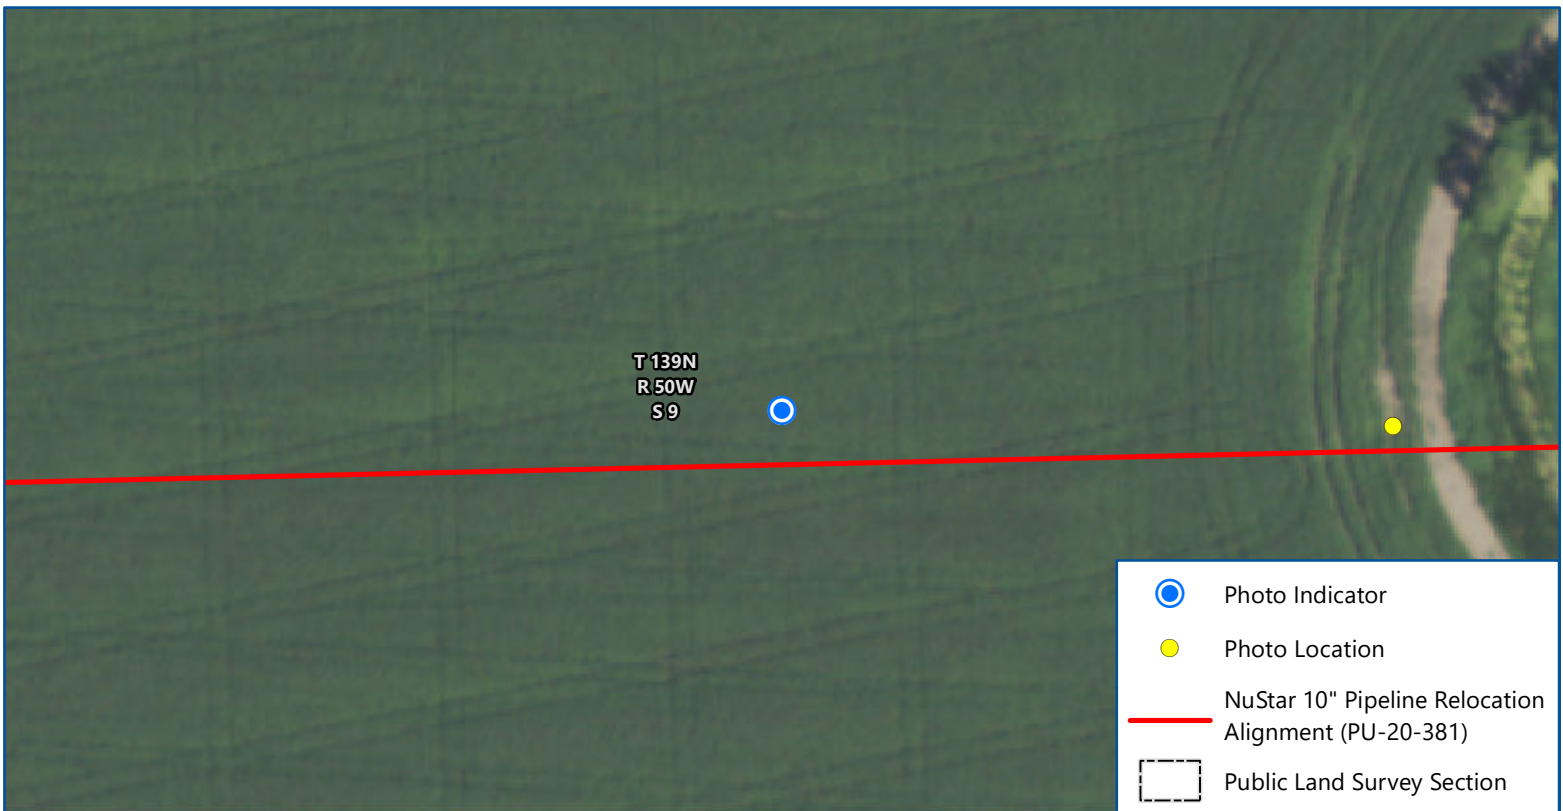
Map 15 of 24

Date: 8/26/2022
 Photo Direction: West
 Comment: No visible issues

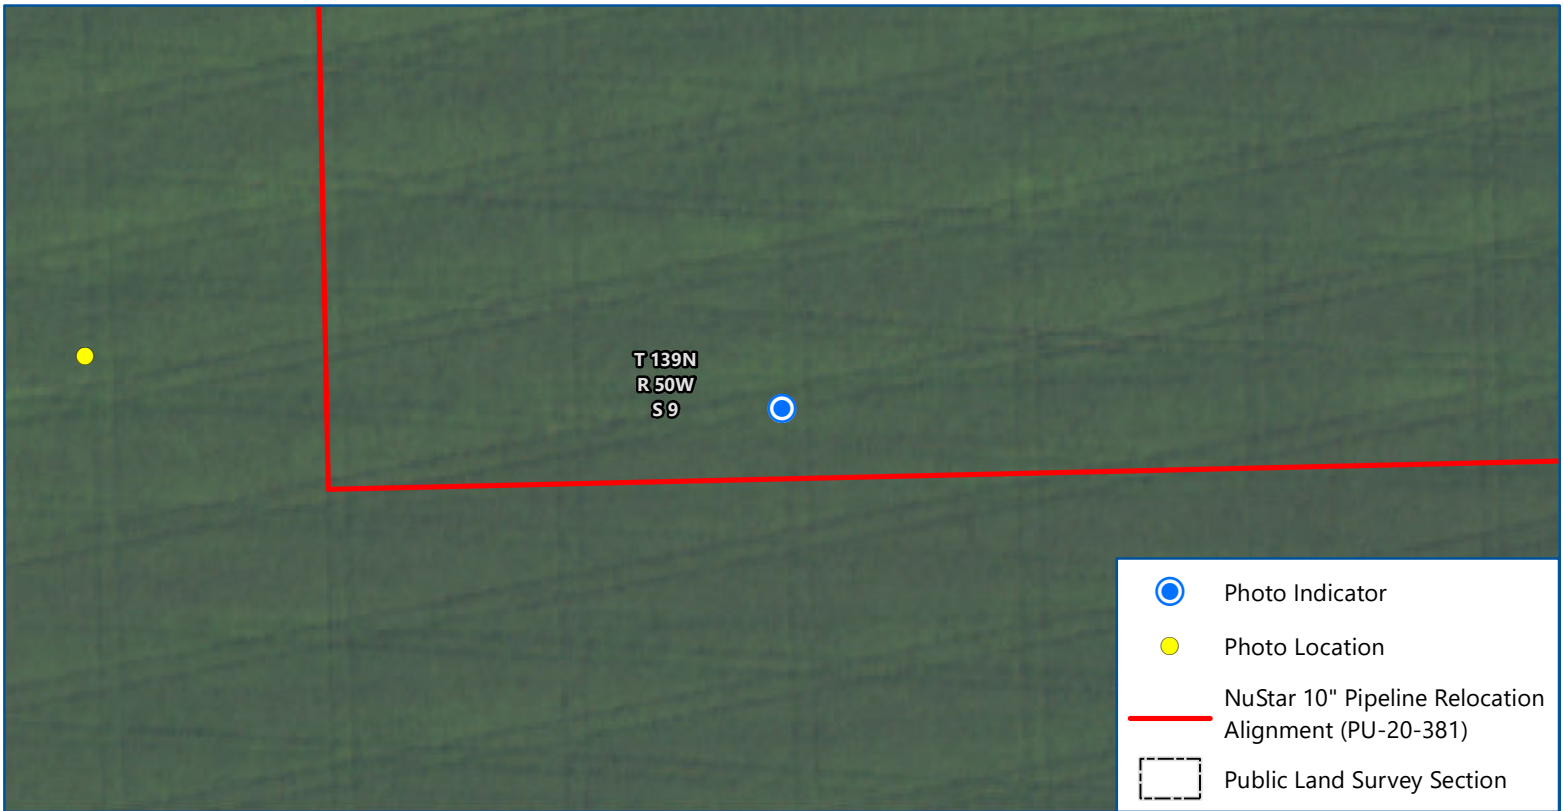
Map 16 of 24

Date: 8/26/2022
 Photo Direction: North
 Comment: Cropland flooded out due to project construction

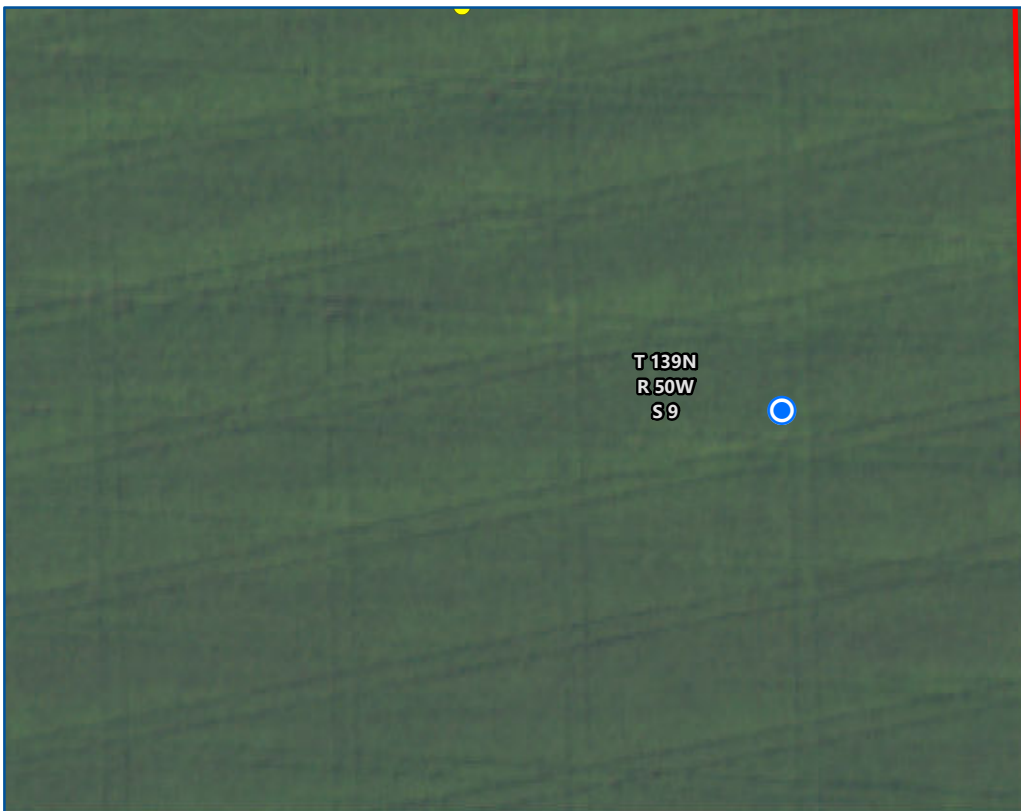
Map 17 of 24

Date: 8/26/2022
 Photo Direction: North
 Comment: No visible issues

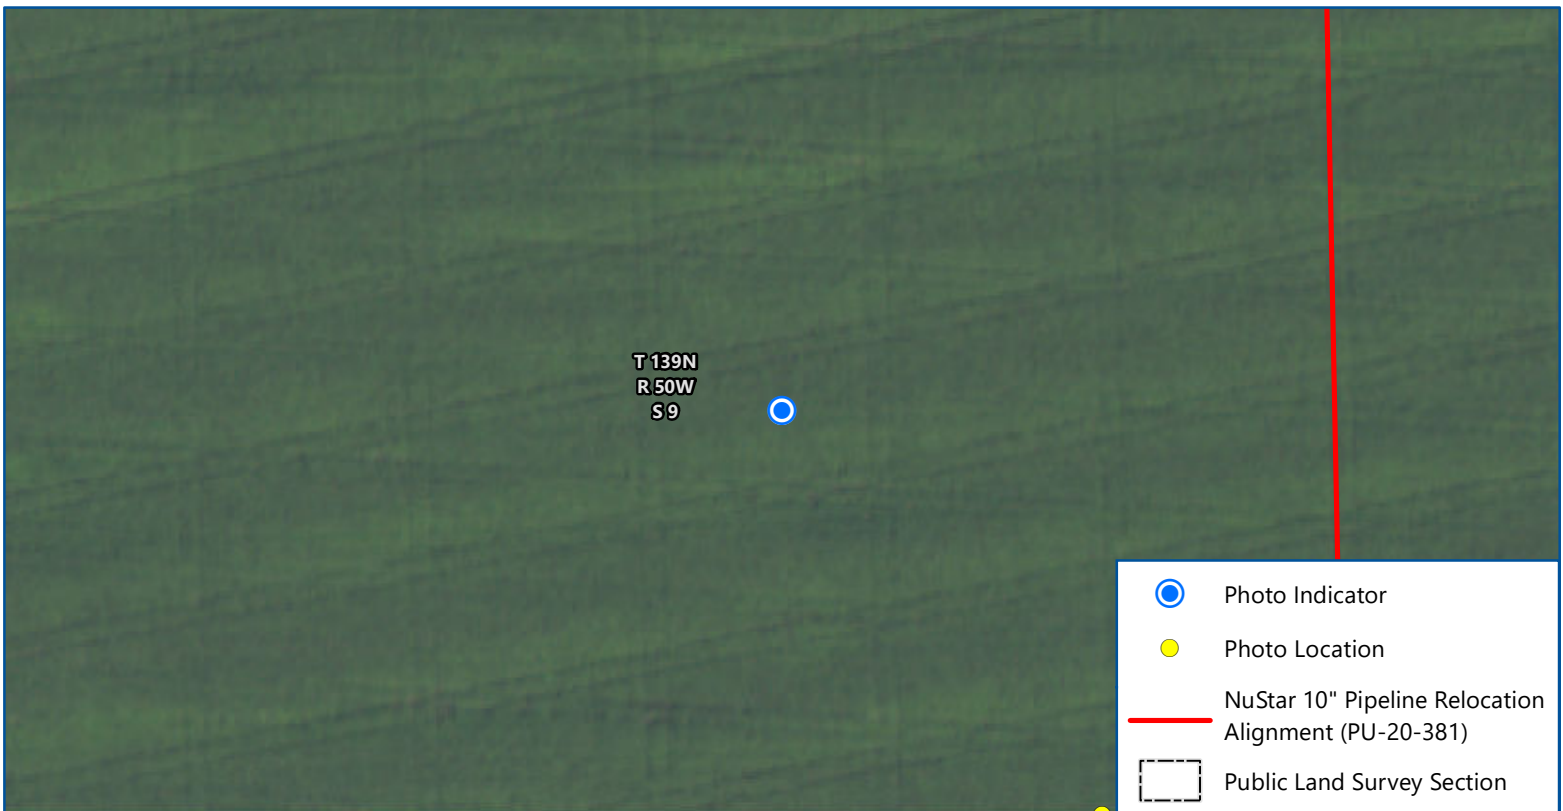
Map 18 of 24

Date: 8/26/2022
 Photo Direction: East
 Comment: 20 acres farmland flooded out due to project
