+NuStar 10" Pipeline Relocation Project

As-Built Inspection Report

Docket Number: PU-20-381

Prepared for North Dakota Public Service Commission

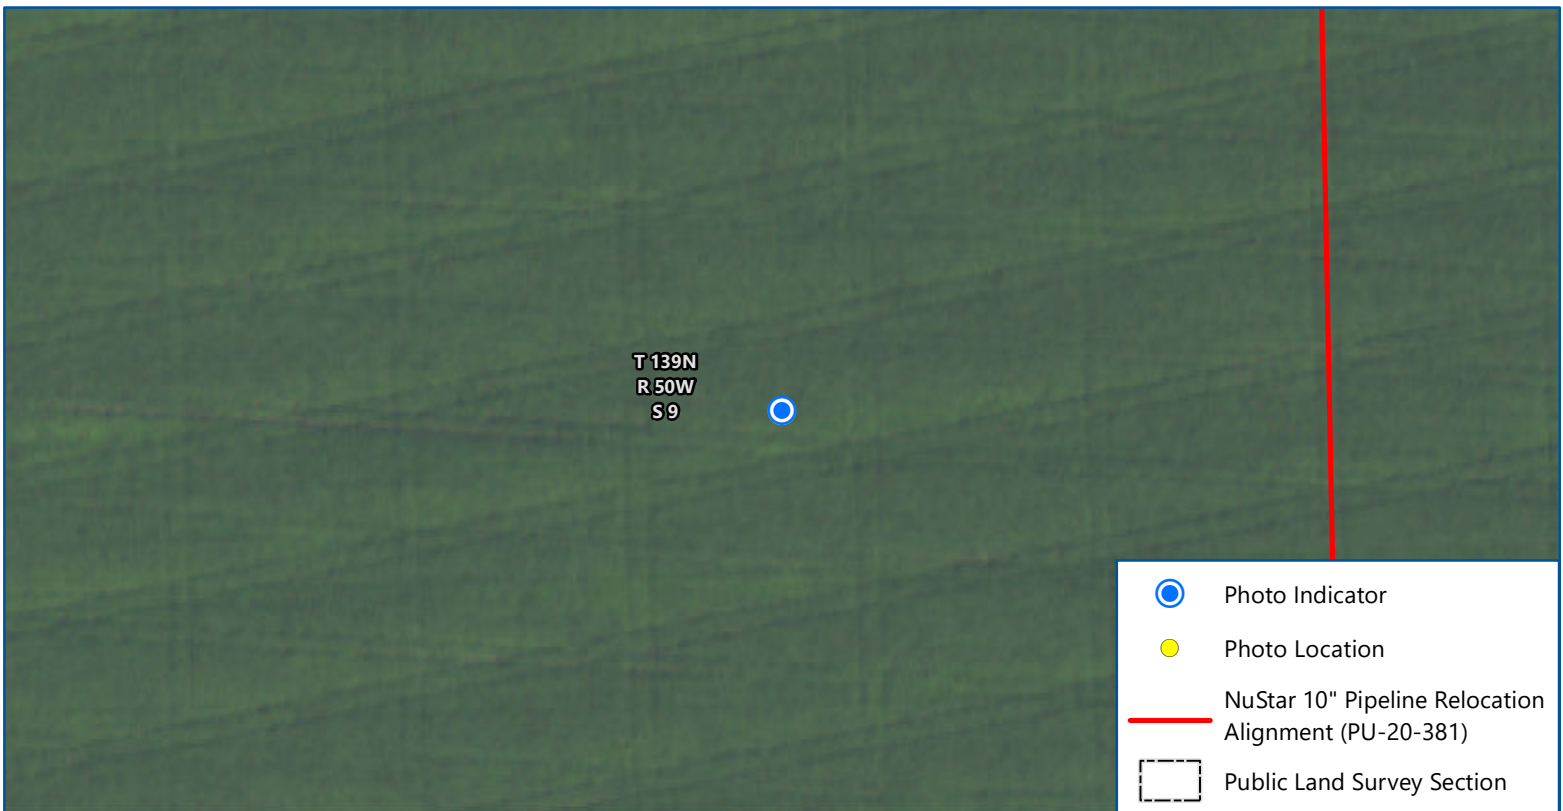
Map 19 of 24

Date: 8/26/2022
 Photo Direction: North
 Comment: No visible issues

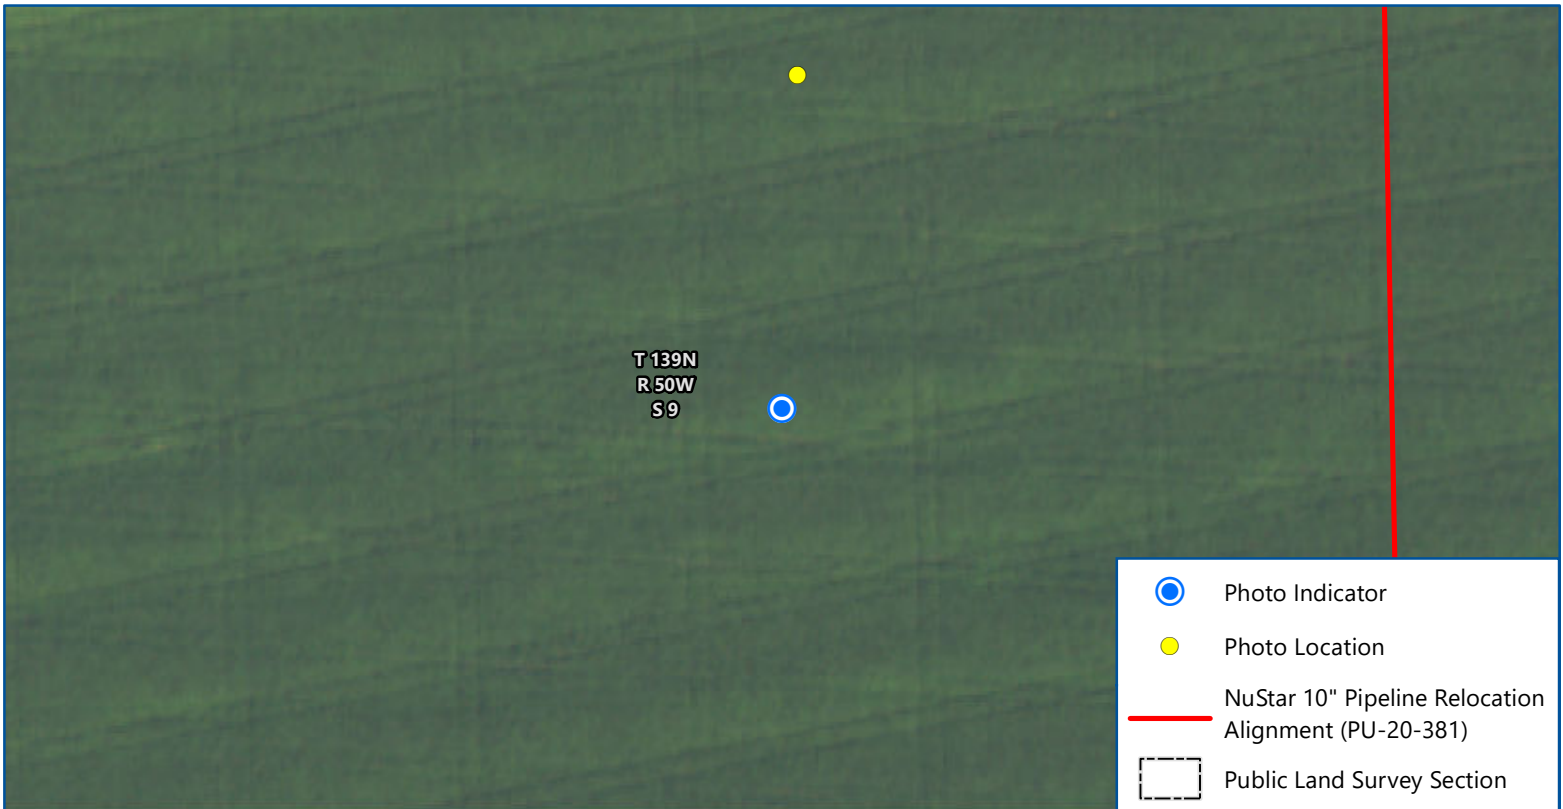
Map 20 of 24

Date: 8/26/2022
 Photo Direction: South
 Comment: No visible issues

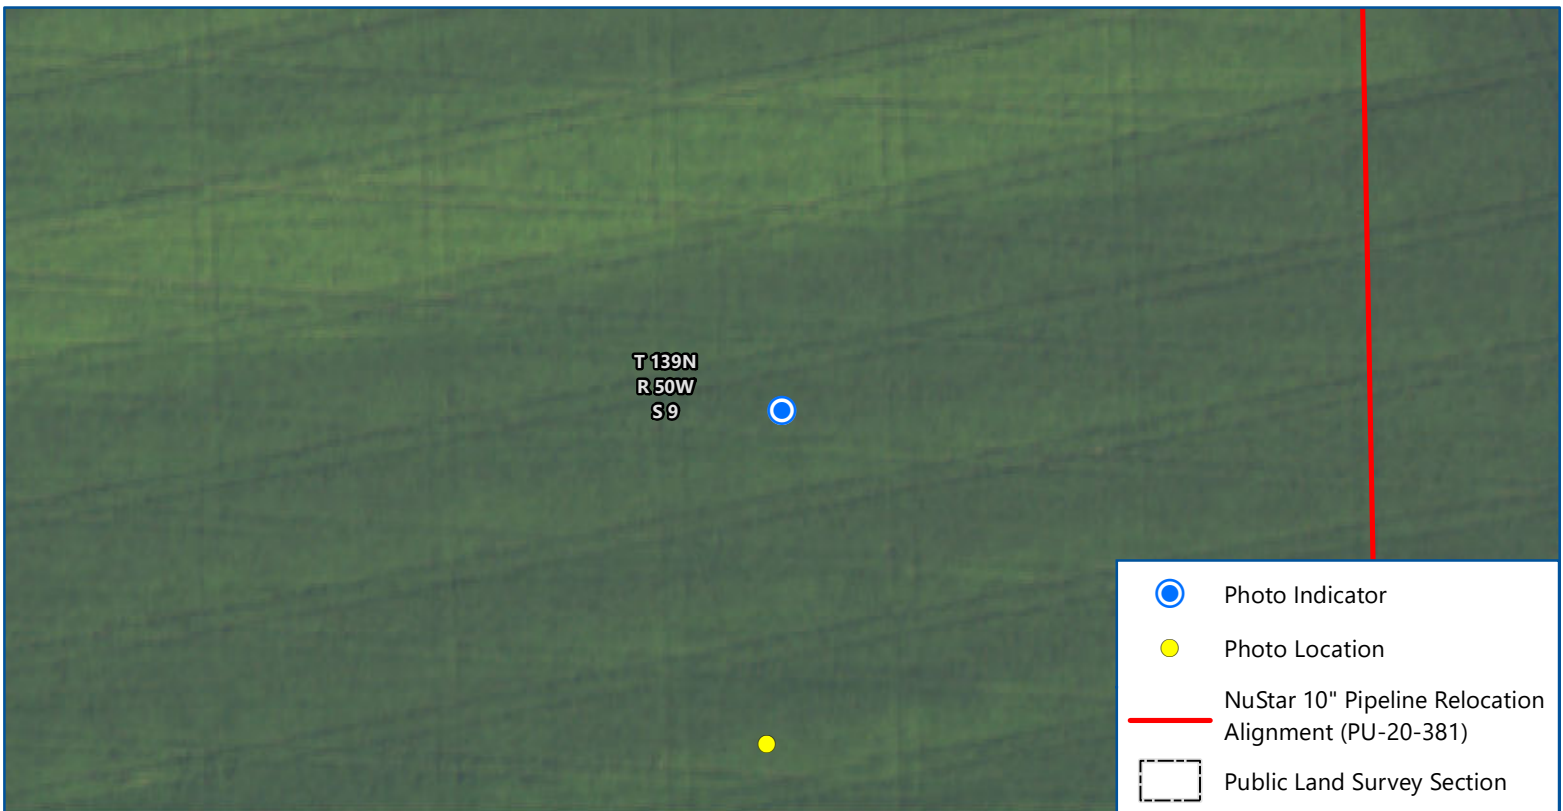
Map 21 of 24

Date: 8/26/2022
 Photo Direction: North
 Comment: No visible issues

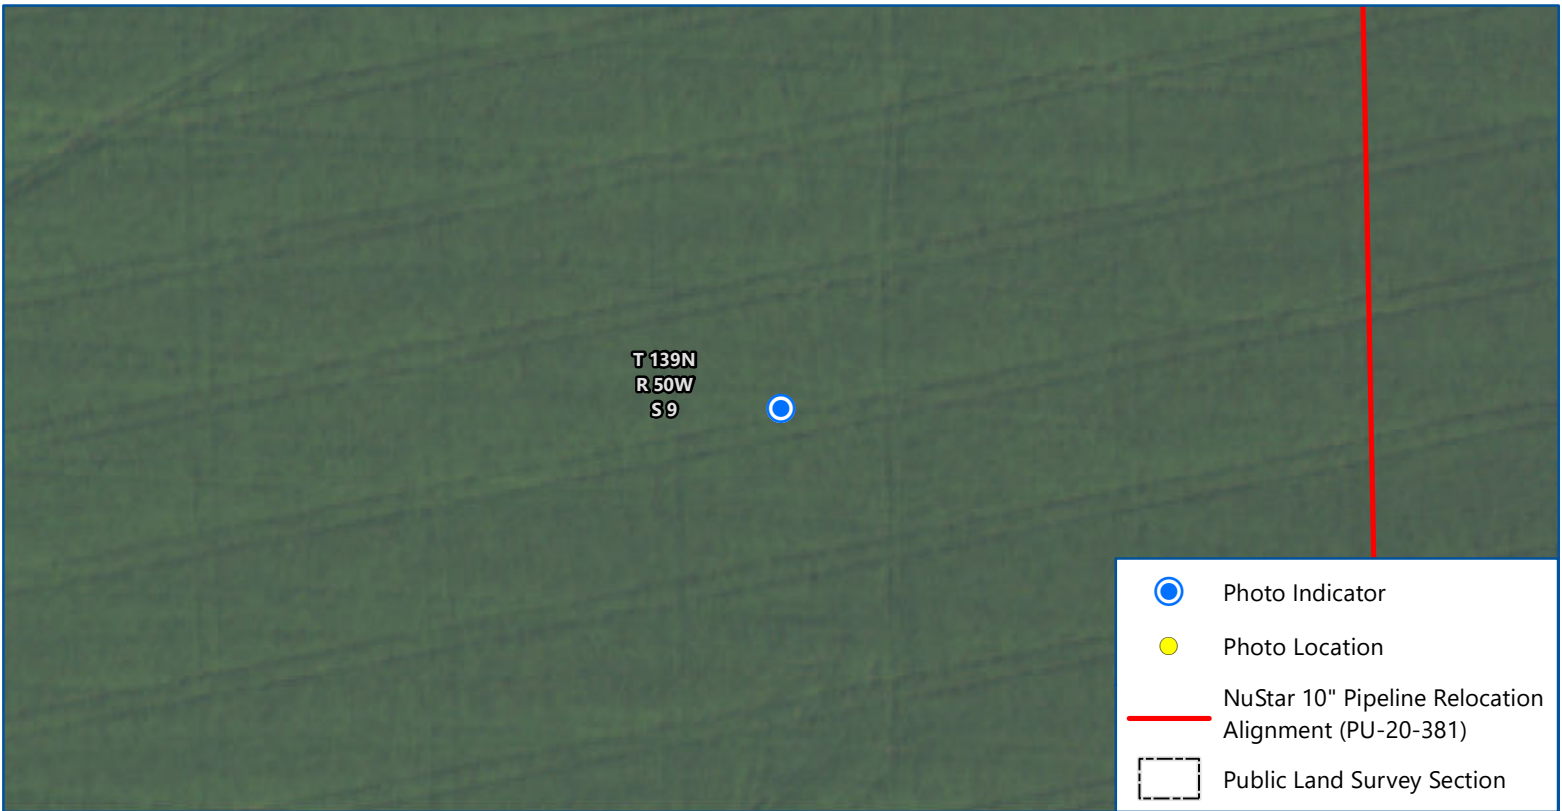
Map 22 of 24

Date: 8/26/2022
 Photo Direction: North
 Comment: No visible issues, narrower pipeline ROW

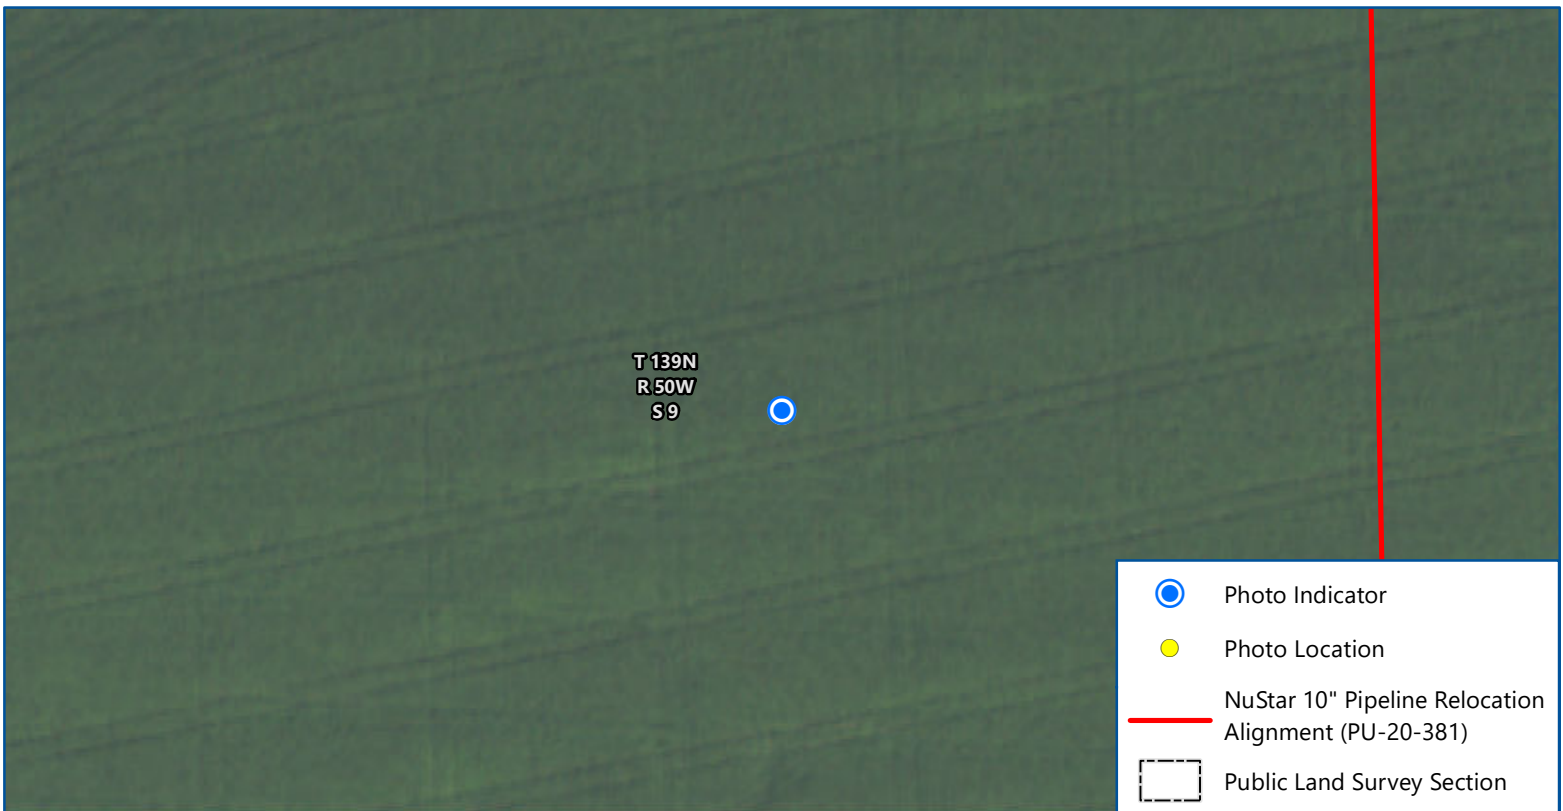
Map 23 of 24

Date: 8/26/2022
 Photo Direction: North
 Comment: No visible issues, tie in point

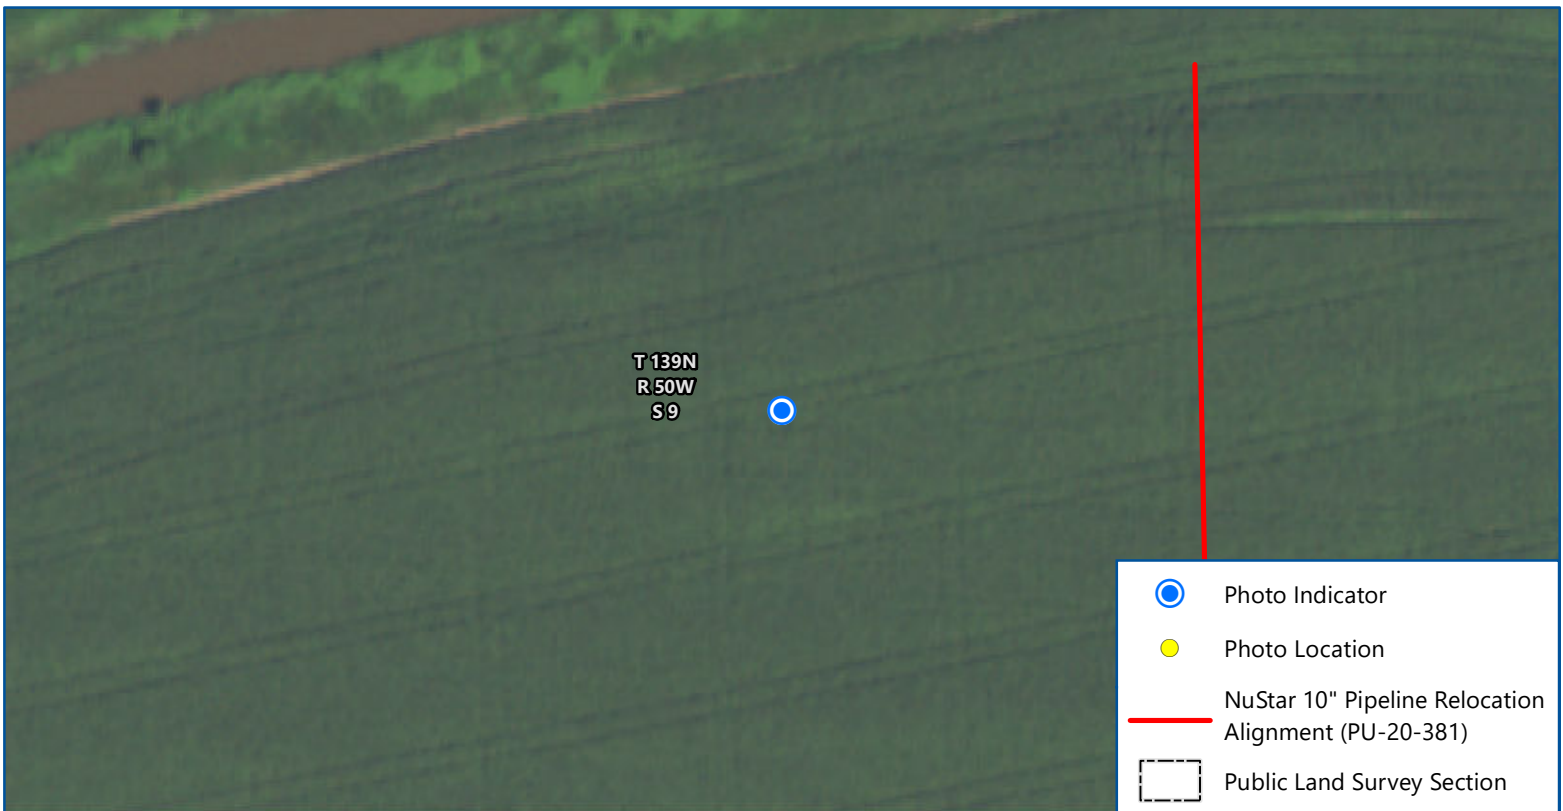
Map 24 of 24

Date: 8/26/2022
 Photo Direction: South
 Comment: No visible issues
