INCIDENT INVESTIGATION #198277

31ST AVE SE & S MAIN ST, MINOT, ND

11 PU-20-423 Filed 01/03/2022 Pages: 37
Additional information from complainant
Montana-Dakota Utilities Co.

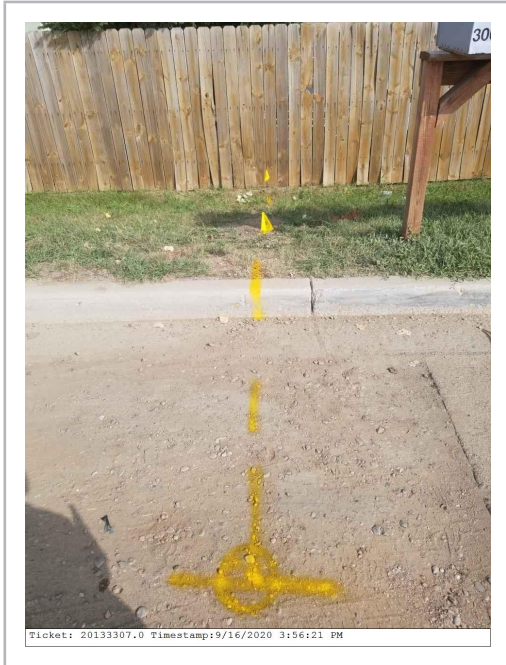
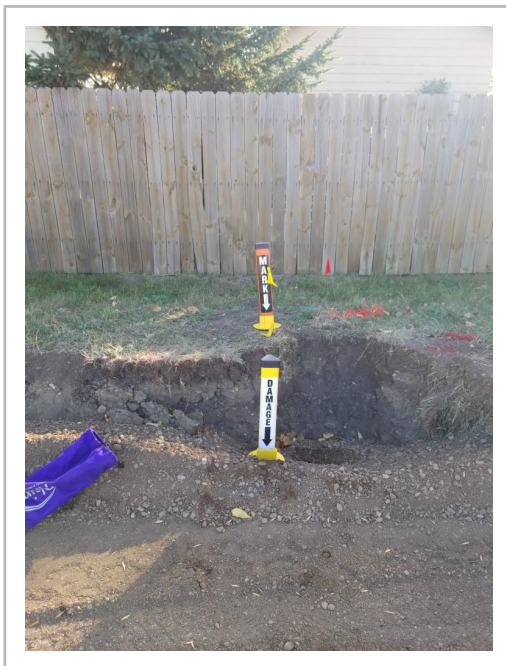
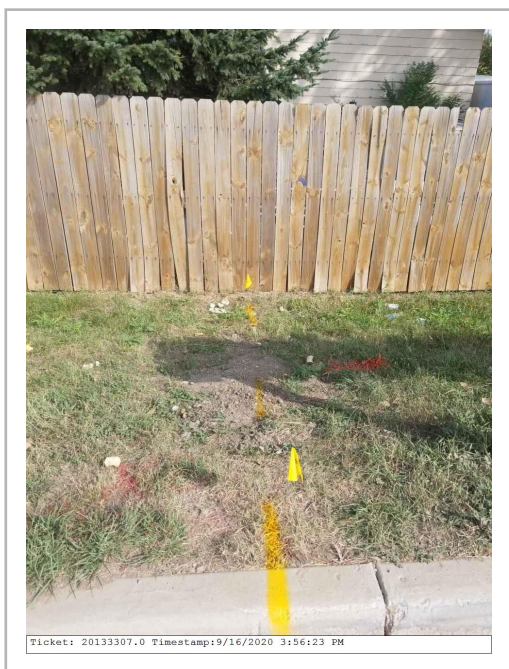
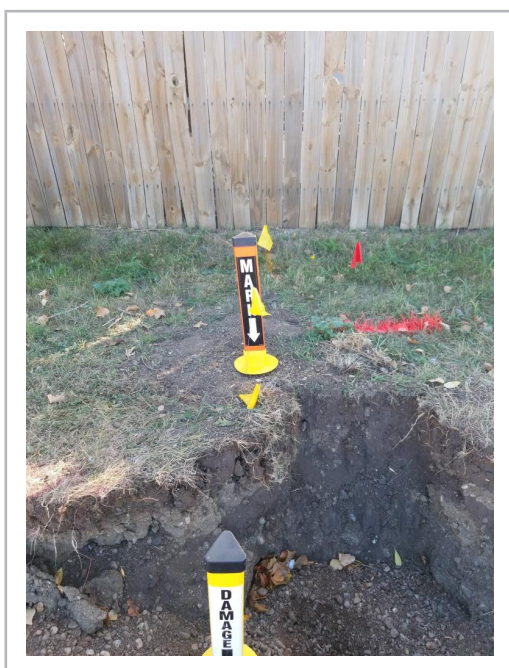
INCIDENT AND SURVEY COMPARISON PHOTOS

Assessment Comments: Wagner didn't pot hole, just dug and thought it was deeper. Travis said we needed to file a complaint with 811, they have already done so. Travis also said due to old mark's and flags we are clearly not at fault. We found a more current ticket, which is why the comparison photos will be from 10-1 and not 9-29

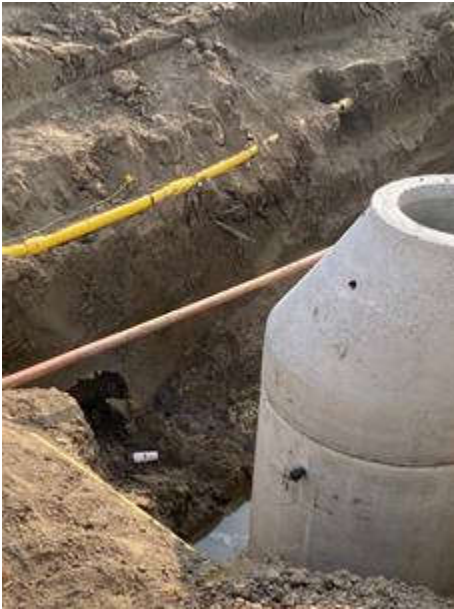
9/11/2020 – 31st Ave & 2nd St SW – Minot, ND 4" plastic nat gas line
Trevor with Wanger to review incident and advise their response.

After further discussions it appears as if this hit was accidental. We had exposed and were protecting the gas line throughout the whole trench we were digging during our pipe installation. Further discussions with the operator, he explained that the bank gave way due to a sand seam and while trying to support the bank with the excavator the line got crushed.

- Both Samantha and Jeff stated the dirt did not fall on the pipe. If it had, it would have dented or crushed the pipe. The pipe was totally ripped in two pieces.
- A good point made by Jeff is: “if Wagner’s was dealing with the bank giving way, why did they not have a trench box instead of using a bucket to support the bank?”
- After the line was ripped open, there was dirt on the pipe. This is the first time I have heard this statement from Jeff and David: “Wagner dumps dirt on the damage as they feel it slows the release of gas down”.
- None the less, this picture shows they use mechanical equipment within the 2’ of facilities.

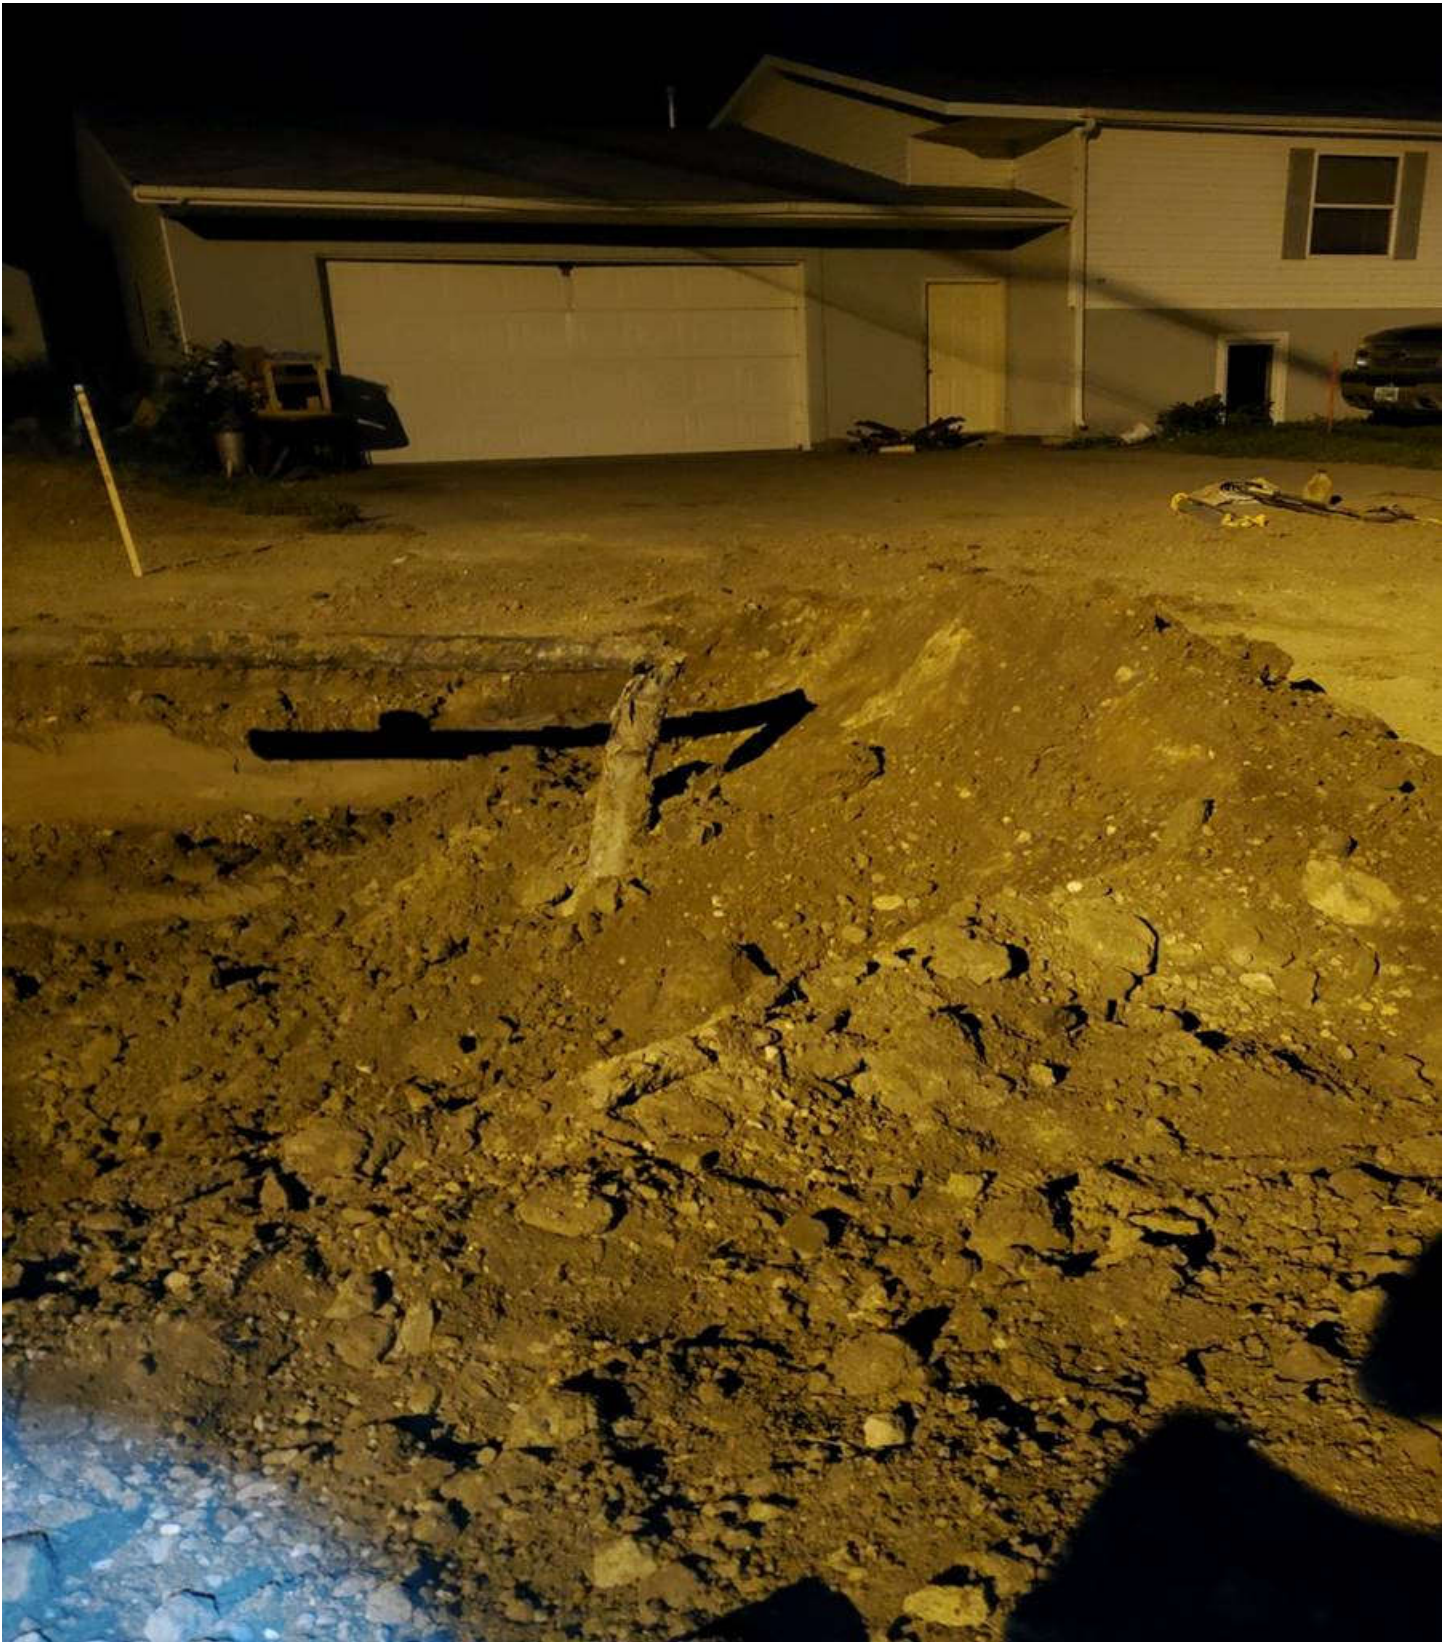
9/14/2020 – 100 31st Ave SE – Minot, ND 4” steel nat gas line

- B & H also stated that Wagner knew that we had not finished installing the replacement main because the pipe was on top of the ground in the staging area and that Wagner had equipment in MDU's way.

- Again, Tom Topolski, Crew Lead stated that when Wagner left the work location the day this was damaged, their worker was laughing and saying it will be out of our way tomorrow.

- Below is the picture from Tom regarding how the damaged pipe was pulled out of the ground.
- Wagner has a very interesting way of taking what someone says and turning it around to fit their narrative. When I spoke about pipe being installed in the 1965-1969 – it isn't that we don't know where our pipe is. The simple fact is that I wasn't part of that installation. MDU gets locates and we spot the lines – just like what we would expect Wagner to do.

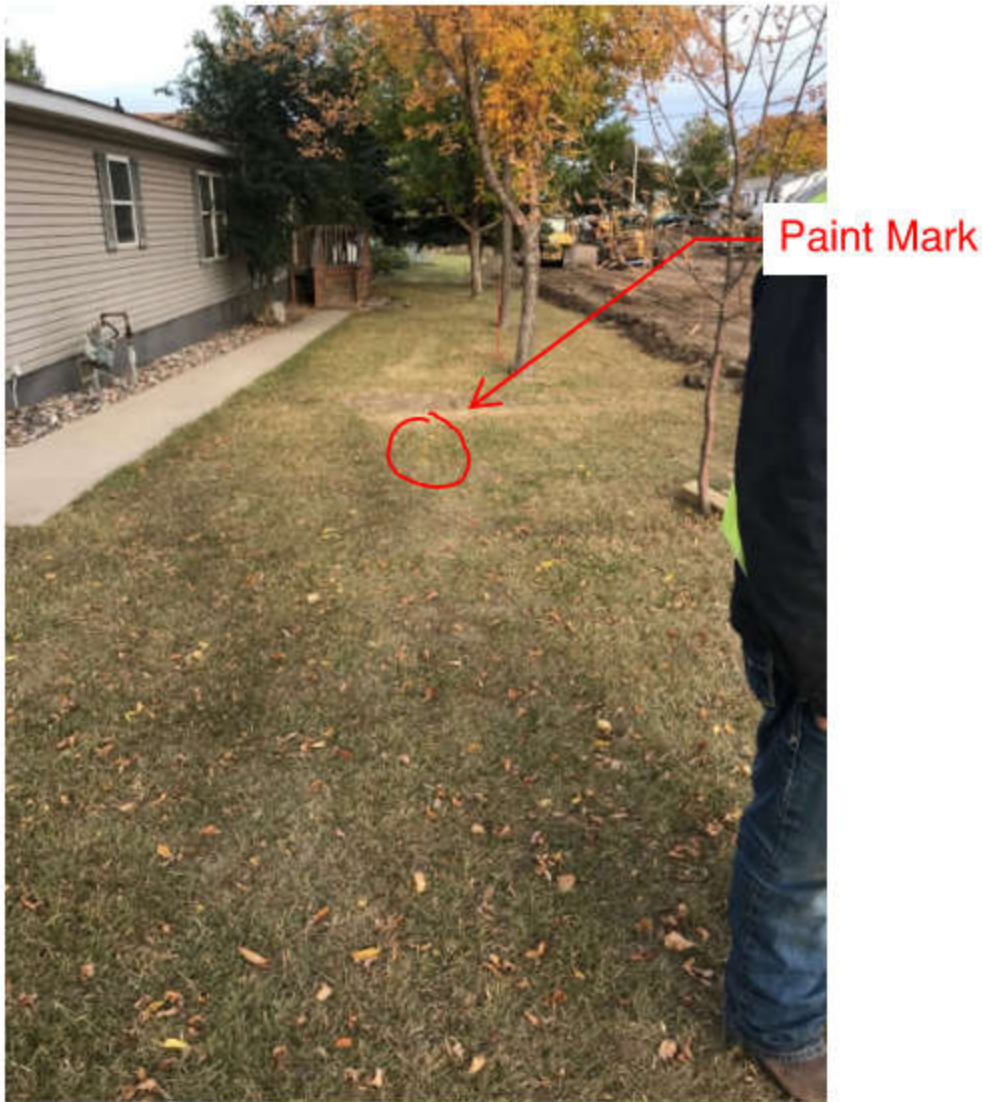
9/26/2020 – 5 31st Ave SE – Minot, ND ¾" plastic nat gas line
Jess Kindred struck the line.
MDU and Wagner to provide a write up with pictures of their version of the incident.

Our version of this incident is the same as what had been submitted to the commission back on Oct 28, 2020. The only mark that was present prior to hitting the line was the paint mark that can be seen in the picture below, which was well over 100' from where the line was hit. We had been told that all services in this area would be lowered but this one had not been.

I have also attached two plan sheets for the Sept 26 & 29 hits which show that the service line location for this address isn't even shown to be located where it was hit. Which begs the question, how could we as the contractor protect MDU's line when the marks for this area did not match what was shown to exist on the plans provided to us for the project. Therefore the line was not properly marked per the ND One Call Rules.

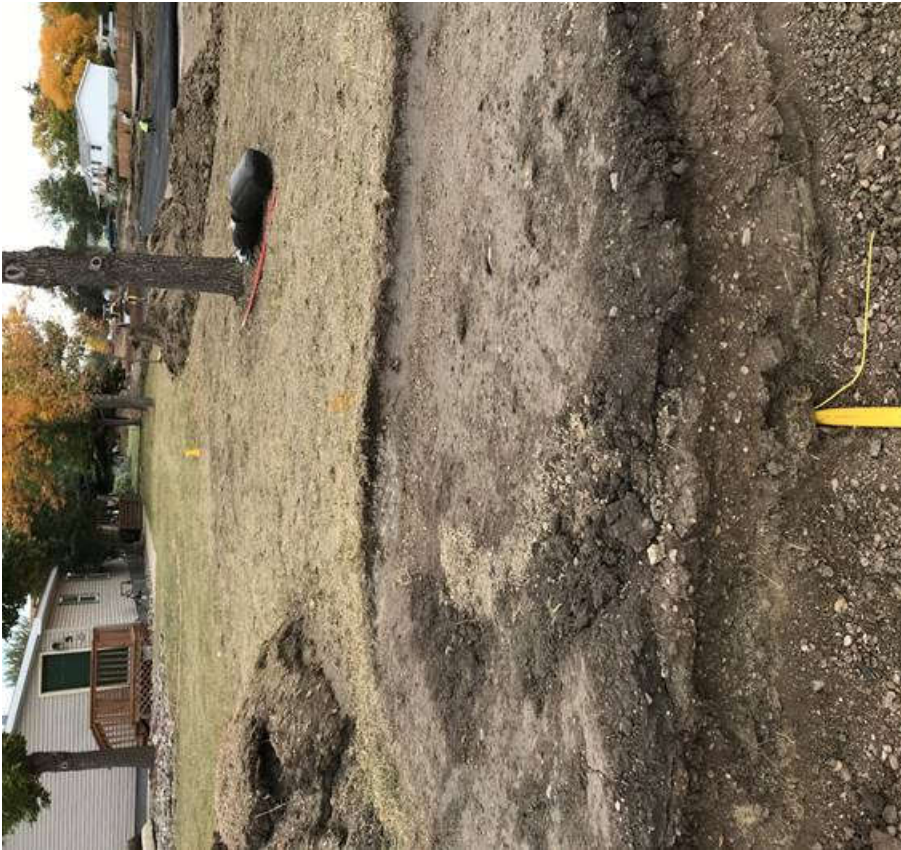
- B & H stated that the service was hit by the main. This picture shows the locate in the yard, not close to where the damage was at. Jeff also noted that the majority of the locates where the damage was done were destroyed by Wagner doing grating work.
- Wagner did not expose the pipe where the line was crossed.
- The picture below is from Chadd Gillmore, MDU first responder. You can see the pipe and the locates.

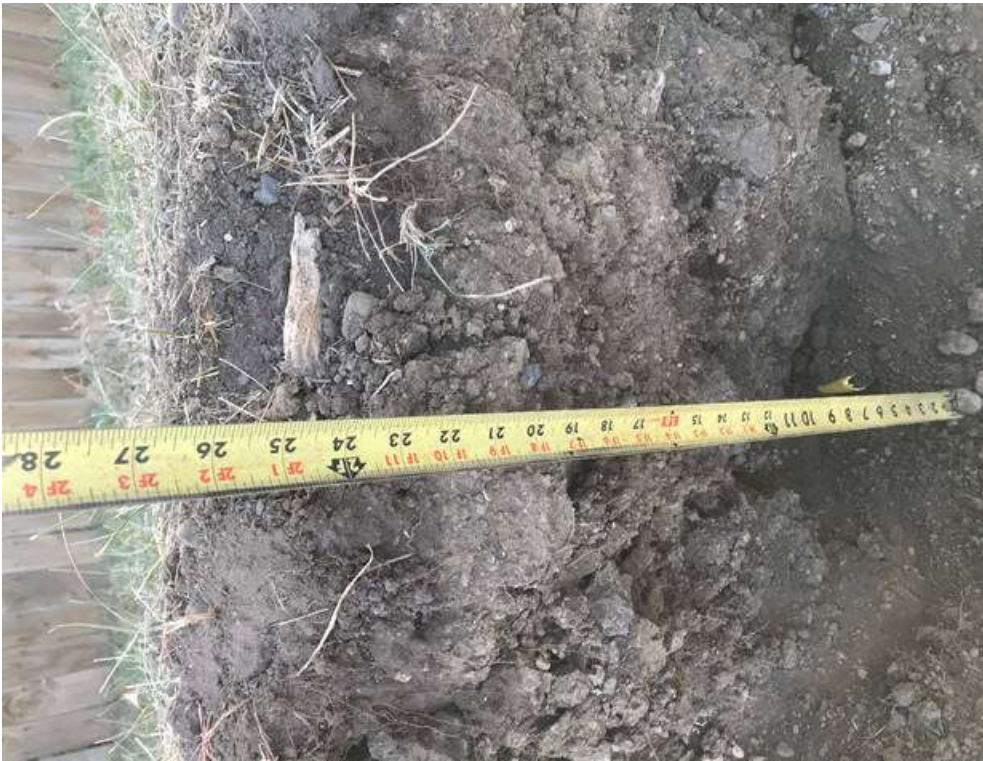
9/29/2020 – 2 31st AVE SE – Minot, ND ¾” plastic nat gas line
Line was potholed very close to location of hit. Depth changed significantly from pothole to hit location.
MDU and Wagner to provide a write up.

Our version of this incident is the same as what had been submitted to the commission back on Oct 28, 2020. The only mark that was present prior to hitting the line was the paint mark/flag next to the fence line, yet there were no marks designating where this line connected into the main. The line had been potholed within 2-3 feet and was struck due to an excessive grade change and not having sufficient cover over the line. As stated in our conference call, the minimum required cover for a gas service line is 10”, and this service was nowhere near that depth when it was struck.

- This again is a case where they potholed, but did not expose the facilities of where they crossed.
- Wagner also states that the gas service line is 10” – the picture below will prove otherwise.
