Bridger Pipeline LLC

8-inch Crude Oil Pipeline – McKenzie County

Case No. PU-20-430

Topsoil Removal Inspection Report

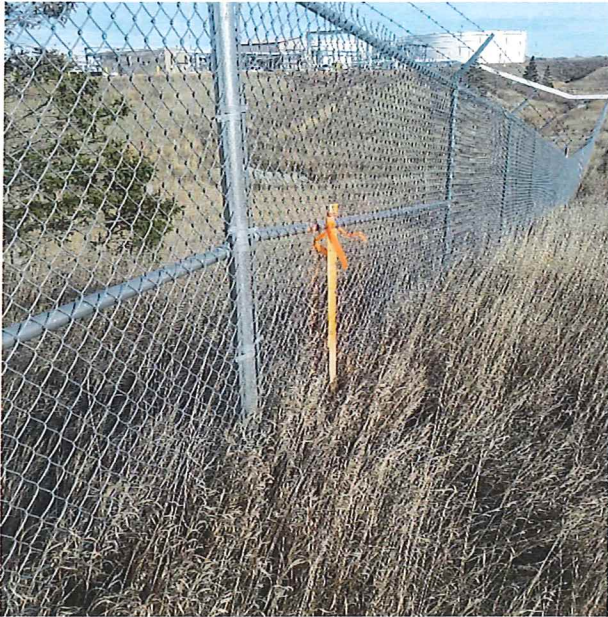
P1 - STA 3+48 BK, Existing Conditions

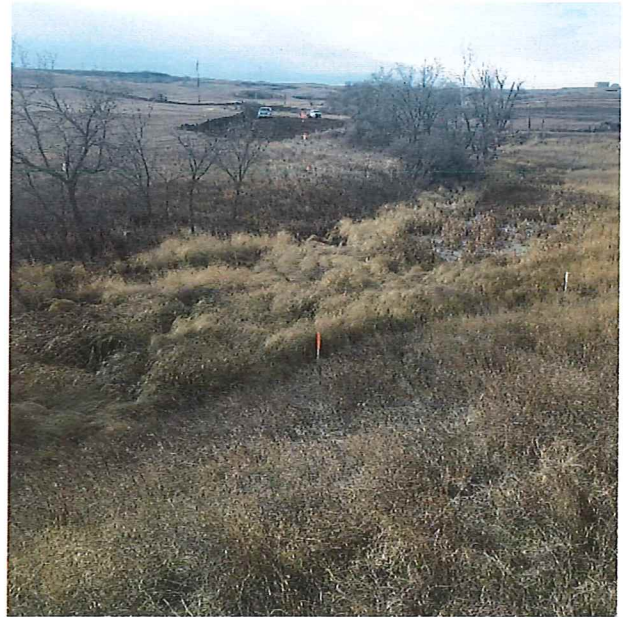
- Wetland from Project Begin to STA 7+26 (See P2, P4)
- Trees/Brush with natural wooded draw from STA 10+80 to STA 12+00
- Trees/Brush within natural grassed draw from STA 27+38 to STA 30+09 (See P9)
- Trees/Brush within 108th Ave NW gravel road ditch from STA 55+51 to STA 58+20 (See P16)
- Crossing of East/West gravel road from STA 64+71 to STA 67+17 (See P21)

P2 - STA 4+74 AH, Existing Conditions

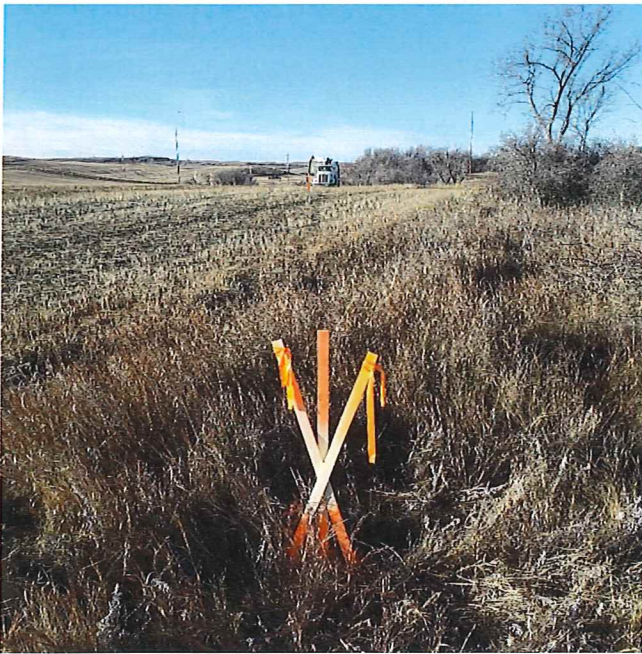
P3 - STA 7+26 AH, Existing Conditions, Bore End

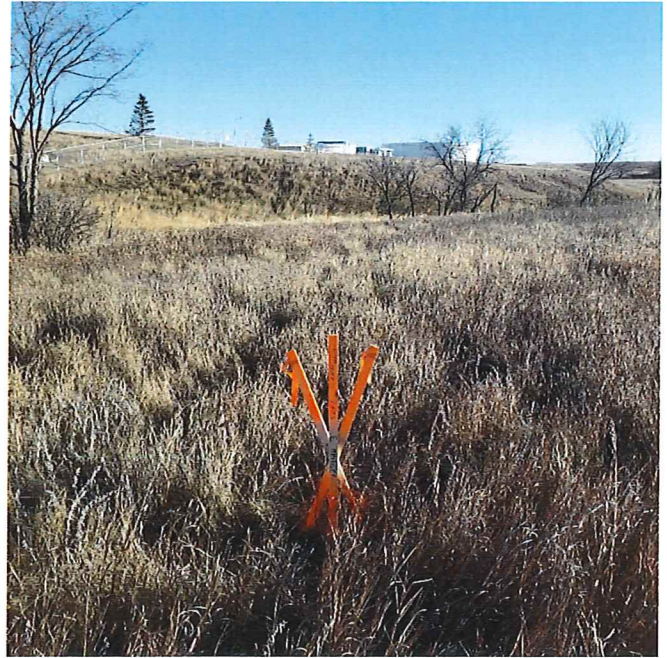
P4 - STA 7+26 BK, Existing Conditions, Bore End

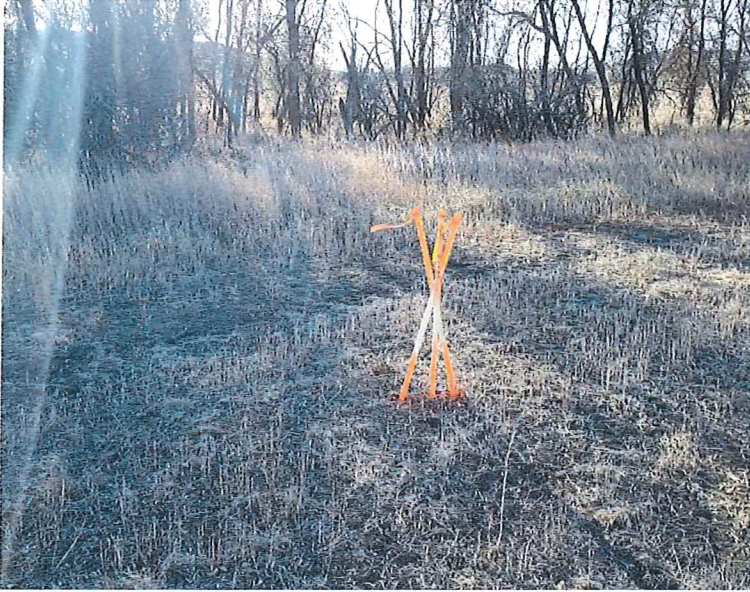
P9 - STA 27+38 AH, Existing Conditions, Bore Begin

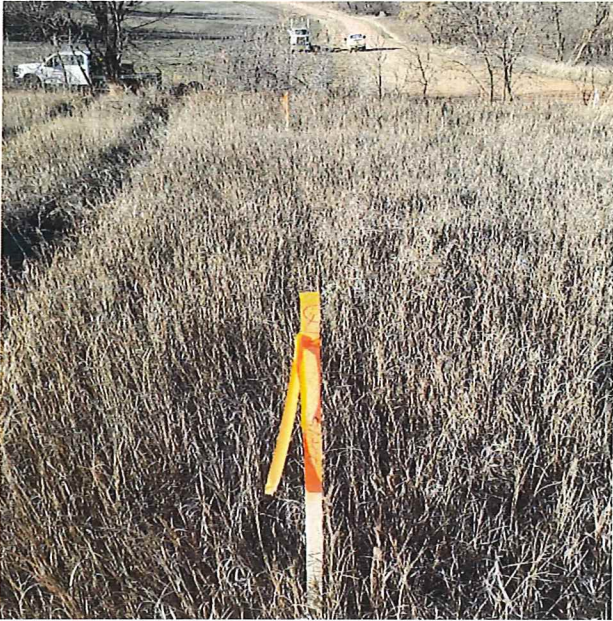
P16 - STA 56+00 AH, Existing Conditions

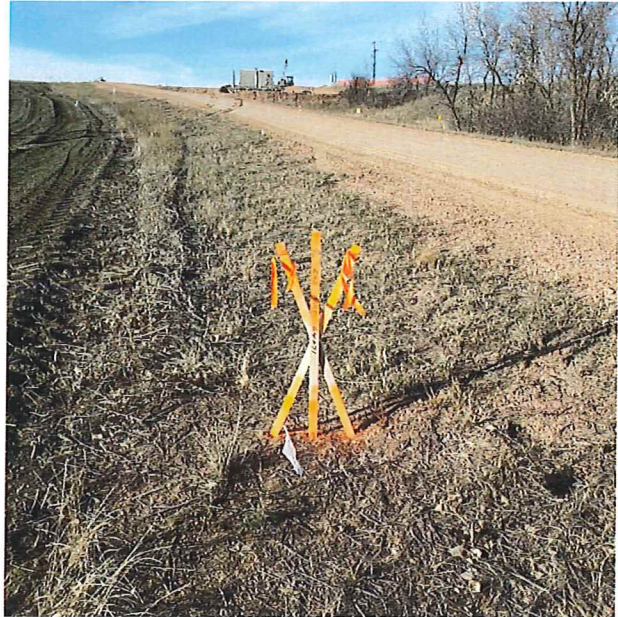
P21 - STA 64+71 AH, Existing Conditions, Begin Bore

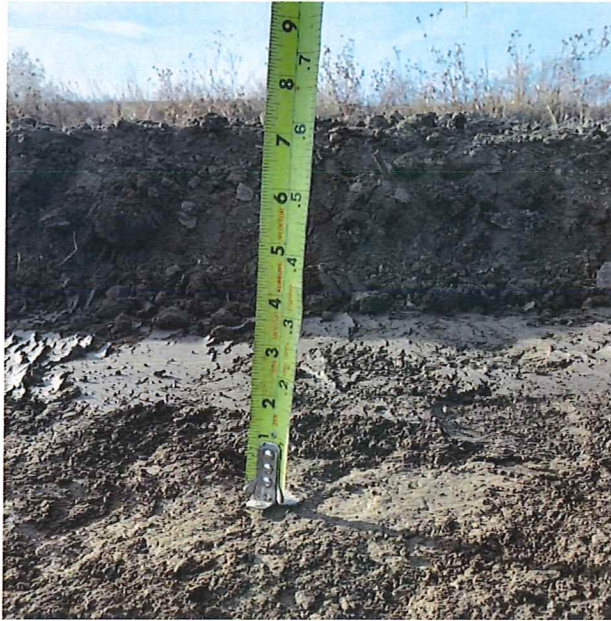
* Prior to start of topsoil stripping, initial field observations were made (See P1-P23). Soil was soft and found to not be frozen. Majority of pipeline alignment where topsoil surface will be disturbed is within agriculture whose crop has already been harvested or there was little to no vegetation. Within agriculture areas, topsoil isn't densely compacted due to previous cultivation. Areas outside of agriculture consisted of natural grassland vegetation (See P3, P4, P12-P17, P22). These areas are mostly staging areas for planned boring crossings under vegetation (trees, shrubs, and natural drainage ways). Wetland area (See P2) will not be disturbed as boring is planned from Project Beginning to approximately STA 7+26 as stated by Tommy Massengale. Location at STA 37+82 which will be excavated had denser existing vegetation (See P12, P13, P28). Location going up steepest hill within project (STA 54+00 to 55+51) has the least amount of topsoil thickness which was measured at approximately 2 1/4 Inch (See P30). Vegetation within this location was also noticed as more scarce (See P29).

* Topsoil stripped with agriculture field at STA 40+40 was measured at a depth of approximately 7 IN (See P29). Subsoil appears as light gray homogeneous lean clay loam.

P29 - STA 40+40 Existing Topsoil

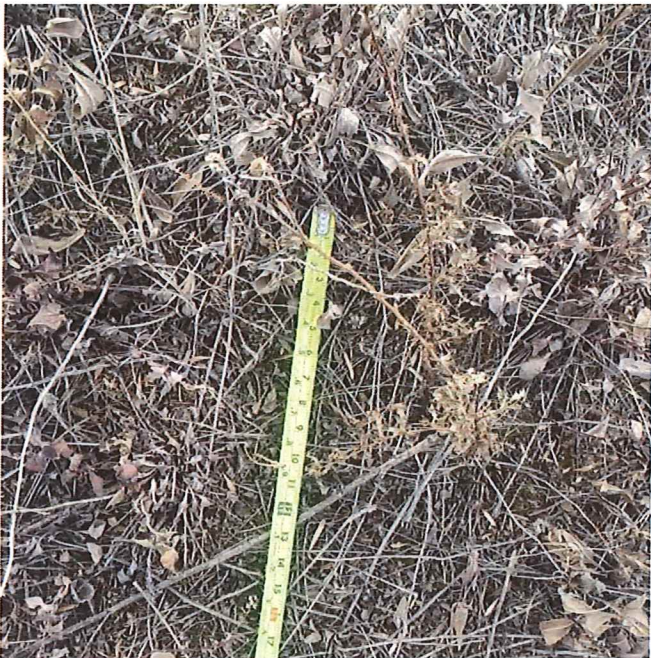
P30 - STA 54+40 Existing Vegetation

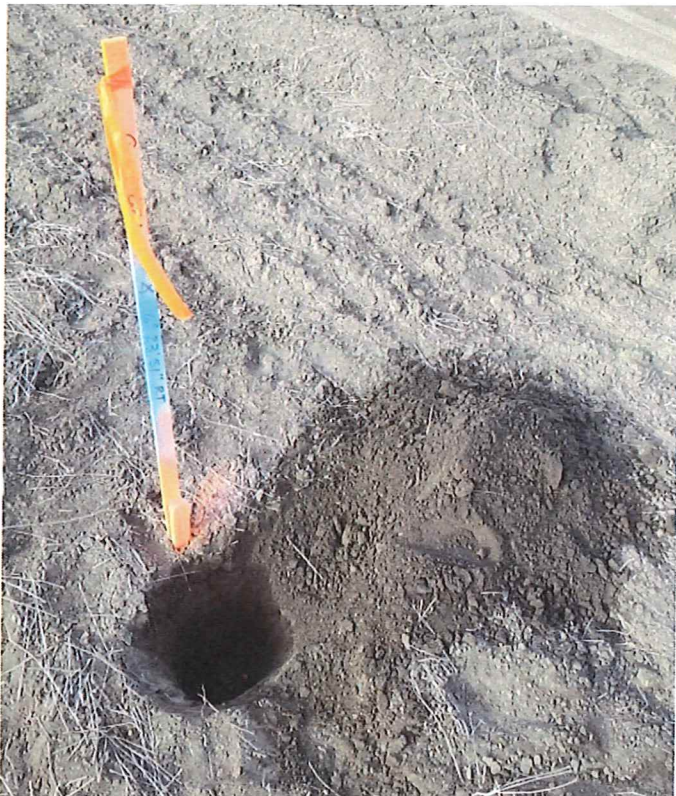
Project: PU-20-430 Bridger Pipeline LLC 8-inch Crude Oil Pipeline		Contractor: Loebro Pipeline LLC	
Date: 11/29/2021	Day: Monday		Subcontractor: Dirty Birds LLC
Weather: Clear & sunny, wind 10-20 mph from NW		Temp: 52 F	Inspector: Brandon Myran
Work Activities: * Work included stripping of topsoil until underlying subsoil (lean to fatty clay) was observed. If topsoil exceeded 12 Inches, contractor would no longer strip topsoil. Topsoil was stripped within 75 foot wide pipeline construction zone and windrowed along left side pipeline centerline. Topsoil was stripped and stockpiled by use of (1) John Deere 872GP Grader and (2) CAT D6 Dozers.			
Labor Force: Bridger Pipeline LLC: 1-Construction Supervisor (Tommy Massengale) Loebro Pipeline LLC: 1-Foreman (Eric Garcia), 3-Operators, 5 Laborers Dirty Birds LLC: 1 Driver, 1 Laborer Avery Inspection: 1-Inspector (Jake Massengale)			
Contractor Correspondence: * Brandon Myran met with Tommy Massengale and Loebro Pipeline LLC foreman (Eric Garcia) at 0930 to go over construction plans. Eric says they plan to use grader to remove topsoil and place windrow on Left side of pipeline centerline. Dozer operator will make final passes consolidating topsoil windrows into one on left edge of construction zone. They will have 1 grader start at approximately STA 7+26 going positive in Stationing following pipeline alignment in order to get one dozer operator started and will bounce to STA 30+09 to start the next section following the underground boring section. Once topsoil is cleared within construction limits, they will at later date start boring sections and begin digging subsoil and placing subsoil on right side of pipeline centerline in order to maintain segregation of topsoil. Contractors are thinking project will take 2.5 weeks. * 1040 Brandon Myran talks with grader operator to let him know the double rolling hill from approximately STA 17+50 to STA 21+20 has topsoil thinning out to about 3 to 4.25 Inches (See P26, P27, P36, P37), so he should be aware to not over cut into subsoil causing mixing of topsoil with subsoil. Grader says he is only doing initial surface cuttings and the dozer will be pushing the windrows to the East and doing more cutting if needed. Brandon Myran relays message to Dozer operator what he told grader operator about thinning topsoil on double knob hill. Dozer says he will slow down to make sure he doesn't over cut. * 1325 Brandon Myran talks with Eric Garcia to verify his dozer operator won't over cut any subgrade to be placed with topsoil windrow. Eric says operator is aware and will continue pushing topsoil left of pipeline centerline and grader will make last passes in order to be more precise on last of topsoil stripping. Any subsoil that was cut by grader or dozer within STA 17+50 to STA 21+20 should now be started windrowing to right of pipeline centerline. Brandon also lets Eric Garcia be aware of thin layer of topsoil (approximately 2.25 IN) around hill top around STA 54+40 (See P30). Thin topsoil correlates with minimal vegetation noticed by inspector (See P31). Hill side near bore end does have some existing brush vegetation (See P32). Eric says they are aware and that the hillside brush shouldn't be an issue in protecting. Loebro plans on extending the bore 2 sticks of pipe so that excavation wouldn't disturb the hillside as bad. Also mentioned to Eric is that freshly loose topsoil within STA 58+00 to STA 64+80 cultivated field may be deeper than 12 Inches (See P33, P34). If topsoil exceeds 12 Inch, salvaging of topsoil can end once 12 Inch is removed.

P33 - STA 62+50 Existing Topsoil

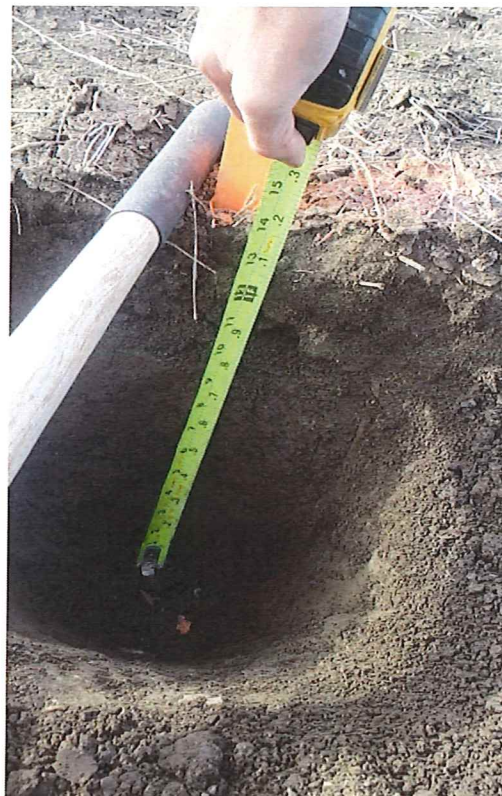
P34 - STA 62+50 Existing Topsoil

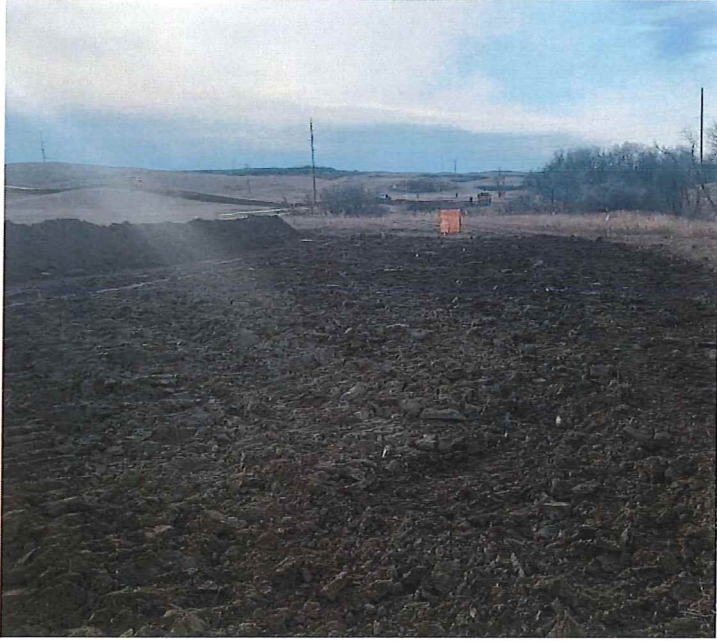
- Grader was used to establish outer boundary of removals within pipeline 75 foot wide construction zone. Grader pushed topsoil windrows to left side of pipeline centerline. Dozer assisted in pushing grader windrows to outer left edge within construction zone (See P35, P37, P38, P39).
- Final topsoil windrow was approximately 30 feet left of pipeline centerline leaving between 2-5 feet left from edge of construction zone which were marked out with blue lathe.

P35 - STA 8+00 AH, Topsoil Removal and Windrow

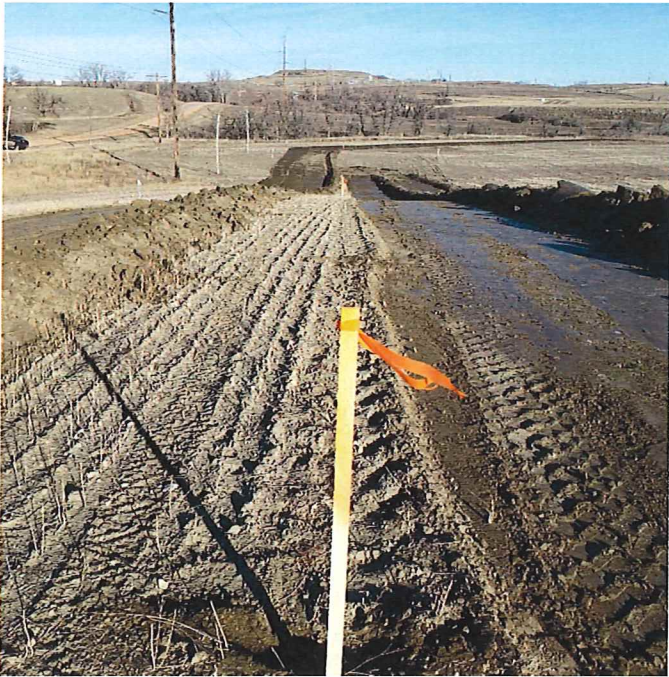
P37 - STA 19+00 BK, Topsoil Removal

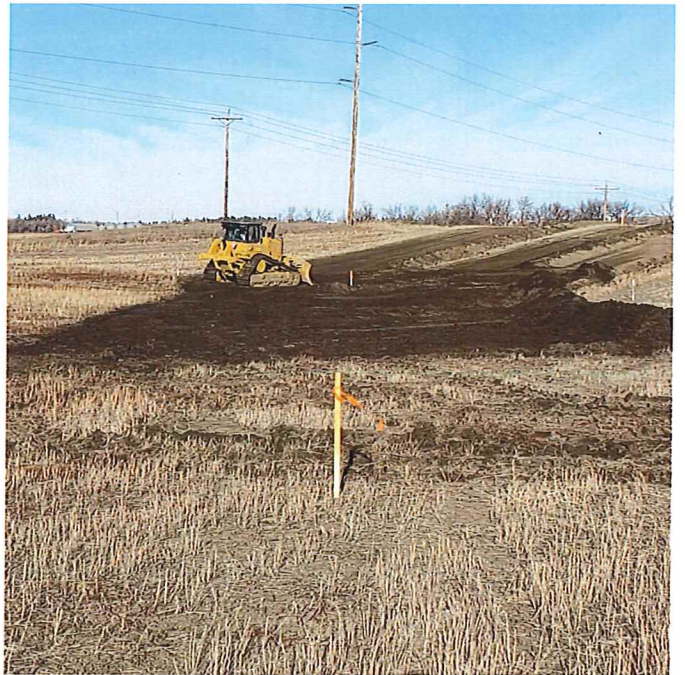
P38 - STA 24+00 BK, Topsoil Removal and Windrow

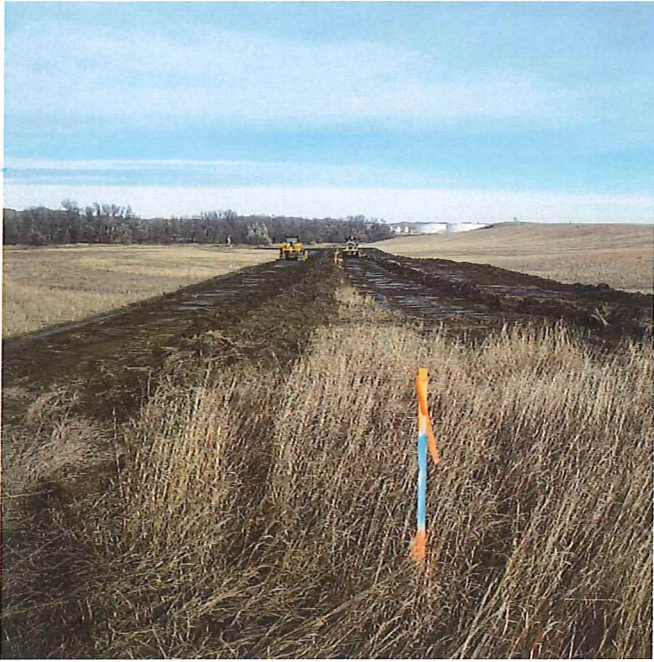
P39 - STA 37+82 BK, Topsoil Removal and Windrow
