Bridger Pipeline LLC

8-inch Crude Oil Pipeline – McKenzie County

Case No. PU-20-430

Construction Inspection Report

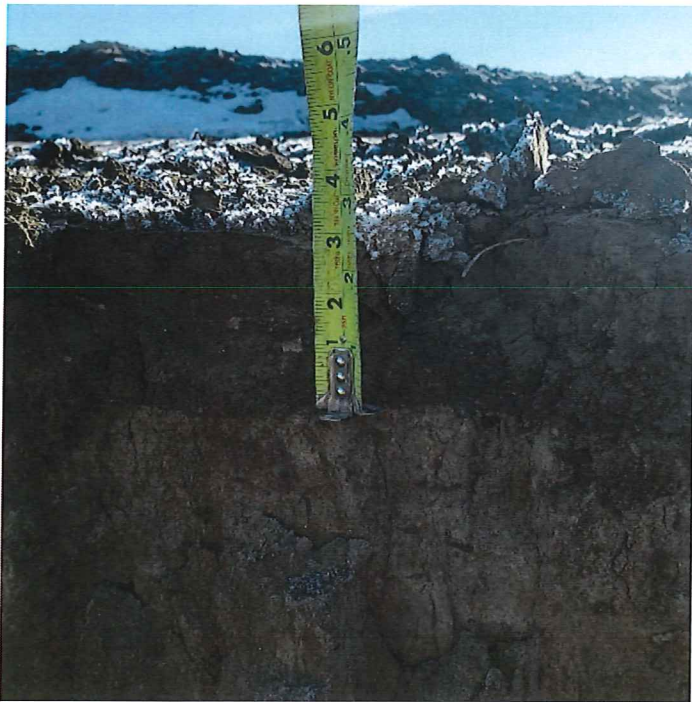
P16 – STA 15+42 Topsoil Remaining

*Inspector notices some areas where topsoil or weathered subsoil appears to not of been removed. Some of the areas are low lying areas where topsoil may have exceeded 12 inches (hence STA 14+00 to STA 16+00). Other areas like from STA 30+09 to STA 33+20 and STA 48+50 to STA 53+50 will have to be backfilled first with gray colored lean clay subsoil before any weathered subsoil or topsoil is placed.

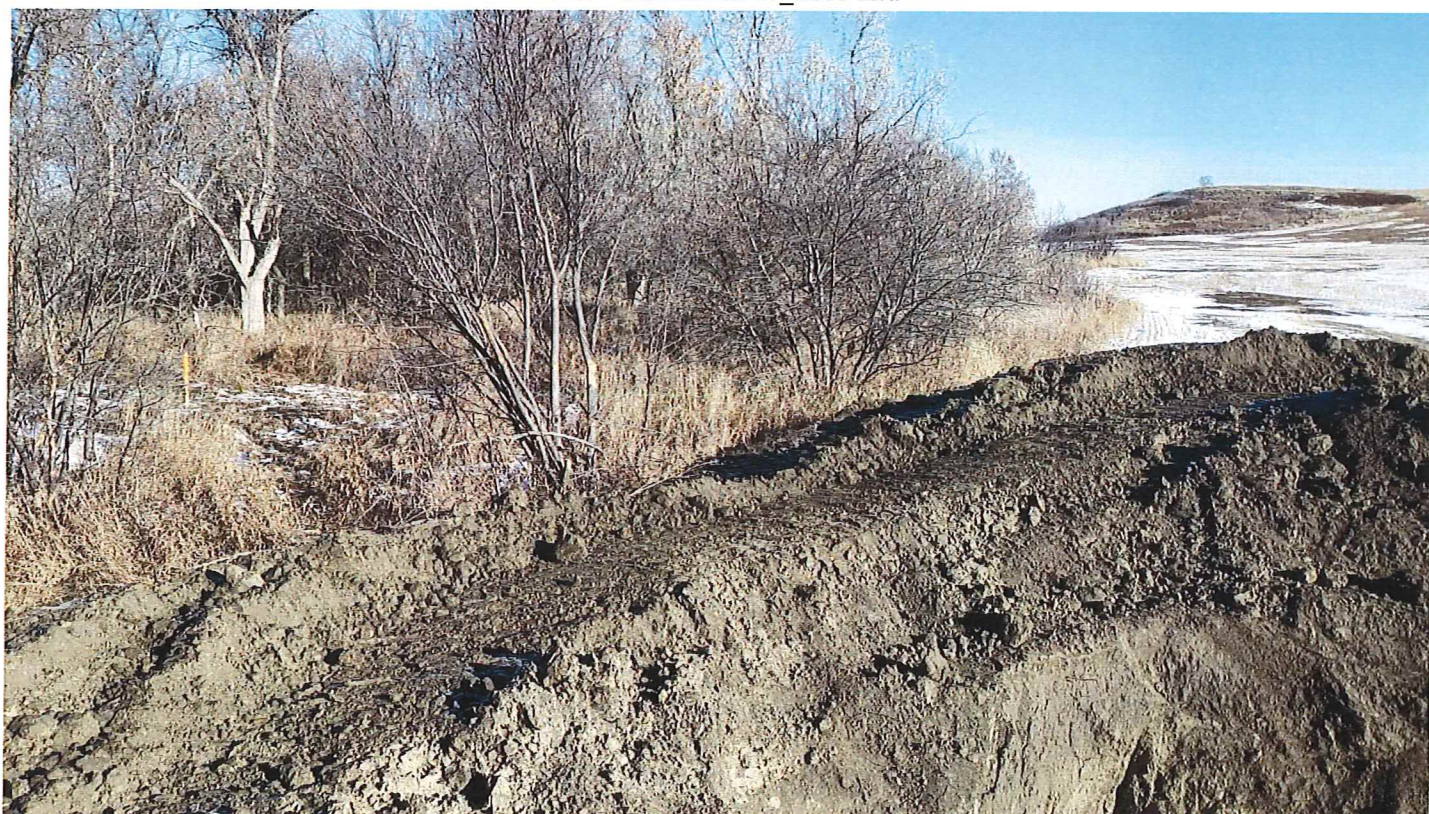
P25 – STA 30+09 LT_Bore End

- Trees/brush along east side of 108th Ave NW appear to of been damaged due to equipment. (See P40)
- Vegetation at End Bore STA 30+09 appear slightly damaged (See P25, P26).

- Vegetation area along east side of 108th Ave NW disturbed by equipment should be revisited within 12 months to determine if replanting is required to match existing conditions.
- Vegetation at End Bore STA 30+09 should be revisited within 12 months to determine if replanting is required.

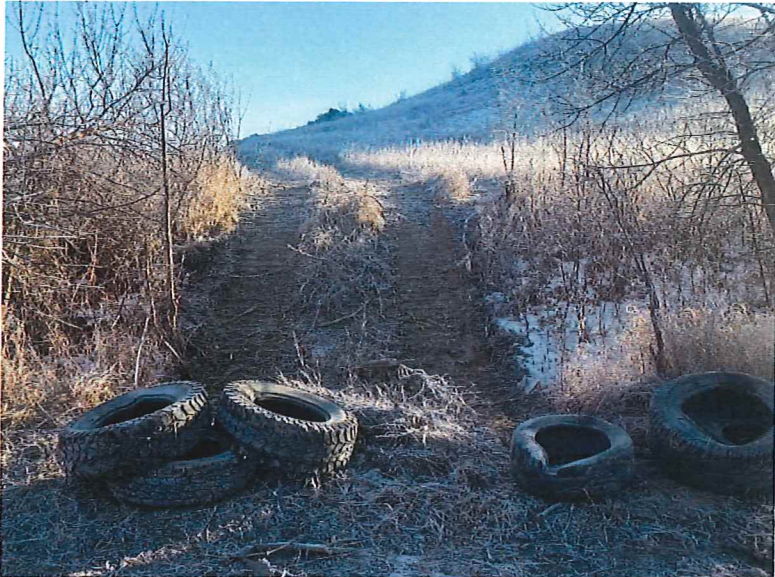
P40 - STA 56+81 Vegetation Disturbance

- Trees/brush along east side of 108th Ave NW appear to of been driven on by equipment (See P40); Area is to be revisited within 12 months to determine any action required.
- Vegetation at End Bore STA 30+09 appear slightly damaged (See P25, P26).
- Hillside tie-in near requires grade work to match previous conditions (See P35). Contractor plans to address tie-in once equipment returns to location for finish grading.
