Bridger Pipeline LLC

8-inch 2.4-mile Crude Oil Pipeline – McKenzie County

Case No. PU-20-430

As-Built Construction Inspection Report

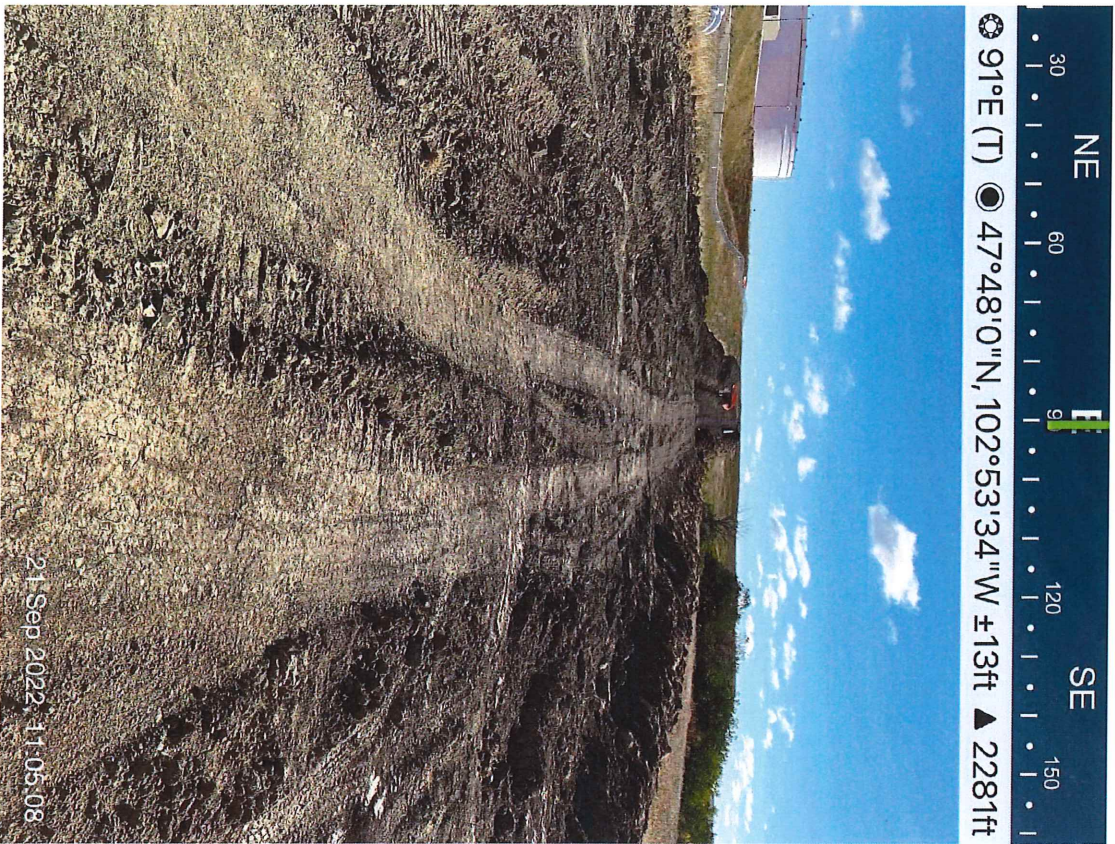
PHOTO 1

At start of project location at connection to existing facility, there is a different project with ongoing construction that crosses perpendicular to this project resulting in topsoil removal and salvage. See Photos 1-4, there is an adjacent pipeline being installed on the south side of the Johnson's Corner Station. There appears to be no erosion control issues with this project that would affect any of the surrounding areas.
