Bridger Pipeline LLC

8-inch 27-mile Crude Oil Pipeline – McKenzie County

Case No. PU-20-430

As-Built Construction and Reclamation Inspection Report

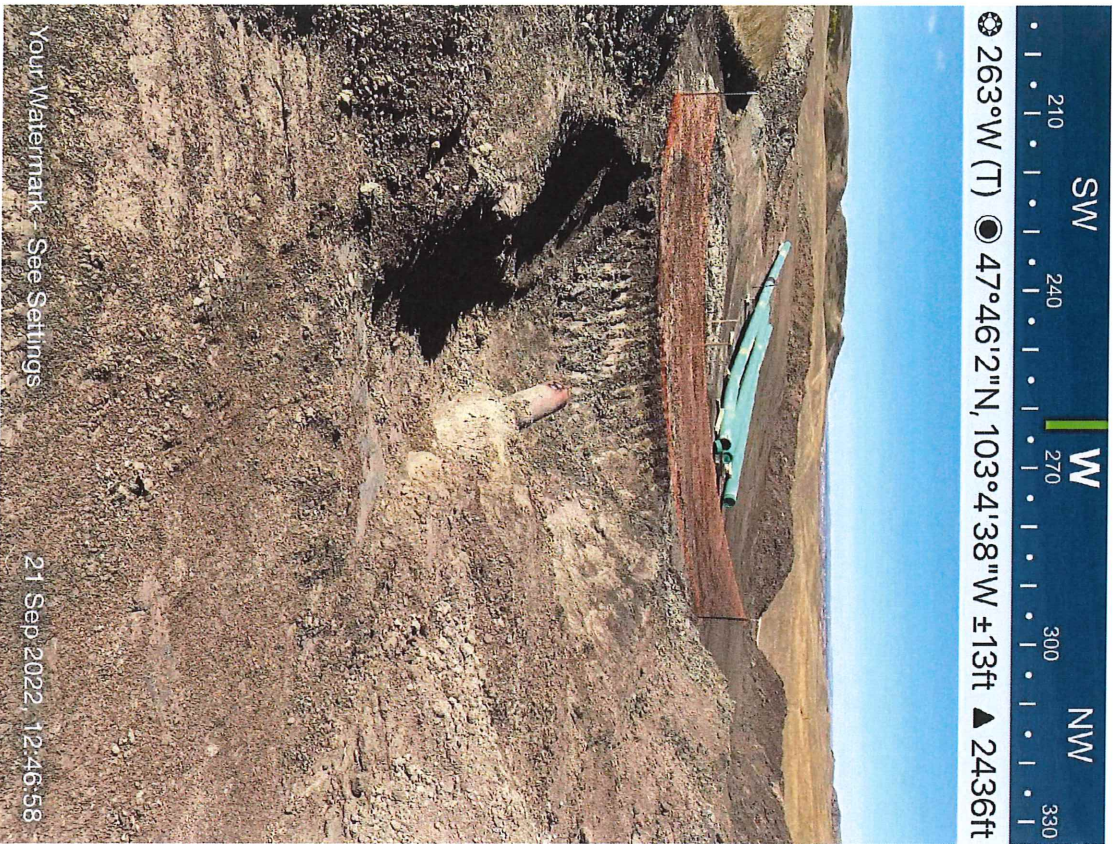
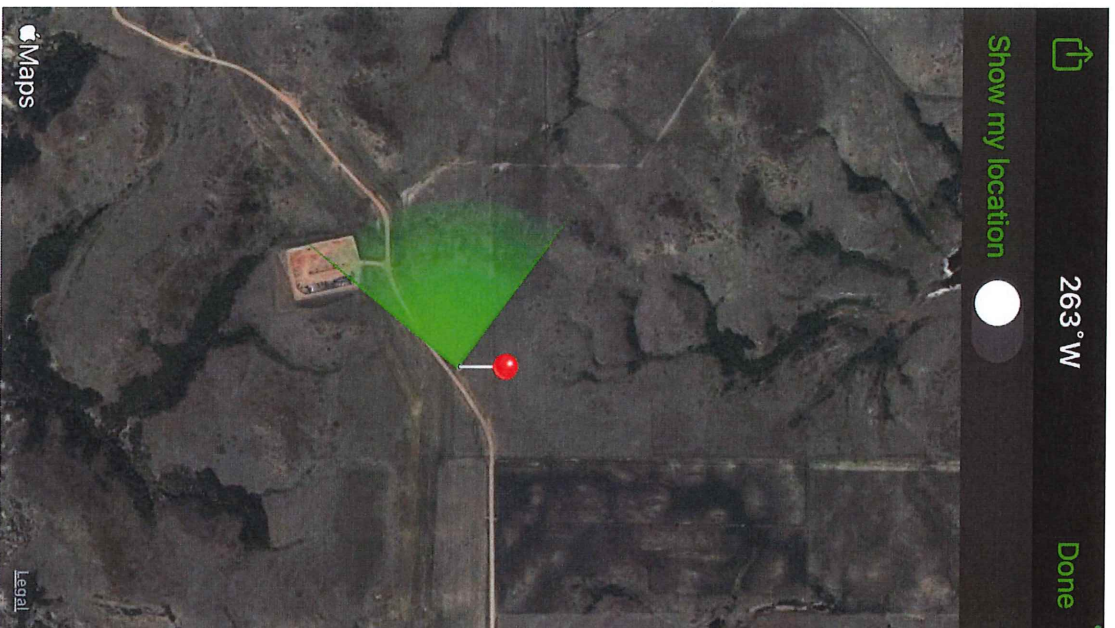
PHOTO 34

This photo is not party of the project. Taken to show the extent of construction near the pipeline.
