Bridger Pipeline LLC

8-inch 2.4-mile Crude Oil Pipeline– McKenzie County

Case No. PU-20-430

Reclamation and Revegetation Inspection Report

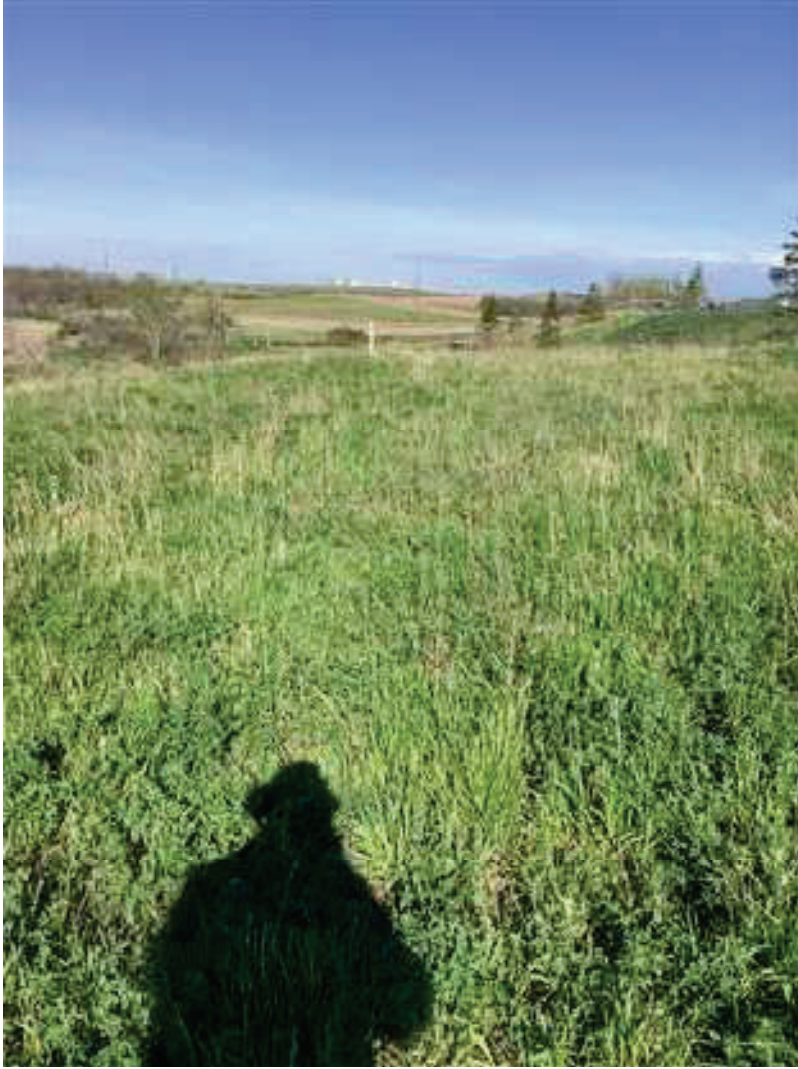
P1 Looking East. Beginning of pipeline, abundant vegetative growth.

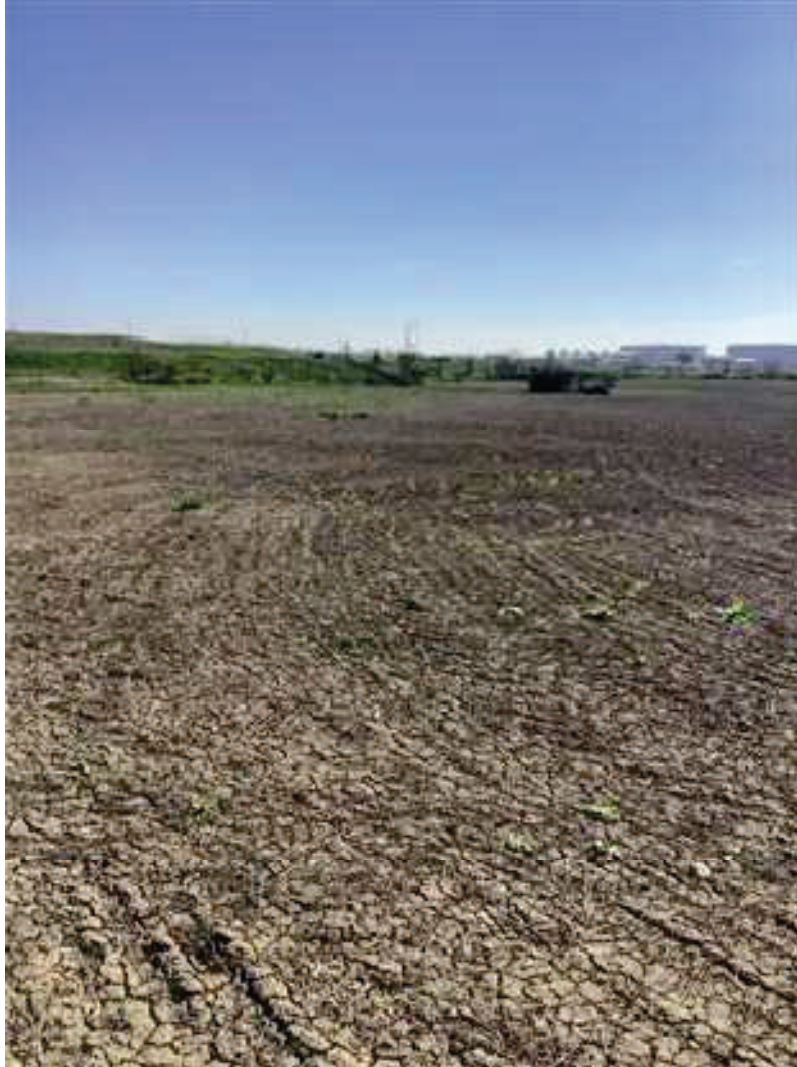
P2 Looking West, abundant vegetative growth.

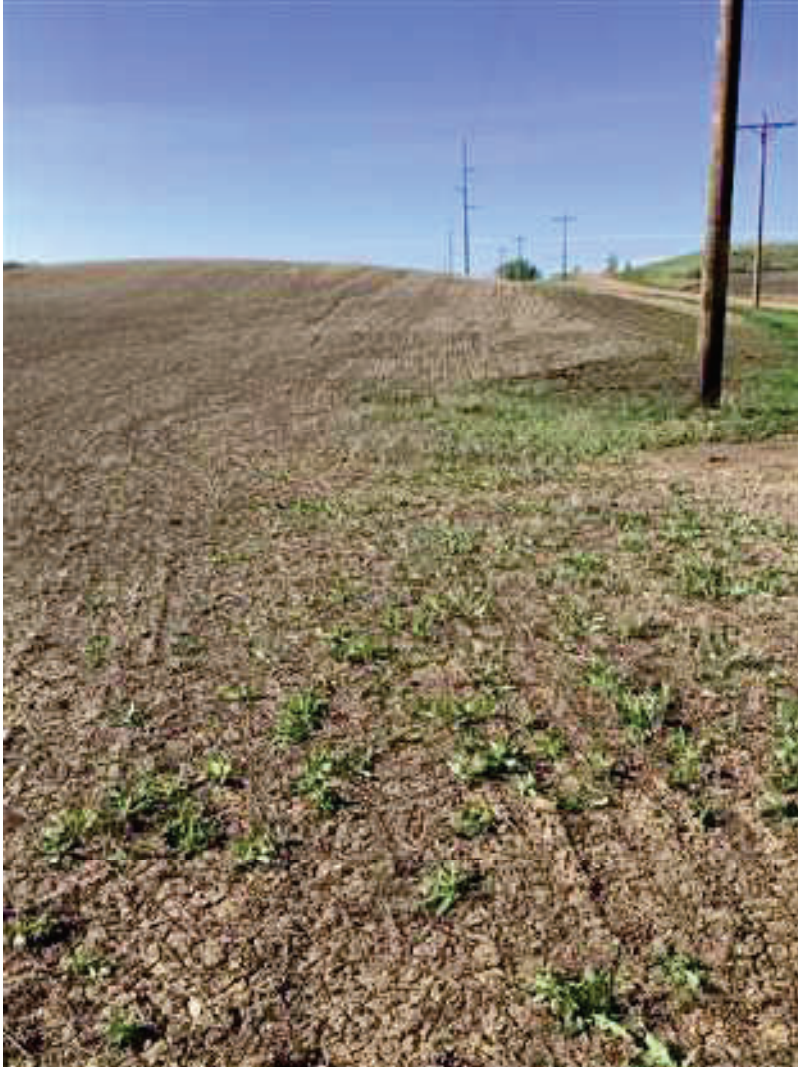
P3 looking NE. Soil cracking visible, however, landowner seems to be working the land.

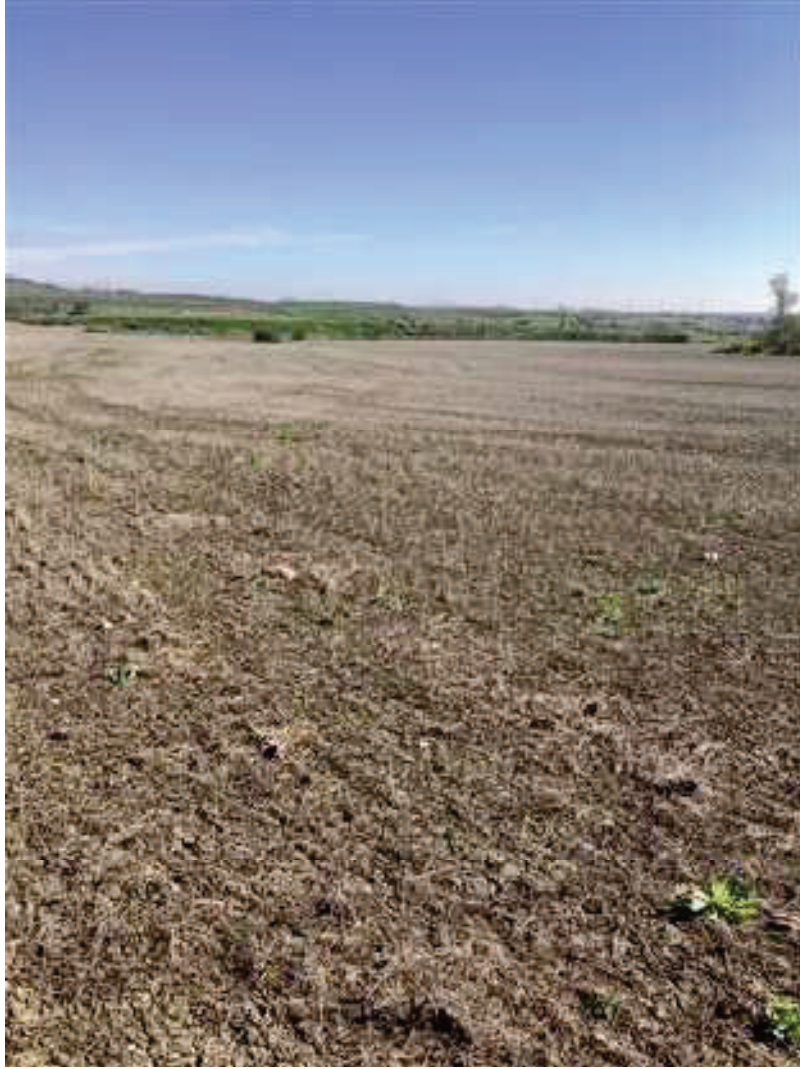
P4 looking South. Some weeds growing, however landowner seems to be working land again.

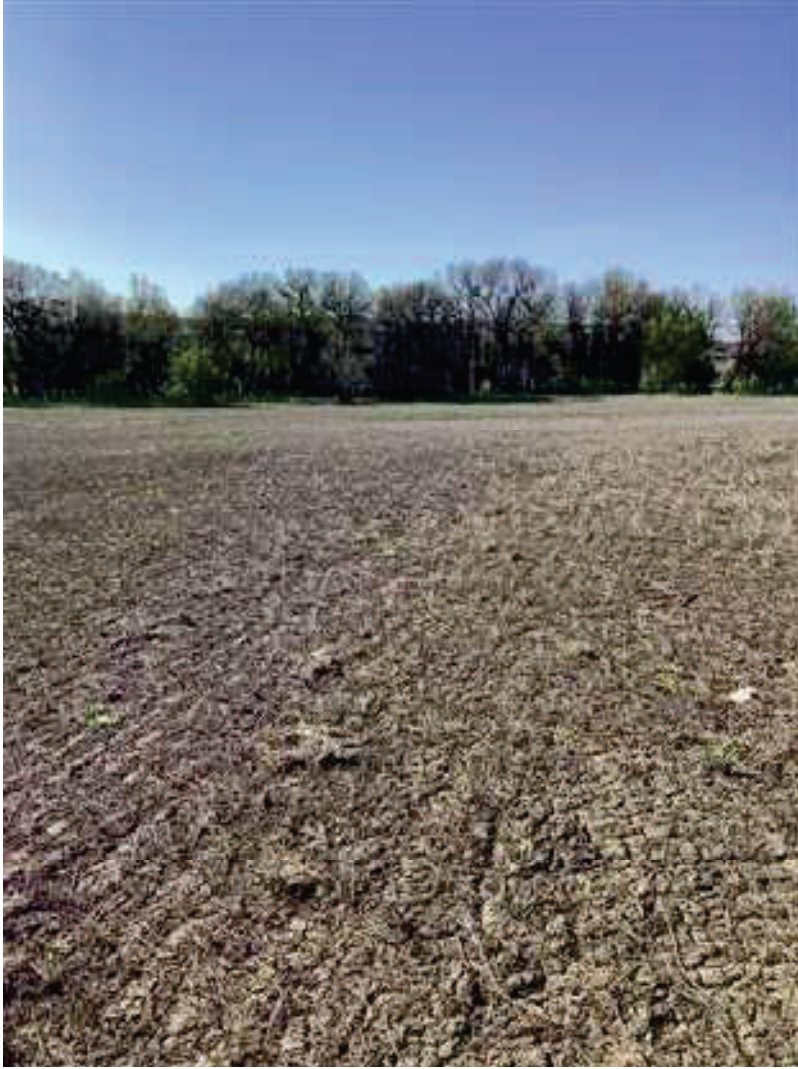
P5 looking NE-Evidence of cultivation by landowner.

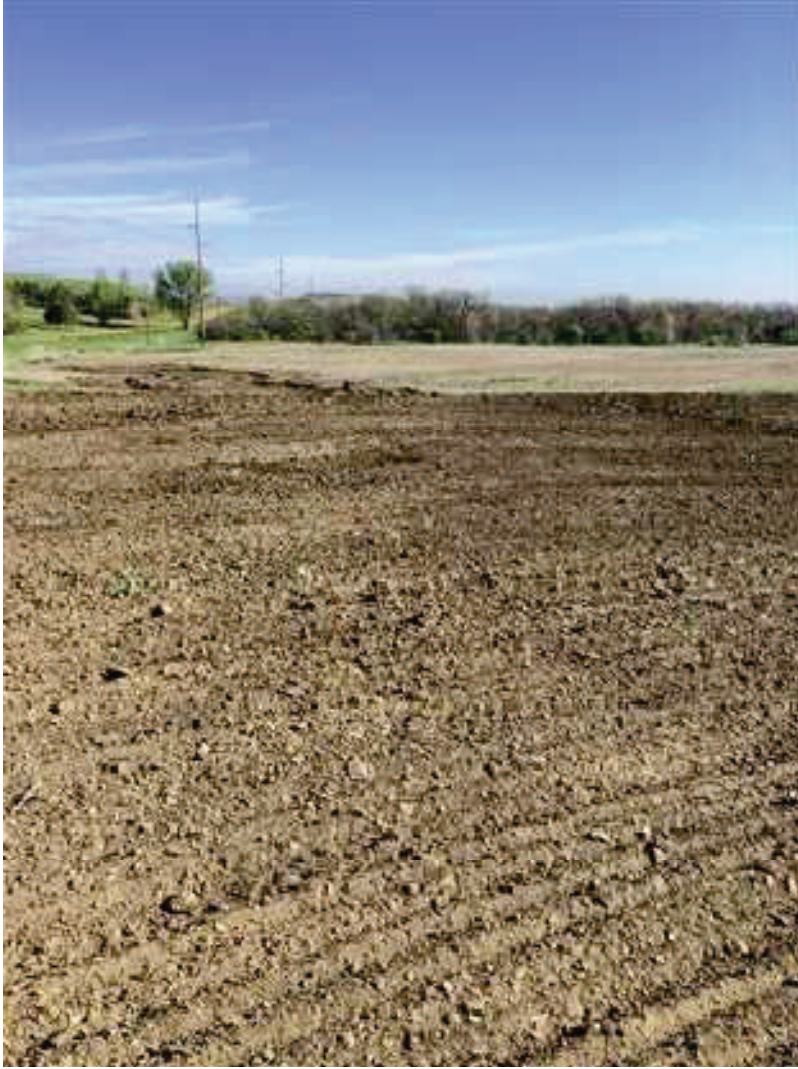
P6 looking SSE, landowner has reclaimed crop land, tree line undisturbed by construction activities.

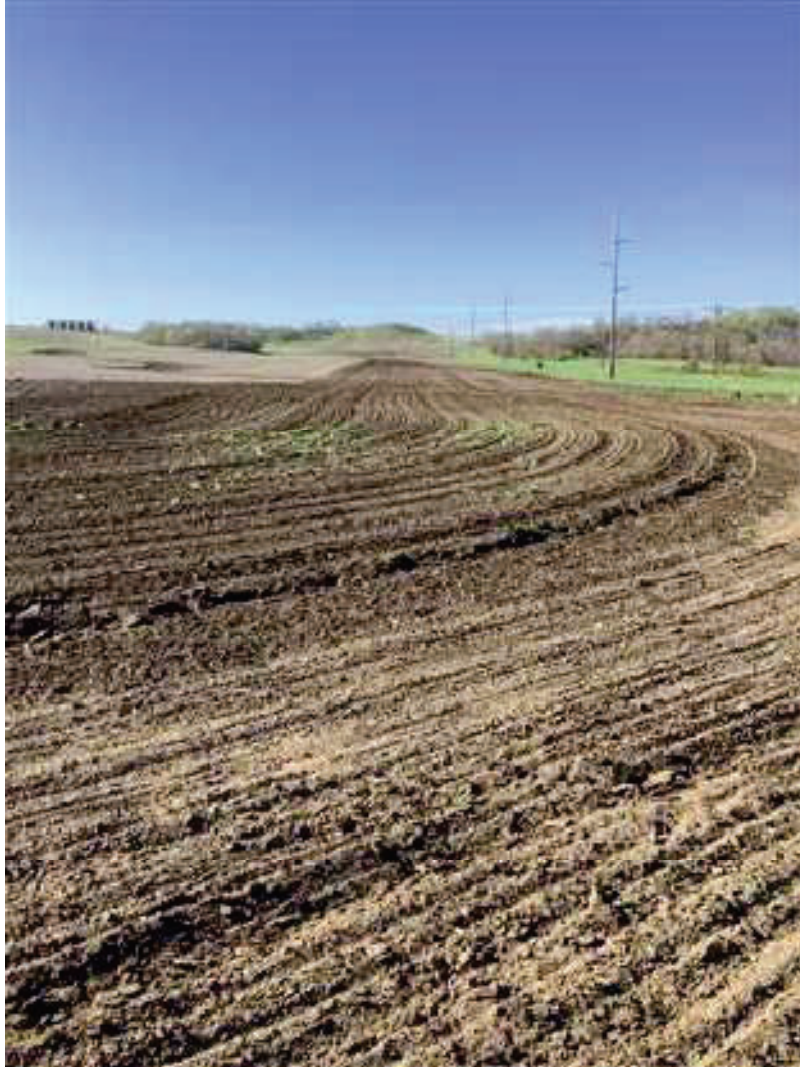
One section along the ROW had been rutted and disturbed by Mckenzie Electric for a different project. This can be seen in P7 and was not a result of this project.

P7 looking North. Owner working crop land of ROW, some torn up material from a different company doing electrical work.

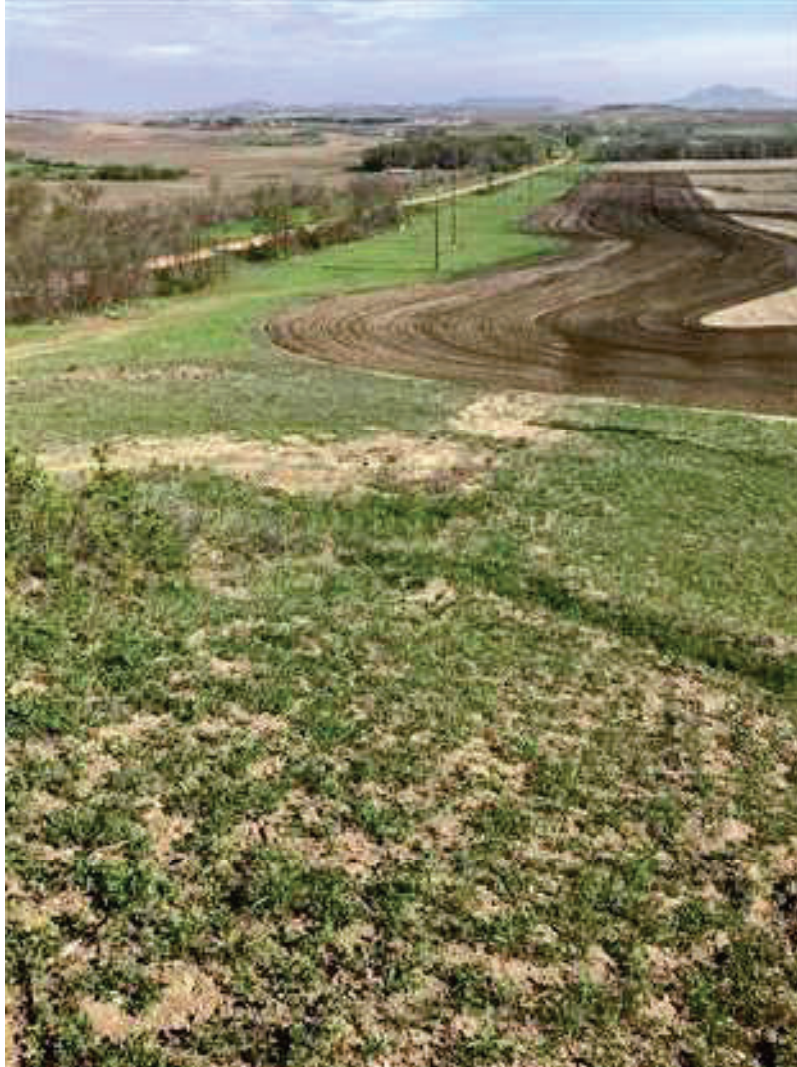
P8 looking South, substantial evidence of farmland being utilized again by landowner.

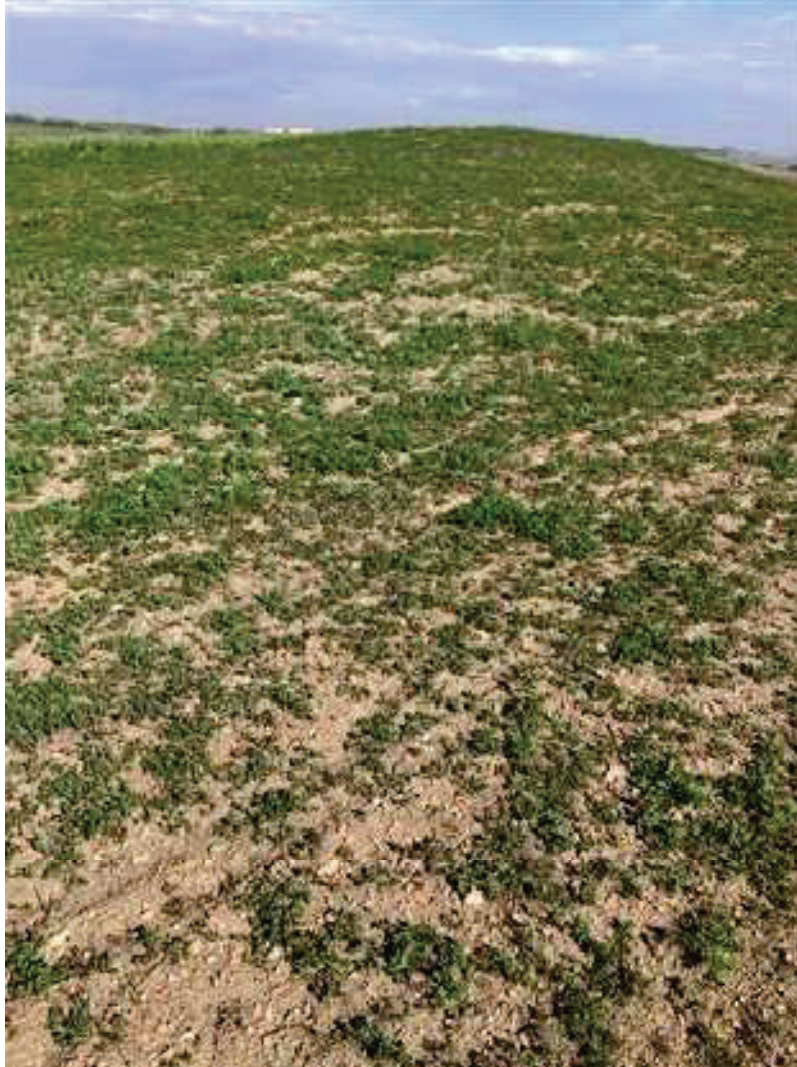
Issues needing remediation: Several spots of excessive bare soil, shown in P9, P11, and P16.

There were several sections where a bare patch of soil was noticed. Includes P9, 11 & 16. These may need further reclamation efforts.

P9, looking NNW, cropland reclamation and vegetation growing.

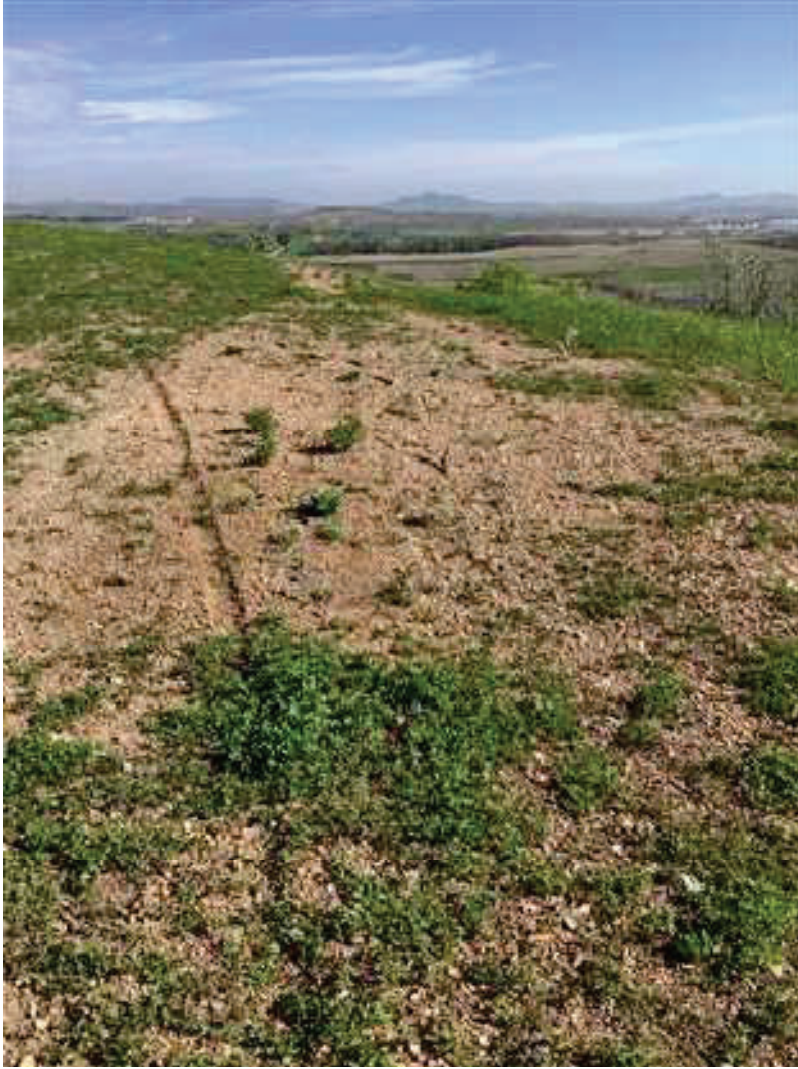
P10, looking West. Vegetation growth evident.

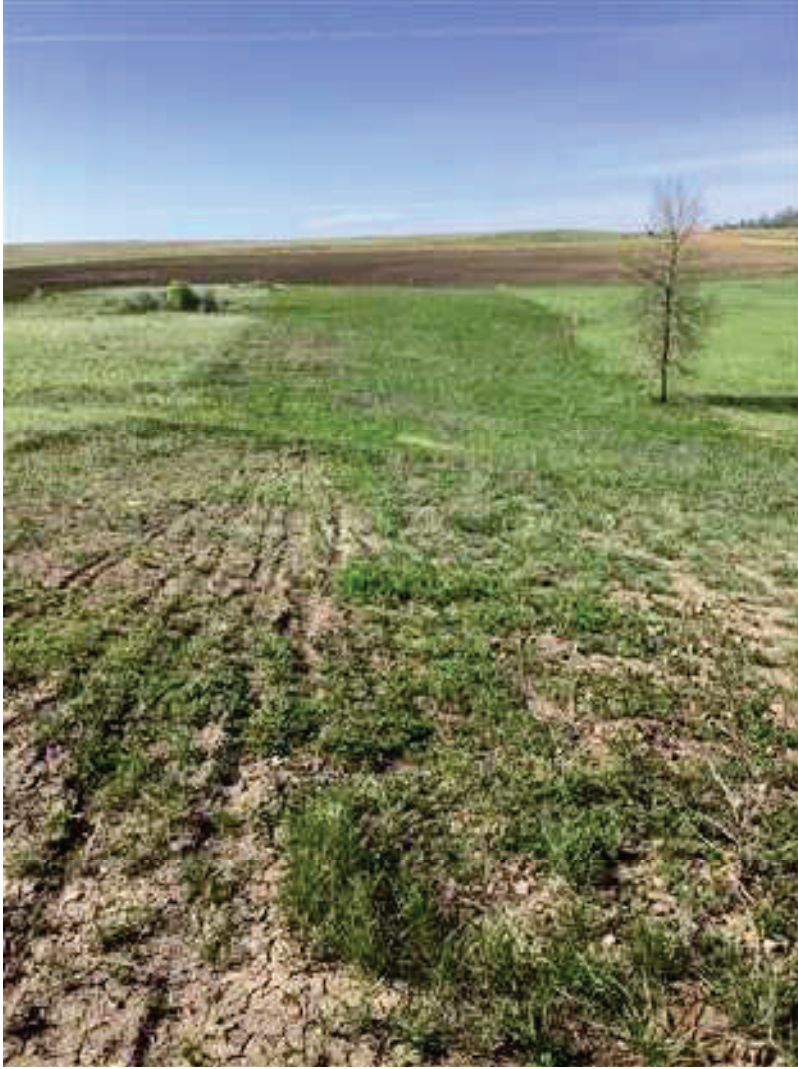
P11 looking North, bare spot with minimal plant cover. Will need reseeding.

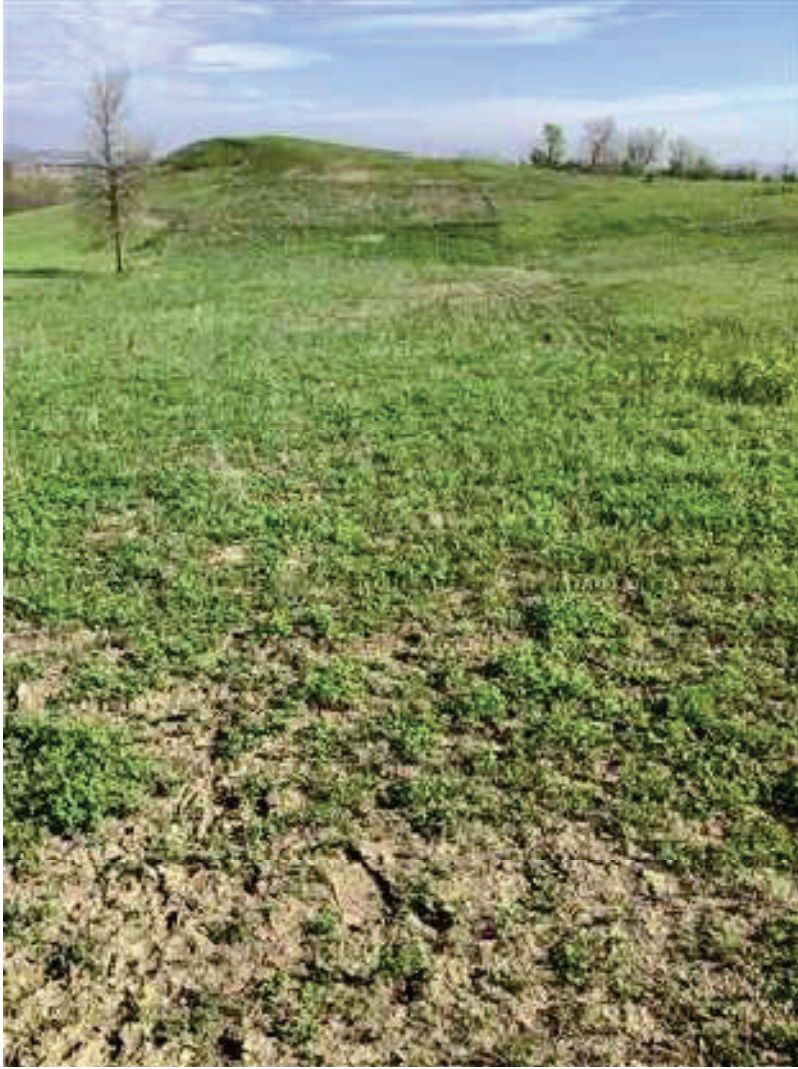
P12 looking south, ROW revegetation evident.

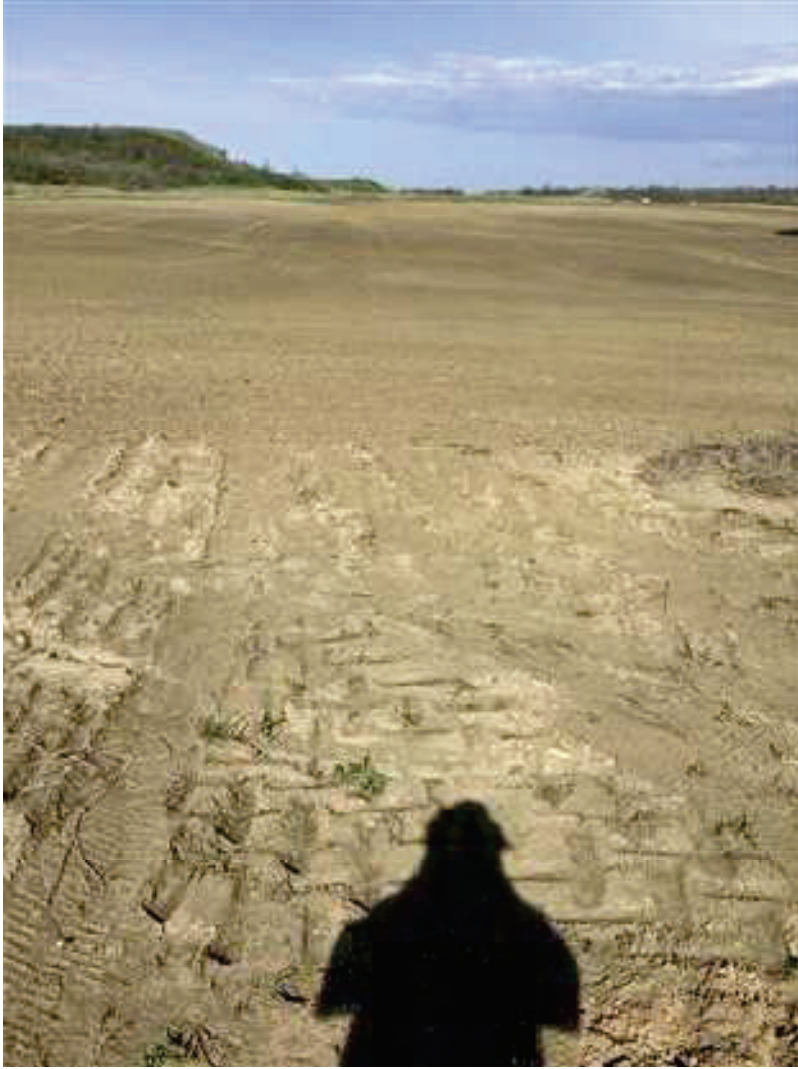
P13 looking North, substantive vegetative cover.

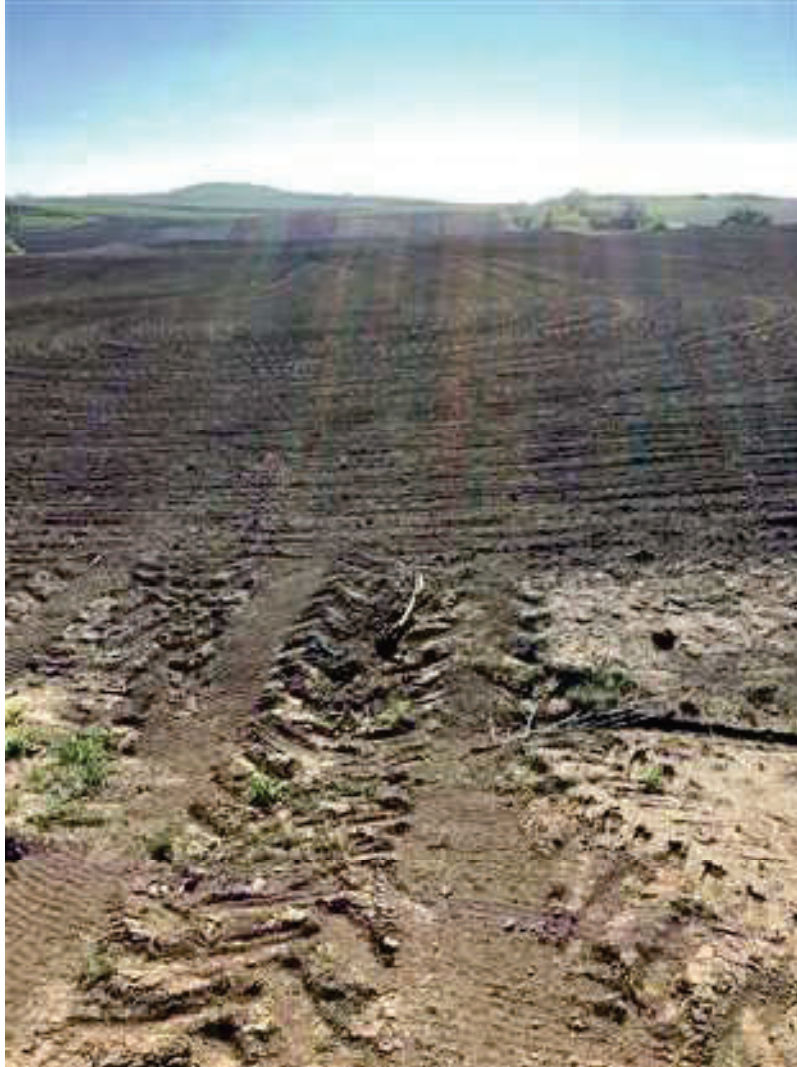
P14 looking West, tracks from farm equipment lead into a field, and field looks like it has been worked.

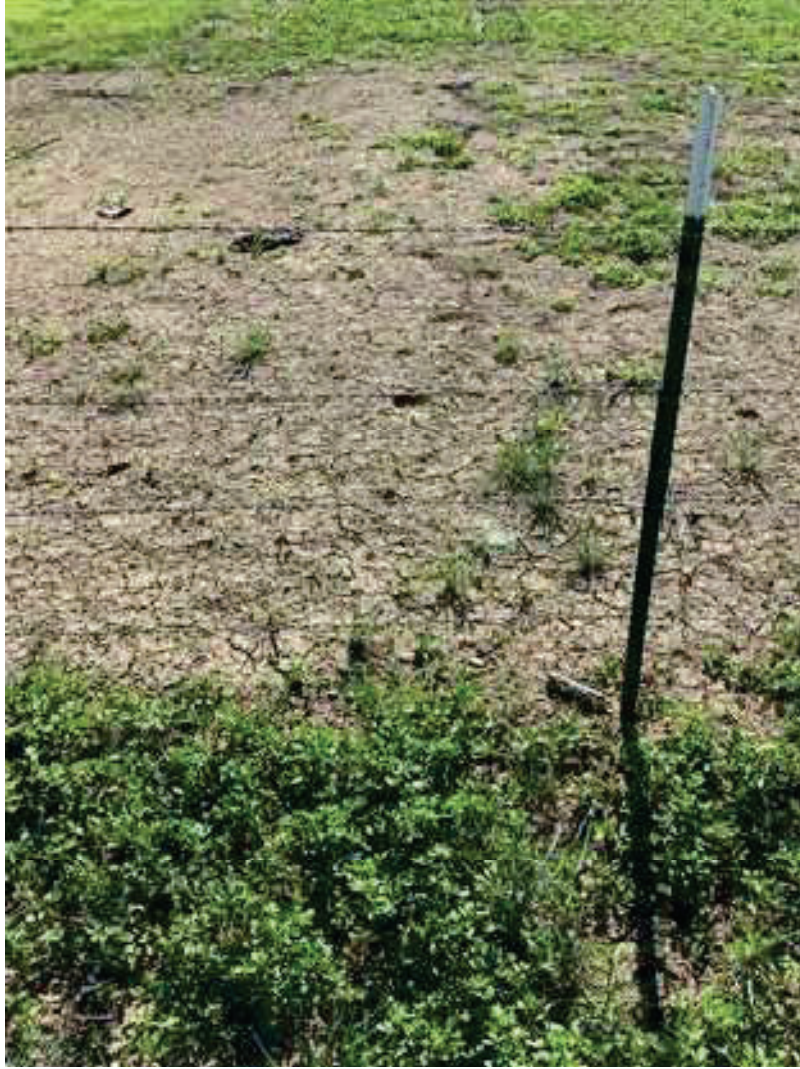
P 15 looking East, another farm field that has been worked, with farm equipment tracks visible.

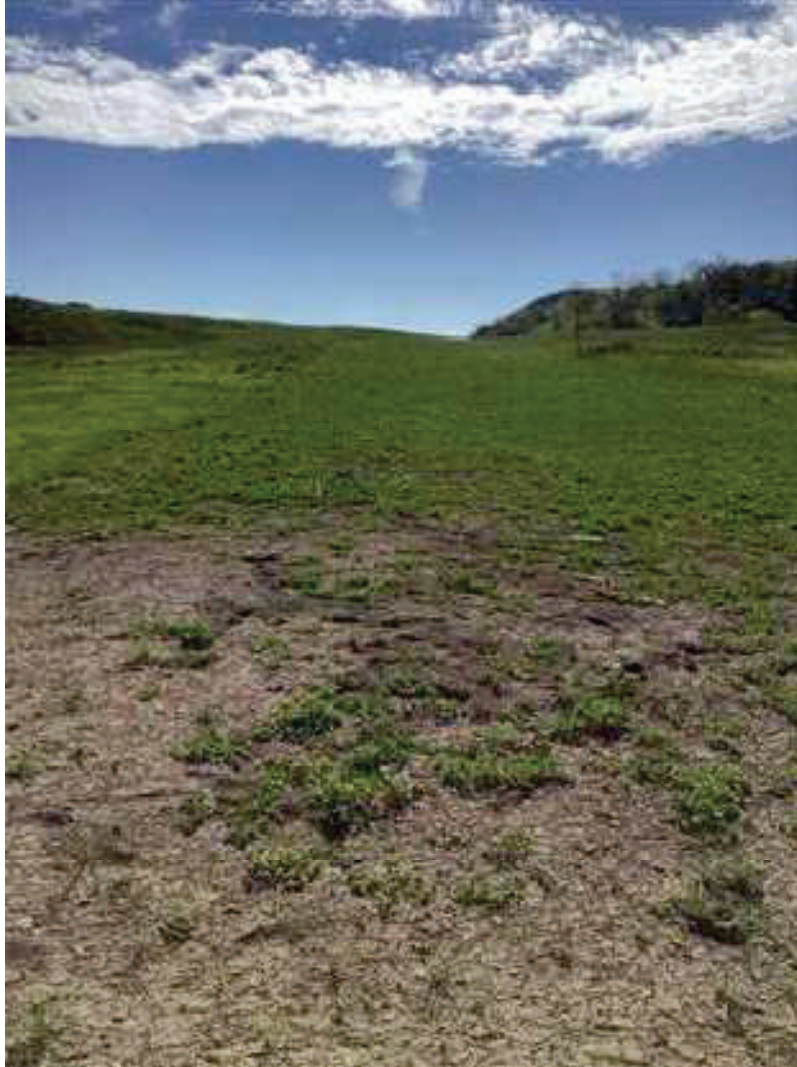
P16 looking East, localized spot of bare soil. Will need reseeding.

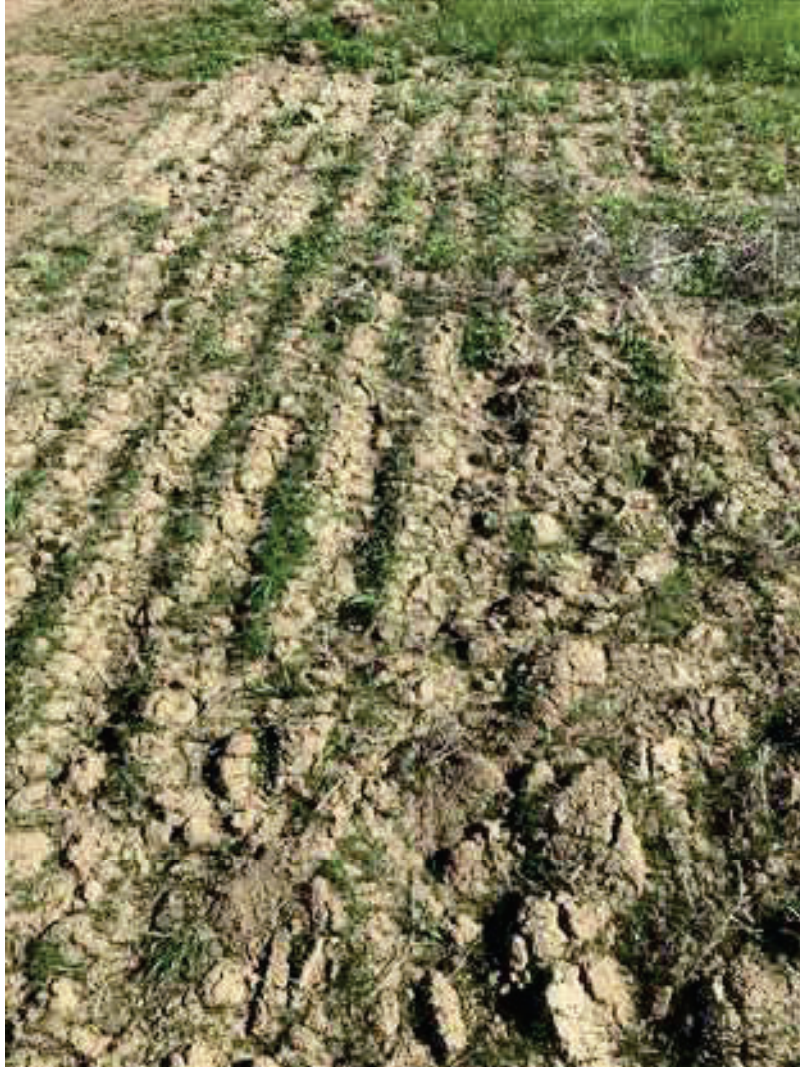
P17 looking East, more of the bare soil shown in P16, but beyond that spot, adequate vegetative cover has been established.

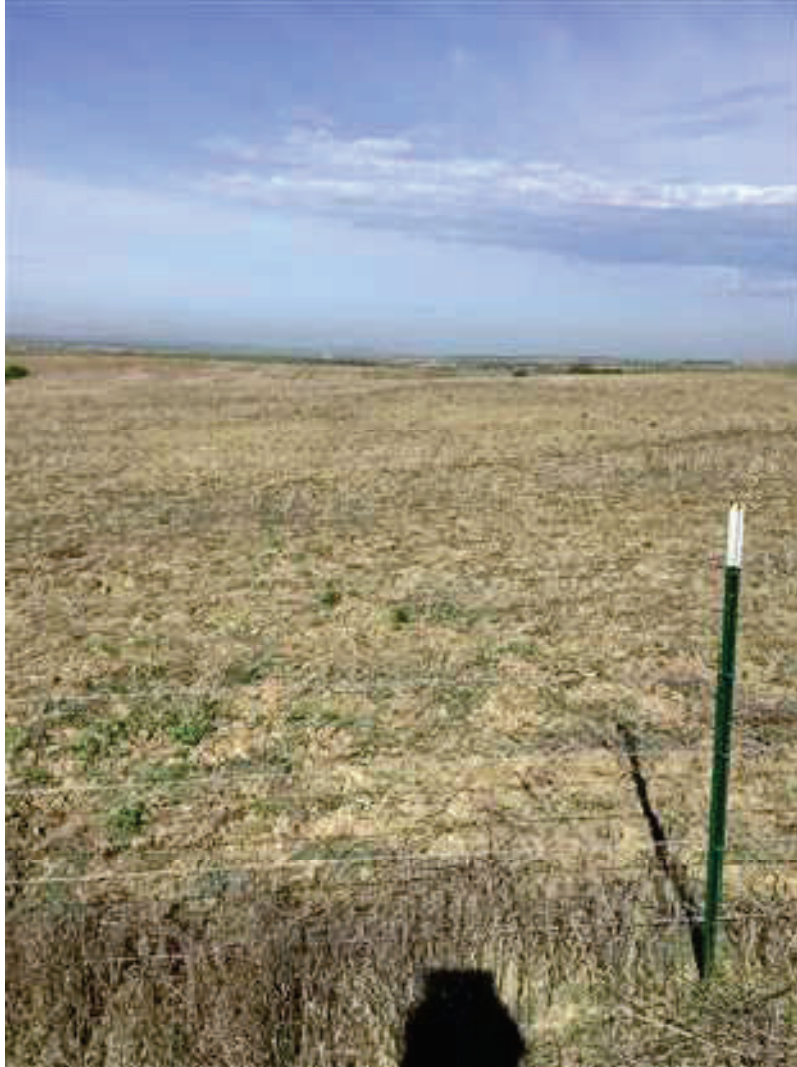
P18 looking North-seeding evident, though soil is cracking.

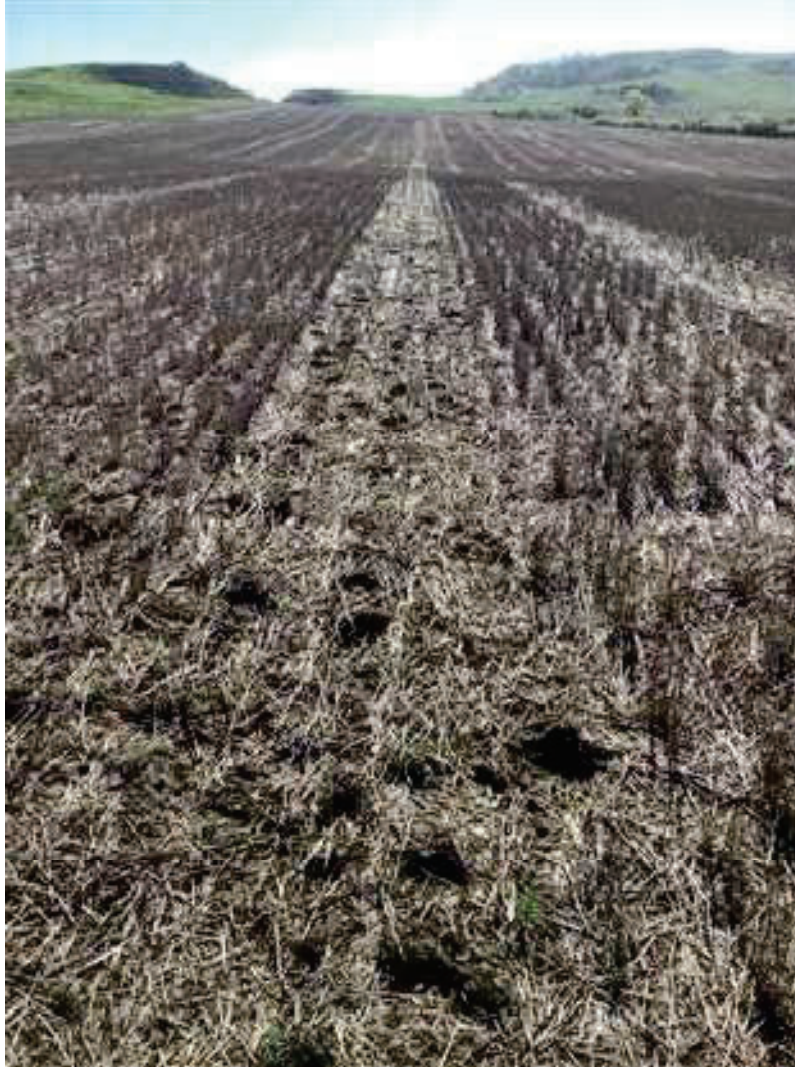
P19 looking West, farmlands have been worked recently, with stalks remaining from last year's harvest.

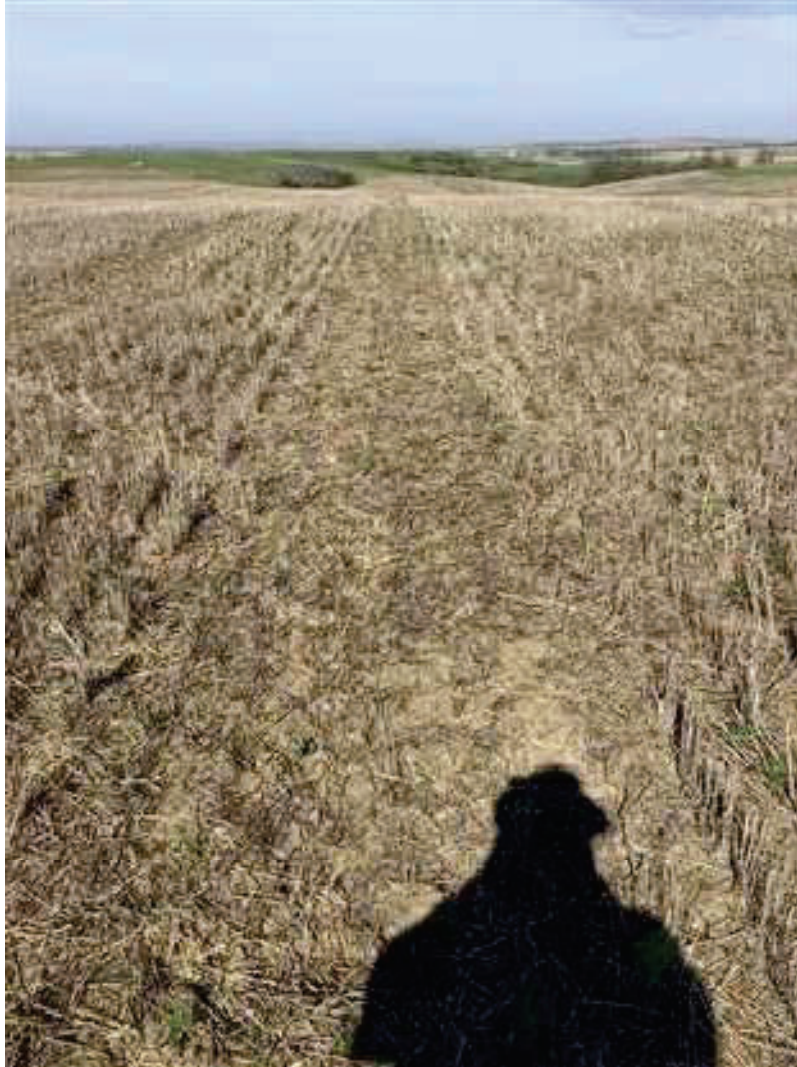
P20 looking East, can see where pipeline was installed. Field is still full of stalks from last year's harvest.

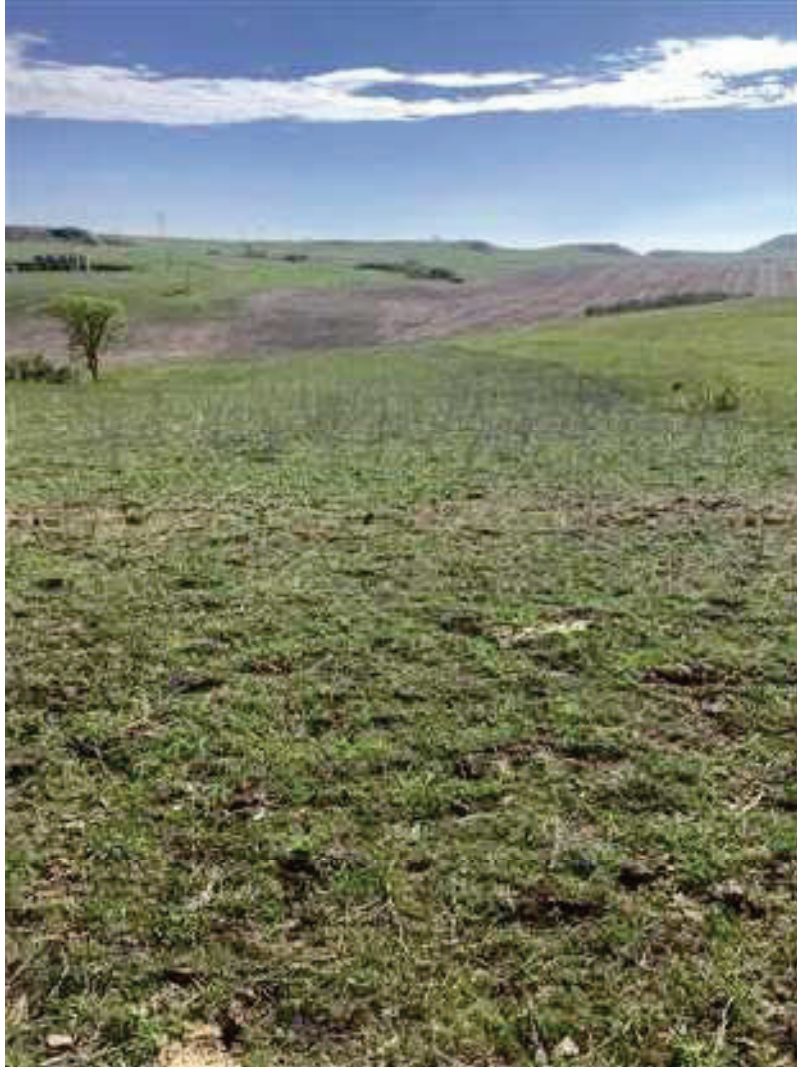
P21 looking West, Pipeline ROW visible, fields have not been worked yet, with last year's stalks still in place.

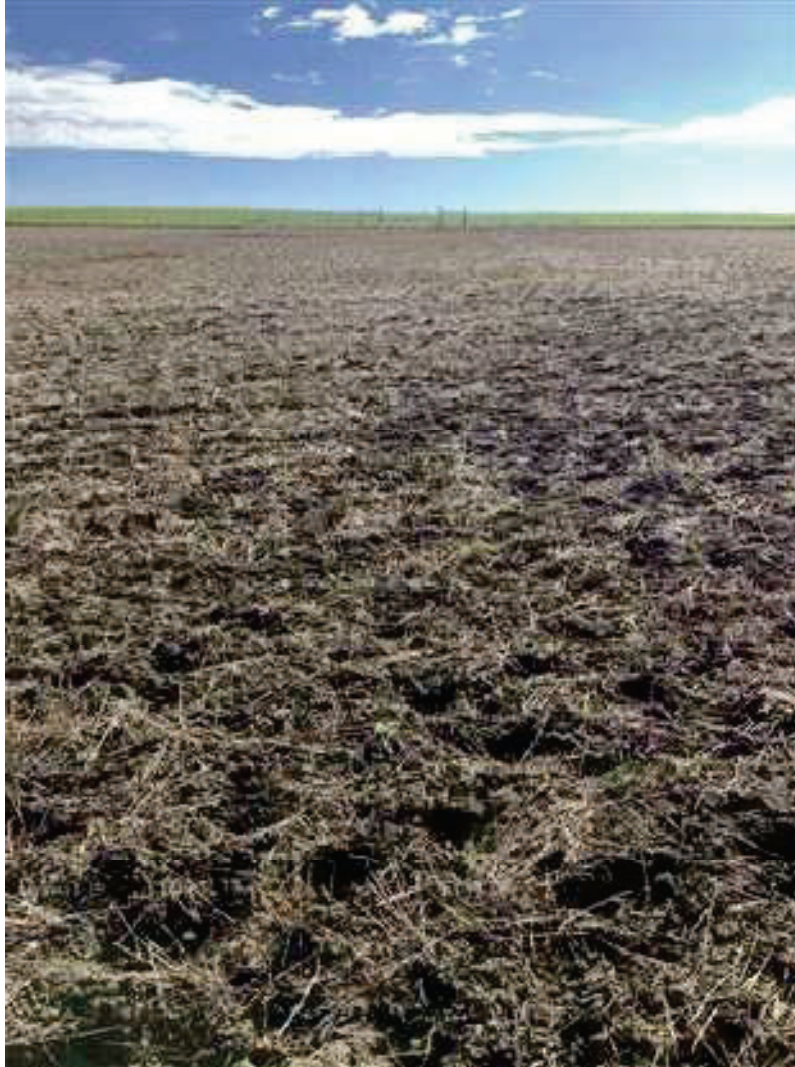
P22 looking NE, ROW has substantive vegetative growth.

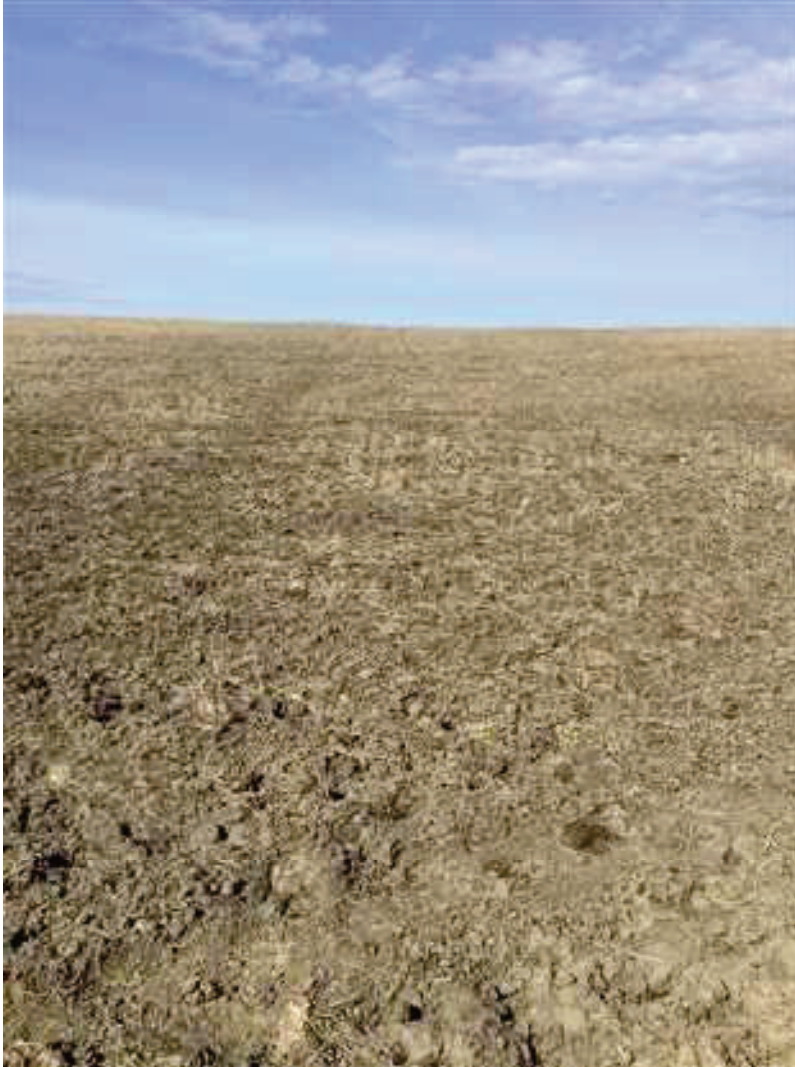
There was a large section of ROW that had little vegetative cover, and numerous hoof prints were present, as was the landowner's cattle herd. This land was back to being used as intended for landowner's purposes (ranching). See P23 & 24.

P23, looking NE, lots of dead vegetation, though this area is used for ranching, lots of hoofprints evident. Vegetation likely killed by landowner's herd.

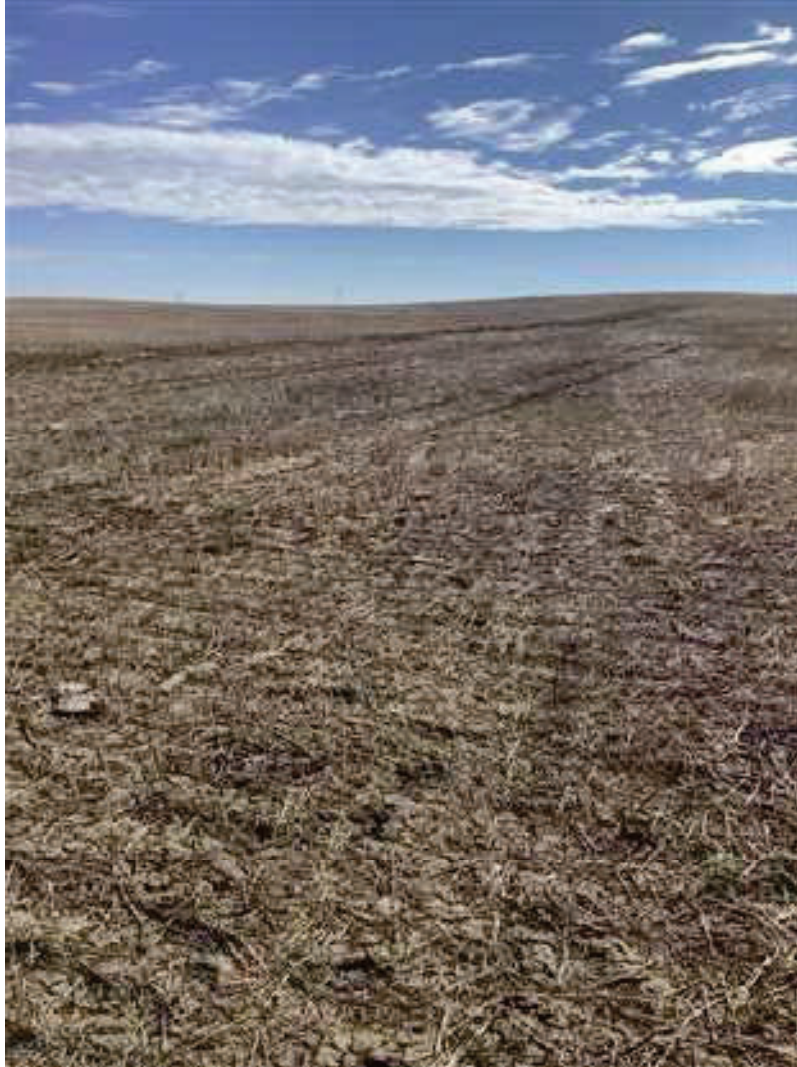
P24 looking WSW, More vegetation dead and trampled with hoof marks in the soil. The herd of black angus cows was maybe 100 feet south of inspector in this picture.

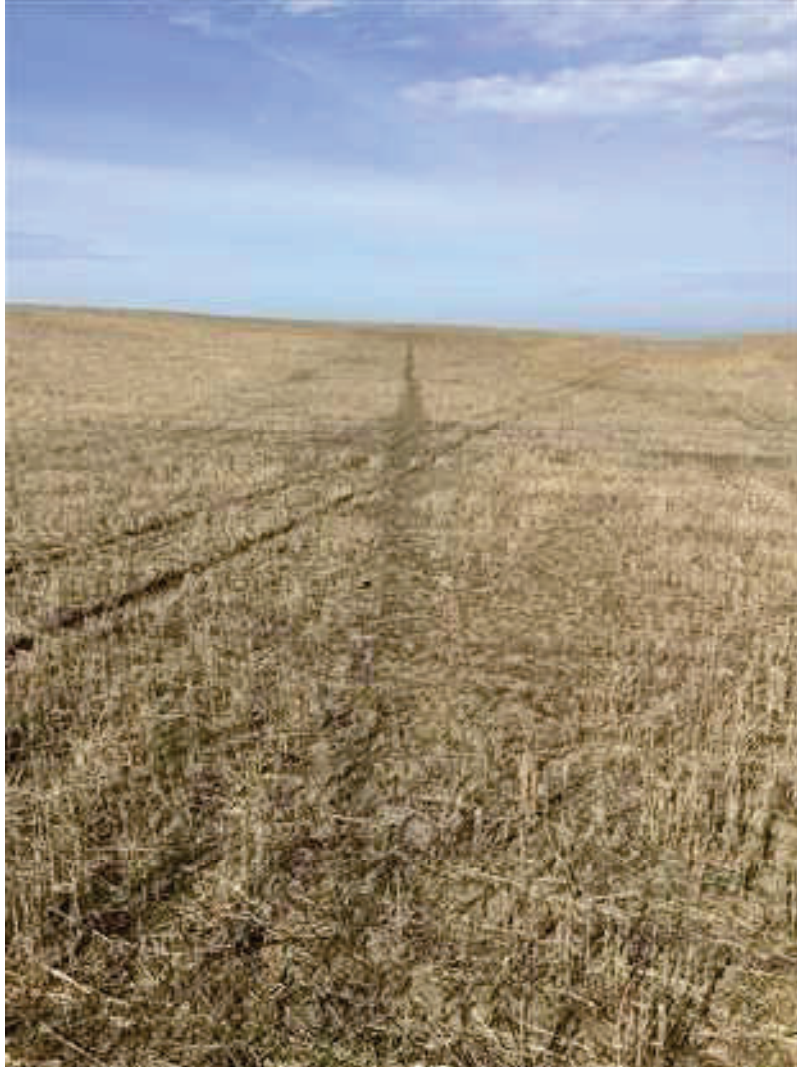
P25 looking NE, lots of dead vegetative material, all stalks from previous year's harvest.

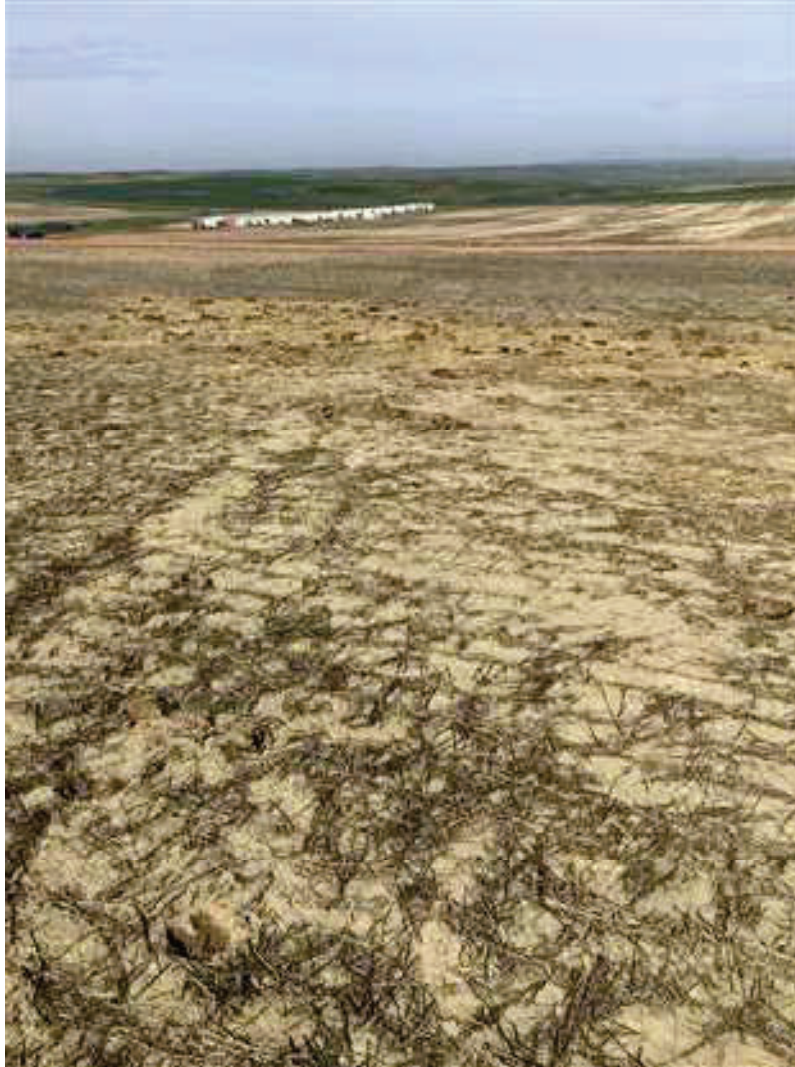
P26, looking SW, pipeline path clearly visible, stalks from previous year's harvest evident, crop land reclaimed.
