Bridger Pipeline LLC

8-inch 2.4-mile Crude Oil Pipeline– McKenzie County

Case No. PU-20-430

Reclamation and Revegetation Inspection Report

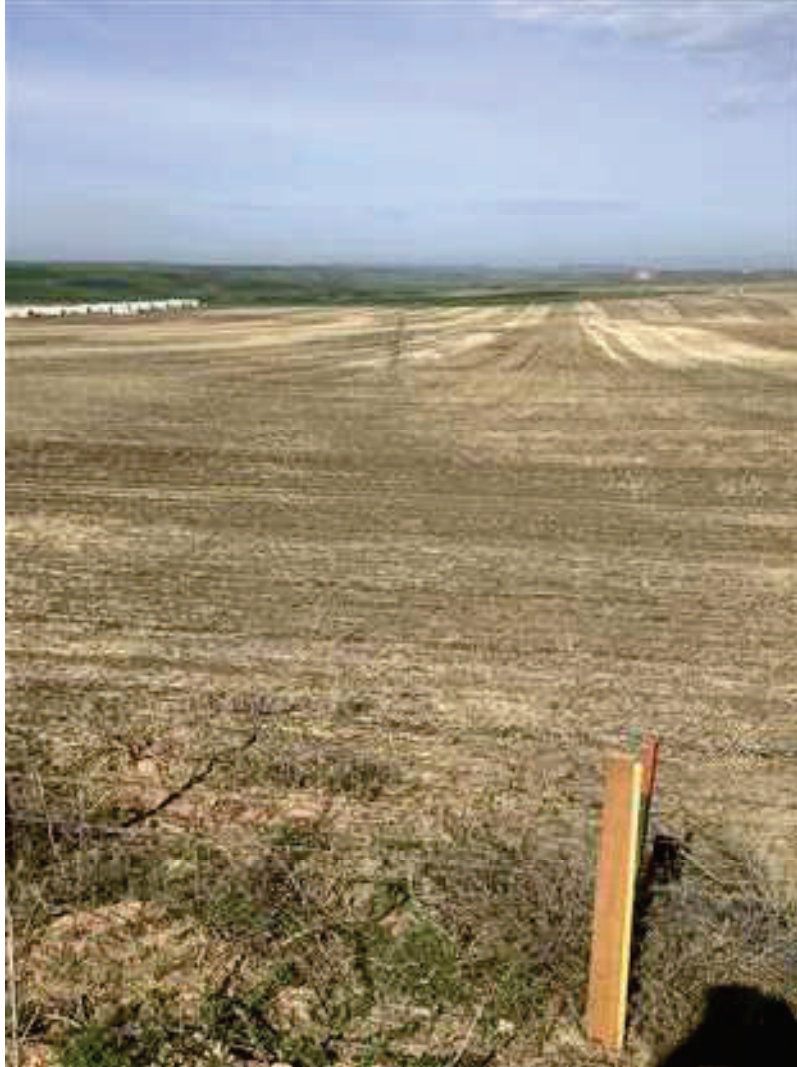
P27 looking SW, lots of bare soil and dead vegetation. Farmer hasn't worked this area yet.

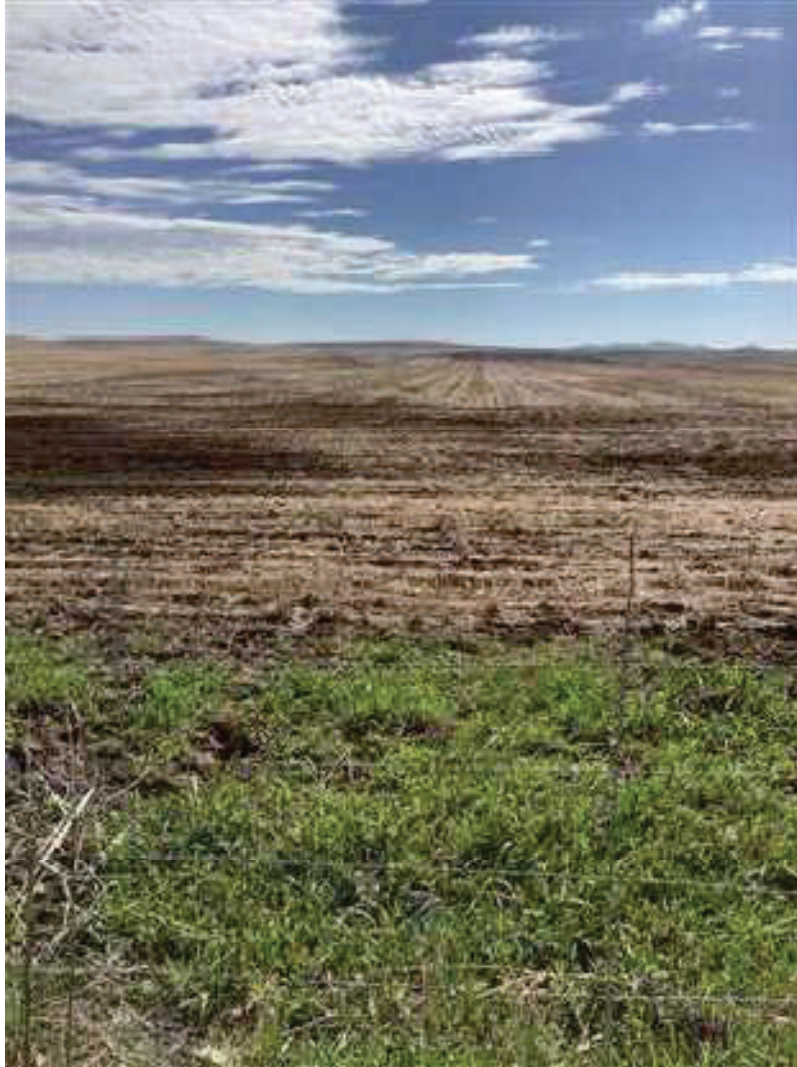
P28 looking SW, pipeline path visible, no issues with crop land apparent.

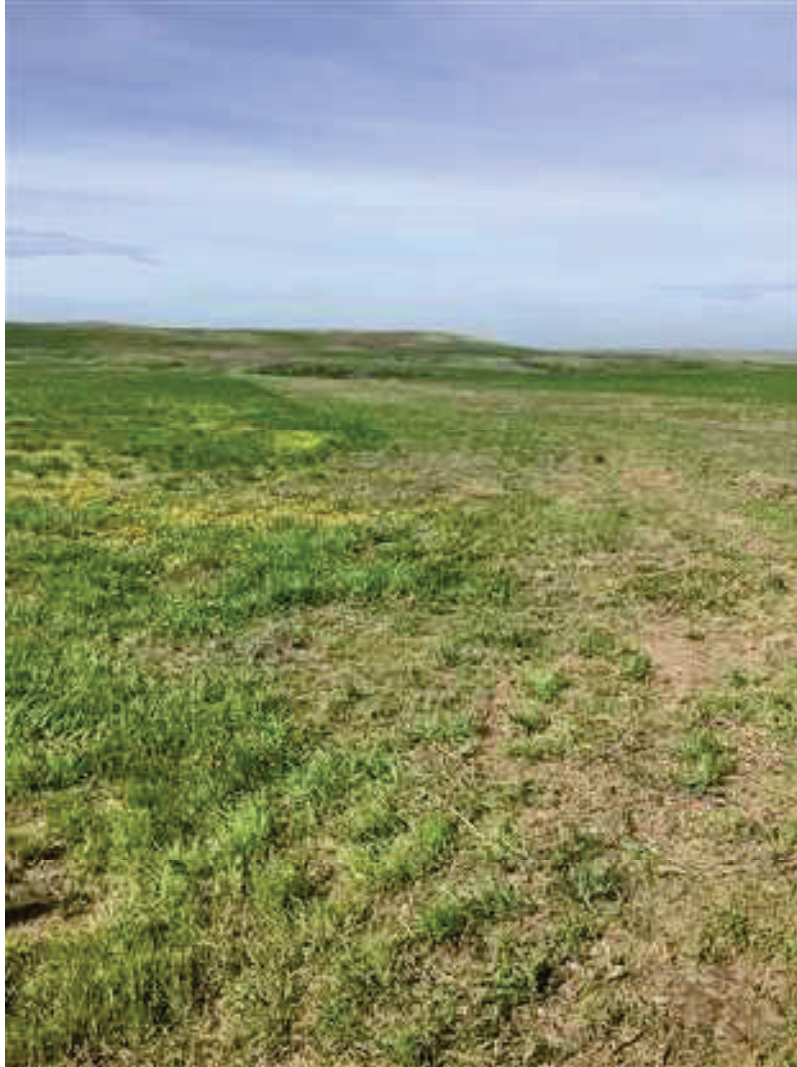
P29 looking East, crop land seems to have been worked, no issues. ROW outside field boundary has adequate vegetative cover.
