# Report of Geohazard Evaluation South Bend Pipeline Segment West Central North Dakota

Tetra Tech Project No. 117-0533085

August 28, 2020

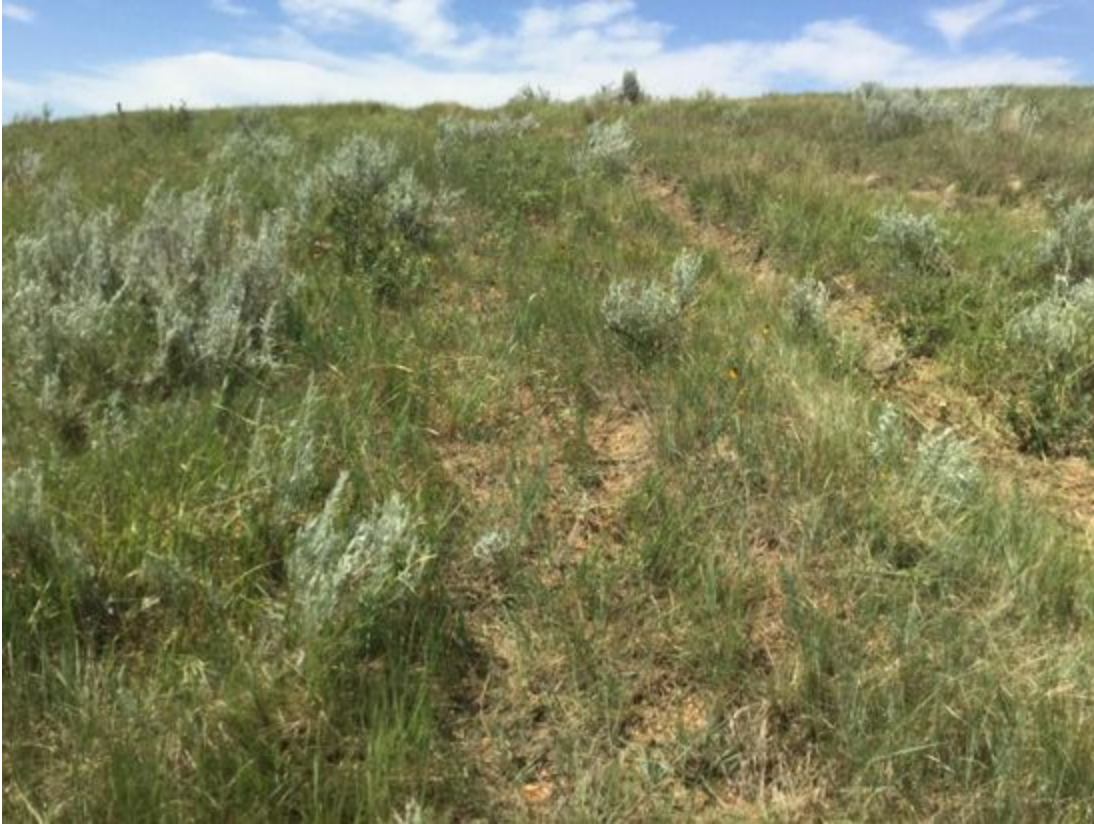
**Photo #3**

**Photo Description:** Looking upslope at historic vehicle wheel paths and minor associated erosion and gullyng.

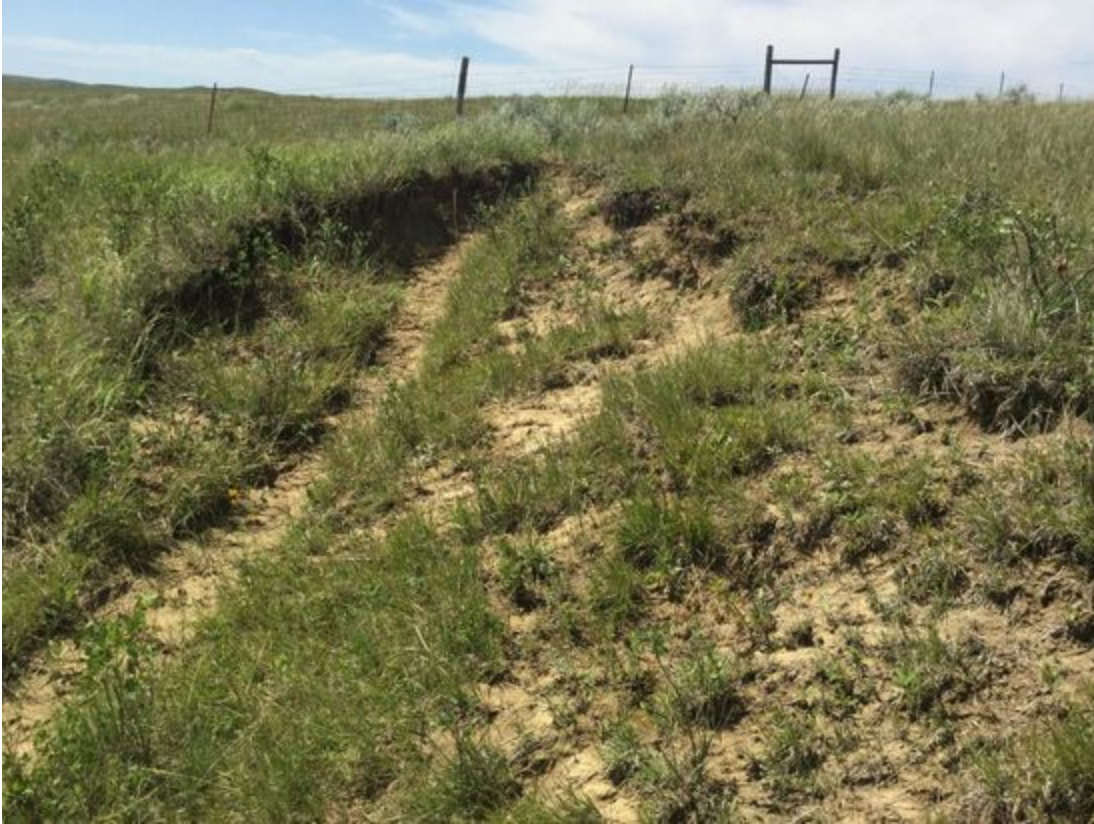
**Photo #5**

**Photo Description:** Looking up slope at livestock trail and minor gullying within, and nearby surficial erosion.

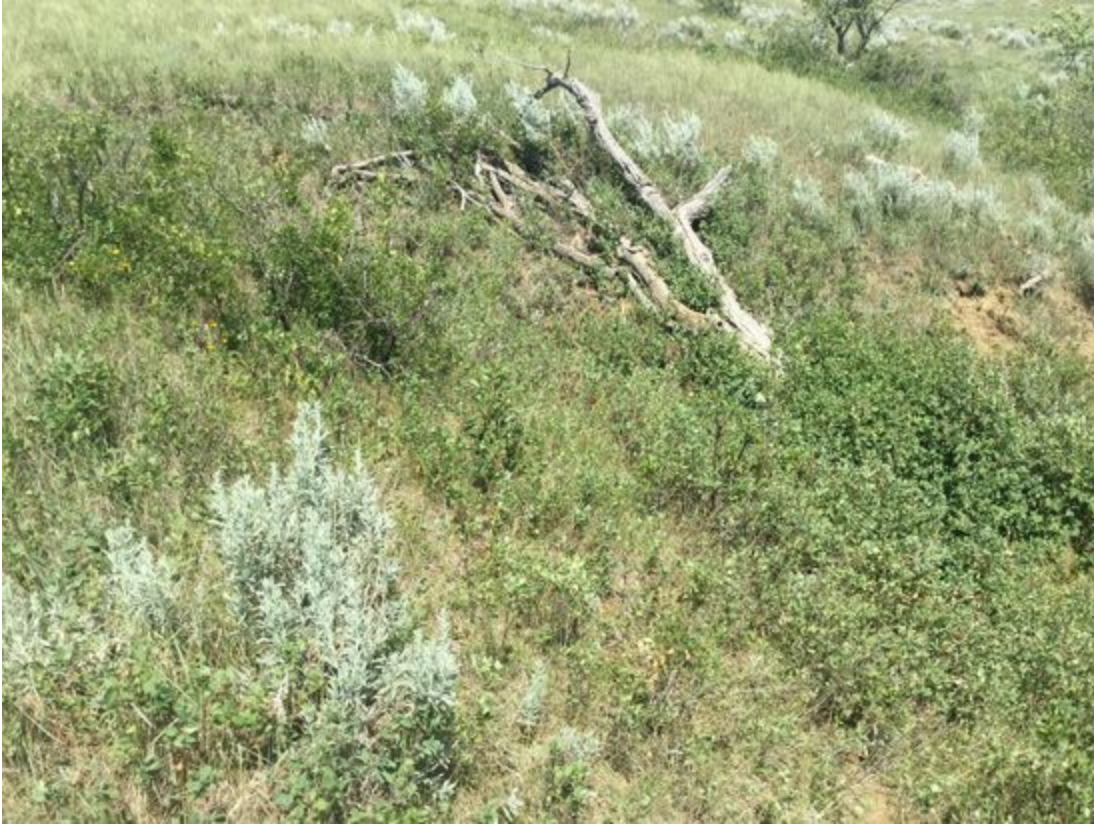
**Photo #6**

**Photo Type:** Slope documentation | **Photo Bearing:** 339 degrees  
**Photo Description:** Erosion and gullying on north edge of slope.

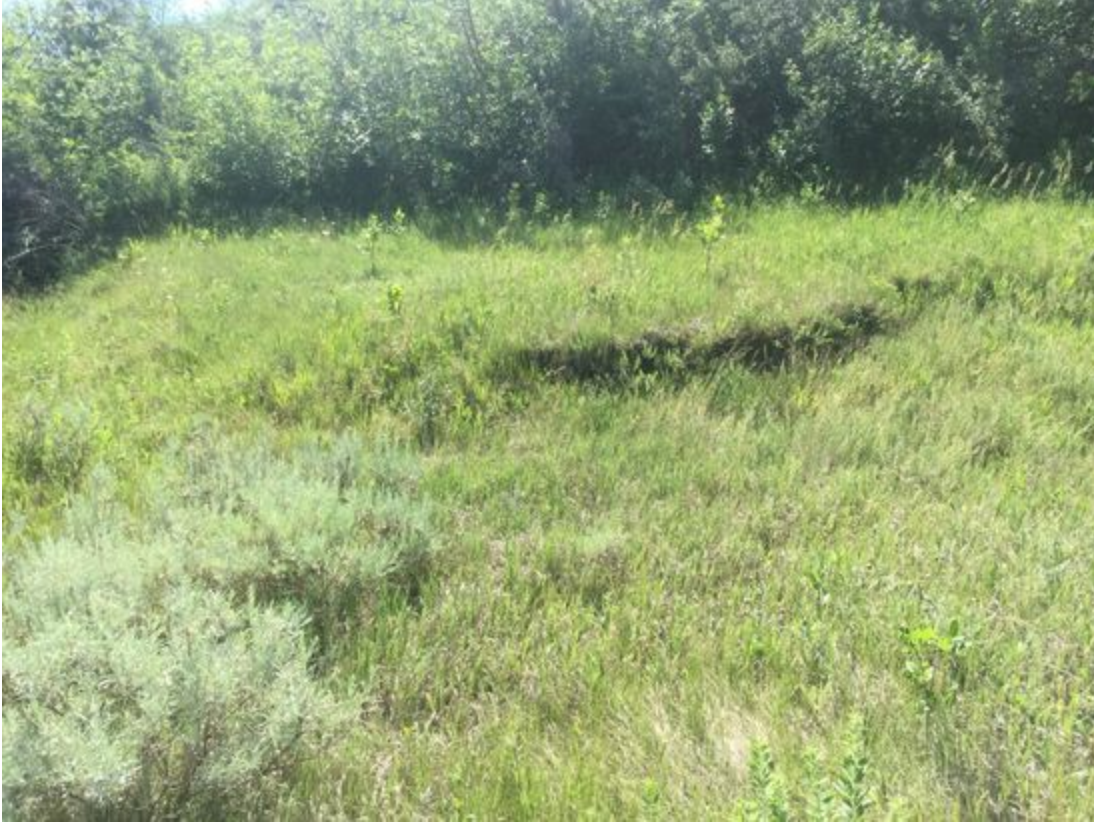
**Photo #2**

**Photo Type:** Slope movement evidence | **Photo Bearing:** 160 degrees  
**Photo Description:** Historic slide/slumping mass at toe of the north-facing slope.  
-----

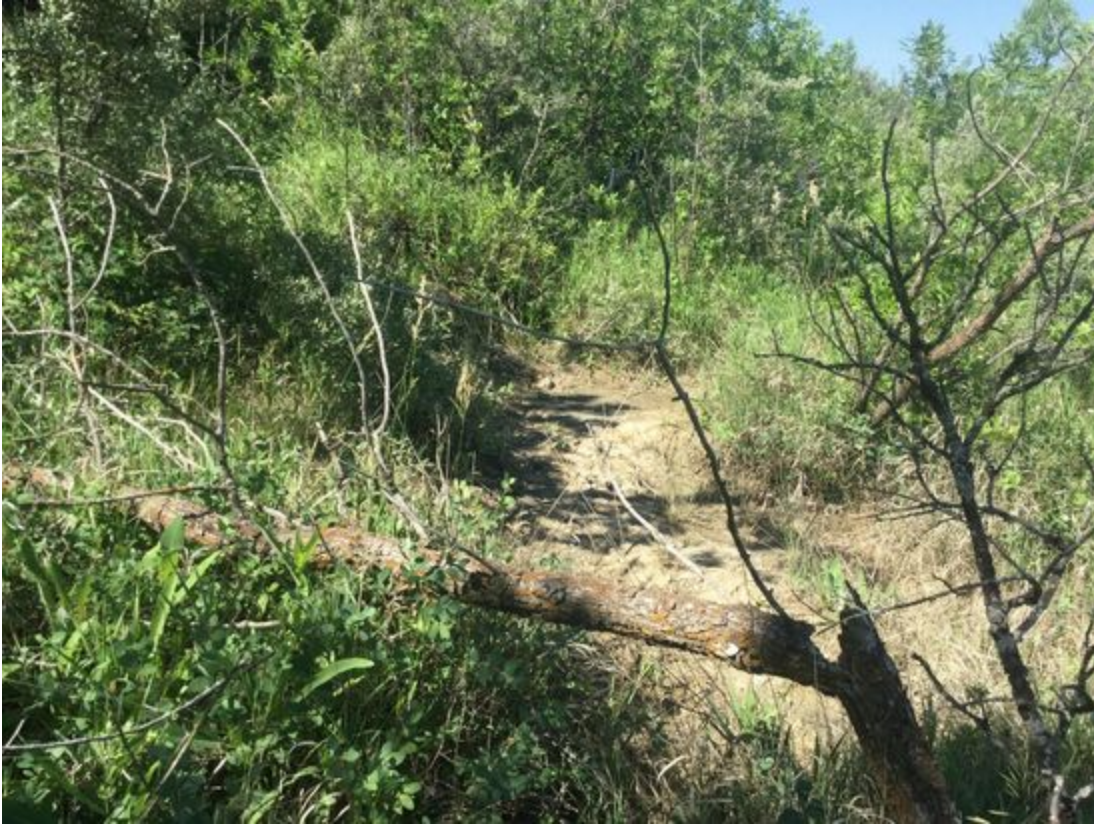
**Photo #3**

**Photo Description:** Area of historic standing water just above the toe of the north-facing slope.-

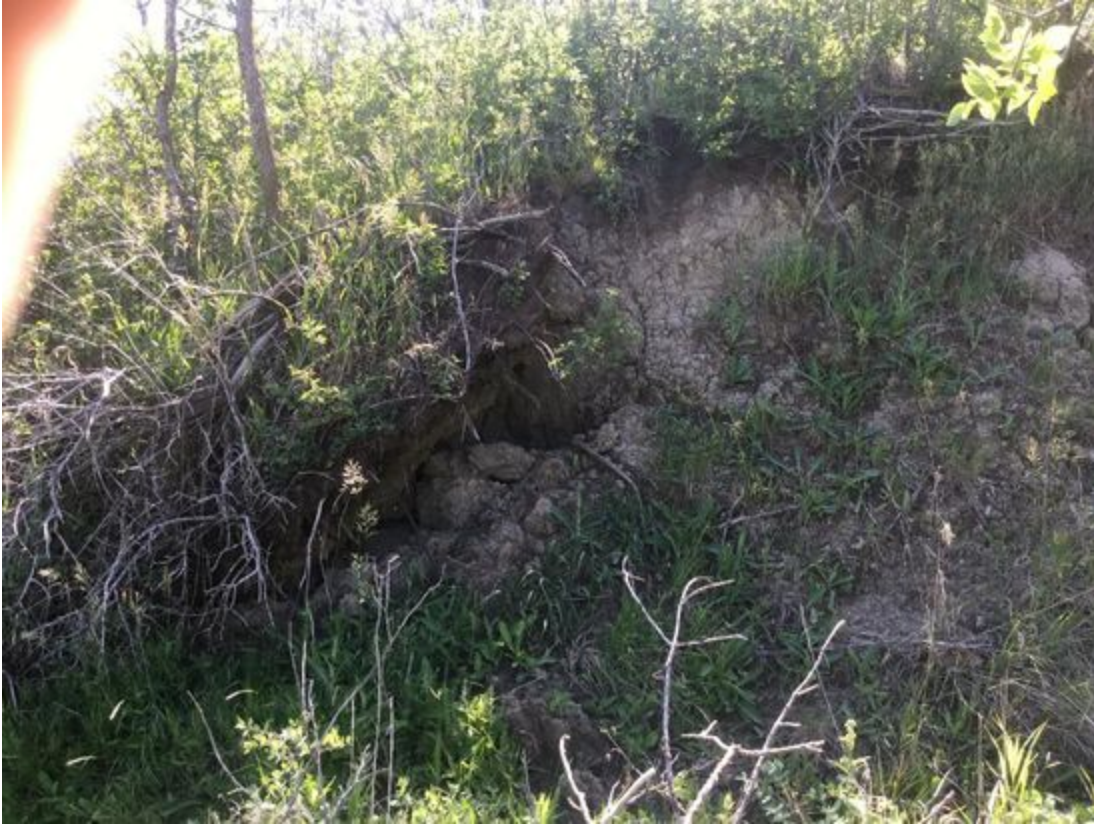
**Photo #4**

**Photo Description:** Oversteepened section of the north-facing slope at historic slide head scarp.

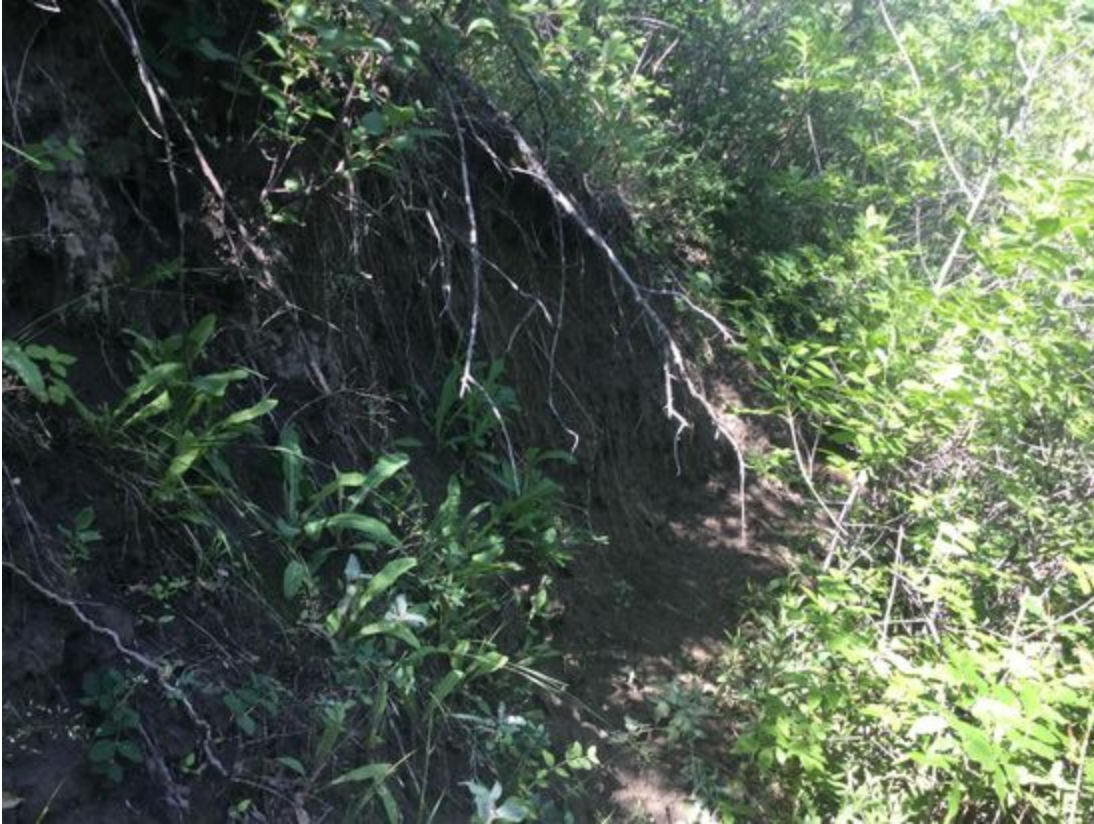
**Photo #5**

**Photo Type:** Slope documentation | **Photo Bearing:** 265 degrees  
**Photo Description:** Oversteepened section of the north-facing slope at historic slide head scarp.

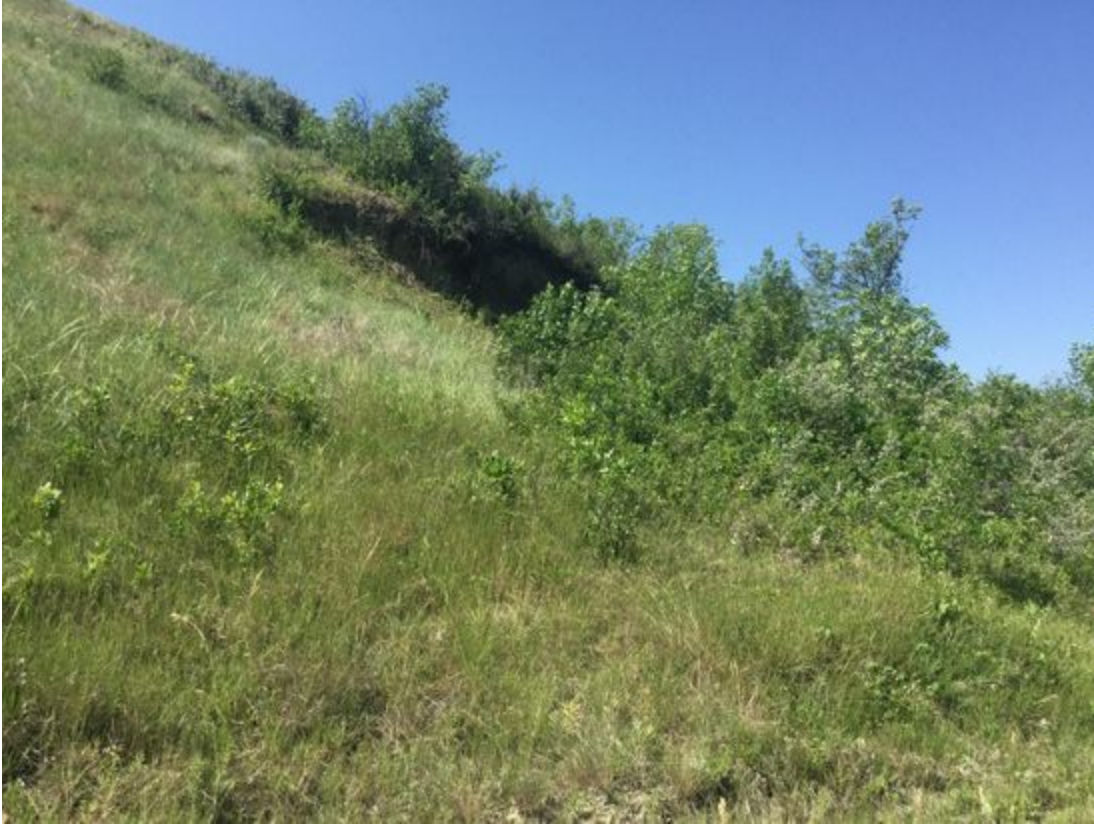
**Photo #11**

**Photo Description:** Looking at historic scarp on the east edge of the north-facing slope.  
-----

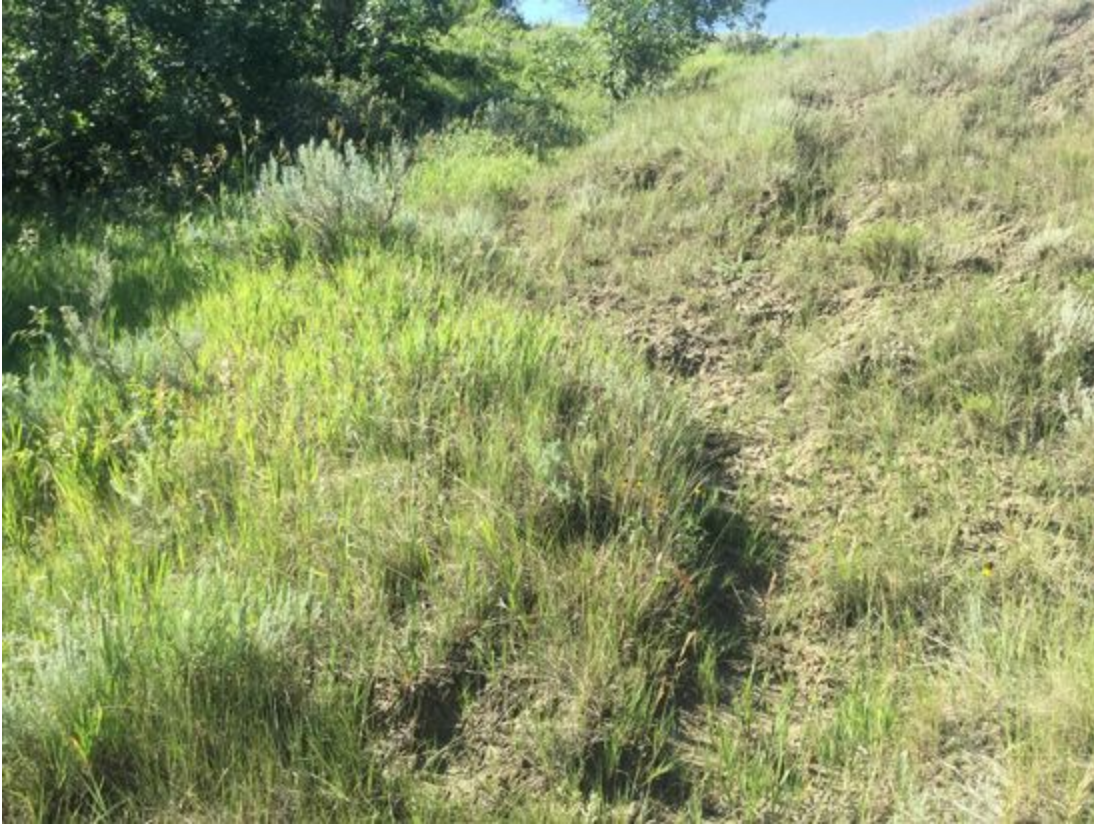
**Photo #3**

**Photo Type:** Slope documentation | **Photo Bearing:** 119 degrees  
**Photo Description:** Looking at small slump and cattle trail.

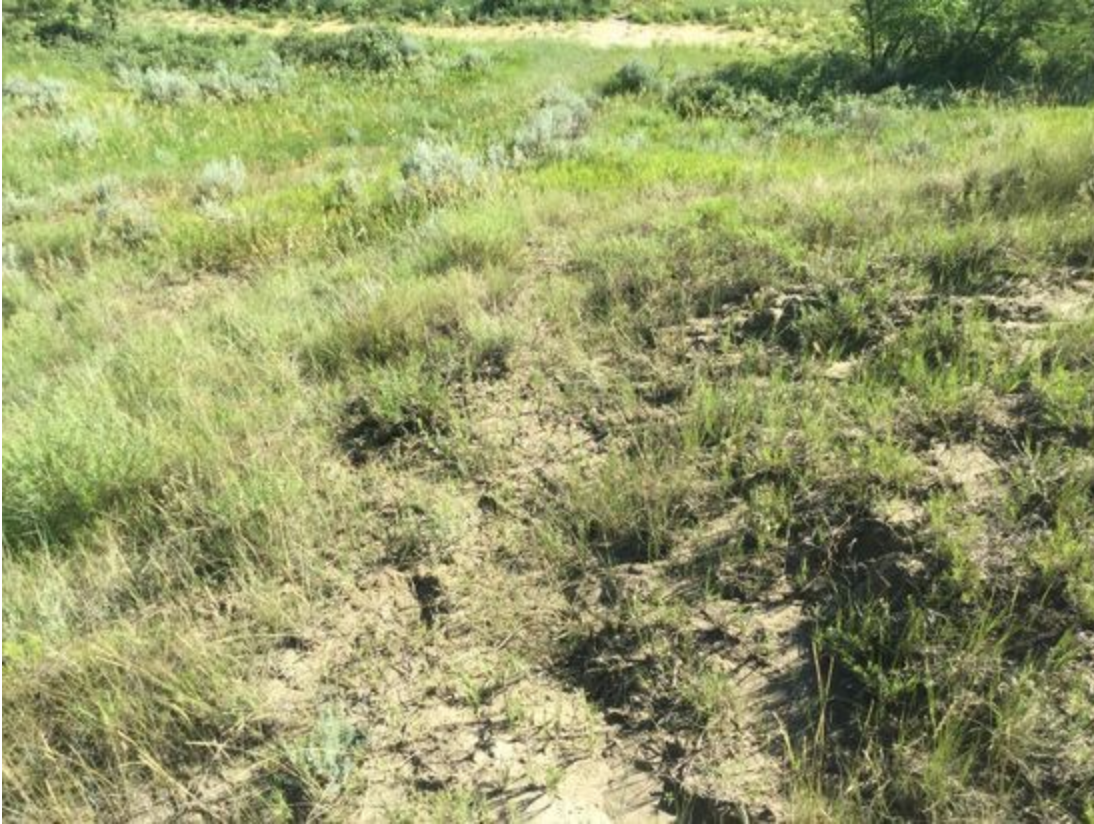
**Photo #5**

**Photo Type:** Slope documentation | **Photo Bearing:** 20 degrees  
**Photo Description:** Minor gullying and livestock trail.

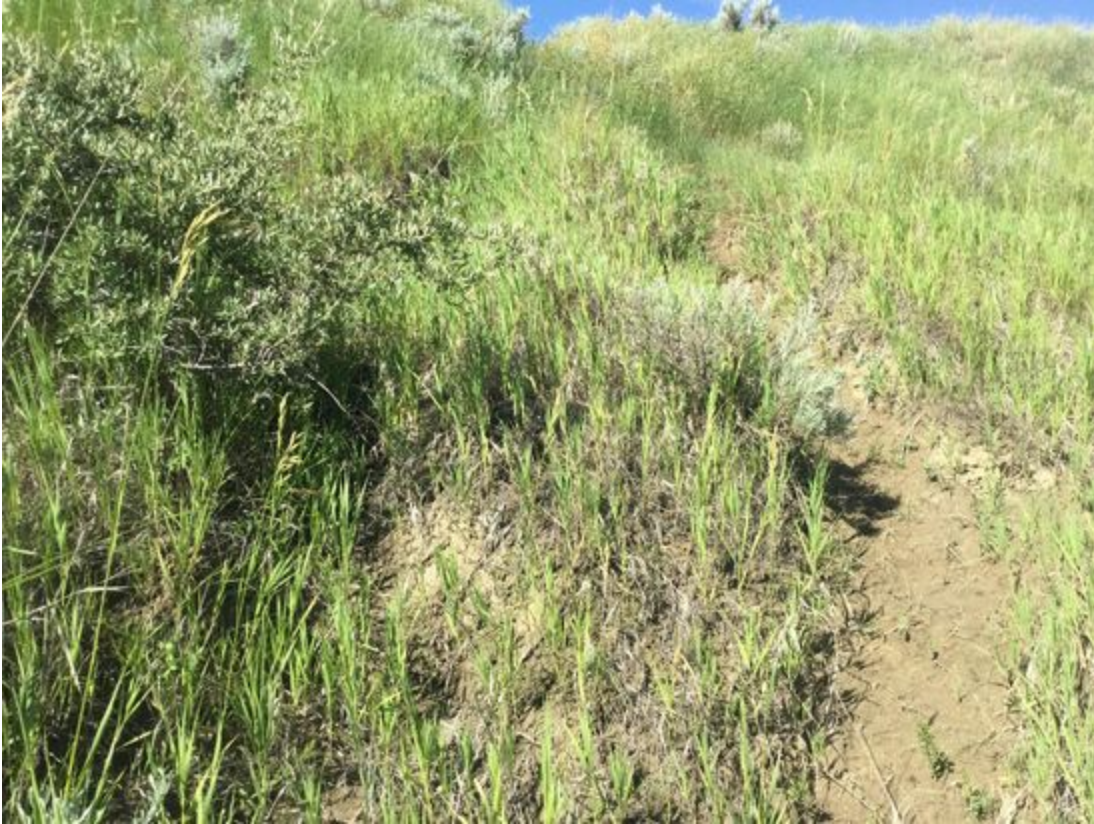
**Photo #3**

**Photo Type:** Slope documentation | **Photo Bearing:** 229 degrees  
**Photo Description:** Looking at gullying on eastern portion of the slope.

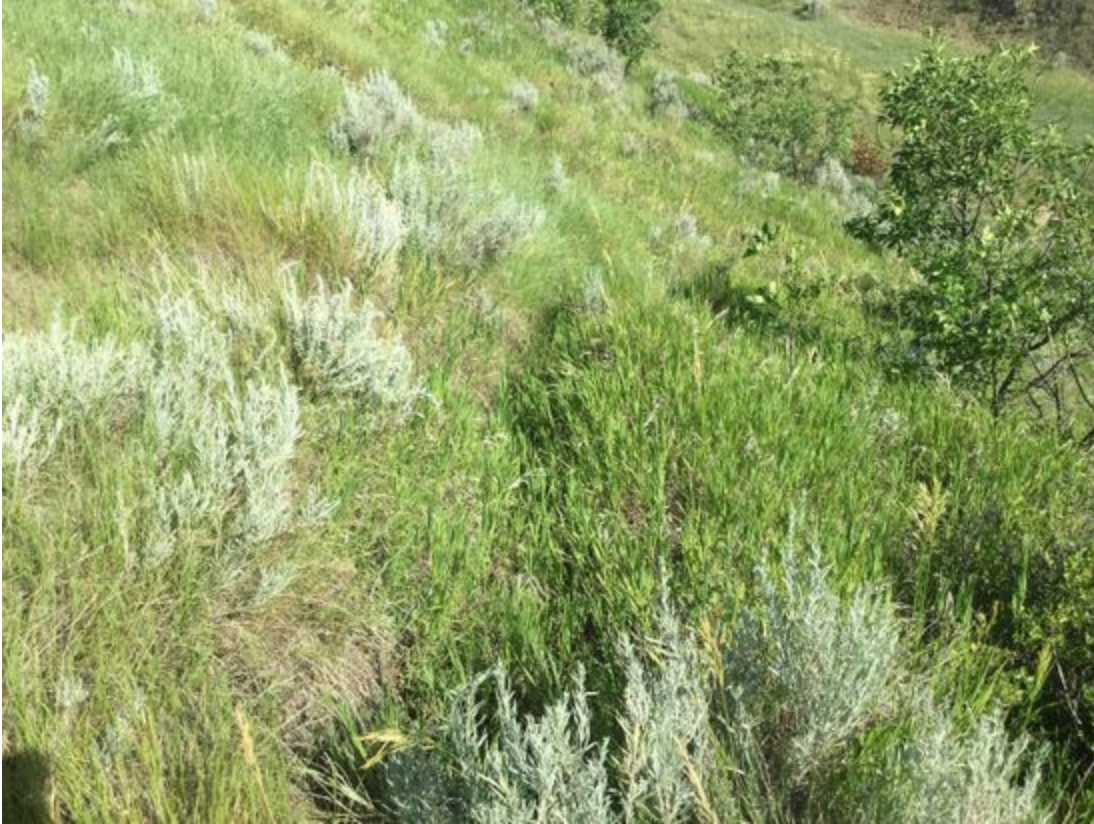
**Photo #6**

**Photo Type:** Slope movement evidence | **Photo Bearing:** 306 degrees  
**Photo Description:** Looking at a possible tension crack near top of slope.
