PU-21-048
Bridger Pipeline, LLC.
South Bend 16-inch Crude Oil
Pipeline
Topsoil Inspection Report

File No. 227705201

July 2022

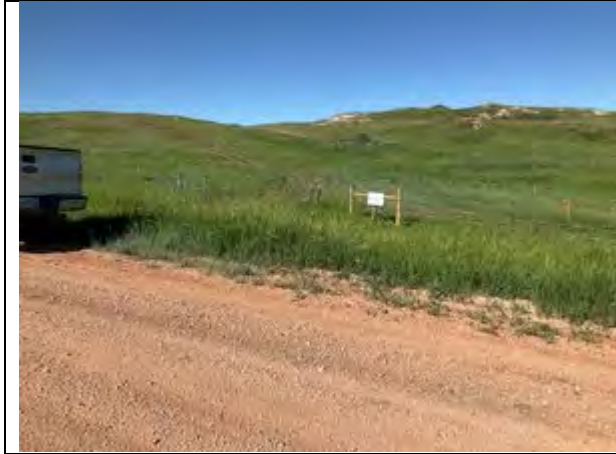
Observation Point: 1

Photo Description: Overlooking Pipeline route at the Montana border.

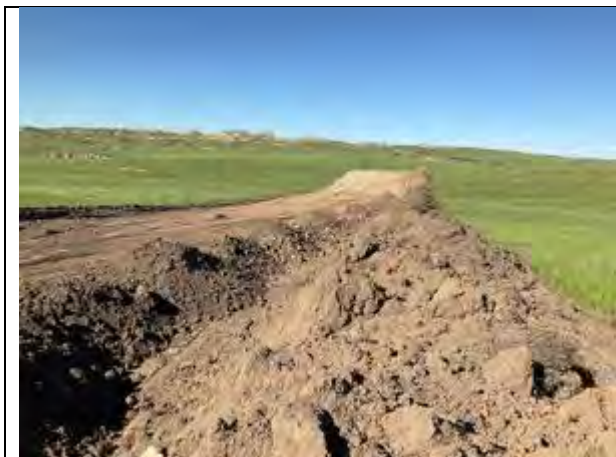
Observation Point: 2

Photo Description: Appropriately stripped and segregated soils

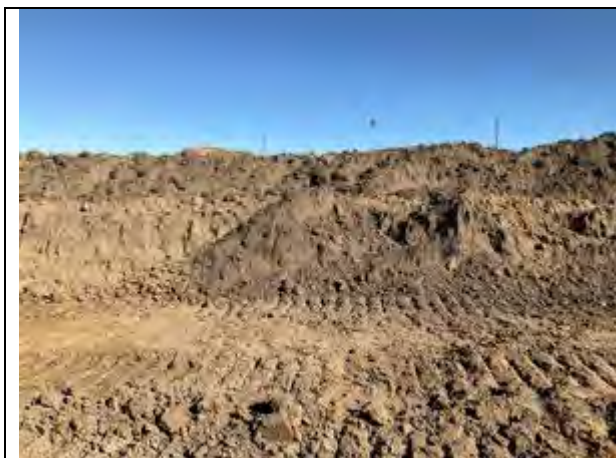
Observation Point: 3

Photo Description: Minor amount of topsoil in subsoil stockpile. Discussed with crew.

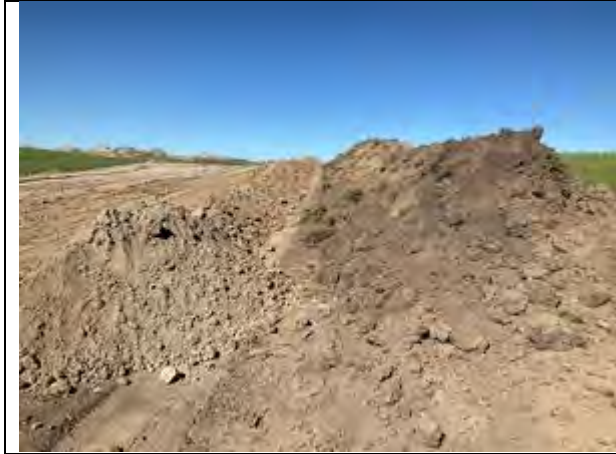
Observation Point: 4

Photo Description: Good soil segregation.

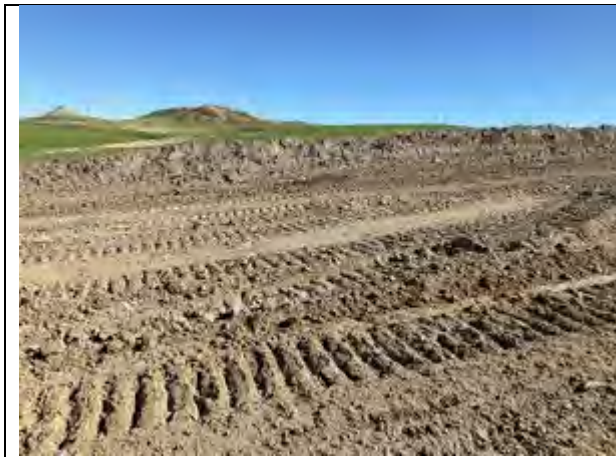
Observation Point: 5

Photo Description: Limited in-situ topsoil present at this location prior to stripping.

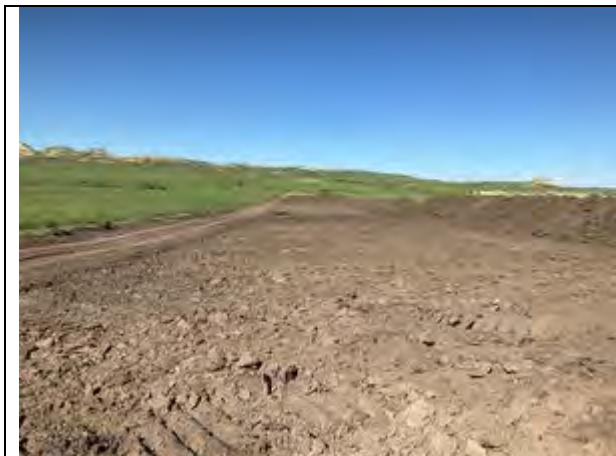
Observation Point: 6

Photo Description: 12" of topsoil stripped appropriately. No subsoil stripped.

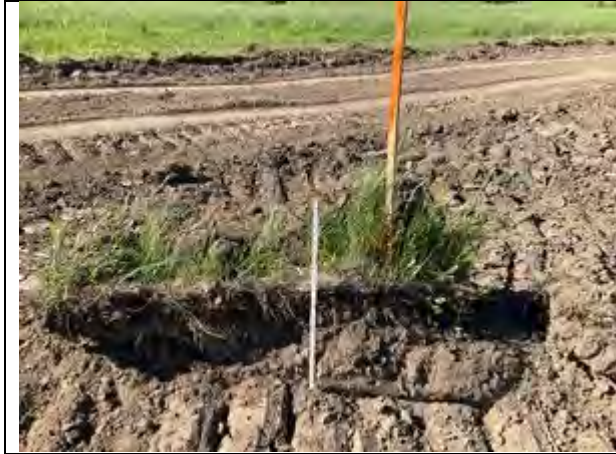
Observation Point: 7

Photo Description: Showing centerline stake where 12"+ topsoil stripped as required.

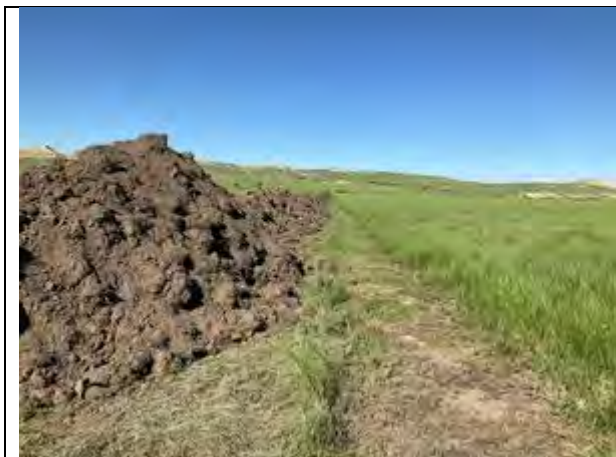
Observation Point: 8

Photo Description: Topsoil stockpile contained within ROW.

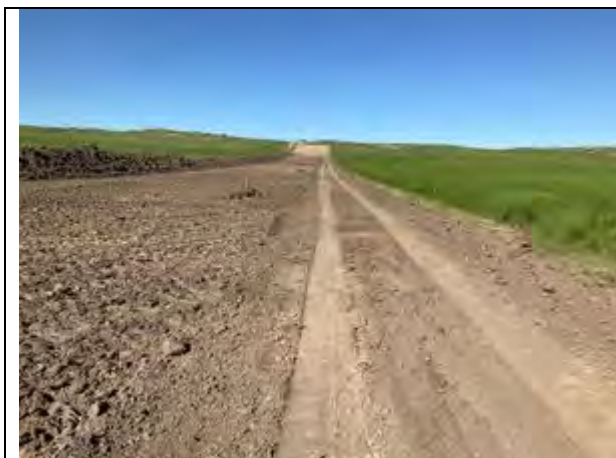
Observation Point: 9

Photo Description: 12" topsoil appropriately stripped over proposed trench but only 9" stripped over working side where equipment traveled. Discussed need to strip all topsoil up to 12" susceptible to compaction or subsoil piling with contractors.

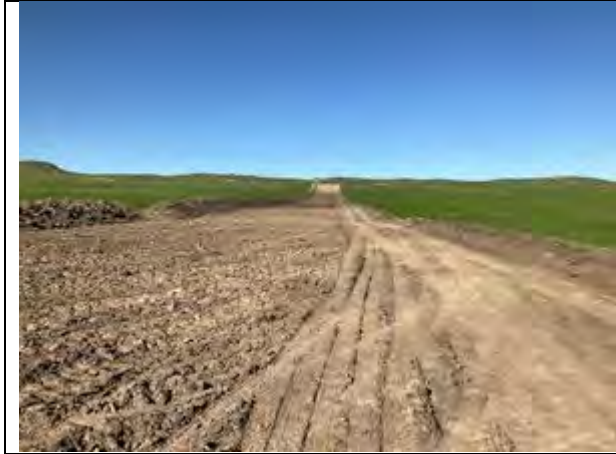
Observation Point: 10

Photo Description: Topsoil appropriately stripped over proposed trench area.

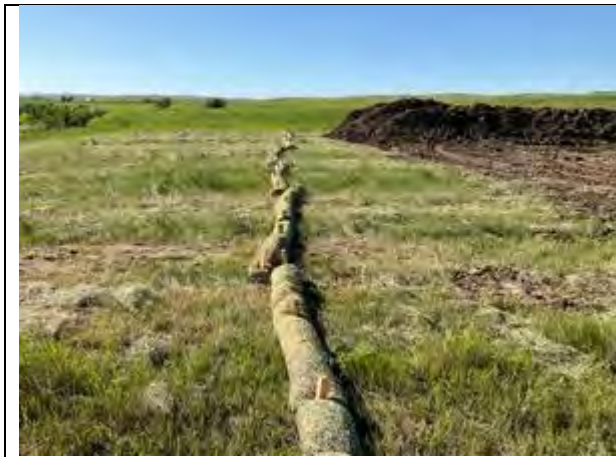
Observation Point: 11

Photo Description: Straw wattle at end of stripped ROW above CS Creek.

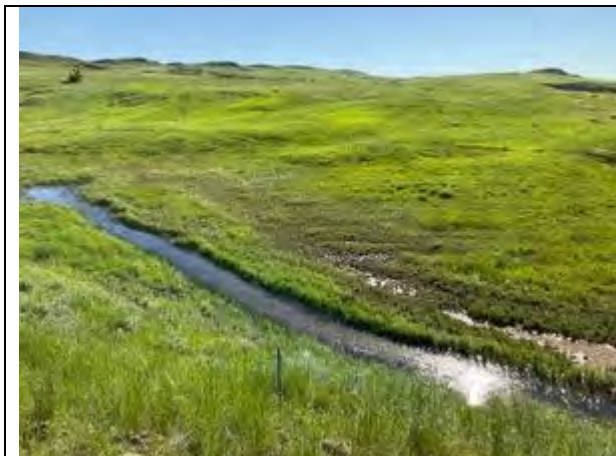
Observation Point: 12

Photo Description: Overlooking potential landslide prone Area H now proposed for HDD at CS Creek.

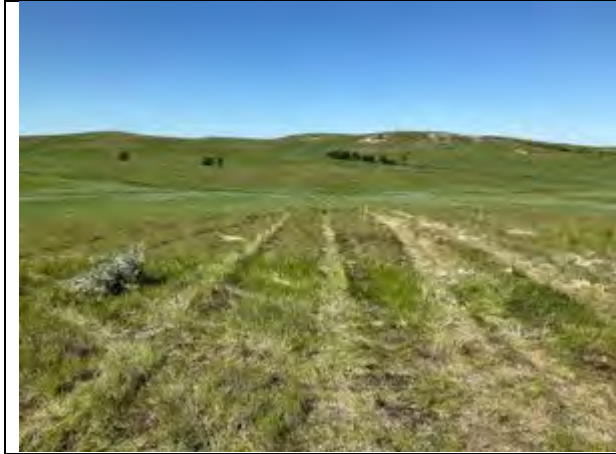
Observation Point: 13

Photo Description: ROW and centerline staked. No other activity taking place yet. 5" in-situ topsoil present along shoulder slope.

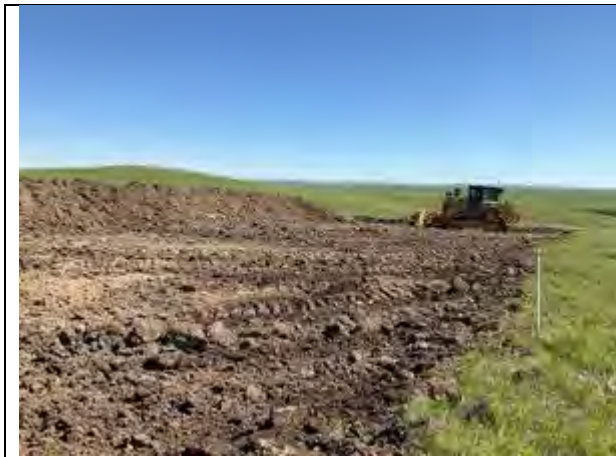
Observation Point: 14

Photo Description: Appropriately stripped topsoil on hilltop.

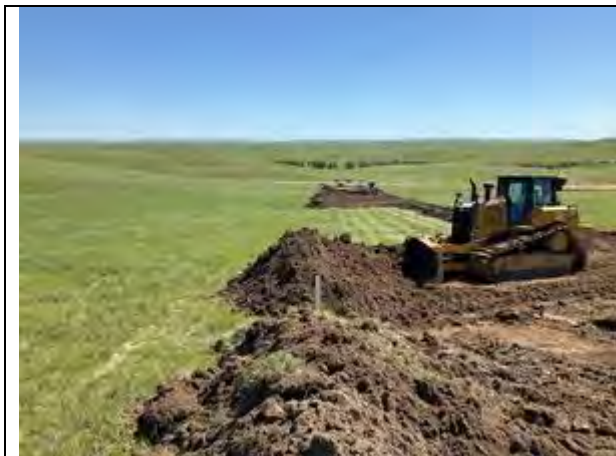
Observation Point: 15

violation of the PSC Order provision #12 related to topsoil, but Stantec was unsure of other ramifications related to route provisions of the ROW and allowing work outside of the ROW could be dependent on the details of the adjacent Bridger easement with individual landowners. Stantec informed Adam Renfandt, PSC, via a phone call the morning of June 23 on this question and recommended Bridger and PSC communicate directly on this matter.

Photo Description: Photo taken from center of topsoil stockpile where topsoil is placed outside of ROW.

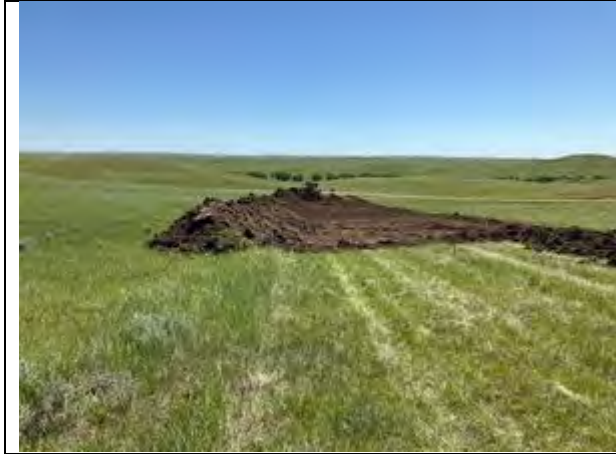
Observation Point: 16

Photo Description: Topsoil stripping in progress.

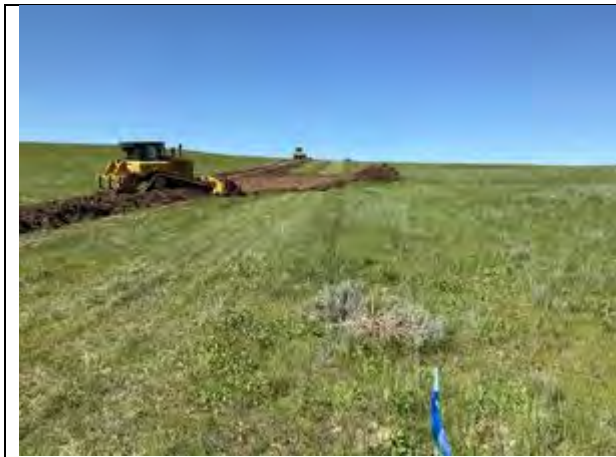
Observation Point: 17

Photo Description: Topsoil stripping in progress.

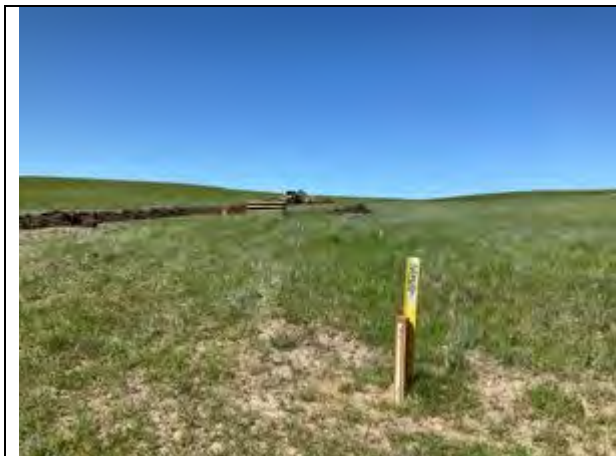
Observation Point: 18

Photo Description: Topsoil stripped and placed 10-15' off ROW over existing Bridger pipeline.
