PU-21-048
Bridger Pipeline, LLC.
South Bend 16-inch Crude Oil
Pipeline
Construction Inspection Report

September 2022

Stantec Consulting Services Inc.
3303 Fiechtner Drive, Suite 100
Fargo, ND 58103

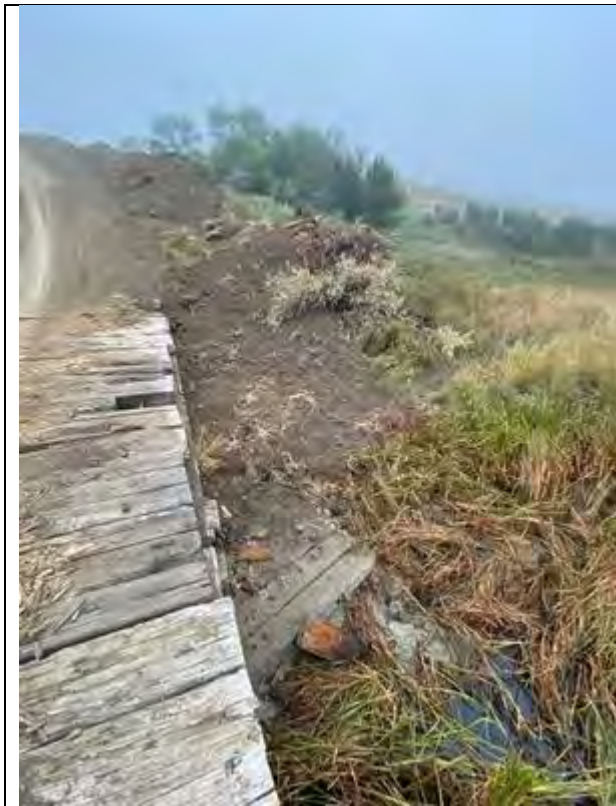
Observation Point: 5

Photo Description: Topsoil stockpile has no erosion prevention methods used and loose soil entering stream. Silt fences are used on other parts of the ROW, but not at this point where erosion is occurring.

- Request Bridger to remove observed sediment and install erosion control in order to prevent sediment washing in Bennie Peer stream (Observation Point 5).

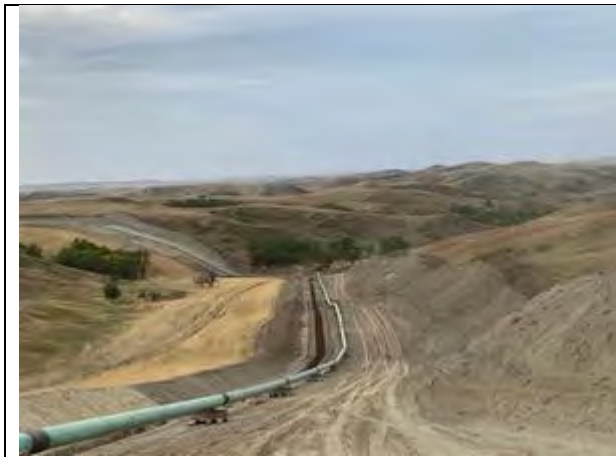
Observation Point: 37
Date Taken: September 14, 2022
Direction Photo is Taken:
Spread: Tomahawk

Photo Description: Stantec is unable to confirm if topsoil is piled upslope of subsoil on the right-hand side. Preventing topsoil to mix during replacement may be difficult.

- Contractors and equipment operators must be careful that subsoil is not mixed with topsoil during reclamation and topsoil must be replaced over areas from which it was stripped only after the subsoil is replaced. This may be challenging along areas of the ROW with steep cuts and Bridger should employ a strategy to ensure this is accomplished.

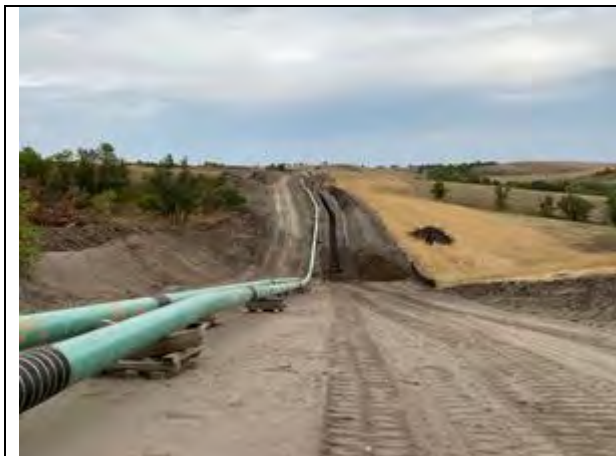
Observation Point: 38
Date Taken: September 14, 2022
Direction Photo is Taken:
Spread: Tomahawk

Photo Description: Trench aligns with shape file and contains appropriate soil segregation.

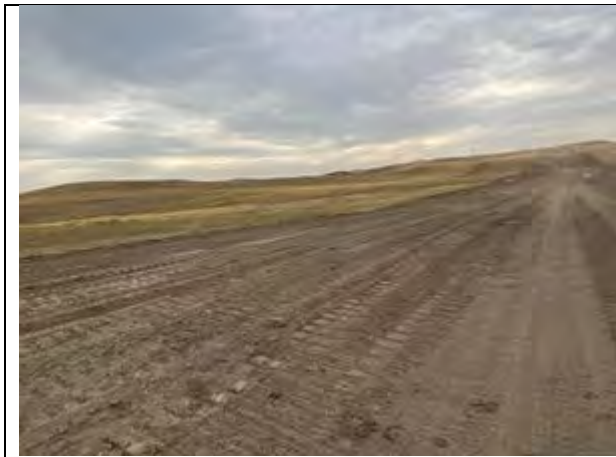
Observation Point: 44
Date Taken: September 14, 2022
Direction Photo is Taken:
Spread: Tomahawk

Photo Description: Adequate subsoil replacement. Topsoil stockpile adjacent to right of way is unmixed.

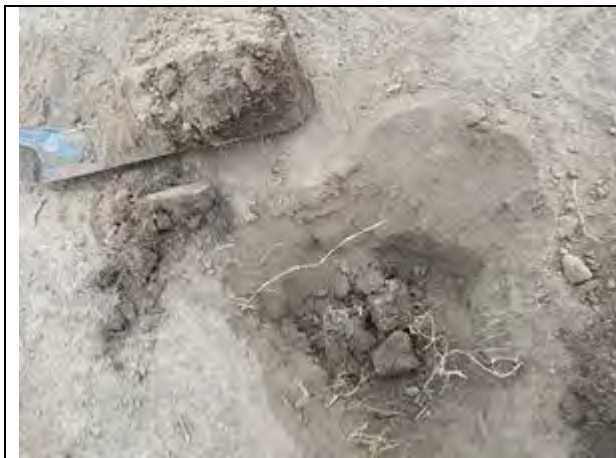
Observation Point: 45
Date Taken: September 14, 2022
Direction Photo is Taken:
Spread: Tomahawk

Photo Description: Topsoil was stripped revealing subsoil with roots.

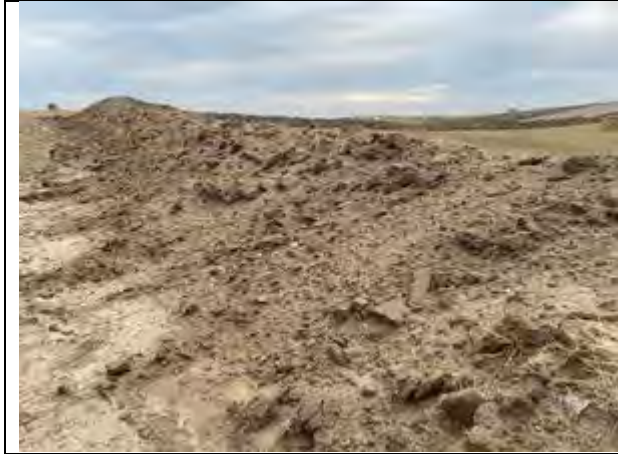
Observation Point: 50
Date Taken: September 14, 2022
Direction Photo is Taken: Southwest
Spread: Tomahawk

Photo Description: Good soil segregation with no topsoil/subsoil mixing observed.

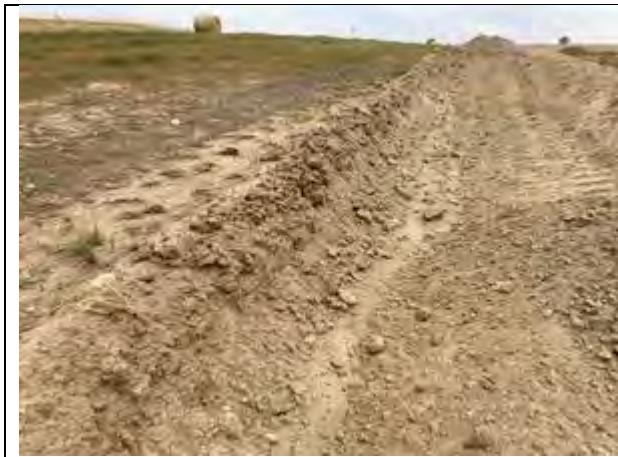
Observation Point: 51
Date Taken: September 14, 2022
Direction Photo is Taken: Southeast
Spread: Tomahawk

Photo Description: Topsoil appropriately stripped.
