PU-21-048
Bridger Pipeline, LLC.
South Bend 16-inch Crude Oil
Pipeline
As-Built Inspection Report

May 2023

Stantec Consulting Services Inc.
3303 Fiechtner Drive, Suite 100
Fargo, ND 58103

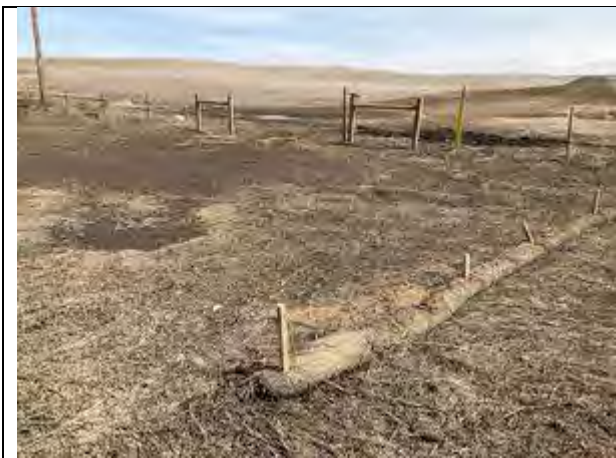
Observation Point: 6
Date Taken: April 26, 2023
Direction Photo is Taken: Northeast

Photo Description: Soil erosion prevention measures in place and fence repaired

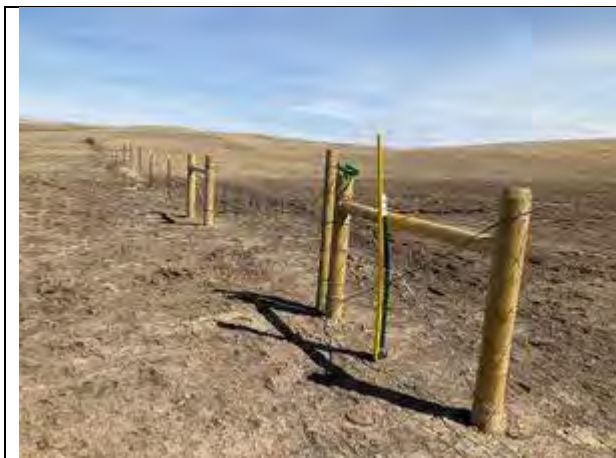
Observation Point: 9
Date Taken: April 26, 2023
Direction Photo is Taken: Northeast

Photo Description: Fencing replaced

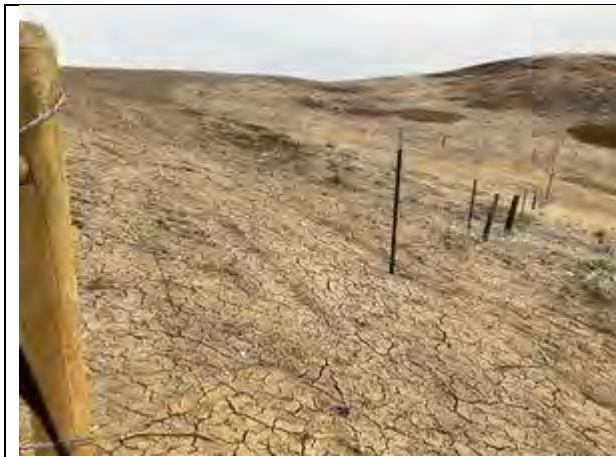
Observation Point: 16
Date Taken: April 26, 2023
Direction Photo is Taken:

Photo Description: Fencing down and needs repair

- Request Bridger to implement BMPs and install additional erosion control measures along swales within the route to prevent soil erosion.
- Request Bridger to repair broken fence to prevent disruption in landowner agriculture practices (Observation Points 16)

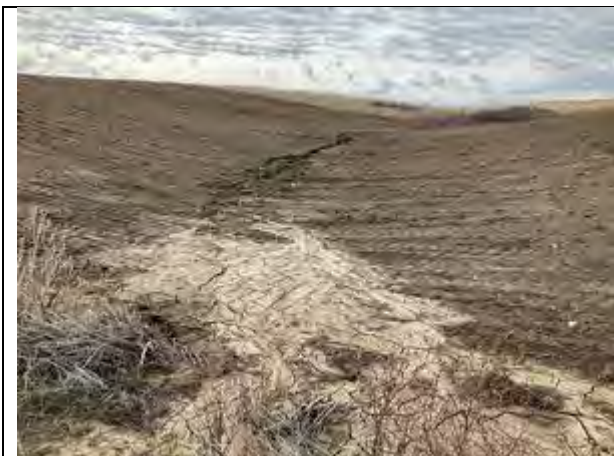
Observation Point: 26
Date Taken: April 26, 2023
Direction Photo is Taken: Southeast

Photo Description: Topsoil movement and erosion observed in respread soil. Add erosion prevention measures.

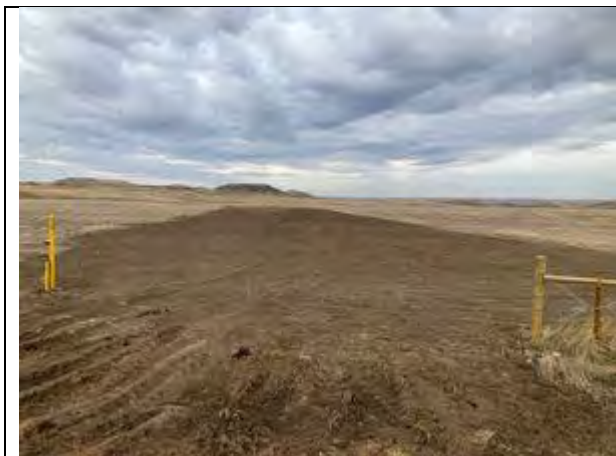
Observation Point: 41
Date Taken: April 25, 2023
Direction Photo is Taken: West

Photo Description: Fence and gate replaced

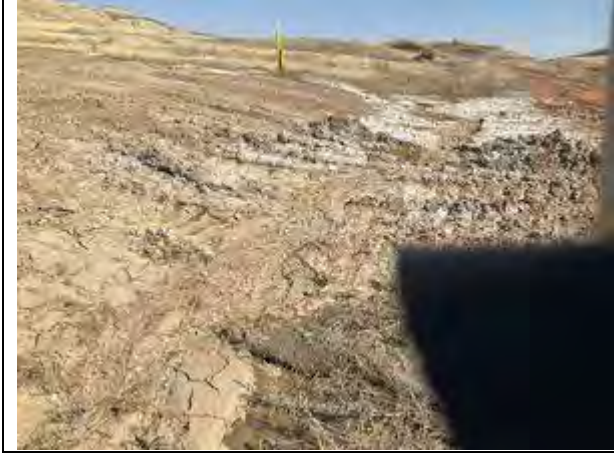
Observation Point: 54
Date Taken: April 25, 2023
Direction Photo is Taken: Southeast

Photo Description: Straw wattle broken and soil is washing down the draw.

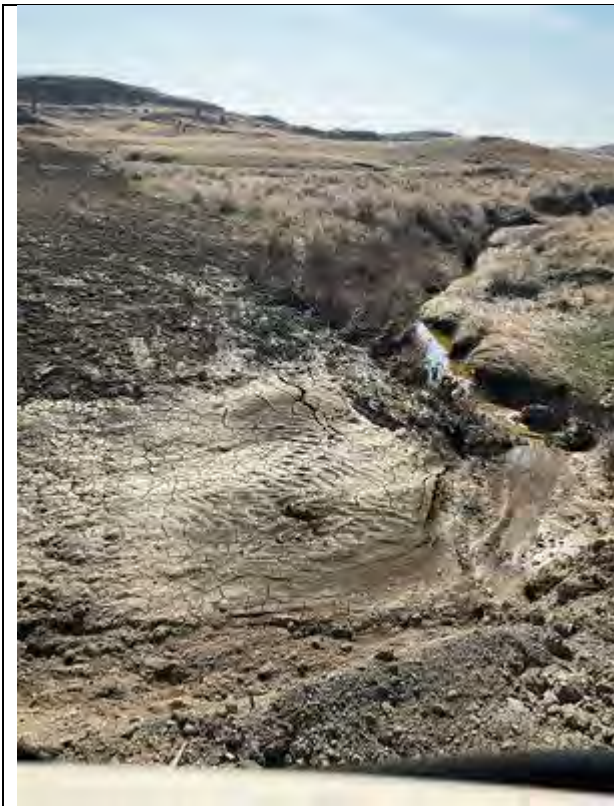
Observation Point: 55
Date Taken: April 25, 2023
Direction Photo is Taken: Southwest

Photo Description: Silt fence damaged and soil moving into stream.

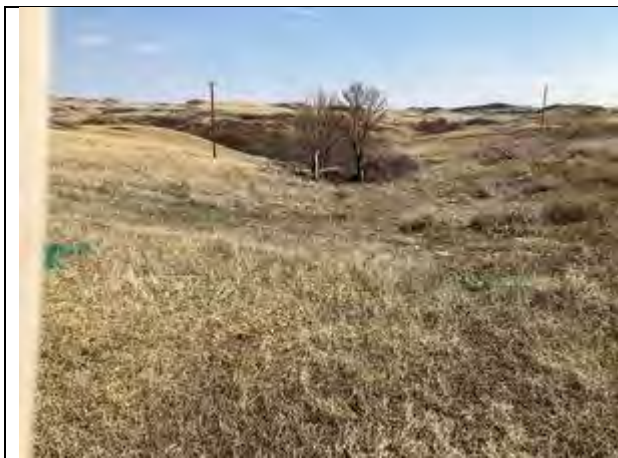
Observation Point: 60
Date Taken: April 25, 2023
Direction Photo is Taken: Northeast
Photo Description: Large ruts from heavy equipment. May contribute to soil movement if not regraded.
Latitude: 47.39246305
Longitude: -103.84866432

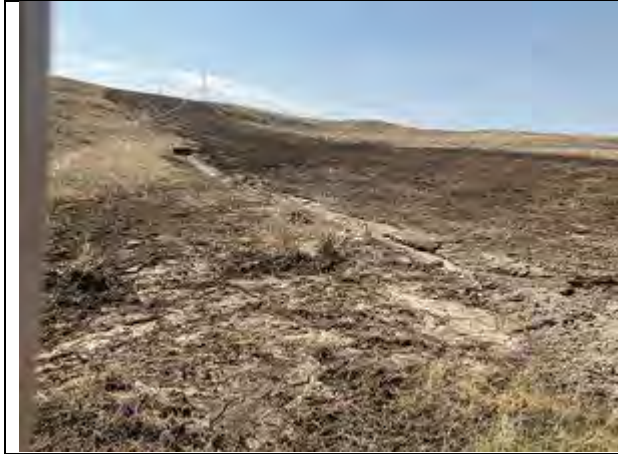
Observation Point: 61
Date Taken: April 25, 2023
Direction Photo is Taken: Northwest
Photo Description: Straw wattles washed out. Repair erosion prevention measures.
Latitude: 47.3924652
Longitude: -103.84866531

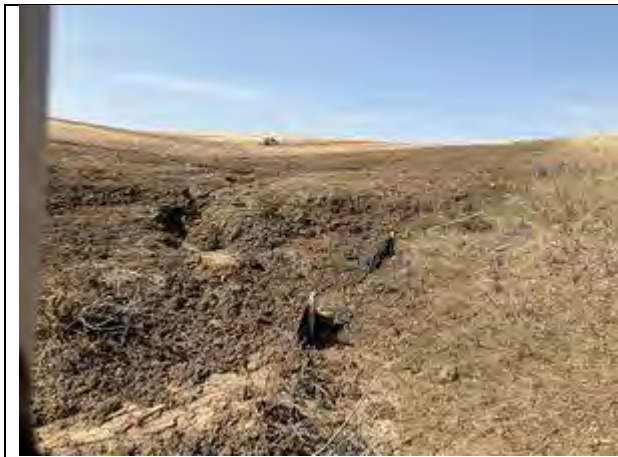
Observation Point: 63
Date Taken: April 25, 2023
Direction Photo is Taken: Northwest

Photo Description: Silt fence broken and not preventing soil movement.

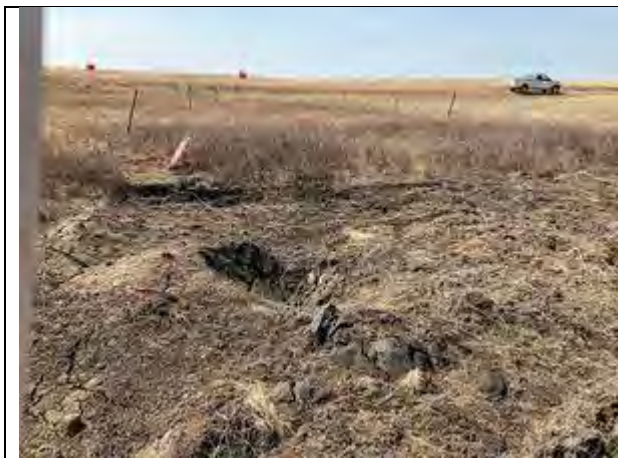
Observation Point: 64
Date Taken: April 25, 2023
Direction Photo is Taken: West

Photo Description: Large depression starting to form and loose fencing wire in field.

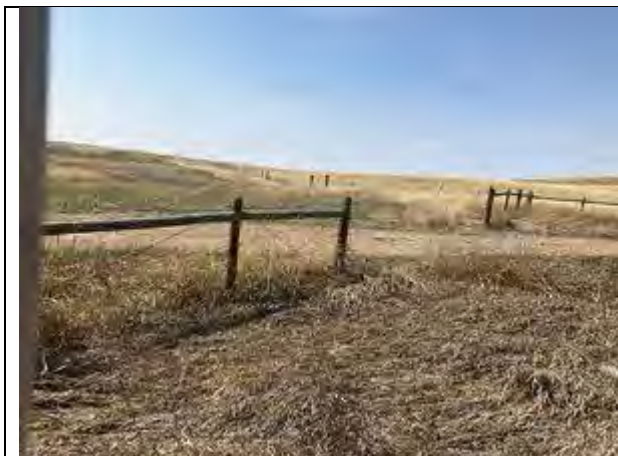
Observation Point: 69
Date Taken: April 25, 2023
Direction Photo is Taken: West

Photo Description: Fence and gate repaired properly
