PU-21-048
Bridger Pipeline, LLC
South Bend 16-inch Crude Oil
Pipeline
Reclamation Inspection Report

File No. 227705201

May 23, 2024

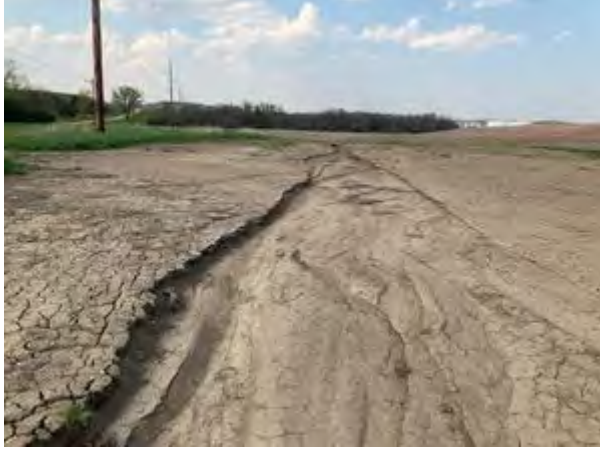
The soil in most cropland appeared to have been adequately replaced and was matching existing topography. Soil erosion was evident at **Observation Point 1 and Observation Point 2** documents a straw wattle in the ditch that is full of sediment that would benefit from being cleaned out or adding additional erosion control measures. Populations of annual weeds, predominantly prickly Russian thistle (*Salsola tragus*) and kochia (*Bassia scoparia*), were common along some areas in the ROW but were generally not a concern.

Soil erosion was evident at multiple locations along the project ROW, including **Observation Points 1, 15-18 and 35**, resulting in lack of pre-project vegetation cover. This issue was most extensive adjacent to Cherry Creek in Section 6, Township 149 North and Range 97 West, where evidence of rill erosion and bare ground was common coinciding with relatively steep slopes. Stantec recommends re-stabilizing the slopes here and installing erosion BMPs to mitigate soil erosion along with re-seeding efforts. The extent of current erosion suggests that previous seed has likely washed away, and Stantec recommends installing fabric, mulch, or use of other methods to properly stabilize steeper slopes in conjunction with re-seeding.

<p>Photo ID: 1</p> <p>Direction Photo is Taken: North</p> <p>Photo Description: Sheet and gully erosion persisting in unvegetated area. Re-seeding and erosion control recommended.</p> <p>Latitude: 47.79290085</p> <p>Longitude: -102.89823562</p>
---	---

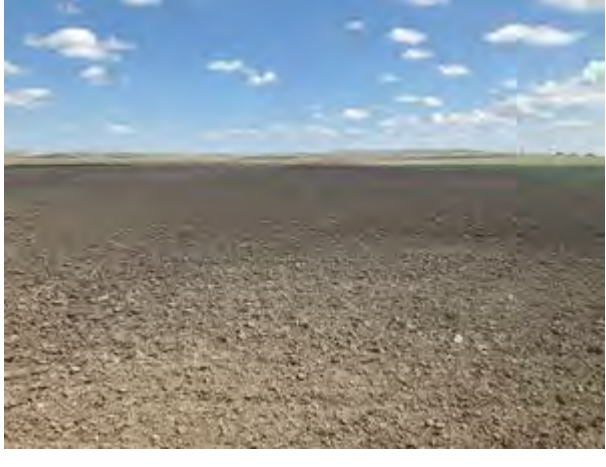
<p>Photo ID: 24</p> <p>Direction Photo is Taken: East</p> <p>Photo Description: Soil contouring looks good. No sign of pipeline scar.</p> <p>Latitude: 47.63129435</p> <p>Longitude: -103.49490513</p>
---	---

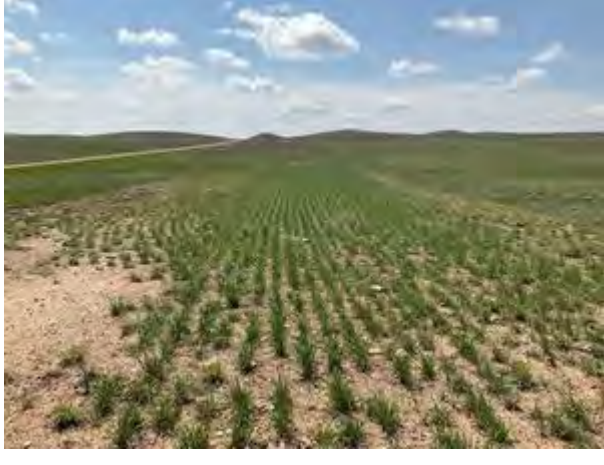
<p>Photo ID: 27</p> <p>Direction Photo is Taken: South</p> <p>Photo Description: Seeded vegetation establishing well. Sideoats grama dominant.</p> <p>Latitude: 47.56749737</p> <p>Longitude: -103.57410746</p>
---	--

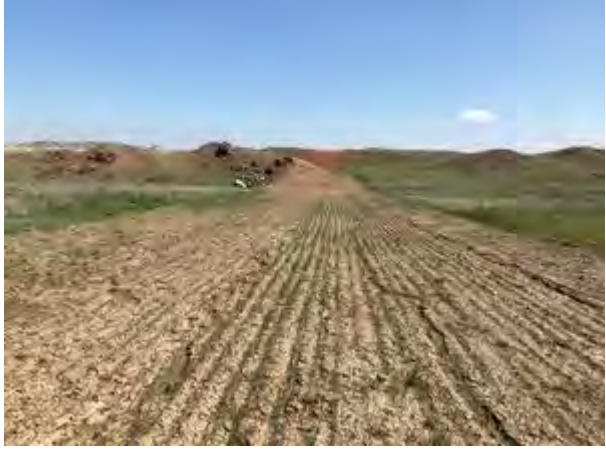
<p>Photo ID: 34</p> <p>Direction Photo is Taken: Northeast</p> <p>Photo Description: Areas of bare ground. Seeded vegetation coming in in rows.</p> <p>Latitude: 47.45496368</p> <p>Longitude: -103.75868307</p>
---	---

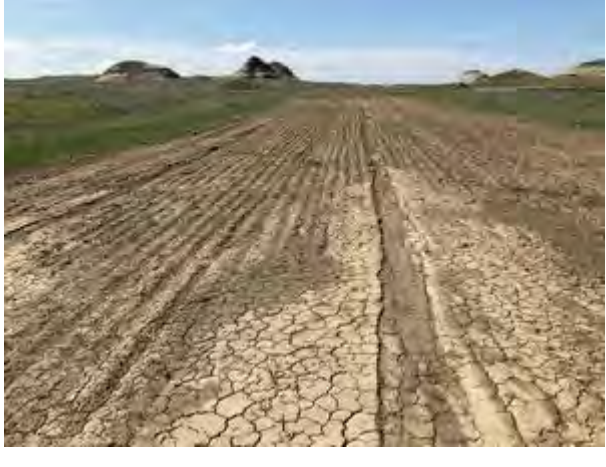
<p>Photo ID: 35</p> <p>Direction Photo is Taken: Southwest</p> <p>Photo Description: Rill soil erosion starting to take place.</p> <p>Latitude: 47.45484281</p> <p>Longitude: -103.75883899</p>
--	--

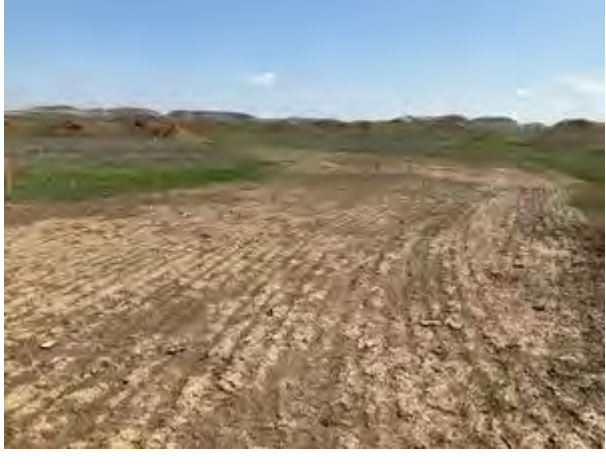
<p>Photo ID: 36</p> <p>Direction Photo is Taken: Northeast</p> <p>Photo Description: Areas of bare ground. Seeded vegetation coming in in rows.</p> <p>Latitude: 47.45420728</p> <p>Longitude: -103.75997116</p>
---	---
