## **Bowman Wind Project**

***Topsoil Inspection Report***

**Docket Number: PU-21-121**

Prepared for North Dakota Public Service Commission

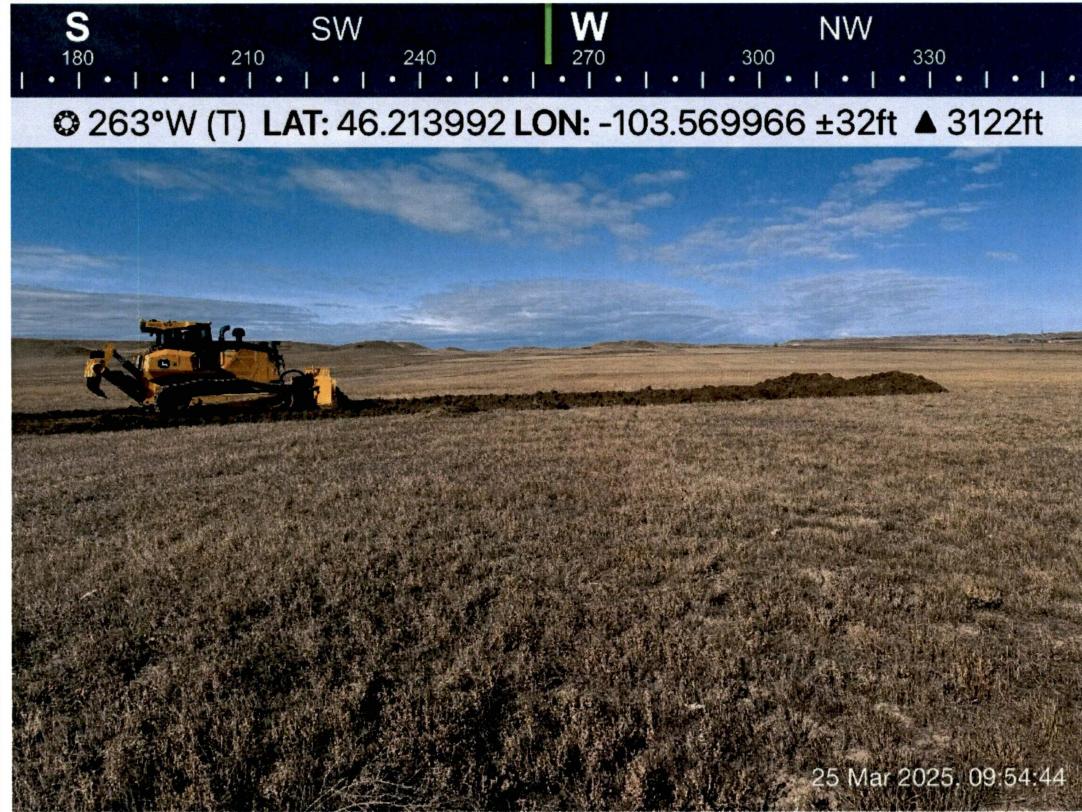
<p><b>S</b> SW <b>W</b> NW 180 210 240 270 300 330 ⌚ 263°W (T) LAT: 46.213992 LON: -103.569966 ±32ft ▲ 3122ft 25 Mar 2025, 09:54:44</p>	Photo #: 1 Direction: West Description: Bulldozer beginning topsoil removal at Turbine Site A06. Observer: Zach Peterson Date: 3/25/2025 Latitude: 46.213992 Longitude: -103.569966

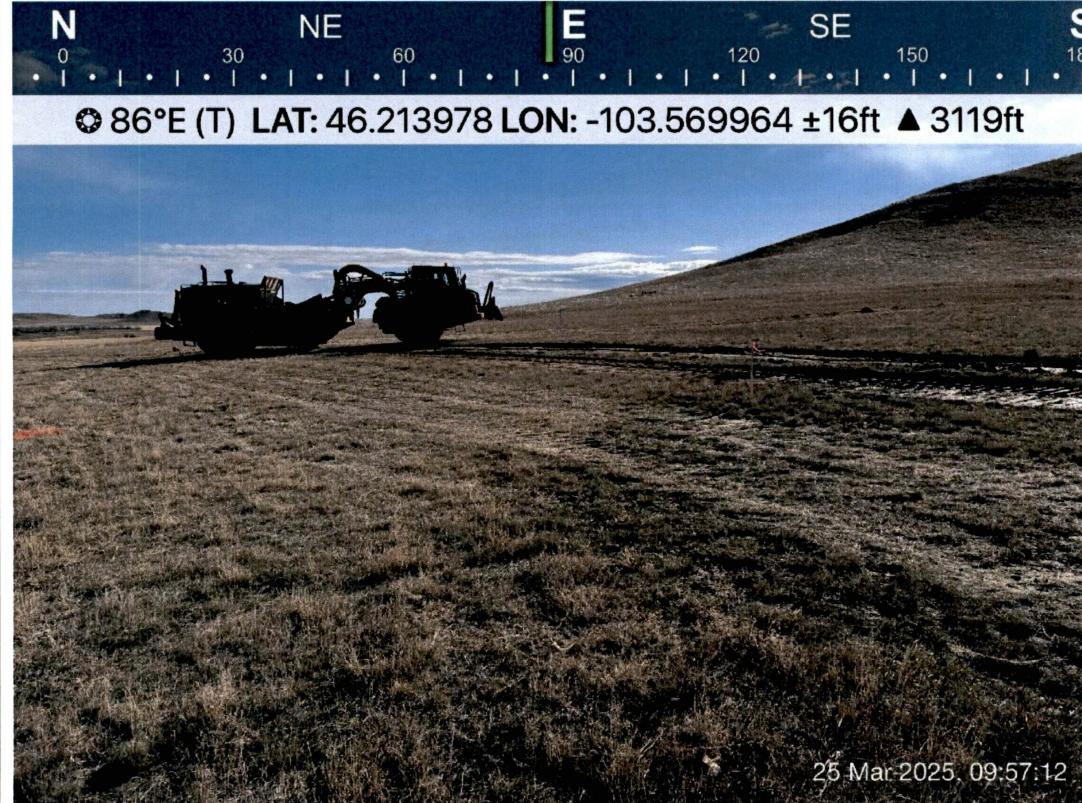
<p><b>N</b> NE <b>E</b> SE <b>S</b> 0 30 60 90 120 150 180 ⌚ 86°E (T) LAT: 46.213978 LON: -103.569964 ±16ft ▲ 3119ft 25 Mar 2025, 09:57:12</p>	Photo #: 2 Direction: East Description: Grader removing topsoil along perimeter of Turbine Site A06. Observer: Zach Peterson Date: 3/25/2025 Latitude: 46.213978 Longitude: -103.569964

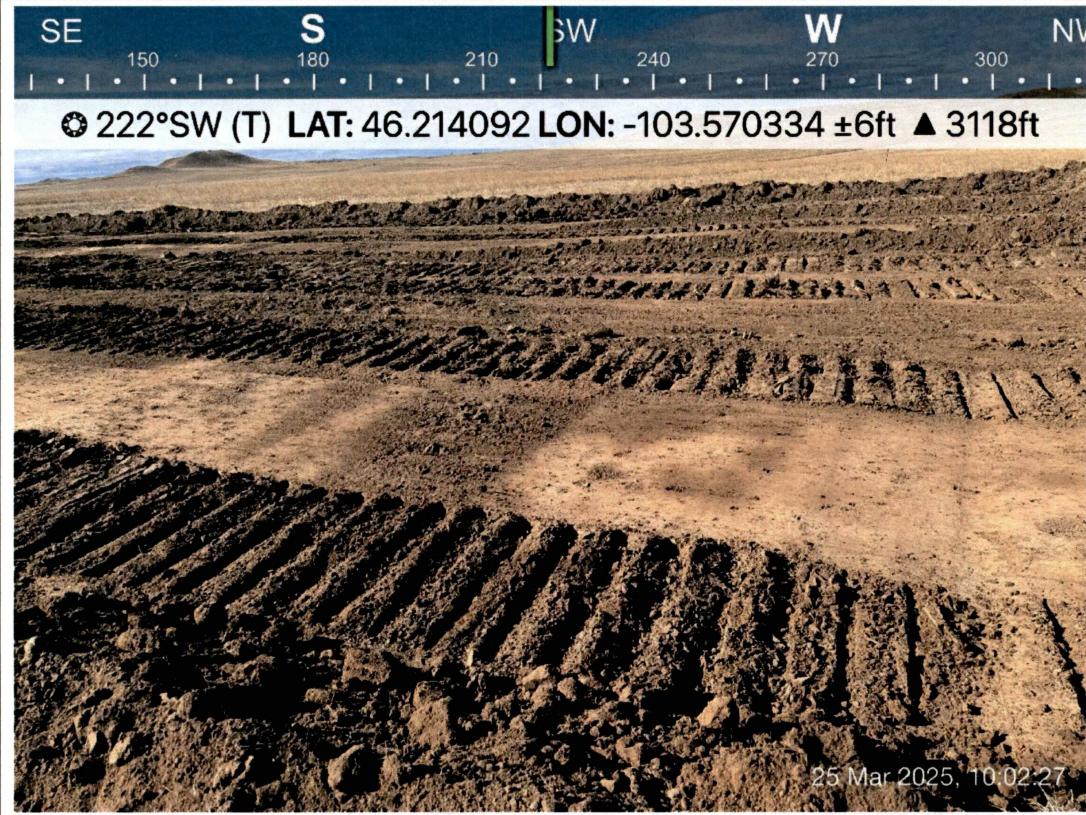
<p>SE 150 180 210 SW 240 270 300 NV</p> <p>222°SW (T) LAT: 46.214092 LON: -103.570334 ±6ft ▲ 3118ft</p> <p>25 Mar 2025, 10:02:27</p>	<p>Photo #: 3</p> <p>Direction: Southwest</p> <p>Description: Topsoil removed by bulldozer to depth where subsoil layer appears.</p> <p>Observer: Zach Peterson</p> <p>Date: 3/25/2025</p> <p>Latitude: 46.214092</p> <p>Longitude: -103.570334</p>

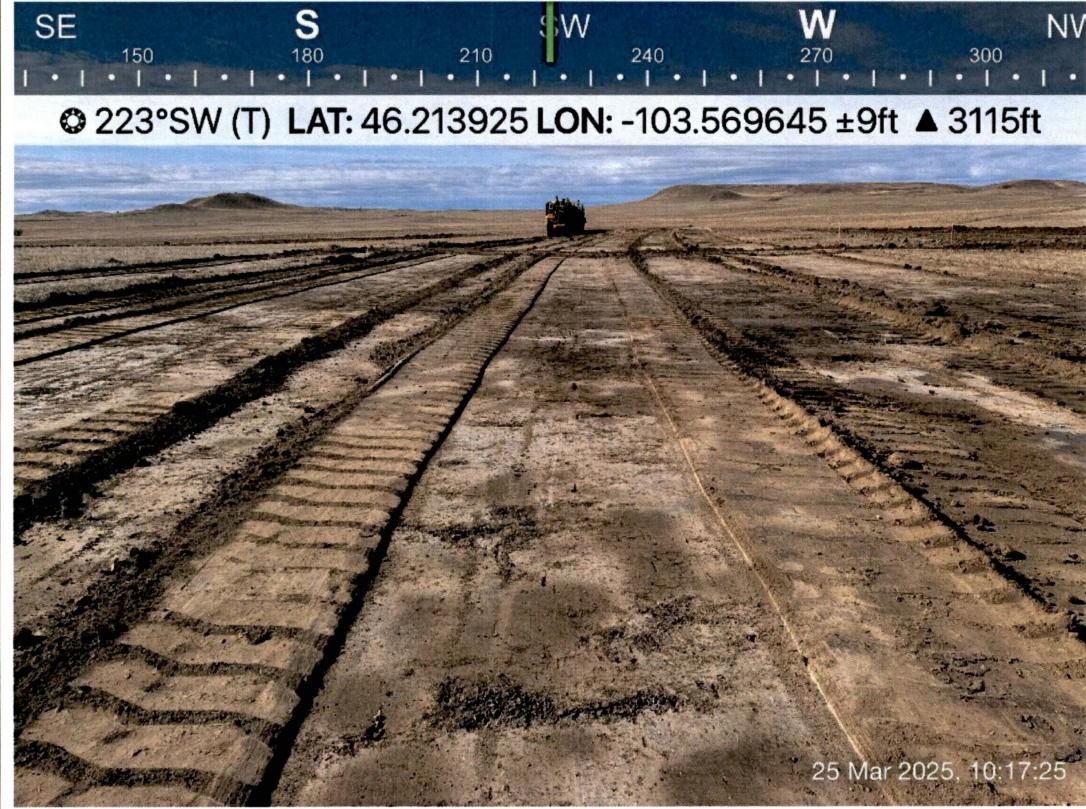
<p>SE 150 180 210 SW 240 270 300 NV</p> <p>223°SW (T) LAT: 46.213925 LON: -103.569645 ±9ft ▲ 3115ft</p> <p>25 Mar 2025, 10:17:25</p>	<p>Photo #: 4</p> <p>Direction: Southwest</p> <p>Description: Topsoil removed by grader to depth where subsoil layer appears.</p> <p>Observer: Zach Peterson</p> <p>Date: 3/25/2025</p> <p>Latitude: 46.213925</p> <p>Longitude: -103.569645</p>

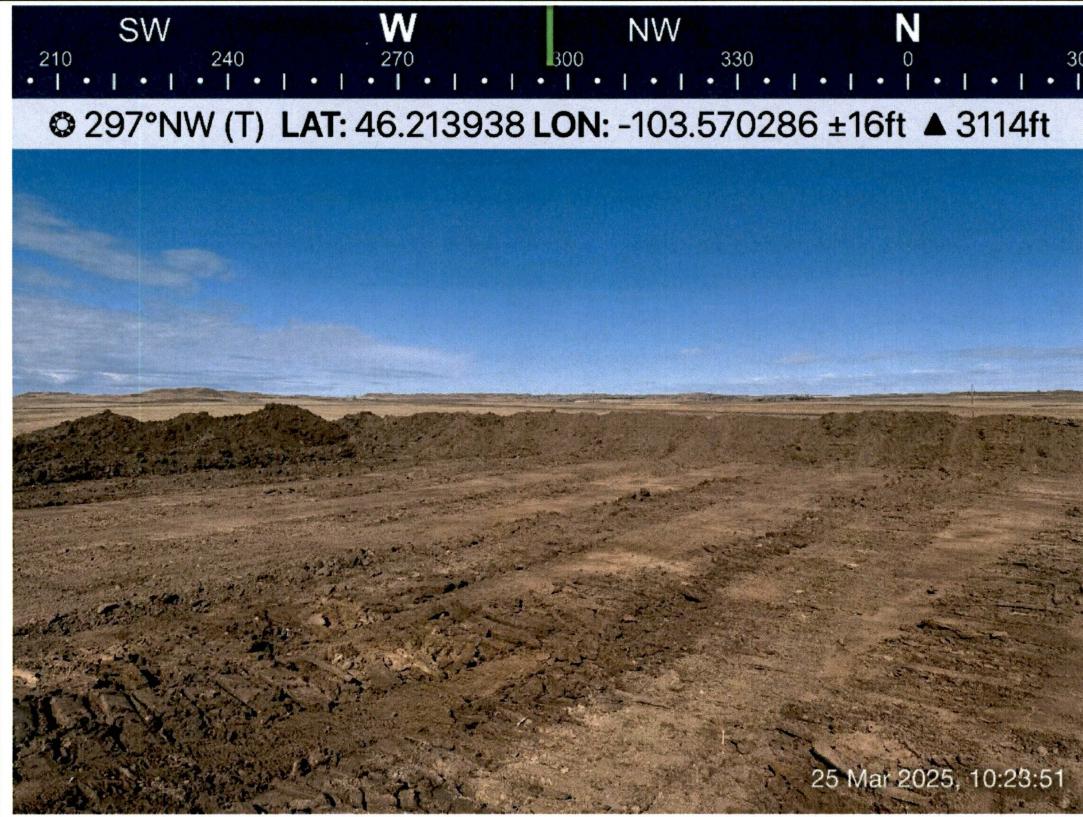
<p>SW 210 240 W 270 300 NW 330 N 0 30</p> <p>● 297°NW (T) LAT: 46.213938 LON: -103.570286 ±16ft ▲ 3114ft</p> <p>25 Mar 2025, 10:23:51</p>	<p>Photo #: 5</p> <p>Direction: Northwest</p> <p>Description: Topsoil pile at Turbine Site A06.</p> <p>Observer: Zach Peterson</p> <p>Date: 3/25/2025</p> <p>Latitude: 46.213938</p> <p>Longitude: -103.570286</p>

Potential Issues	Recommendations
<b>SWPPP Maintenance</b>	Silt fence, straw waddles, and other BMPs must be regularly checked to ensure sediment from the site does not move offsite.

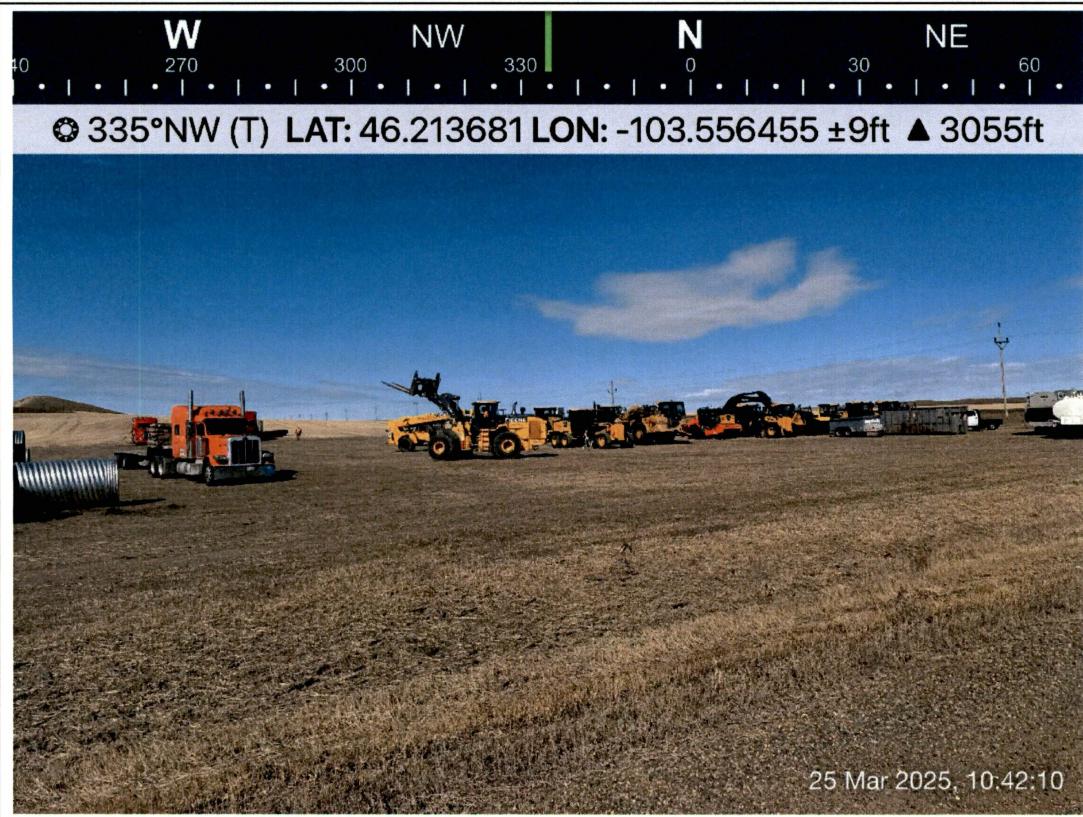
<p>W 270 300 NW 330 N 0 30 NE 60</p> <p>● 335°NW (T) LAT: 46.213681 LON: -103.556455 ±9ft ▲ 3055ft</p> <p>25 Mar 2025, 10:42:10</p>	<p>Photo #: 6</p> <p>Direction: Northwest</p> <p>Description: Equipment and materials staged at Bowman Wind Laydown Yard.</p> <p>Observer: Zach Peterson</p> <p>Date: 3/25/2025</p> <p>Latitude: 46.213681</p> <p>Longitude: -103.556455</p>
