## **Bowman Wind Project**

### **Construction Inspection Report**

***Docket Number: PU-21-121***

Prepared for North Dakota Public Service Commission

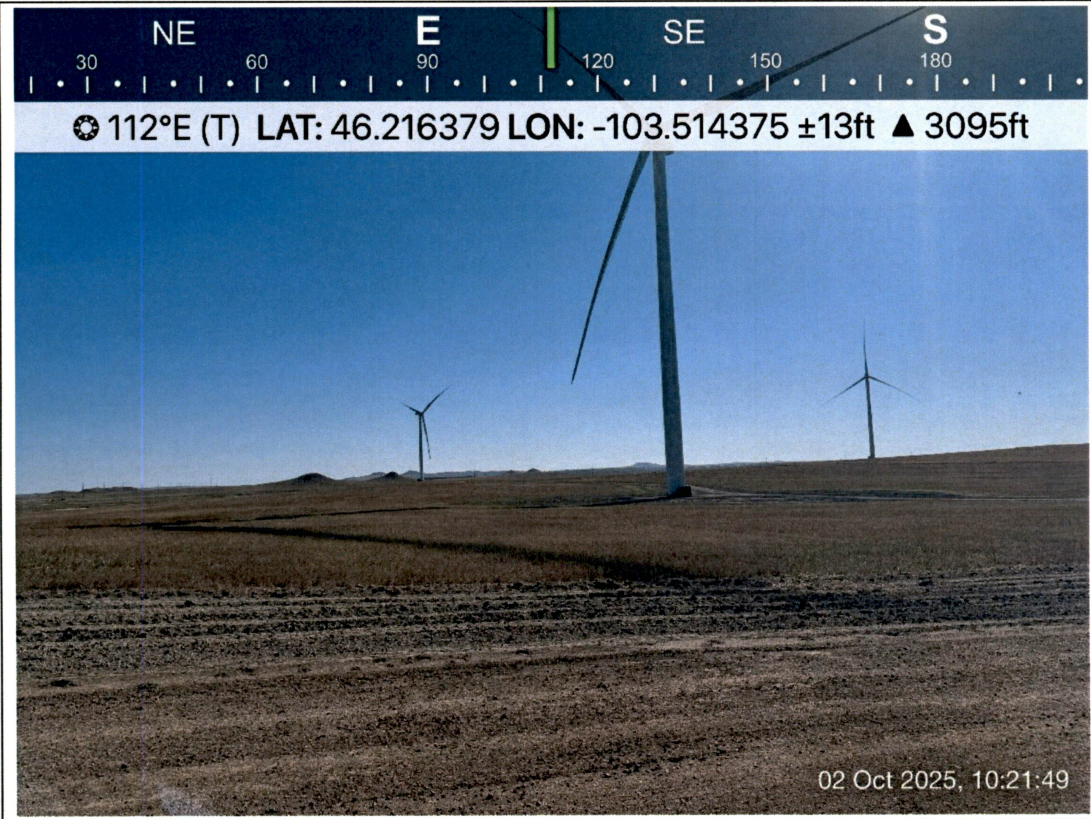
<p>Photo #: 1</p> <p>Direction: Southeast</p> <p>Description: Turbines B13, B14, and B16 completed.</p> <p>Observer: Zach Peterson</p> <p>Date: 10/2/2025</p> <p>Latitude: 46.216379</p> <p>Longitude: -103.514375</p>

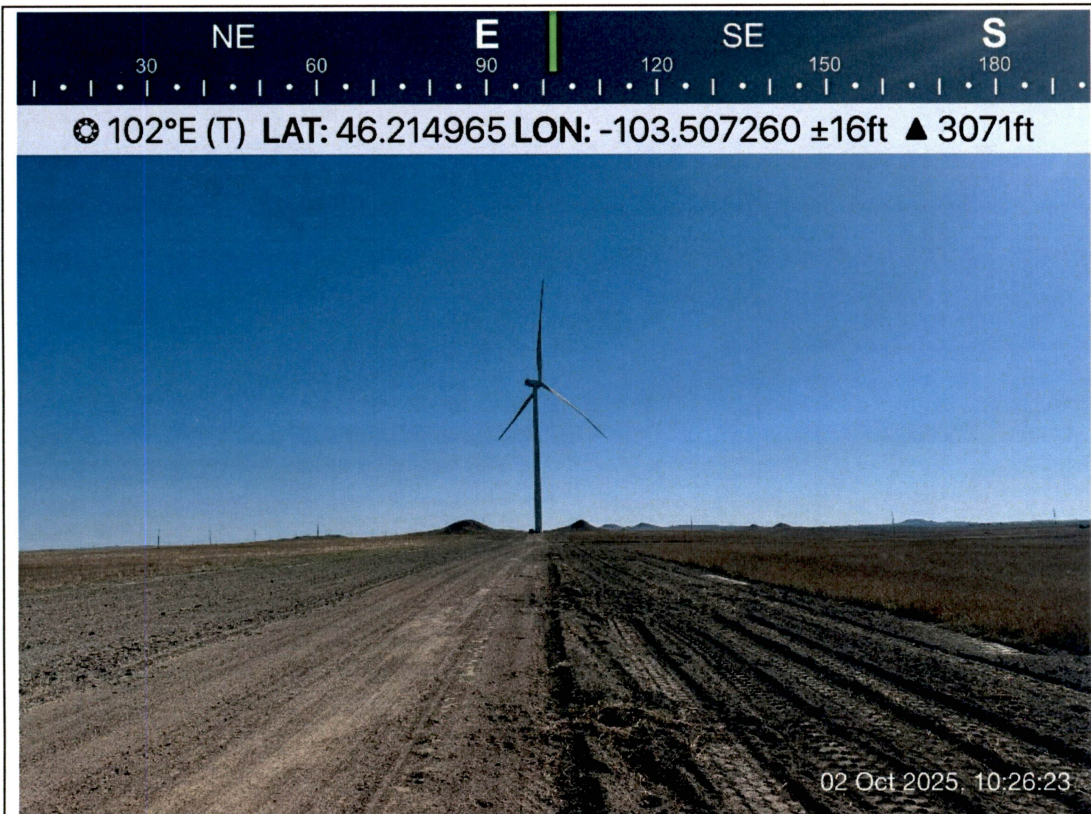
<p>Photo #: 2</p> <p>Direction: East</p> <p>Description: Access road and Turbine B14.</p> <p>Observer: Zach Peterson</p> <p>Date: 10/2/2025</p> <p>Latitude: 46.214965</p> <p>Longitude: -103.507260</p>

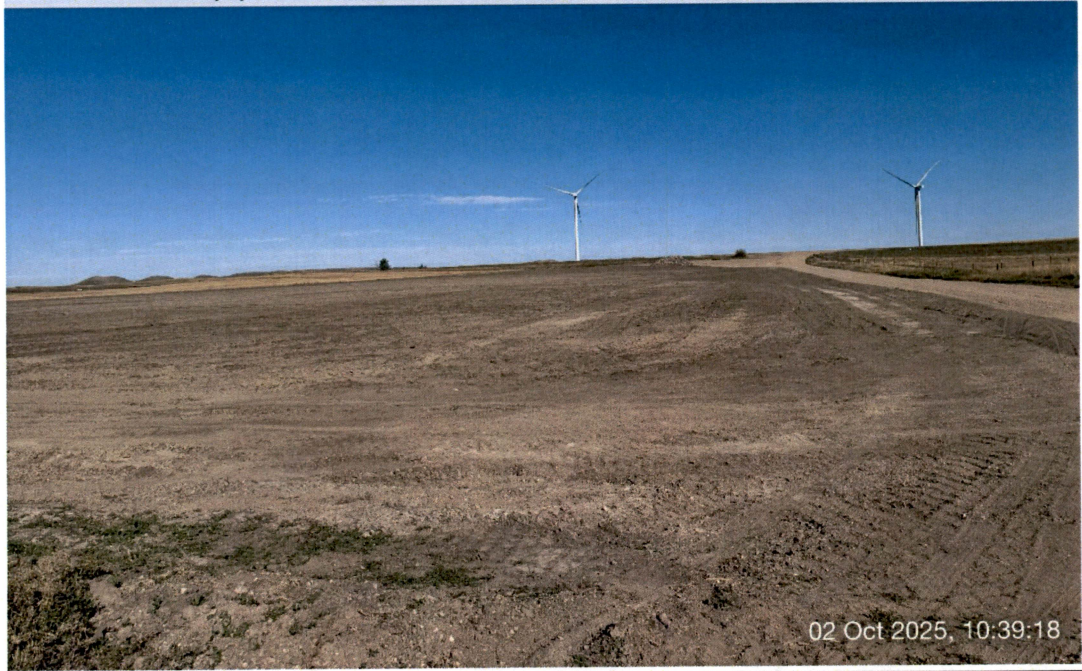
<p>02 Oct 2025, 10:39:18</p>	<p>Photo #: 3</p> <p>Direction: Northwest</p> <p>Description: Marshalling yard for turbine components and equipment.</p> <p>Observer: Zach Peterson</p> <p>Date: 10/2/2025</p> <p>Latitude: 46.205738</p> <p>Longitude: -103.514972</p>
<p>SW W NW N</p> <p>210 240 270 300 330 0 30</p> <p>☉ 297°NW (T) LAT: 46.202139 LON: -103.522586 ±22ft ▲ 3024ft</p>

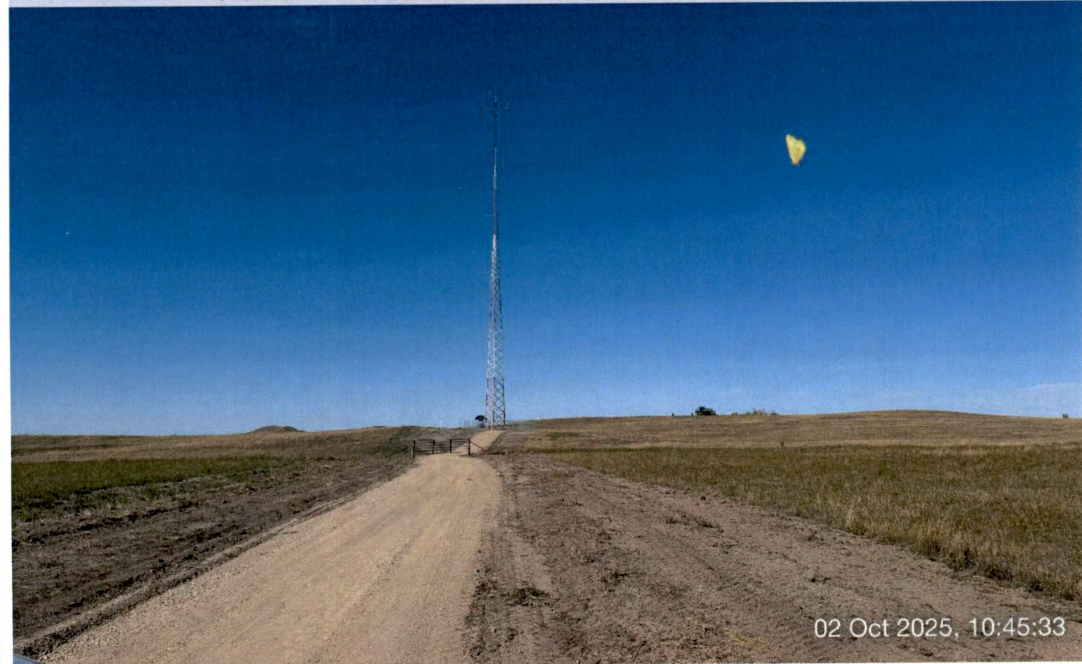
<p>02 Oct 2025, 10:45:33</p>	<p>Photo #: 4</p> <p>Direction: Northwest</p> <p>Description: Access road and Met Tower 1.</p> <p>Observer: Zach Peterson</p> <p>Date: 10/2/2025</p> <p>Latitude: 46.202139</p> <p>Longitude: -103.522586</p>

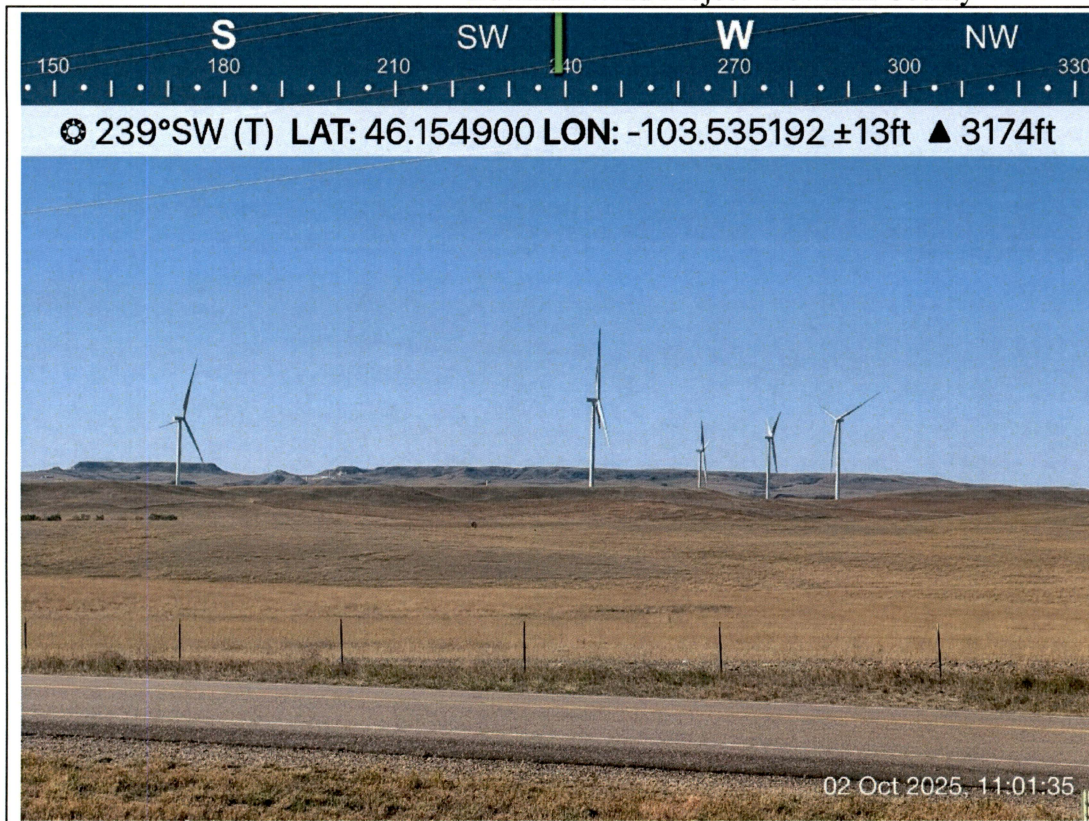
Photo #: 5

Description: Overview of E-line turbines.

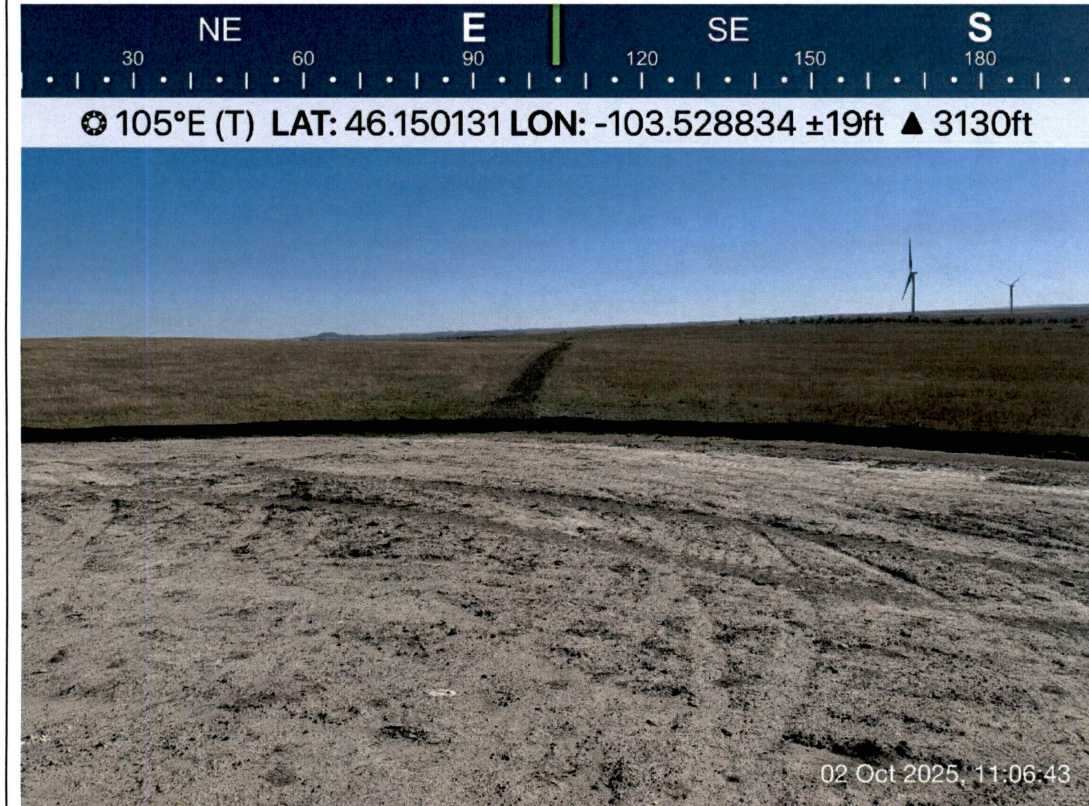
Photo #: 6

Description: Silt fence along perimeter and collection line at Turbine F56

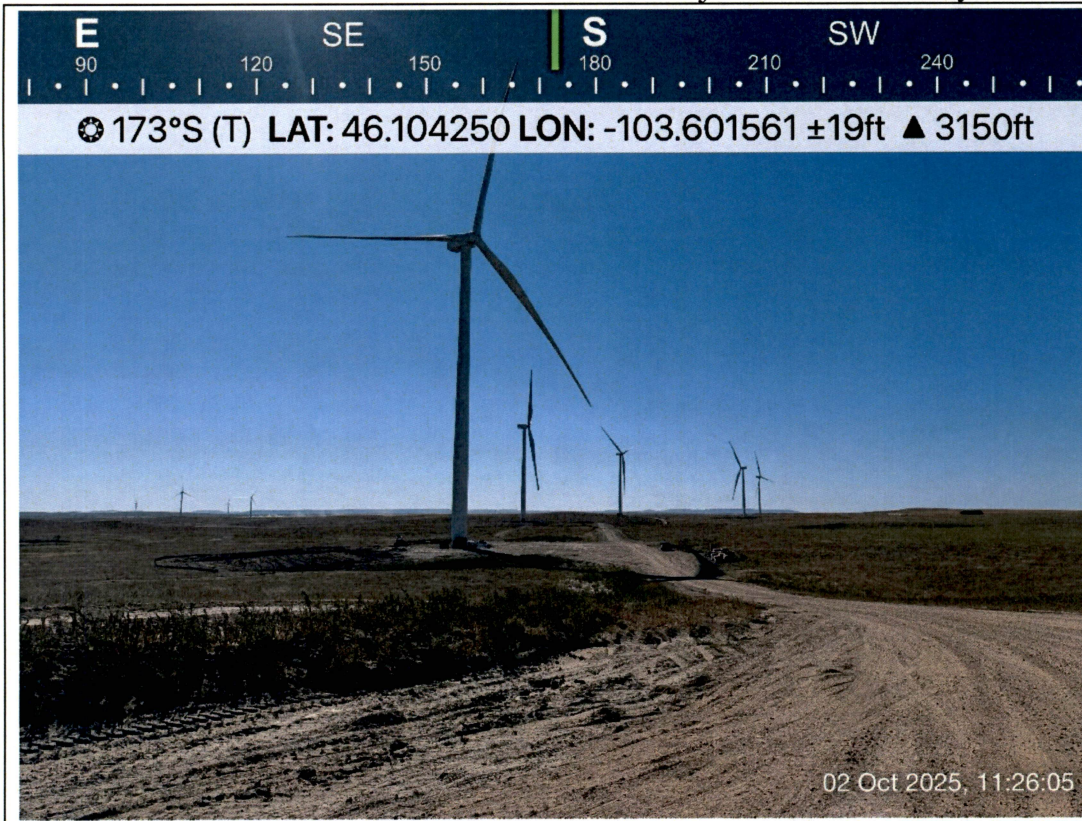
Photo #: 7

Description:  
Reclamation ongoing at  
recently constructed H-  
line turbines.

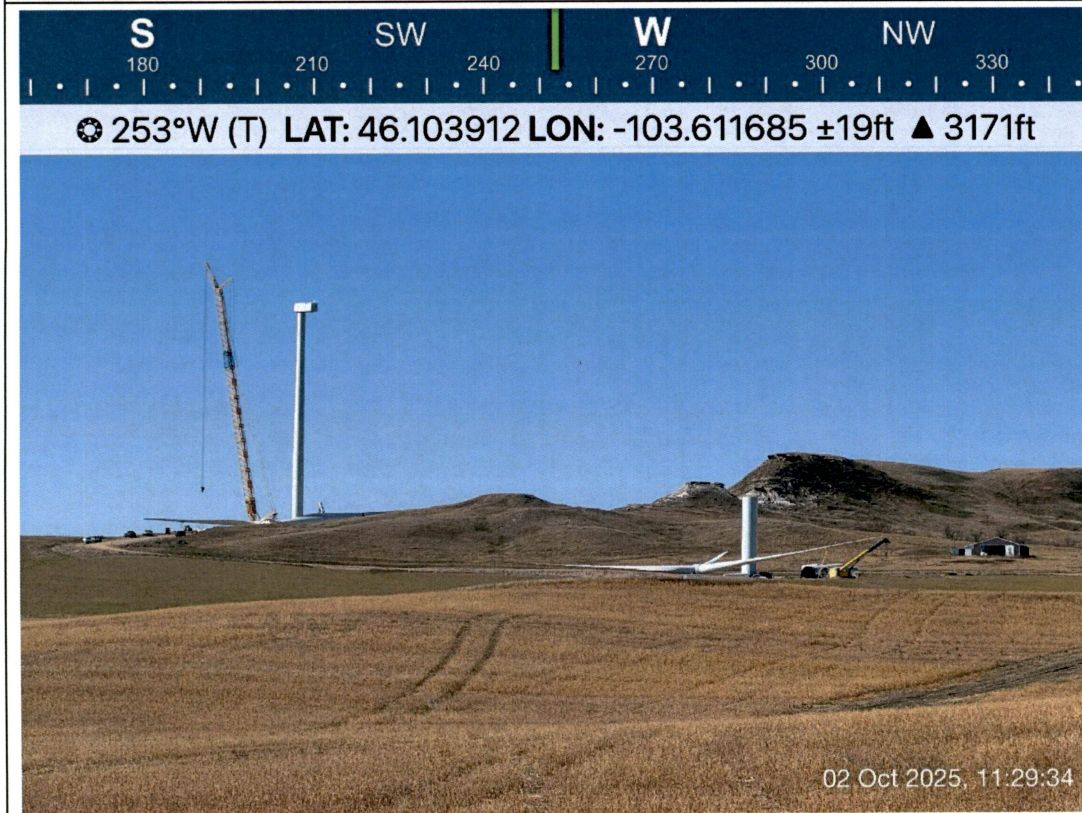
Photo #: 8

Description:  
Construction ongoing at  
Turbines G63 and G67.

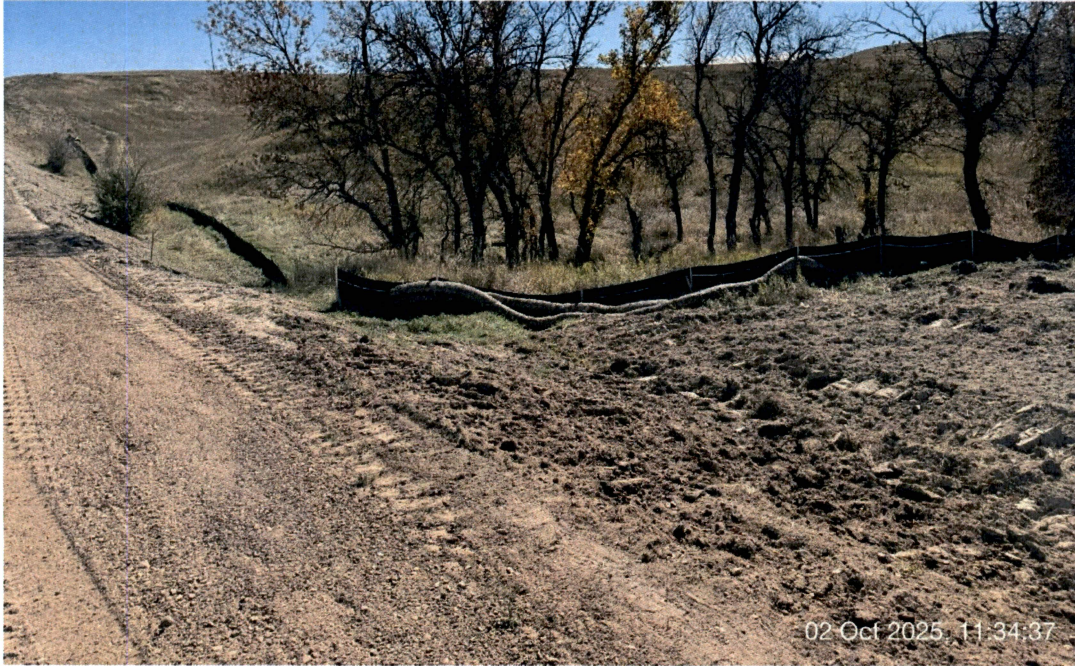
<p>02 Oct 2025, 11:34:37</p>	<p>Photo #: 9</p> <p>Direction: Southeast</p> <p>Description: Silt fence and straw waddles in place to prevent sediment runoff into creek.</p> <p>Observer: Zach Peterson</p> <p>Date: 10/2/2025</p> <p>Latitude: 46.104768</p> <p>Longitude: -103.626659</p>
<p>NW 330 0 30 60 90 120 S</p> <p>☉ 40°NE (T) LAT: 46.107222 LON: -103.631074 ±16ft ▲ 3296ft</p>

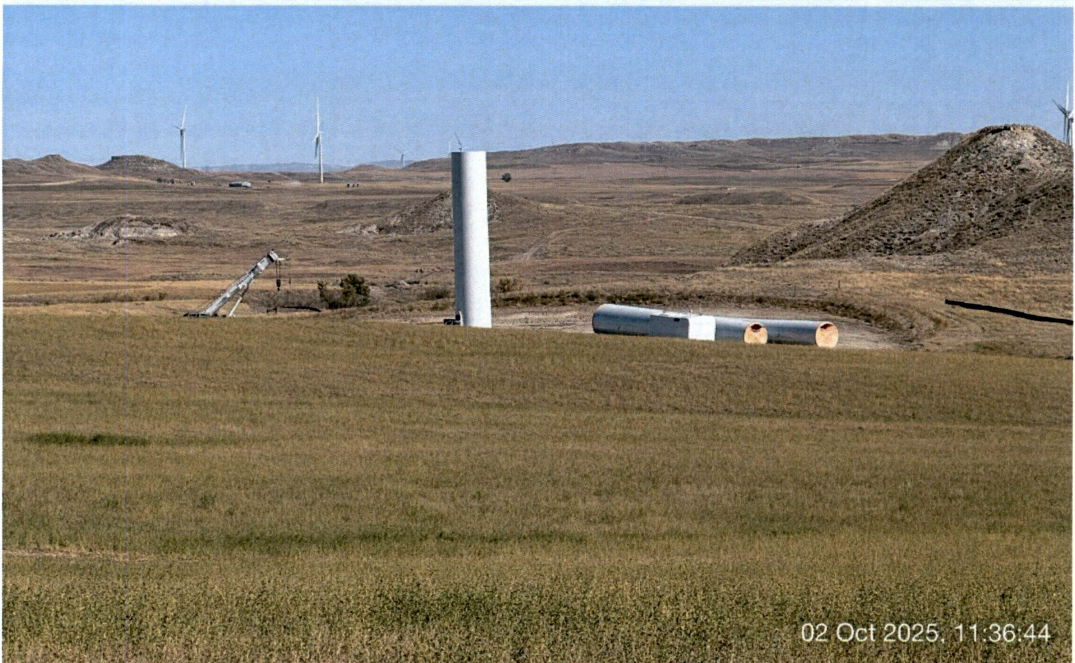
<p>02 Oct 2025, 11:36:44</p>	<p>Photo #: 10</p> <p>Direction: Northeast</p> <p>Description: Components staged for construction at Turbine G65.</p> <p>Observer: Zach Peterson</p> <p>Date: 10/2/2025</p> <p>Latitude: 46.107222</p> <p>Longitude: -103.631074</p>

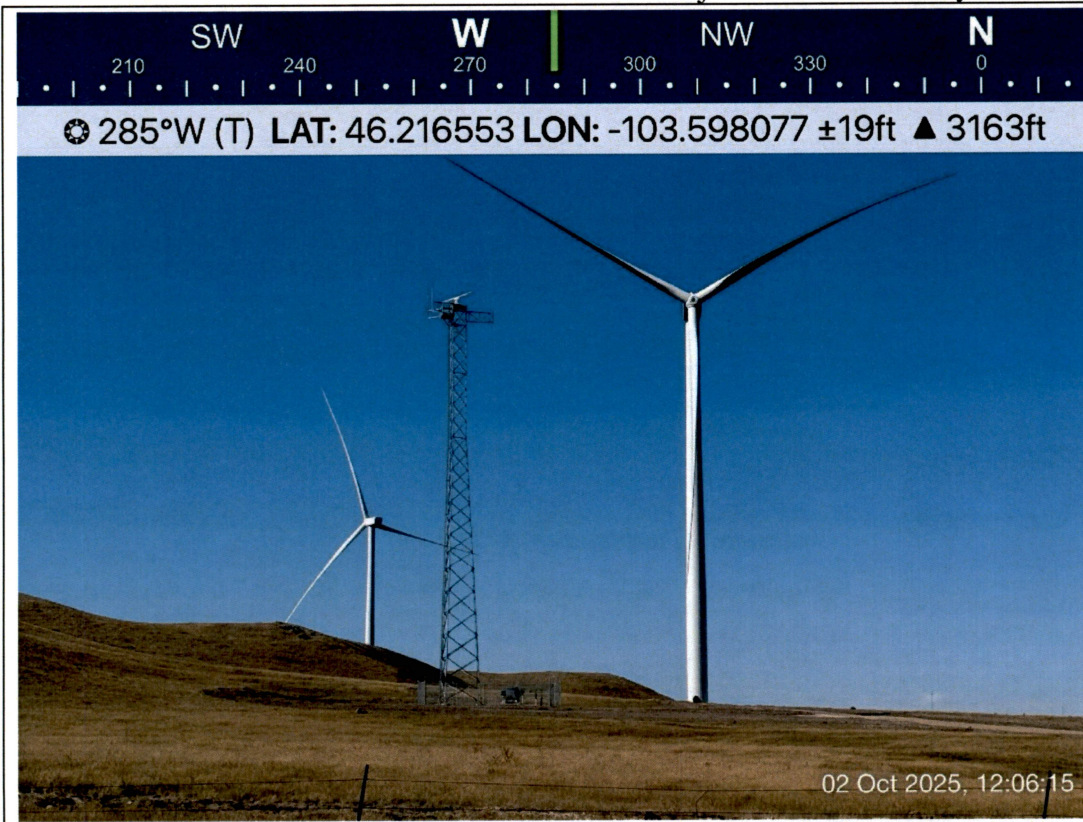
Photo #: 11

Description: ADLS tower and completed Turbines A01 and A09.

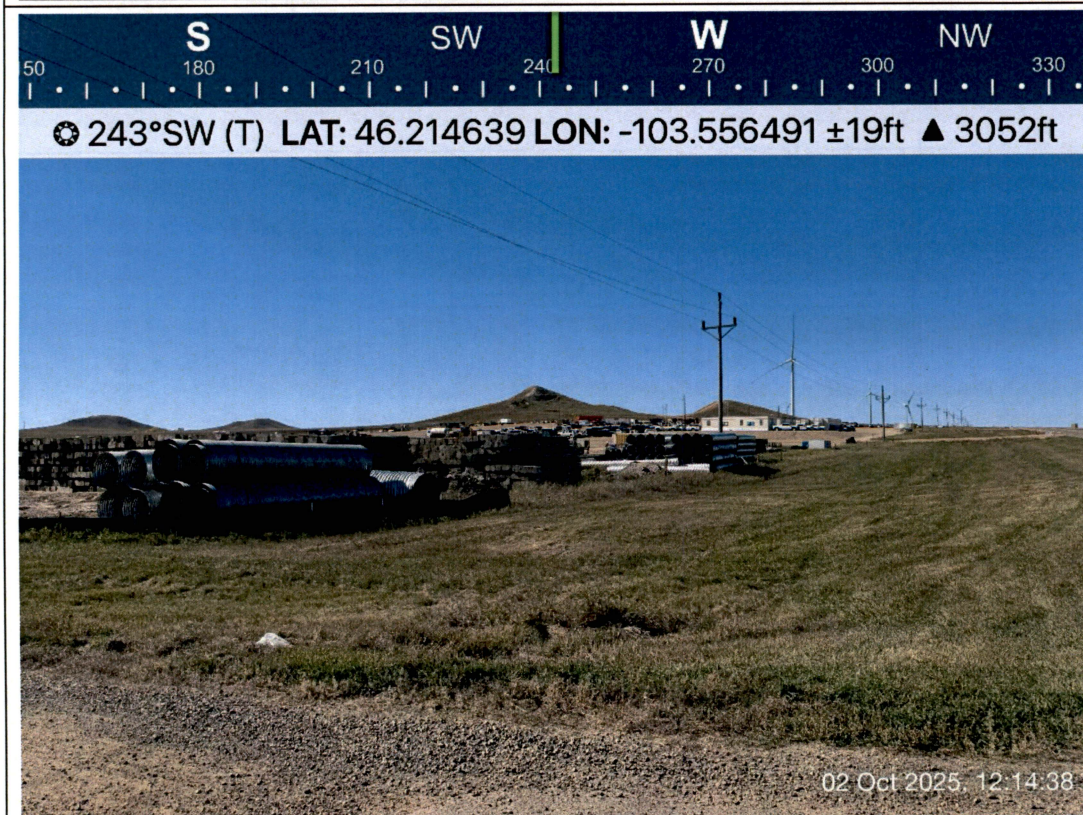
Photo #: 12

Description: Laydown yard and O&amp;M buildings.
