MDU 230 kV Transmission Line Project- Morton County

Reclamation Inspection Report

Docket Number: PU-21-151

Prepared for North Dakota Public Service Commission

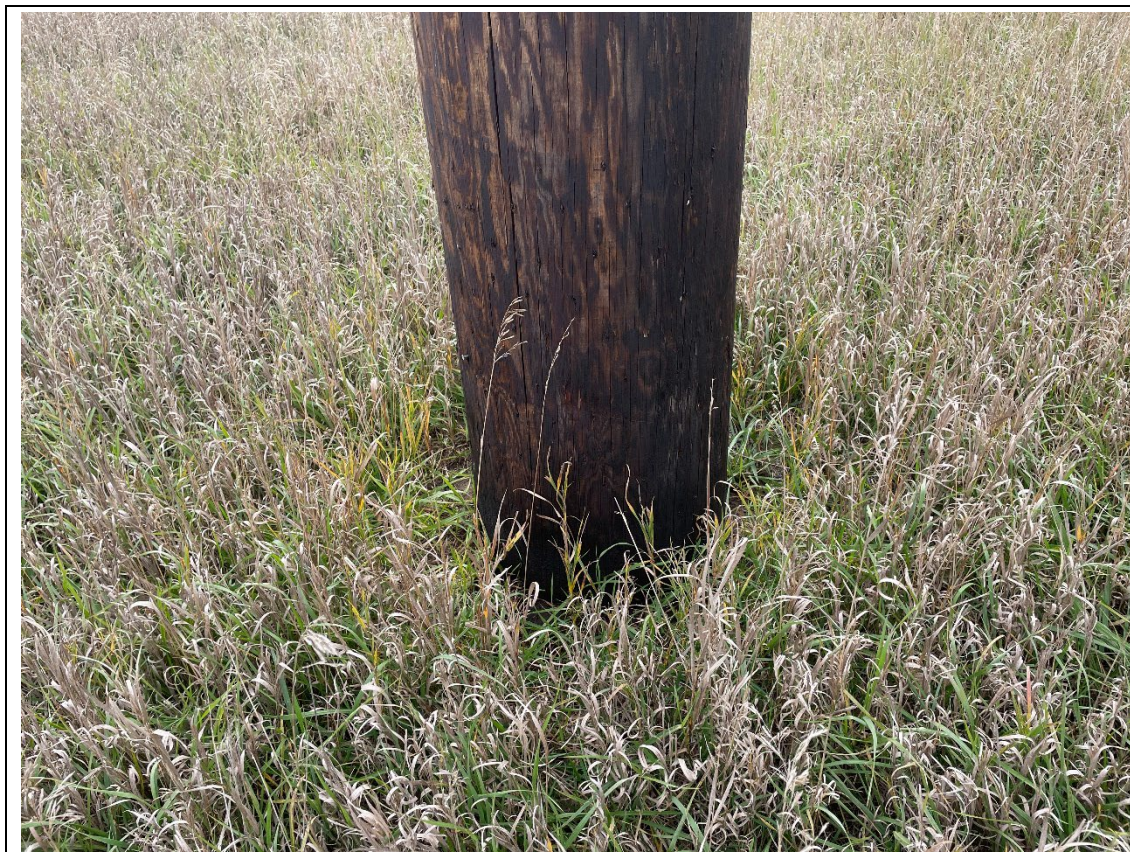
Photo #: 1

Description: Vegetation reestablished at base of Structure #14. Composed of planted native seed mix and smooth brome.

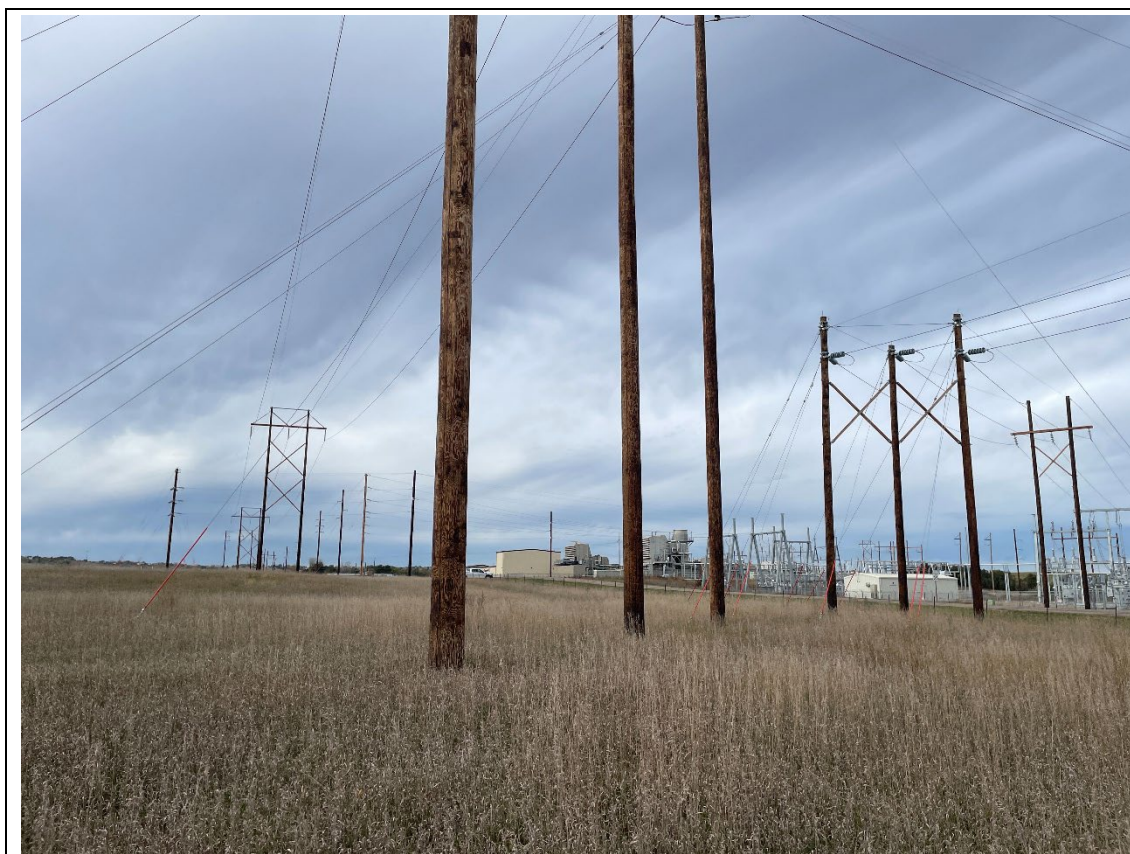
Photo #: 2

Description: Overview of Structures #12, 13, and 14.

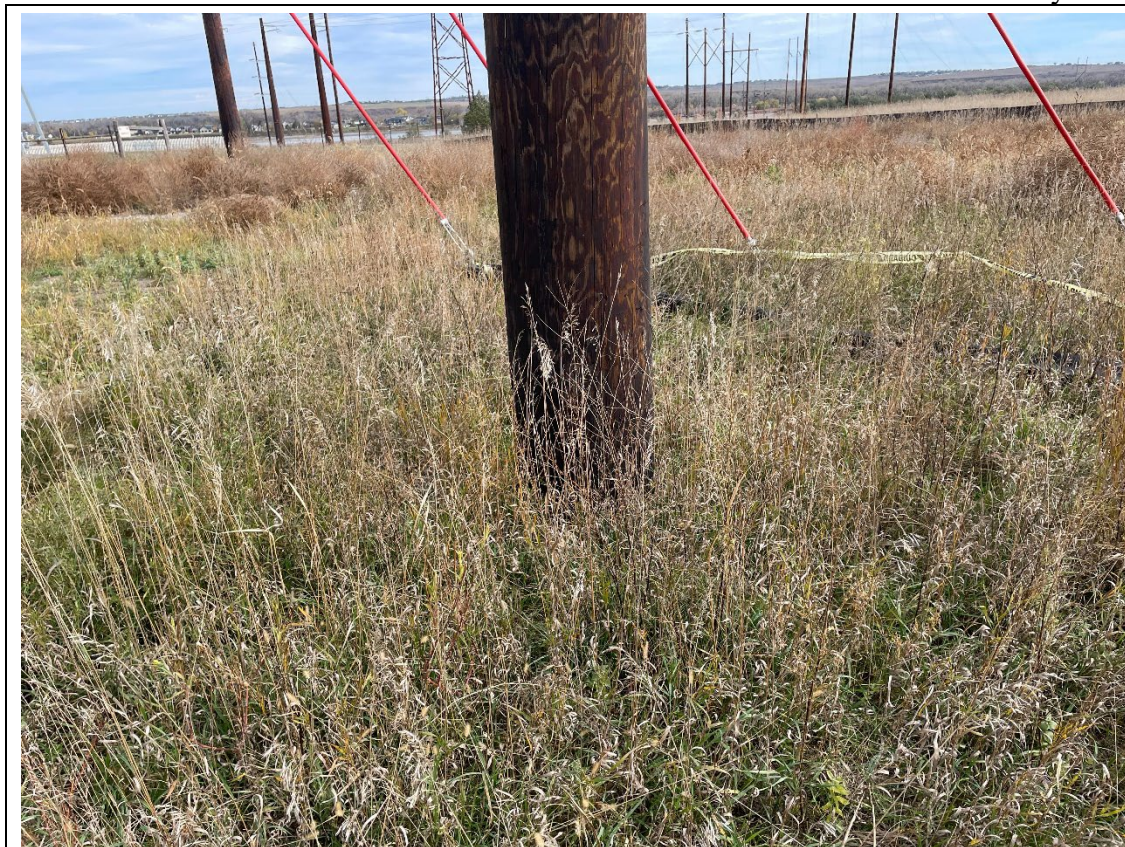
Photo #: 3

Description: Structure #13 with established vegetation composed of planted native grasses and smooth brome.

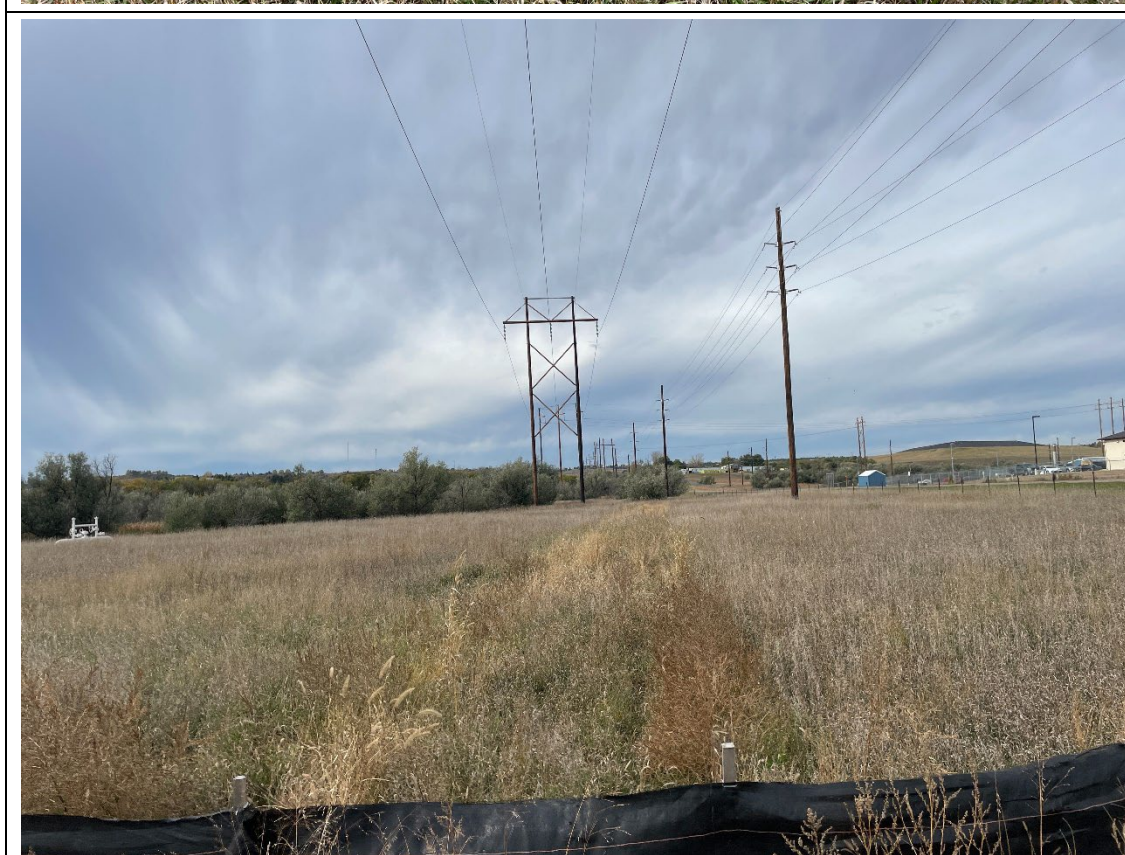
Photo #: 4

Description: Reseed area between Structures #12 and 13. Vegetation composed of planted native grasses along with smooth brome and weeds encroaching from adjacent areas

| Potential Issues | Recommendations |
|--|---|
| Areas with dense, extensive cover of annual weeds or noxious weeds. | Monitor and manage these areas to promote the establishment of grasslands and crops. Consult with landowners and ag producers to determine course of action. Spraying or periodic mowing of noxious weeds and annual weeds may be necessary to decrease the seed set of undesirable and nuisance species. |

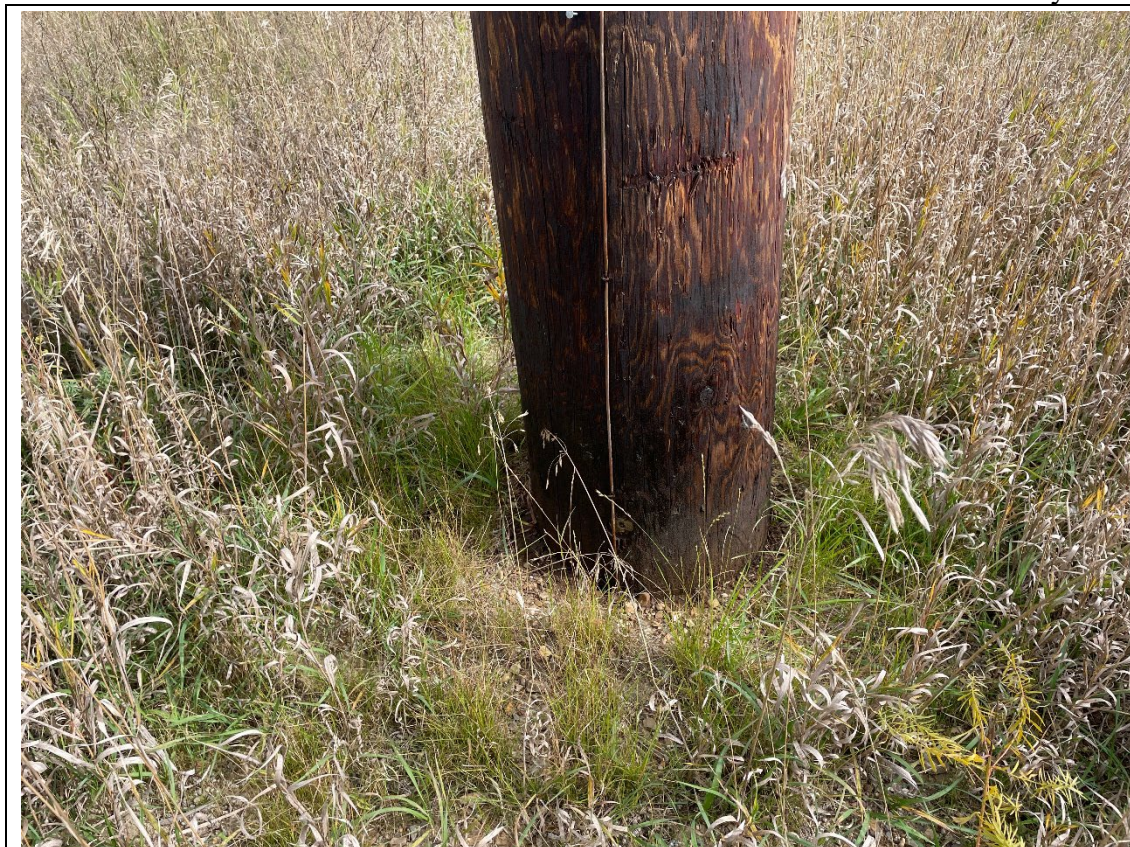
Photo #: 5

Description: Base of Structure #12. Established vegetation composed of planted native grasses with smooth brome encroaching from adjacent area.

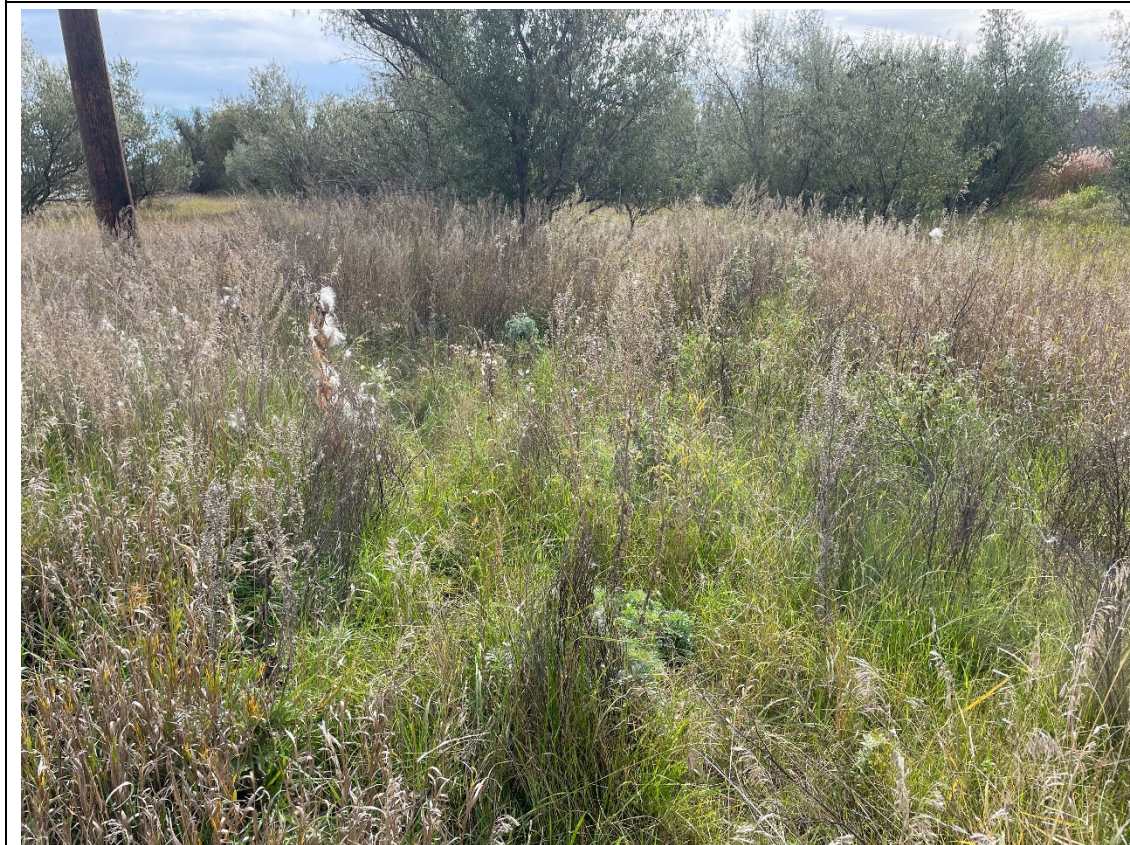
Photo #: 6

Description: Reclaimed area near Structure #12 where underground gas line was damaged during construction. Vegetation composed of a mix of planted native grass and smooth brome, Canada thistle, absinth wormwood, and leafy spurge.

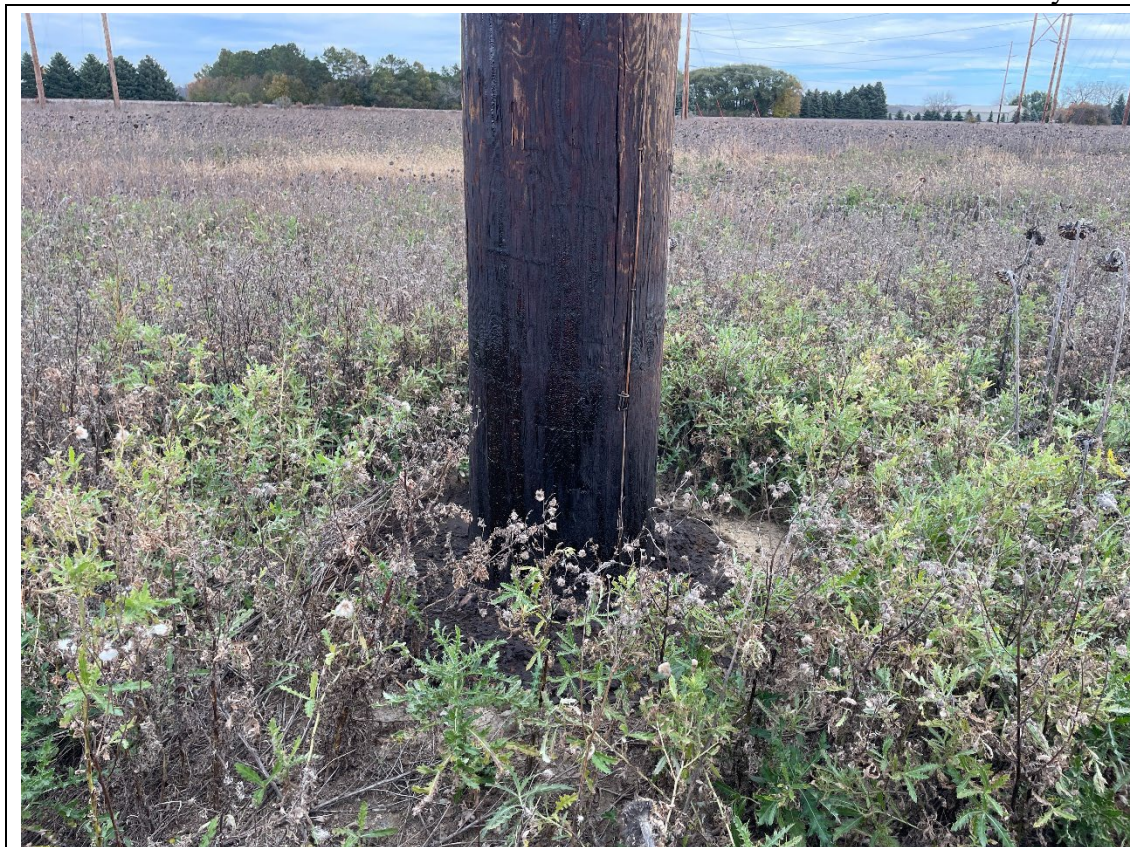
Photo #: 7

Description: Base of Structure #1 showing creosote seeping from pole. Vegetation composed of weeds and sunflowers similar to adjacent areas of crop field not disturbed by construction activities.

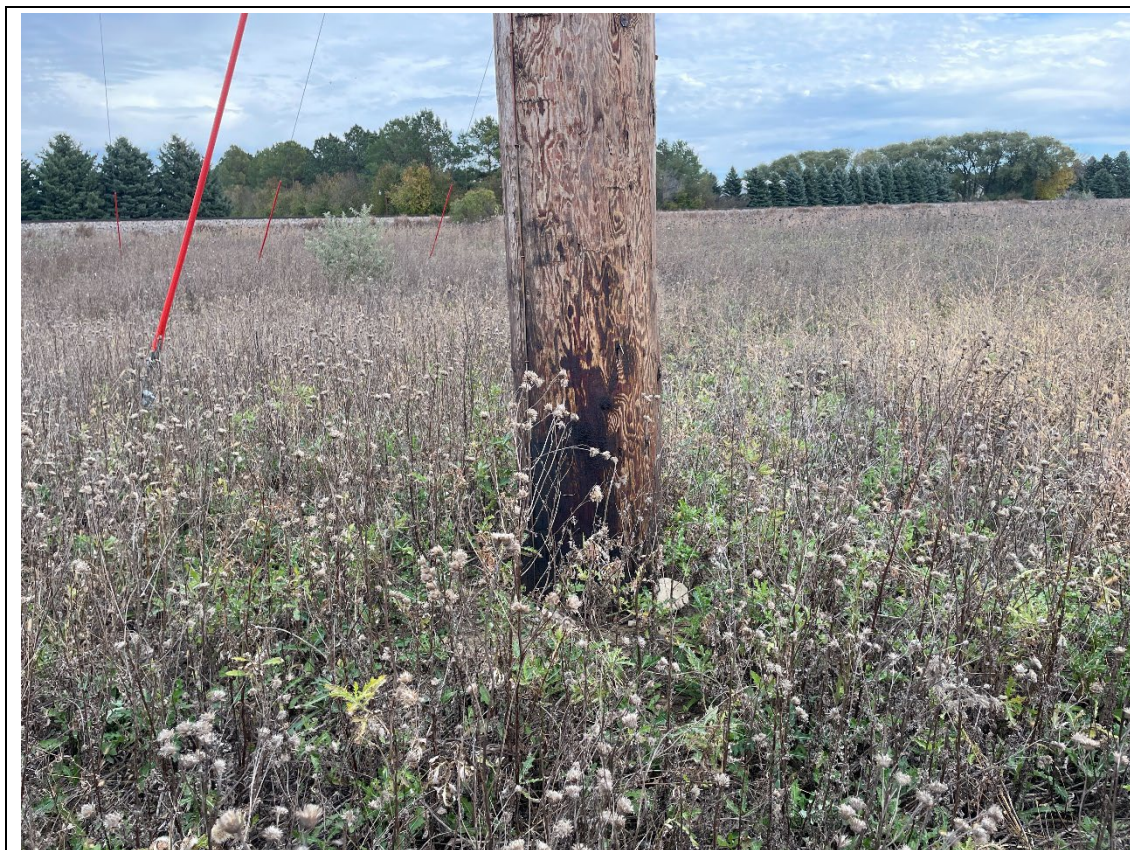
Photo #: 8

Description: Structure #2 located in sunflower field. Vegetation and ground cover is similar to adjacent areas of crop field not disturbed by construction activities.

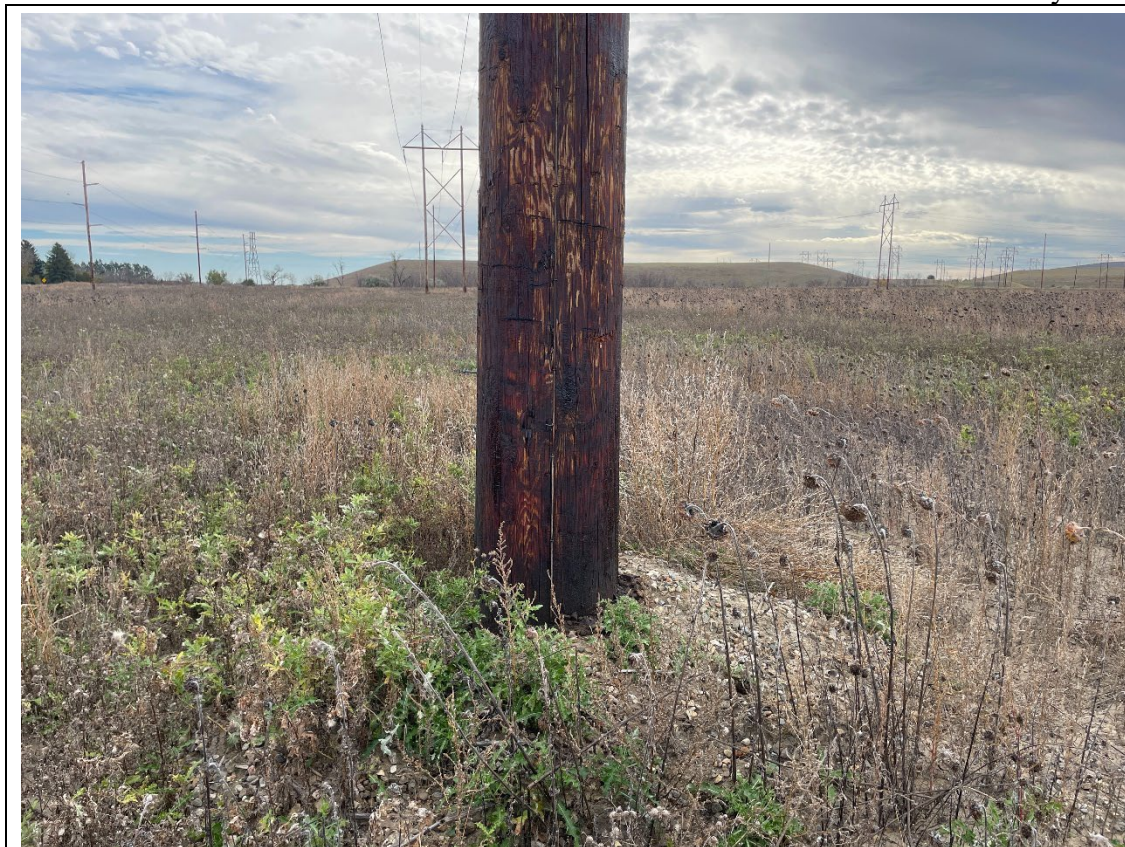
Photo #: 9

Description: Structure #3 located in sunflower field. Vegetation and ground cover is similar to adjacent areas of crop field not disturbed by construction activities.

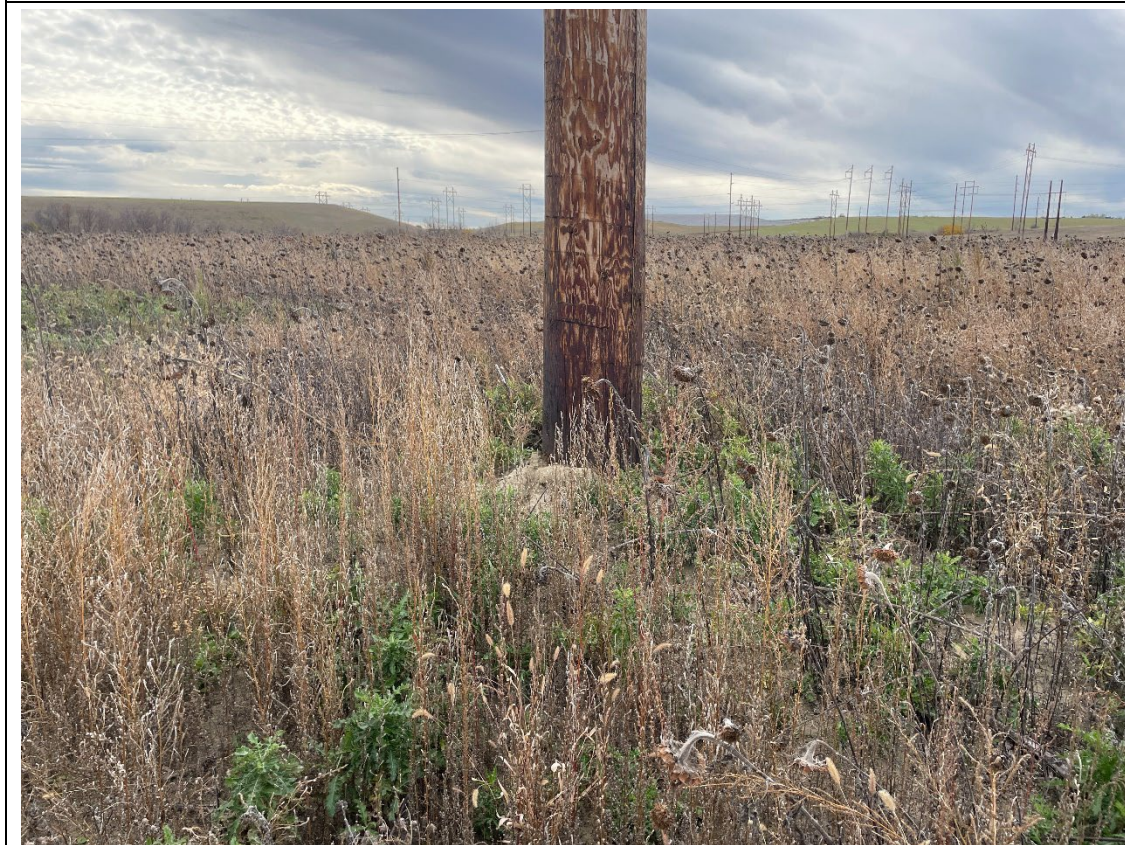
Photo #: 10

Description: Structure #4 located in sunflower field. Vegetation and ground cover is similar to adjacent areas of crop field not disturbed by construction activities.

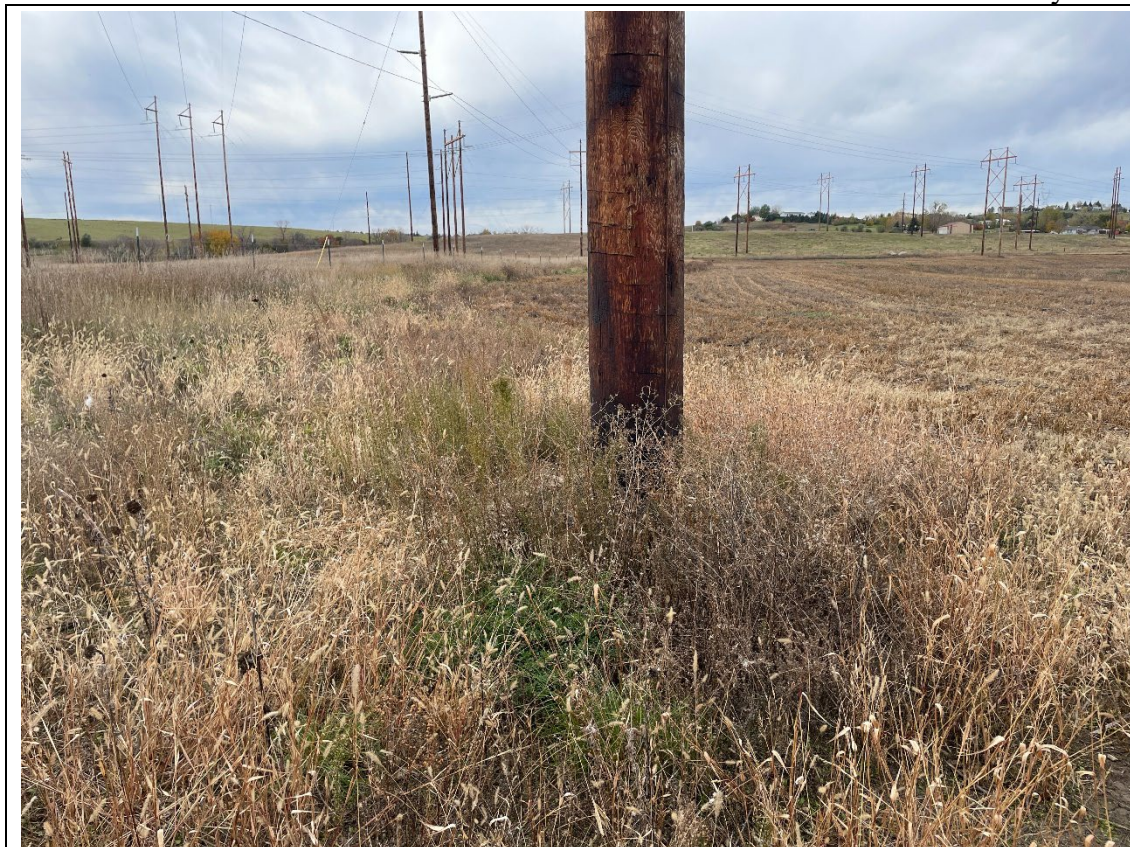
Photo #: 11

Description: Structure #6 located on edge of sunflower field.

Vegetation composed of planted native grasses and encroaching crested wheatgrass from adjacent areas.

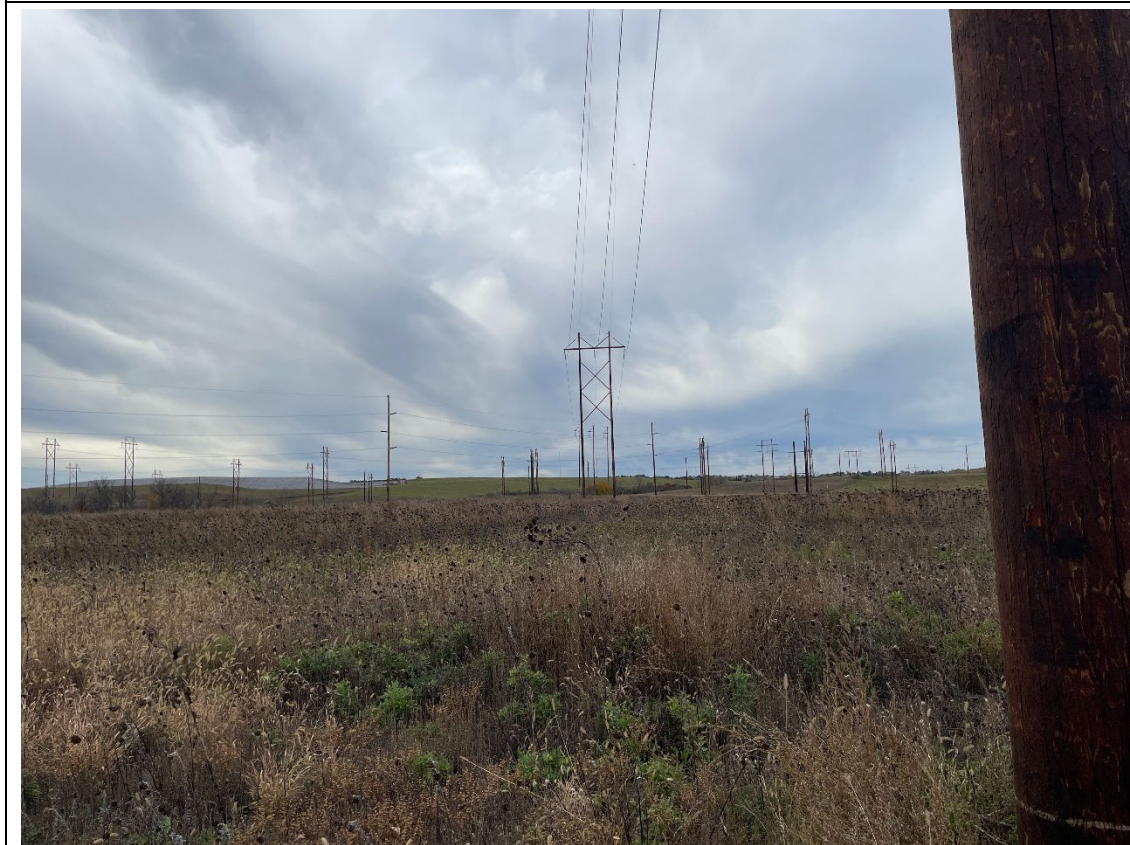
Photo #: 12

Description: Overview of Structures #1, 2, 3, 4, and 5 located in sunflower field.

Condition of areas disturbed by construction activities similar to adjacent areas not disturbed by construction activities.
