## INCIDENT INVESTIGATION #209476

806 Bruegger St, Alexander, ND

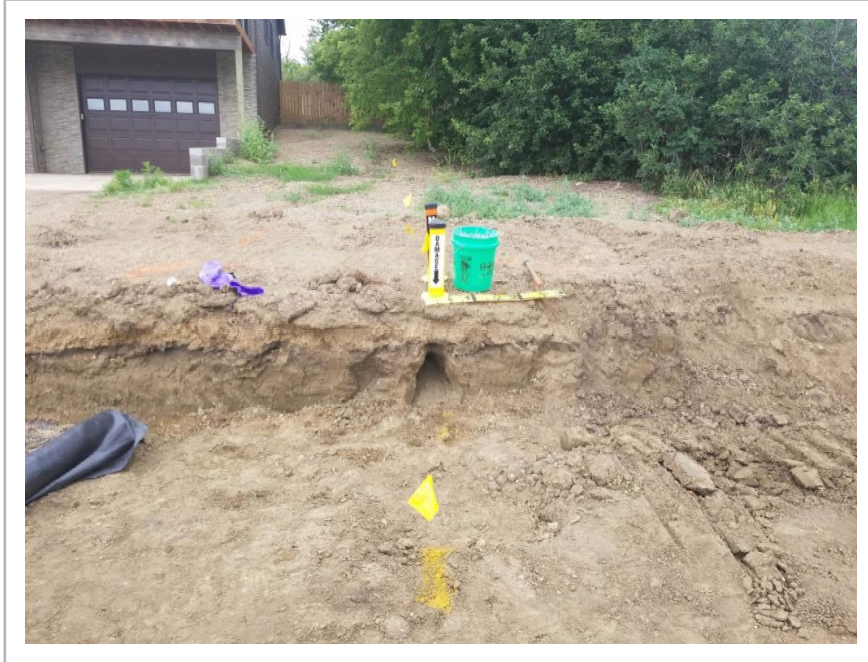
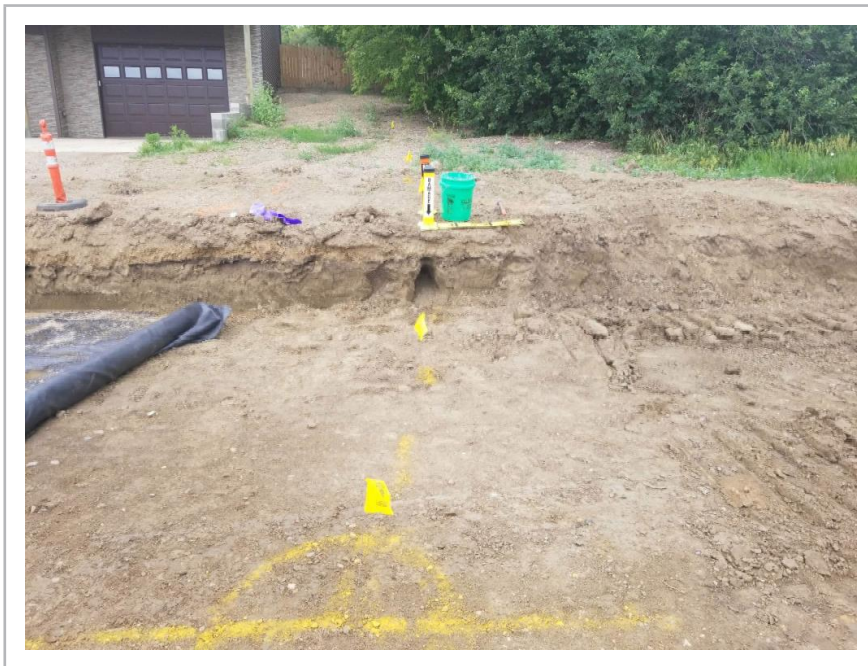
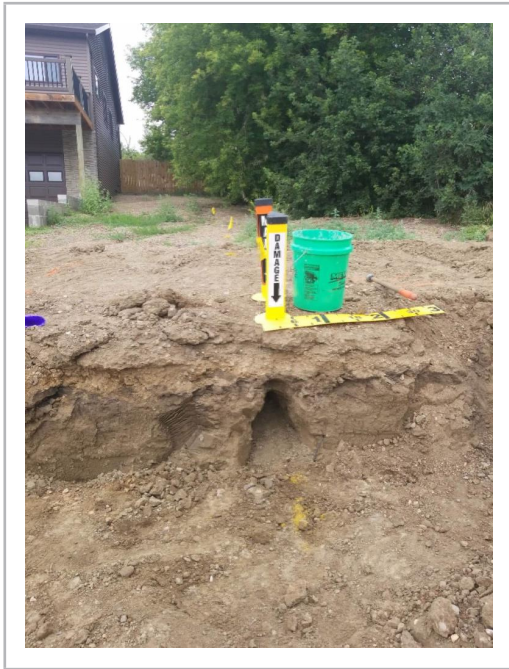
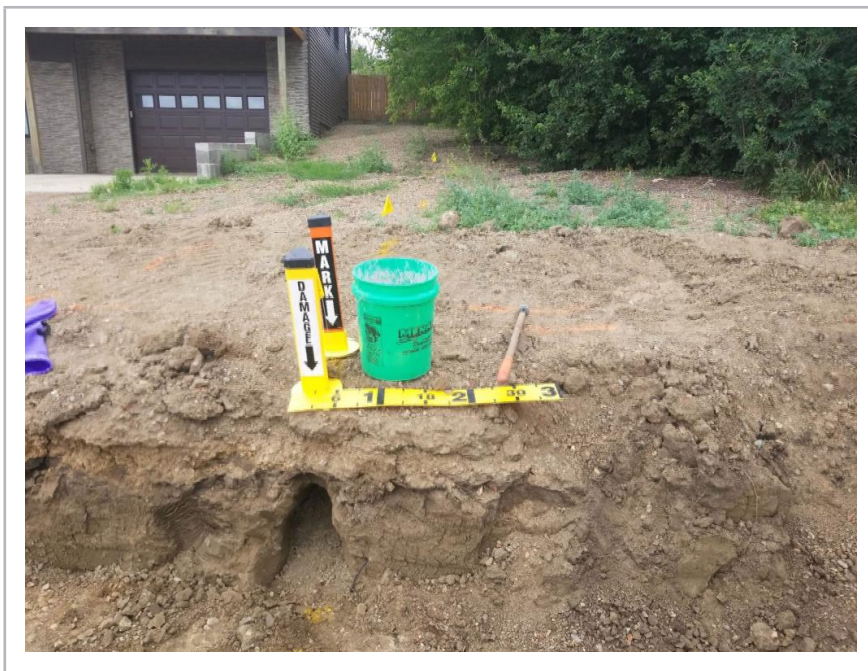
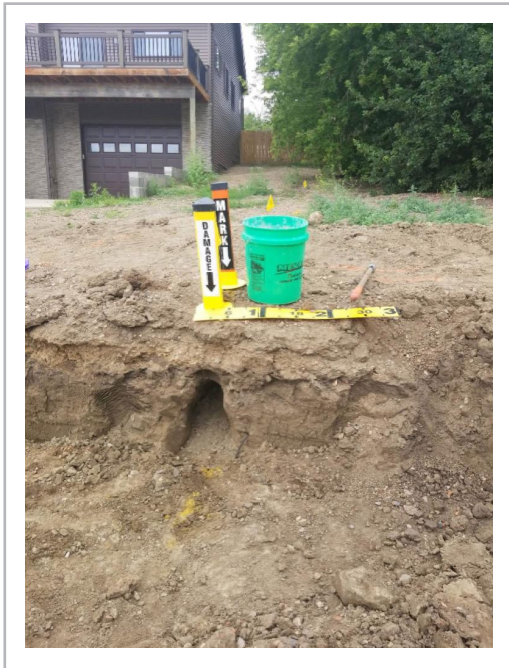
**Root Cause:** Excavator failed to maintain clearance after verifying marks

**Assessment Comments:** Utility exposed. Contractor still hit. Locator marks were accurate.
