## INCIDENT INVESTIGATION #209477

820 Brugger St, Alexander, ND

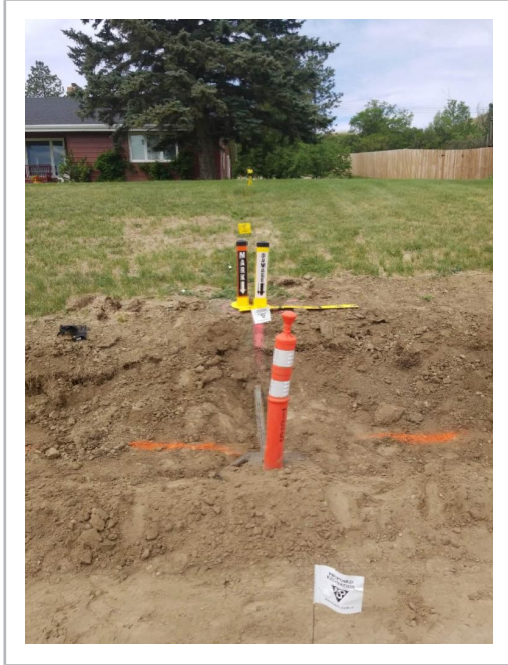
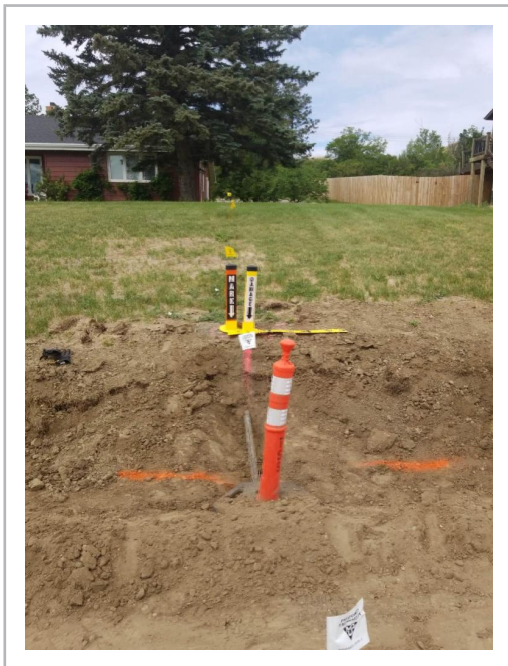
# NEW INCIDENT PHOTOS

**Assessment Comments:** Utility exposed. Contractor still hit. Locator marks accurate.
