# Hiland Crude, LLC

2.9-mile Crude Oil Pipeline – Williams County

Case No. PU-21-353

Topsoil Removal Inspection Report

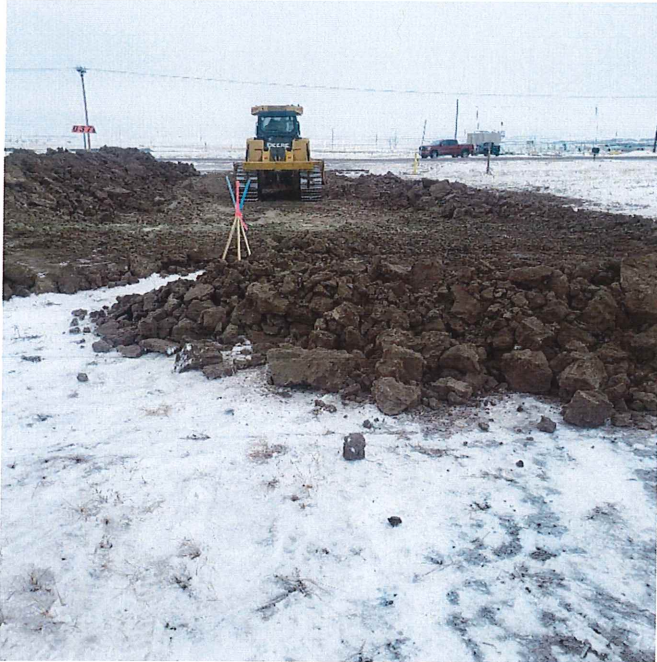
P3 - STA 4+11 BK, Topsoil Removal

\* 1100 Initial work began at prepping tie-in to wood mats along east side of Co Hwy 42 with subsoil after topsoil was stripped and windrowed RT of pipeline centerline (See P3). Inspector checked depth of existing topsoil near tie-in to wood mats with use of tape measure. Topsoil measured at 6 inches (See P4). Topsoil and subsoil was observed as frozen. Day's planned work area starting at Co Hwy 42 to approximately STA 21+00 consists of hay crop which has already been harvested. Majority of visible vegetation is less than 6 inches high. Within the first section of topsoil stripping, it was observed that subsoil appeared as a light tan to gray in color compared to dark brown topsoil (See P31, P33, P34). Subsoil appears to be a sandy lean loam.

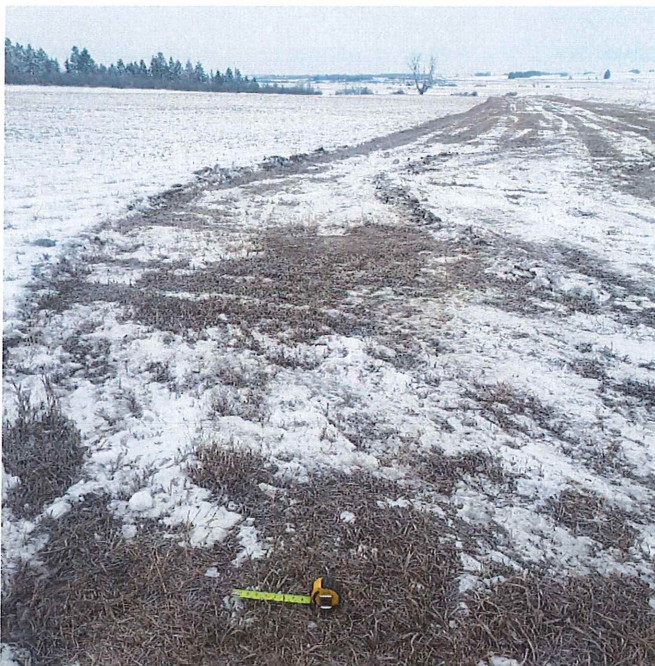
P19 - STA 12+42 AH, Existing Vegetation

\* Prior to start of topsoil stripping beyond entrance location, Brandon Myran walked day's planned area to make initial field observations (See P9-P26). Construction ROW area consisted of crop land previously used for hay production. For reference of existing vegetation, Brandon Myran used tape measure to record existing vegetation (See P19, P20).

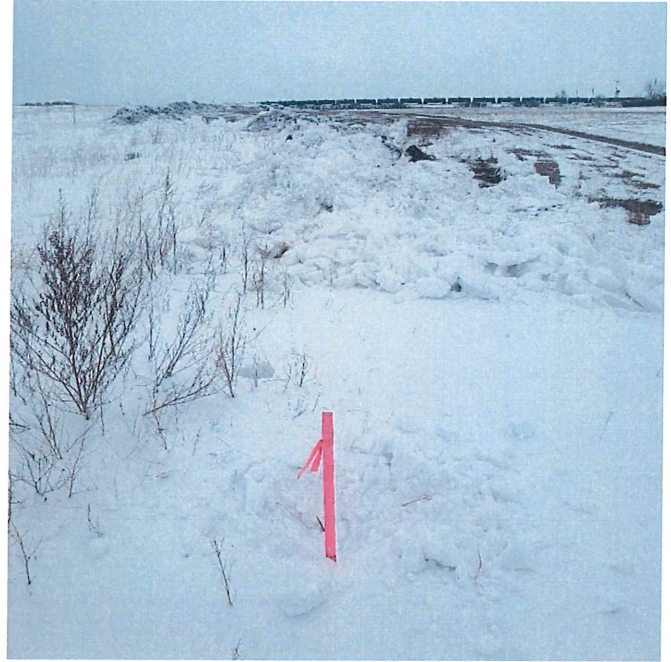
P26 – STA 21+95 BK, End of Snow Removal

\* Previous work on 01/12/2022 included windrowing of snow piling right (RT) of pipeline centerline along construction Right of Way (ROW) starting at Co Hwy 42 and ending at approximately STA 21+00 (See P26). Also completed was installment of walking wood mats crossing the east side ditch of Co Hwy 42.

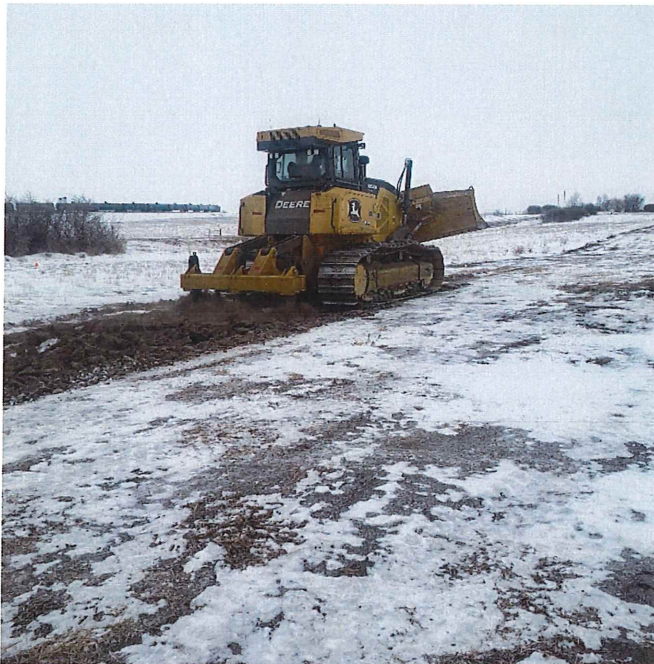
P27 – STA 6+00 AH LT, Longitudinal Topsoil Ripping

- 1308-1330 Dozer operator starts making passes on left edge of pipeline work zone from STA 4+50 to STA 7+00 using 3 prong ripper spaced 3 feet apart each on dozer. Plan is to only make 250 foot stretches at a time. Dozer makes 2 passes (1 down and 1 back) offsetting slightly from the previous pass in order to minimize size of frozen topsoil chunks and continues from left of centerline to right of centerline (See P27, P28, P29).

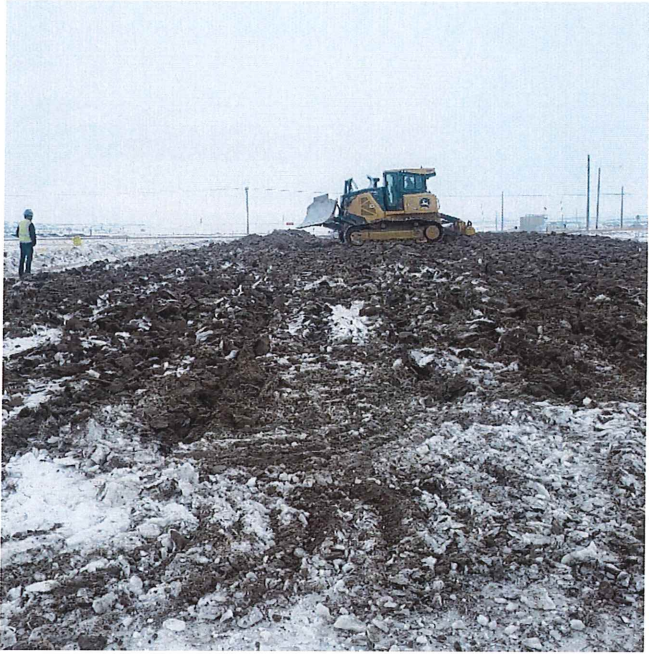
P30 – STA 6+00 BK, Perpendicular Topsoil Ripping

- 1330-1350 Dozer than starts ripping topsoil perpendicular (See P30) from pipeline alignment to have cross ripping starting at STA 4+50 and shifting toward STA 7+00.

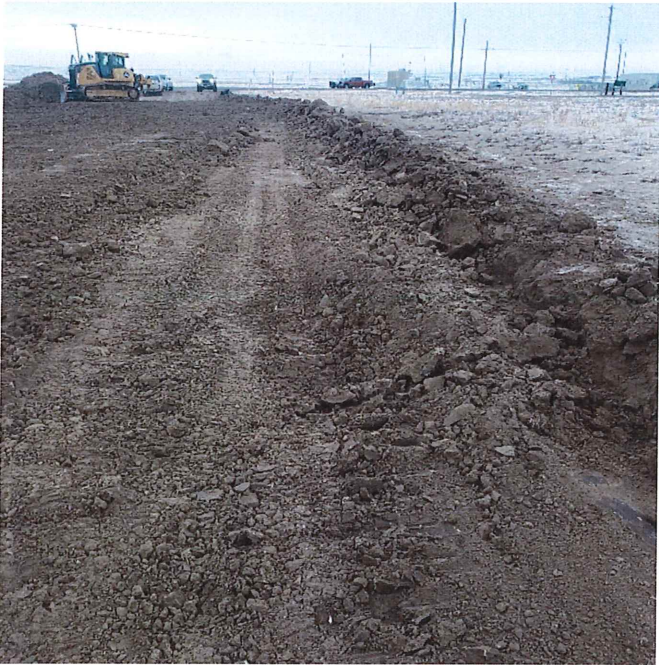
P31 – STA 6+60 Topsoil Removal

No concerning issues were identified during inspection. Inspector only had to notify contractor foreman and equipment operator of one location at approximately STA 6+60, 30 feet each way where topsoil depth check thinned out less than 5 Inches. Contractor was notified dozer ripper prongs won't need to go any deeper once topsoil transition to subsoil is reached. Contractor is to adjust appropriately to maintain segregation and avoid over cutting.

- 1400-1410 Dozer starts shoving topsoil from Left of Centerline to Right of Centerline (See P31).
- John Deere Excavator begins assisting by pulling topsoil from Left of Centerline to more of center of pipeline. Excavator operator is assisting at this point until they get closer to next ditch crossing where wood mats will be used.
